# D4-B Plant-011 Building 222-B

## FACILITY STATUS CHANGE FORM

Date Submitted: 9-18-2018	Area: 200 East	Control Number: D4-B Plant-011
Originator: D. Turlington/ S. Guillen	Facility ID: 222-B	Phone: 509-373-0176

**Asbestos Building Inspection**  
**222-B/200 East Area**  
**March 5, 2018**

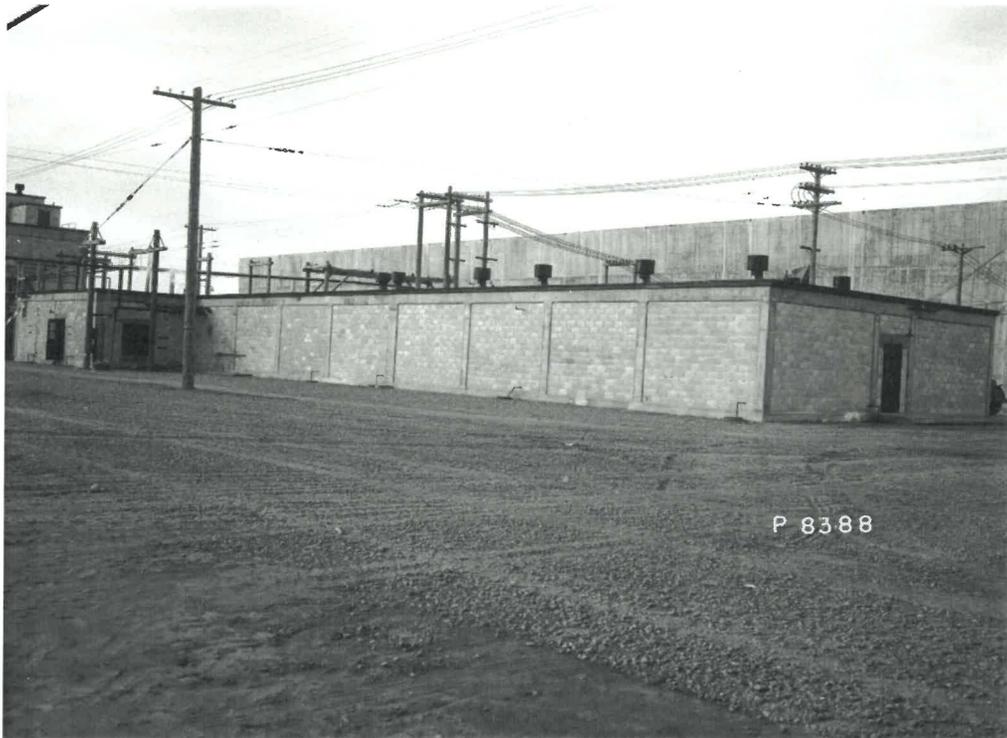
**222B Before Demolition**

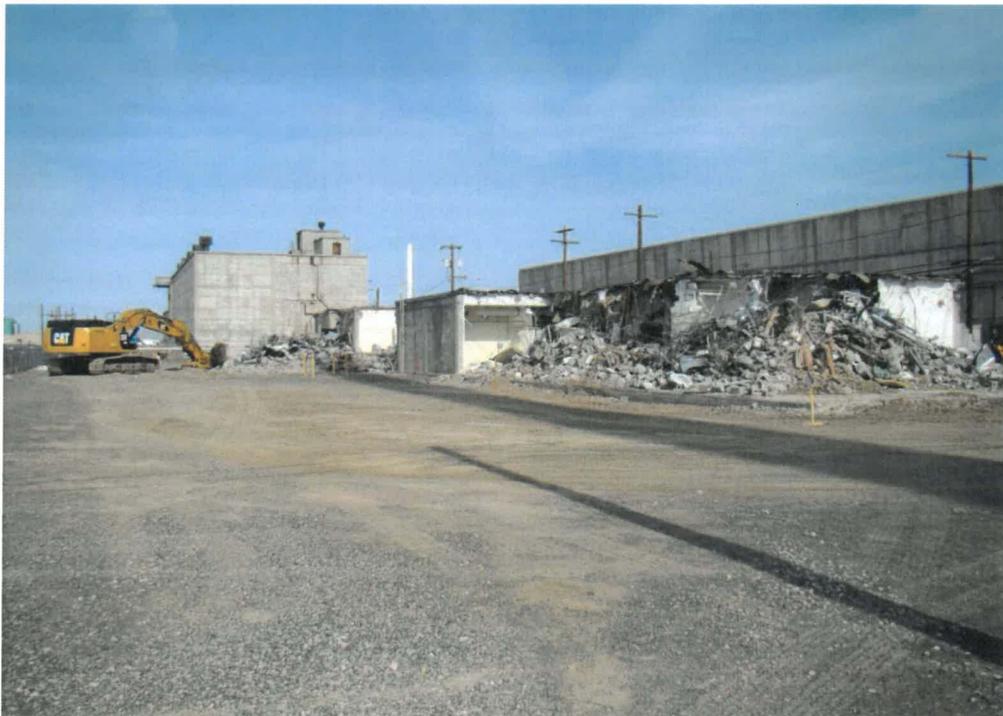
**222B During Demolition**

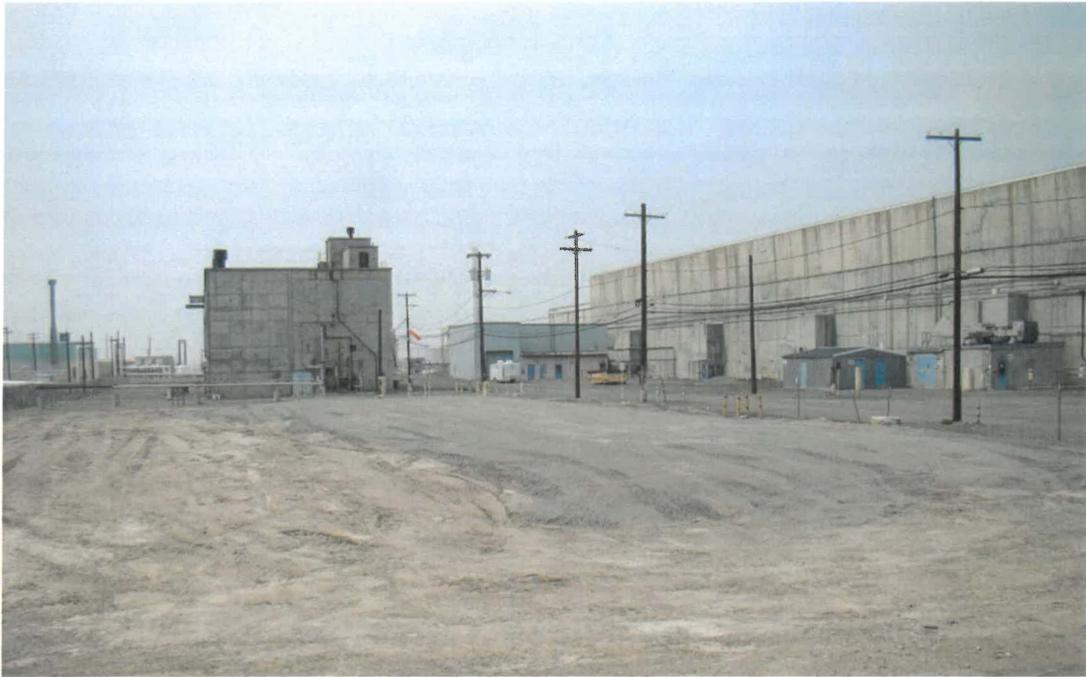
**222B After Demolition**

Above Grade structure completely removed down to grade, the slab was left in place, all penetrations were grouted and plugged and a minimum 6" gravel (5/8 minus) cap was placed over and contoured.

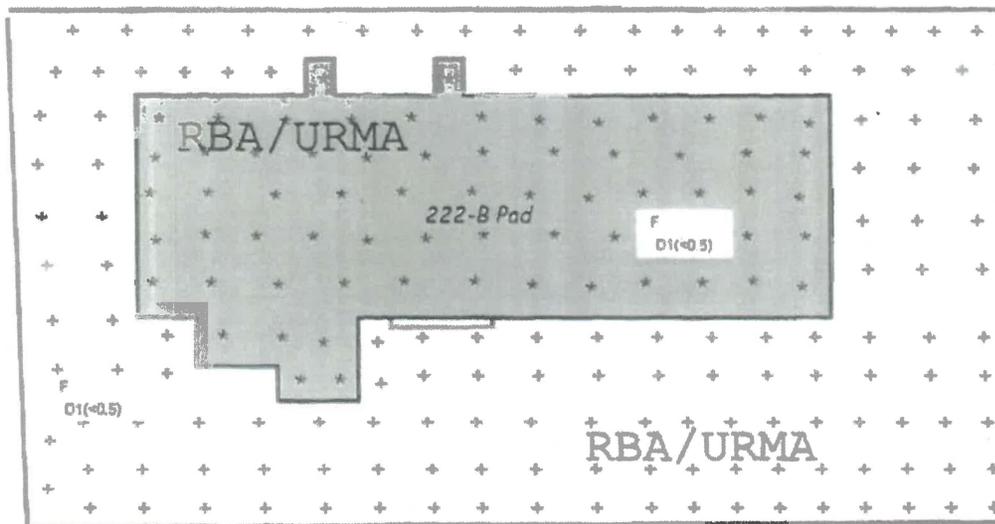
Map Name: 222-B RBA

SURVEY PERFORMED WITH NO INDICATION OF PREVIOUSLY IDENTIFIED FCA 22B-010 AND 011, POSTED DEMO AND DEBRIS REMOVED. CONFIRMED WITH PERFORMING RCT THAT HAS SINCE LEFT THE COMPANY. THIS INFORMATION WAS USED TO CLOSE OUT THE FCA LOG AND ANNUAL ROUTINE SURVEILLANCE TASK FOR THESE FCA'S  
*[Signature]* 2/1/18
