## FACILITY STATUS CHANGE FORM

<b>Date Submitted:</b> Apr 28, 2008 <b>Originator:</b> M. L. Proctor <b>Phone:</b> 521-9622	<b>Area:</b> 300 <b>Facility ID:</b> 3706/3706A <b>Action Memorandum:</b> #1 for the 300 Area	<b>Control #:</b> D4-300-006
--	--	---------------------------------

## Attachment 1: Facility Information

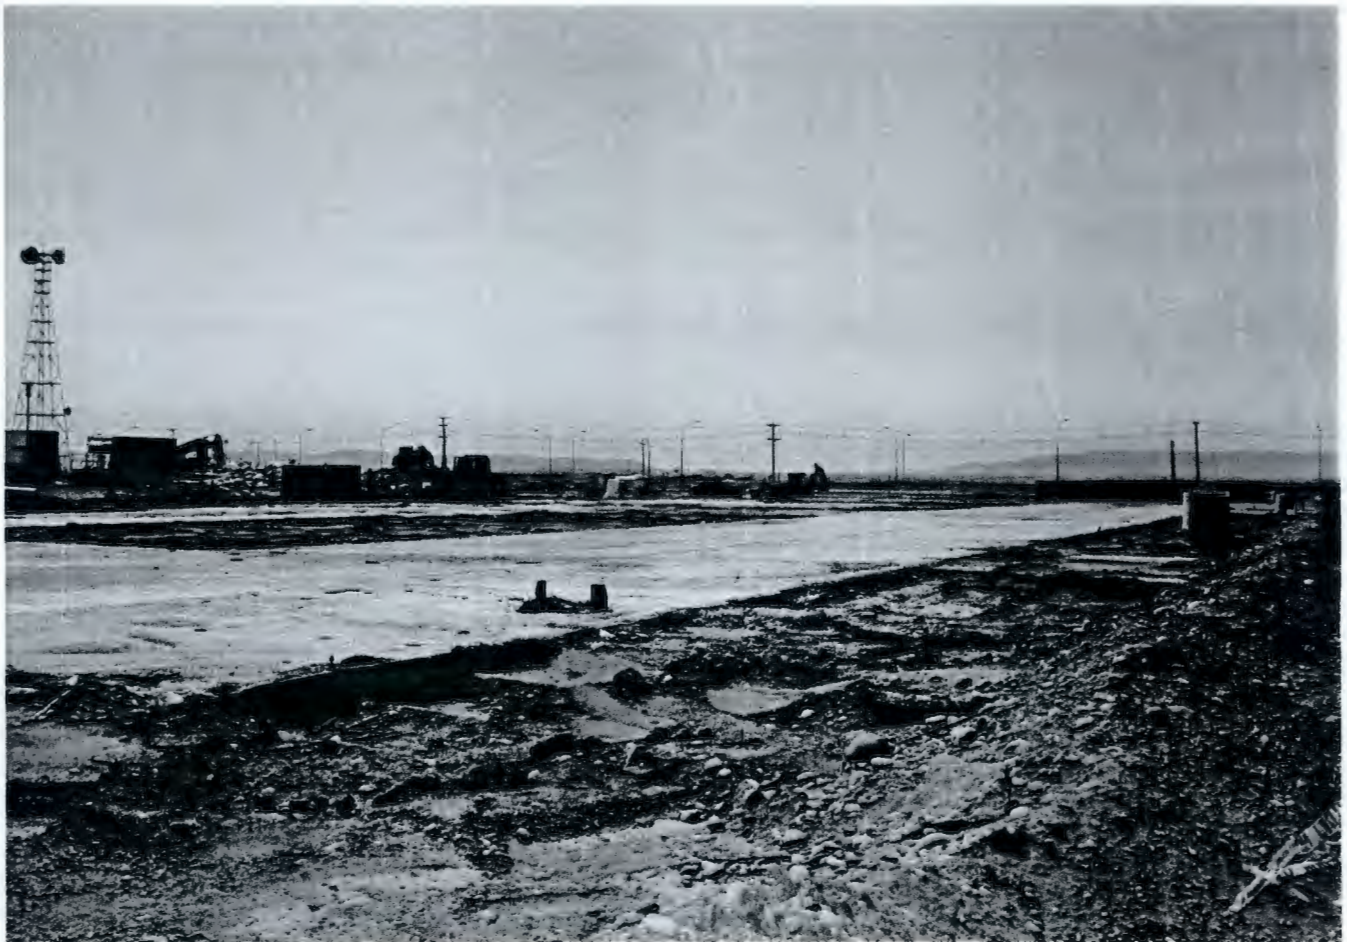
View of 3706 Concrete Slab from the Northeast (May 2006)
