Project W-566 AZ-102 Condensate Line Independent Integrity Assessment Report

Tank Operations Contractor (TOC) RECORD OF REVISION		(1) Document Number: RPP-RPT-50189	Page 1
(2) Title: Project W-566 AZ-102 Condensate Line Integrity Assessment Report			
Change Control Record			
(3) Revision	(4) Description of Change – Replace, Add, and Delete Pages	Authorized for Release	
		(5) Resp. Engr. (print/sign/date)	(6) Resp. Mgr. (print/sign/date)
1 RS	A complete revision by the IQRPE to add clarity to the document following discussions with Ecology.	Jeremy J. Whitcomb

AZ-102 CONDENSATE LINE

AZ-102 Condensate Line replacement

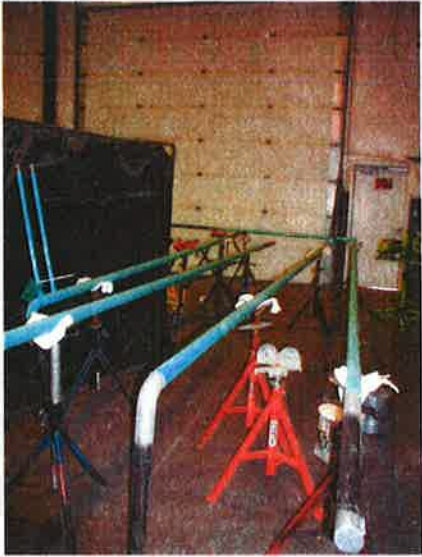
<p>Four AZ piping spool pieces</p> </div> <div style="text-align: center;">

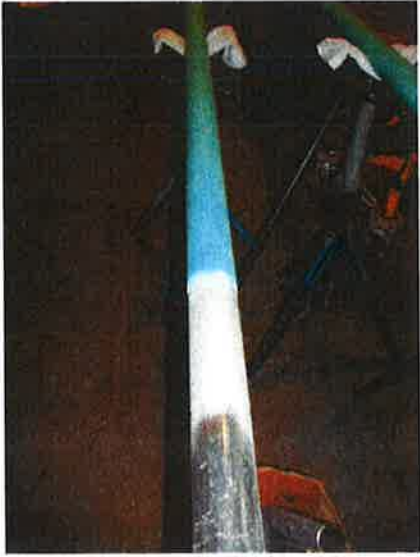
<p>Close-up of field joint holdback</p> </div> </div>

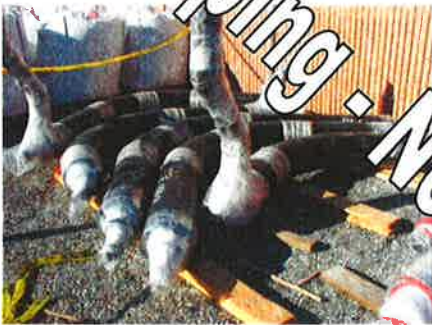
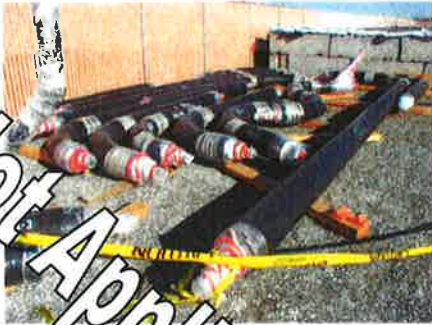
</div> <div style="display: flex; justify-content: space-around;"> <p>Insulated SY piping in Richland</p> <p>Insulated SY piping in Richland</p> </div>

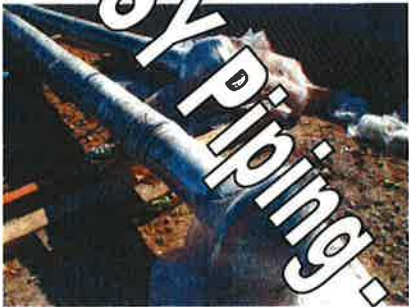
</div> <p>Insulated and wrapped SY piping in Pasco</p> <p>Coating repair area</p> <p>After our inspection work was completed, a meeting was held at Meier Architects with myself, Rod Powell (Meier), and Don Laegre (WRPS). Discussions were held concerning all coating inspection work that has been completed to date as well as field work that is anticipated to start in the mid March time frame (AZ piping installation). I pointed out that I would like to have access to the installation locations as the piping is being installed and the field joints are being coated. I was informed that efforts would be made to try to accommodate. Installation timing of the SY piping was not known, but estimates put it somewhere in the mid March time frame. There will be a total of eight separate SY piping lines that are to be installed. Again, I requested that I be allowed to have access to the installation area in order to witness the coating work associated with the installation of the field joints.</p> <p>I informed the clients that I would provide them with a C'D that contains all inspection reports to date, a summary of the coating inspection work completed to date, and copies of all photographs.</p>
