## FACILITY STATUS CHANGE FORM

| <b>Date Submitted:</b><br>April 14, 2011 | <b>Area:</b><br>300 Area | <b>Control #:</b><br>D4-300-040 |
| <b>Originator:</b><br>John Harrie | <b>Facility ID:</b><br>323 Mechanical Properties Laboratory | |

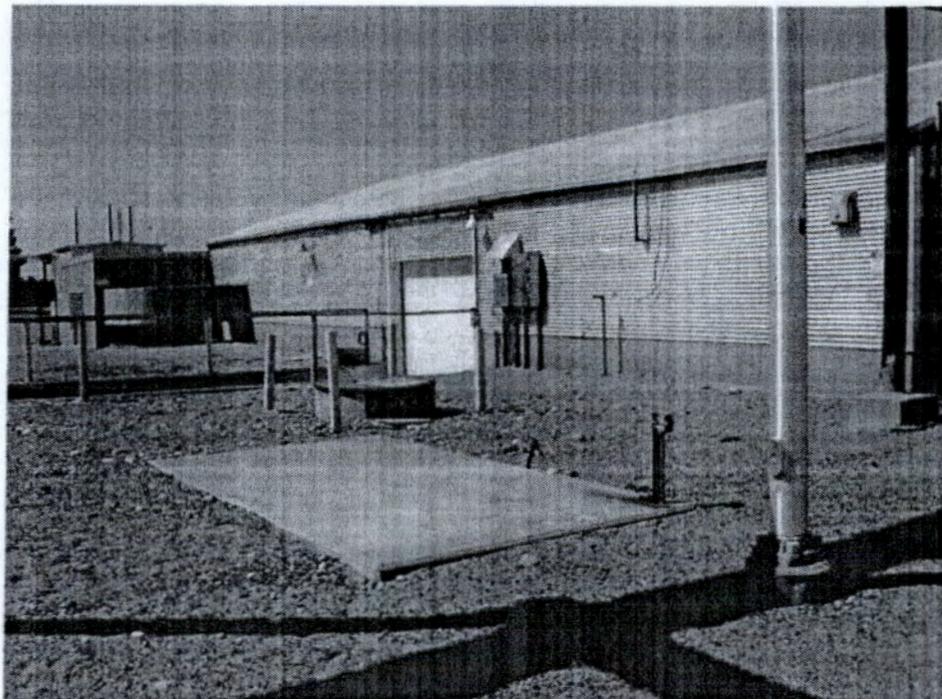
**Figure 2. 323 Building, Pre-Demolition May 2006**

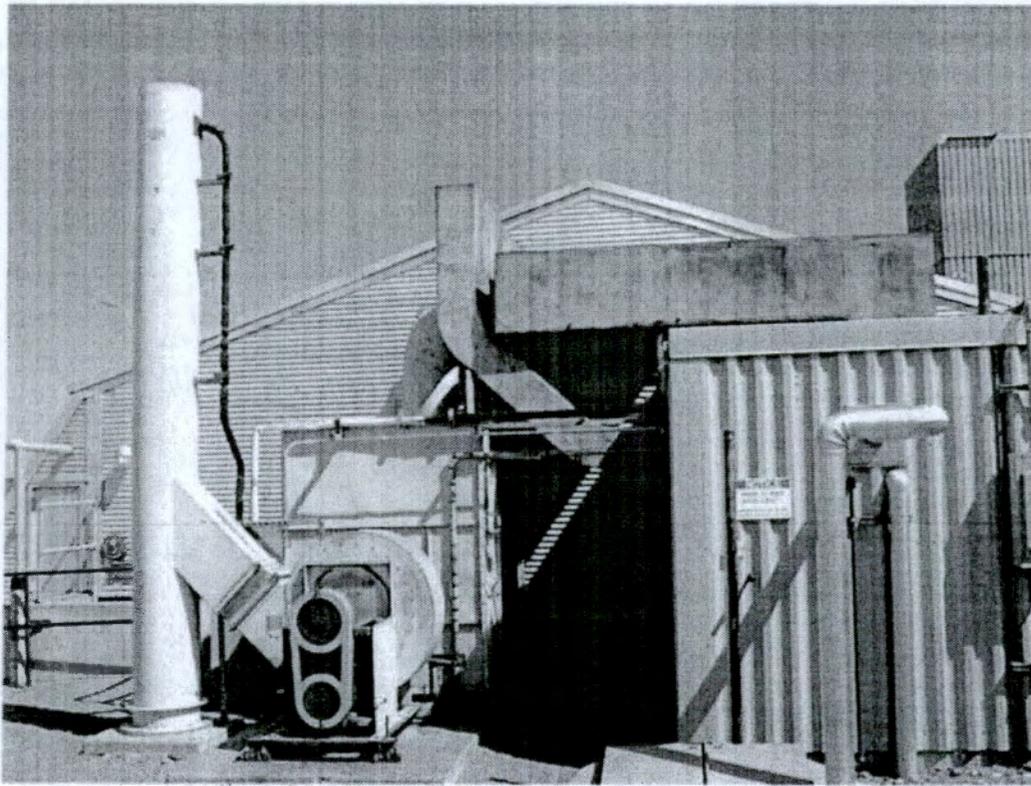
**Figure 3. 323 Building Site Ventilation System, Pre-Demolition**

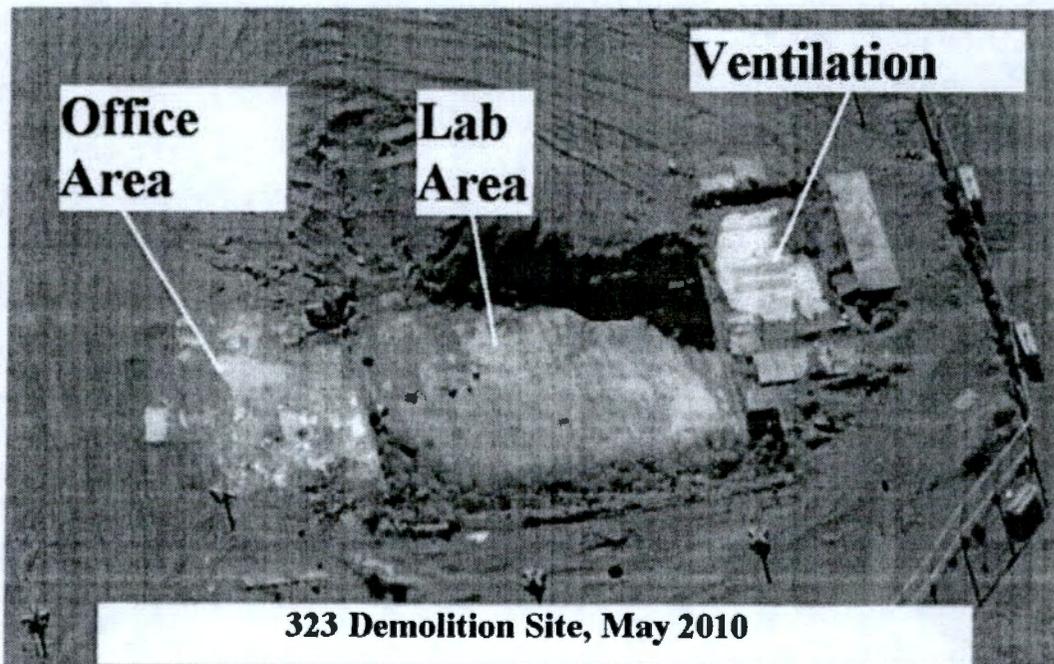
All above-ground 323 building structures were removed. The below-grade slabs associated with the 323 building and ventilation system and below-slab tanks have been left in-place.

**Figure 4. 323 Building Site, Post-Demolition**
