DOCUMENT NO. RHO-CD-1076

DATE September 1980

STRUCTURAL EVALUATION OF THE PUREX NO. 1 BURIAL TUNNEL

G. R. Silvan

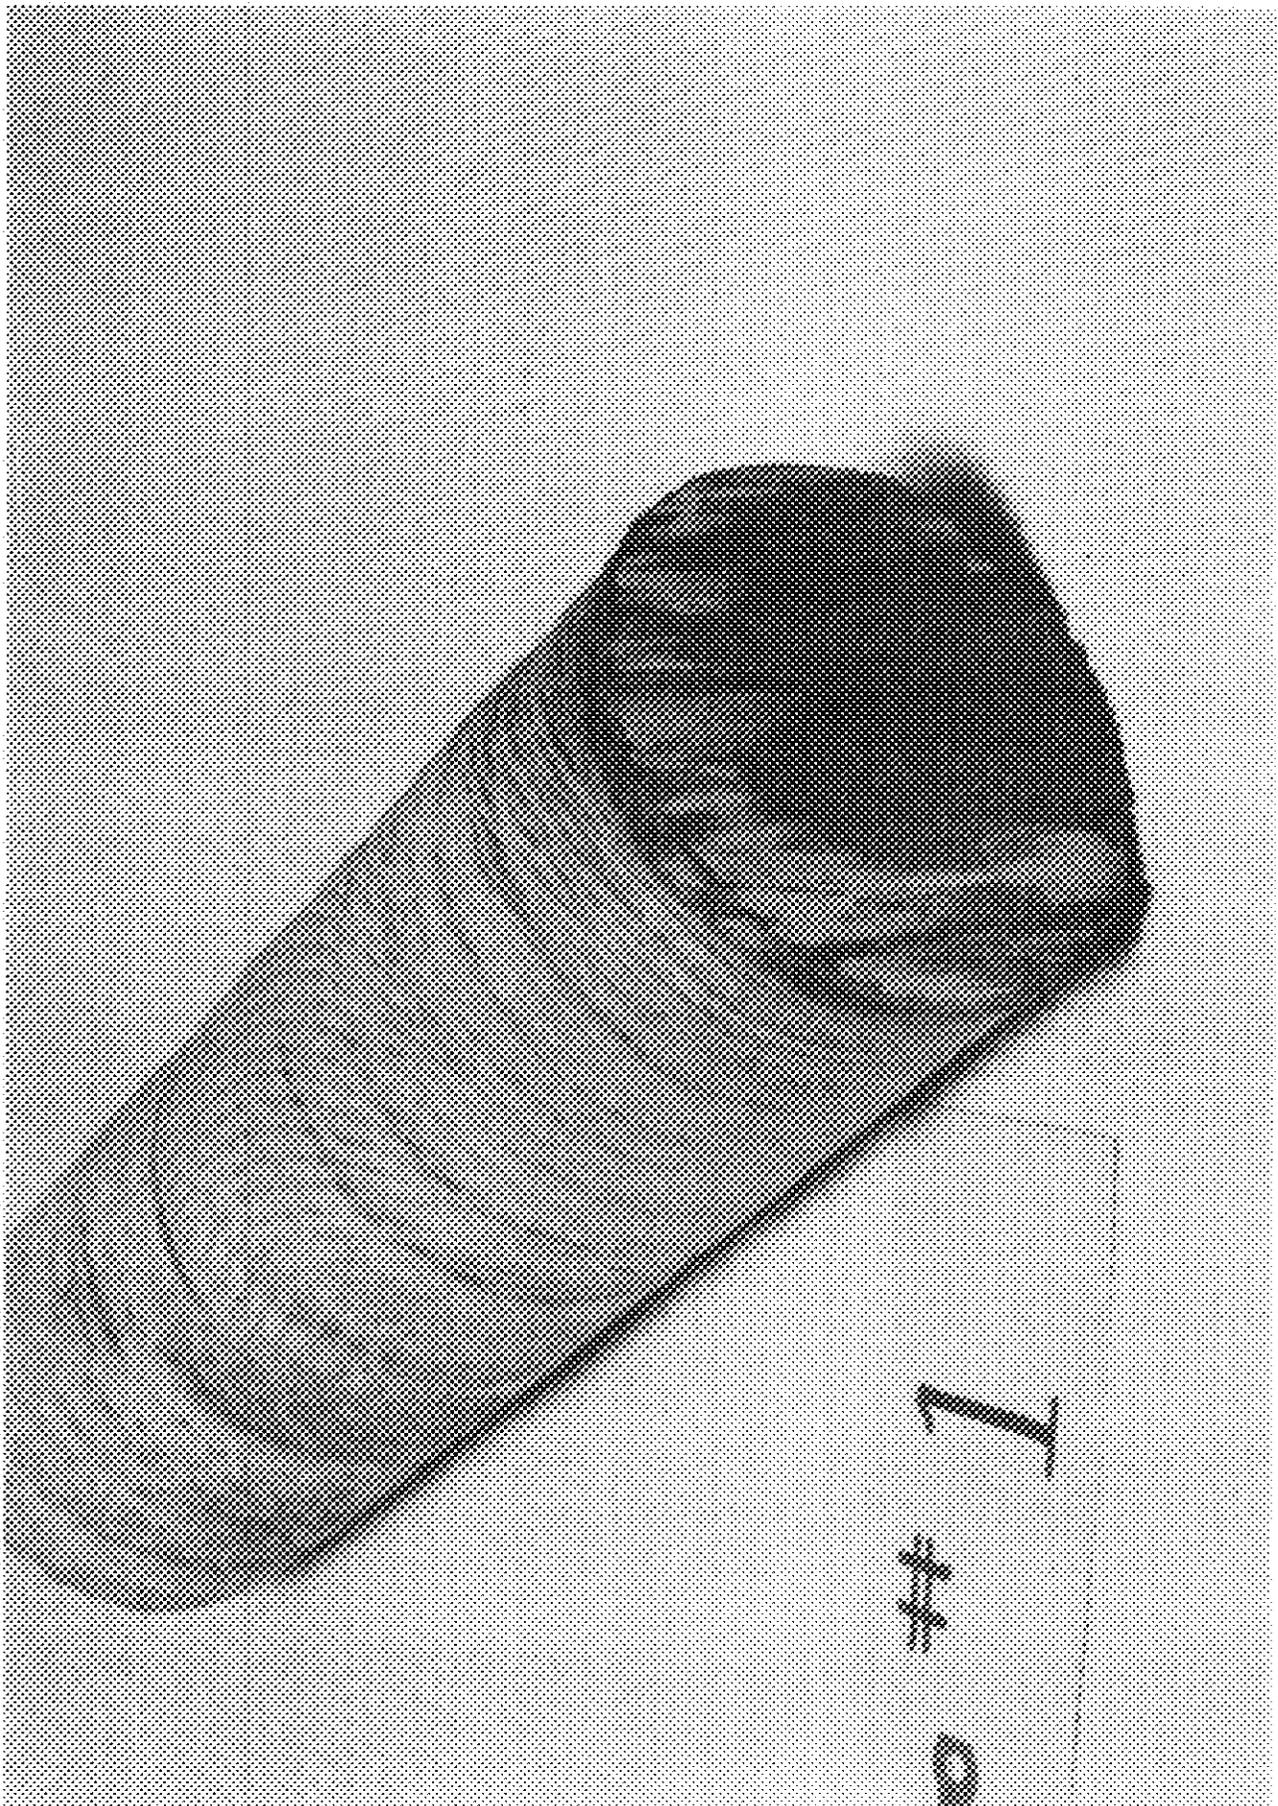
Figure 10: Core Sample, Location No. 1

Location Number 1: Approximately 18 feet south of the water filled door and 4 feet east of the tunnel centerline.

Locations one and two were selected because they were the areas that appeared to have received the largest amount of radiation exposure, and location number three was selected as a reference.

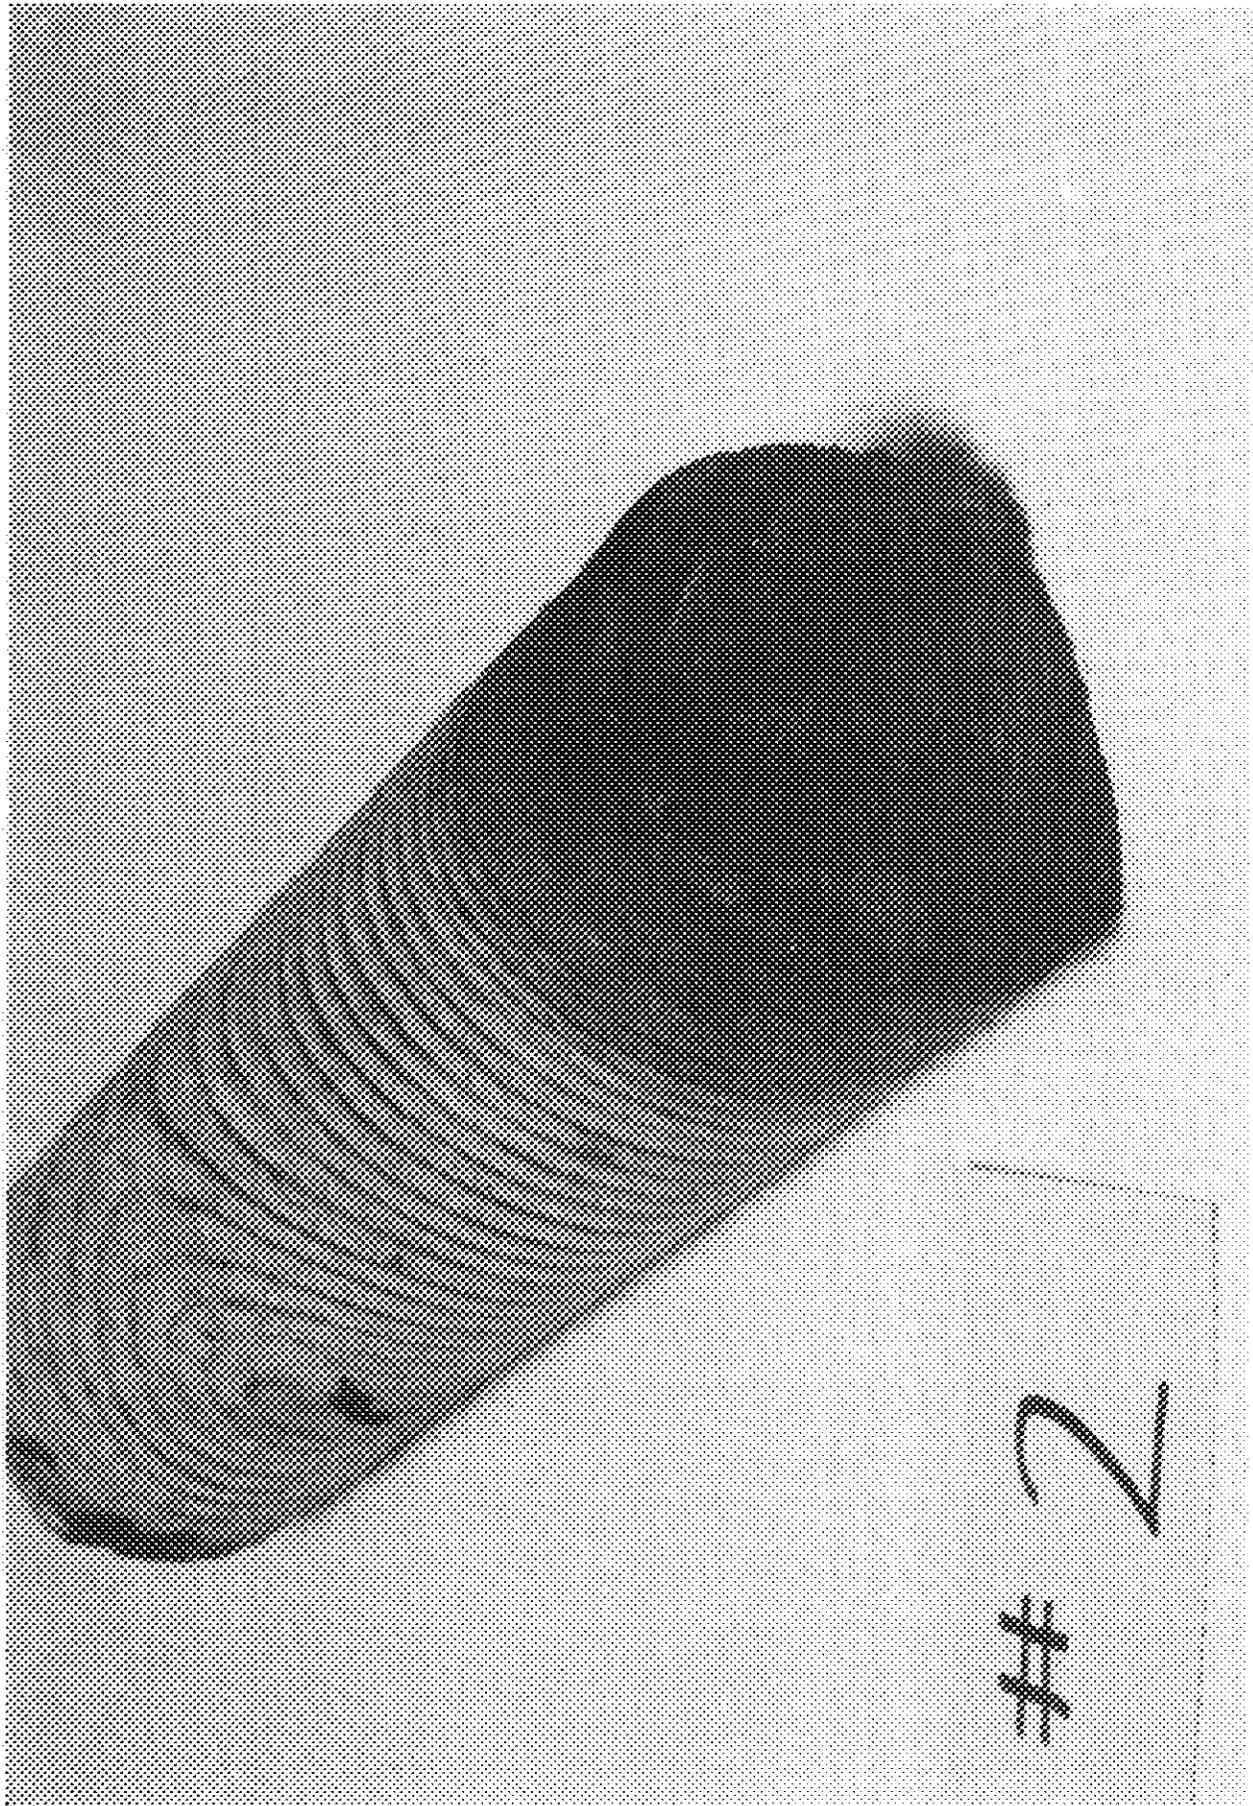
Figure 11: Core Sample, Location No. 2

Location Number 2: Approximately 54 feet south of the water filled door and 4 feet west of the centerline.

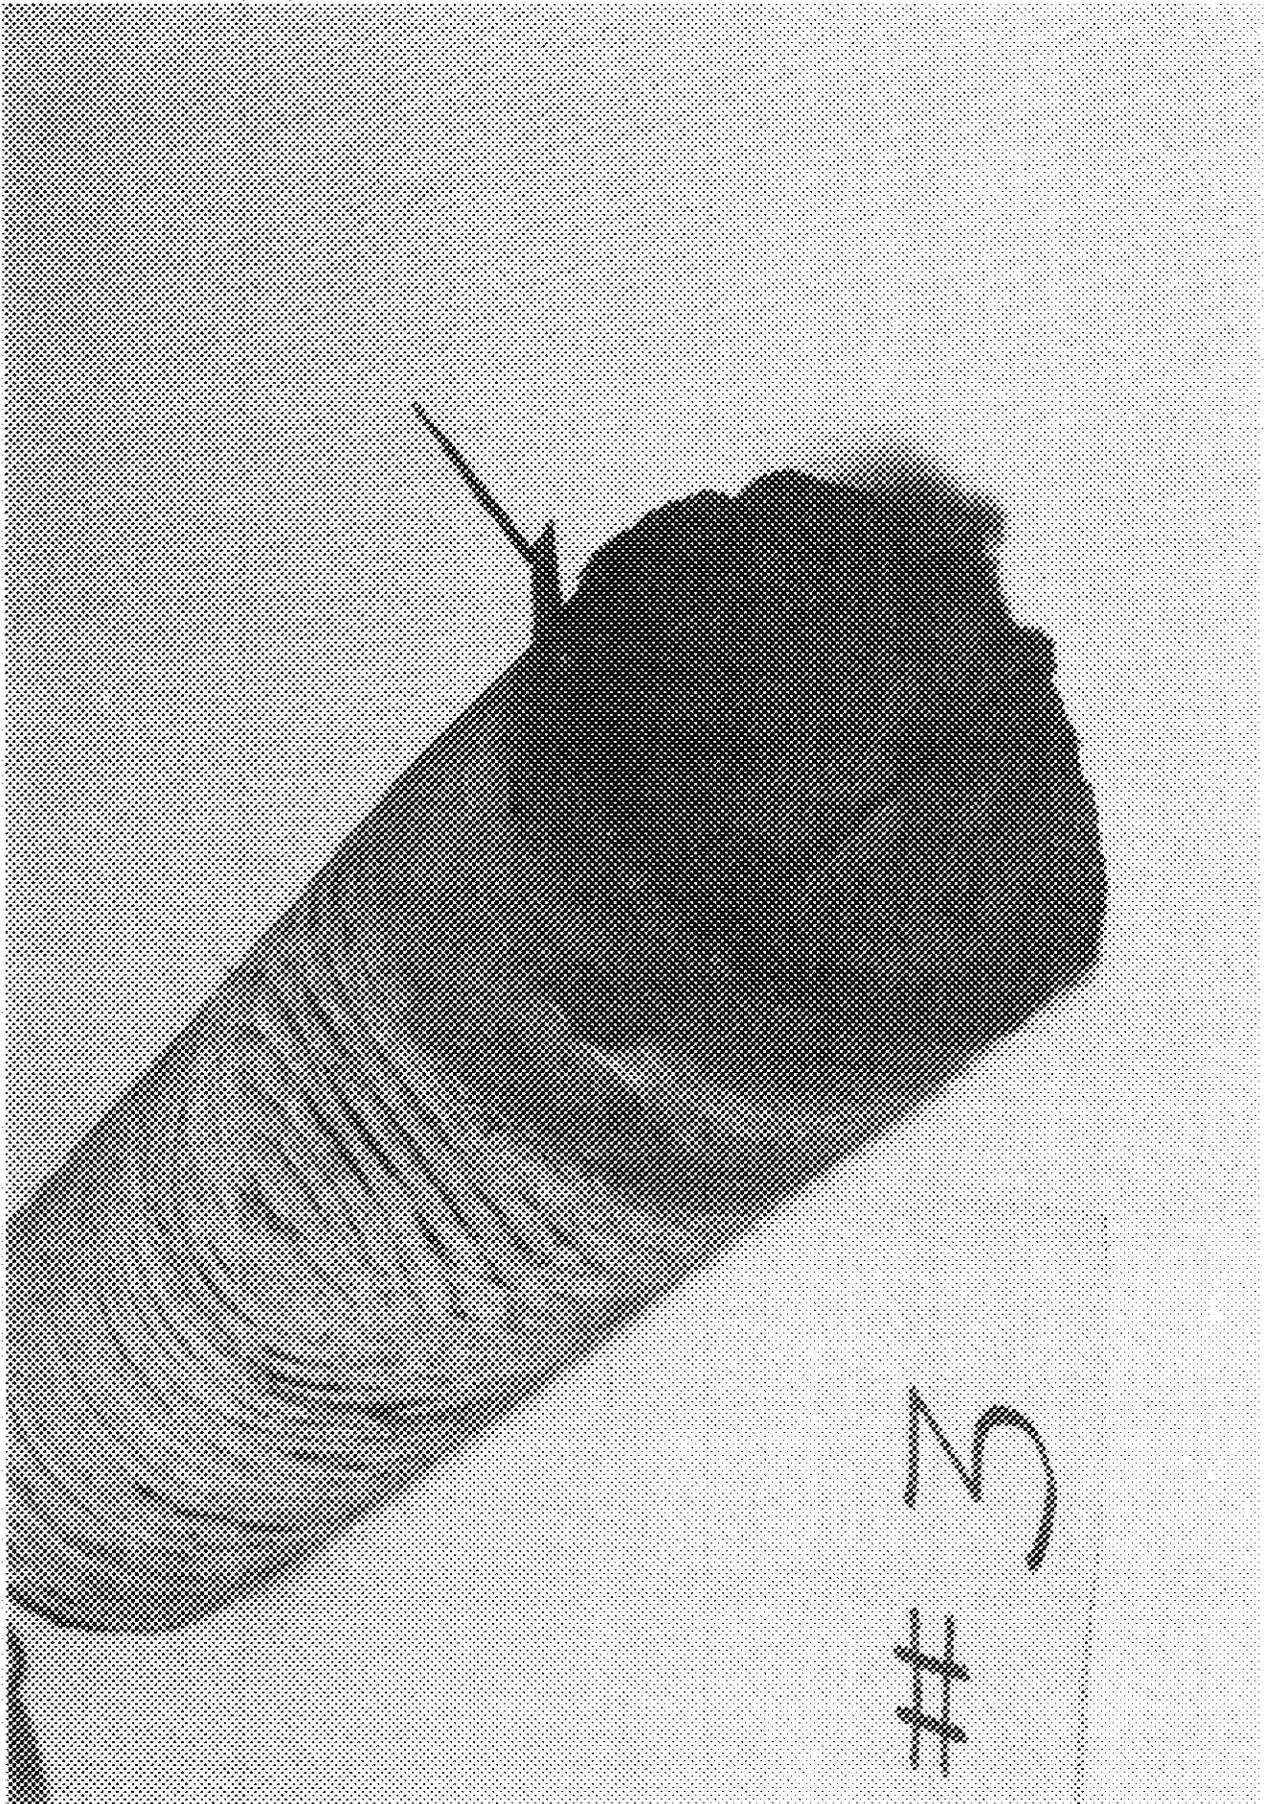
Figure 12: Core Sample, Location No. 3

Location Number 3: Approximately 154 feet south of the door and 4 feet east of the centerline.

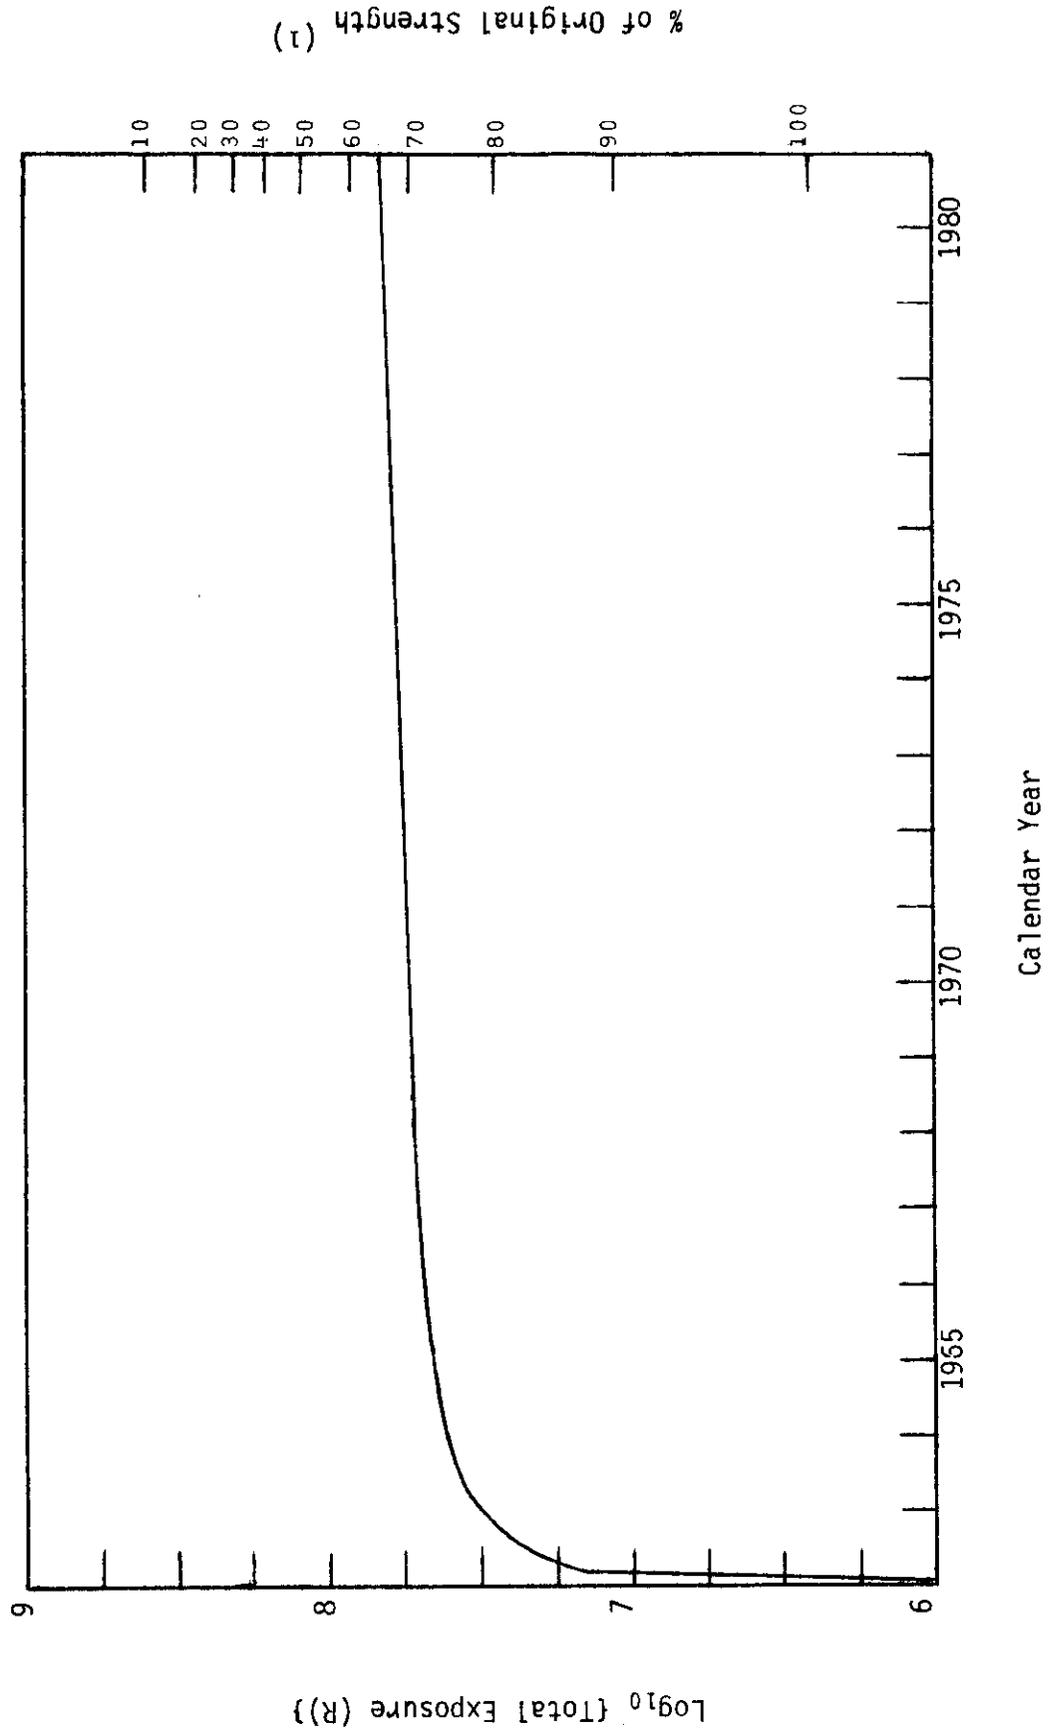
FIGURE 13: WORSE CASE EXPOSURE PROFILE

Radiation. Several locations in the tunnel have been exposed to large amounts of gamma radiation due to the presence of the failed process equipment in the tunnel. Studies have shown that large amounts of gamma radiation can lower the strength of wood.<sup>(1)</sup> The results of the core sample tests bear this out. Samples number one and two which have received large dose of radiation are noticeably weaker than sample number three even though they are similar quality wood. Fortunately, even though the wood has been weakened, it is still within allowable strength limits. A worse case radiation profile has been prepared (see appendix) and is shown in figure 13. The most severe effects

of the gamma radiation occur in the first three years and the effects gradually tapered off thereafter. Radiation is not expected to be a major factor in any future weakening of the tunnel.
