FINAL REPORT

CONSTRUCTION QUALITY ASSURANCE (CQA)

FINAL REPORT
CONSTRUCTION QUALITY ASSURANCE (CQA)
ENVIRONMENTAL RESTORATION DISPOSAL FACILITY (ERDF)
SUPER CELLS 9 & 10
SUBCONTRACT S013213A00
010.032-00-ROB

PHOTOGRAPH LOG

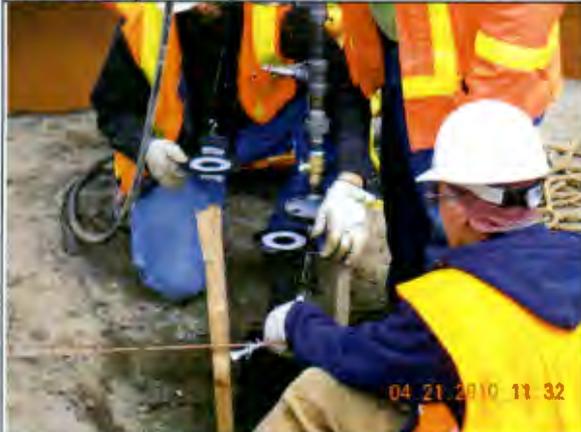
Facing W – After hydrostatic testing failed, BMWC discovered a faulty O-ring, which was replaced.

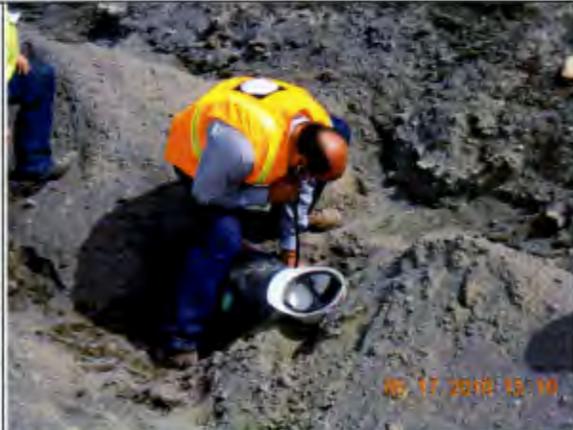
05-17-2010 15:10

Facing Down – BMWC attempting to locate the failed weld in th 10x16-in HDPE between MH-32 and MH-33.

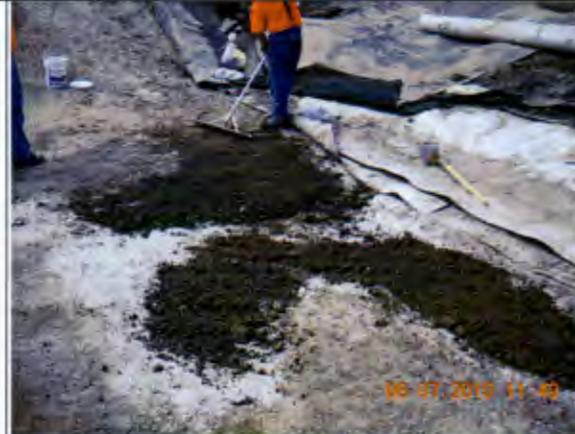
Facing SW – TWS removed non-conforming admix in the southwest corner and replaced with fresh admix and additional bentonite.

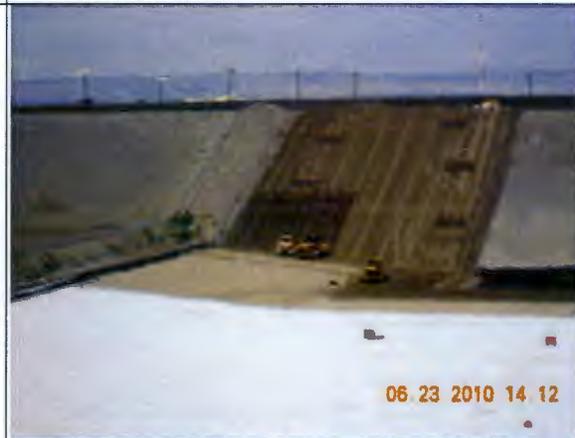
Facing N – TWS re-rolling grid C1 on the north embankment after failing density tests.

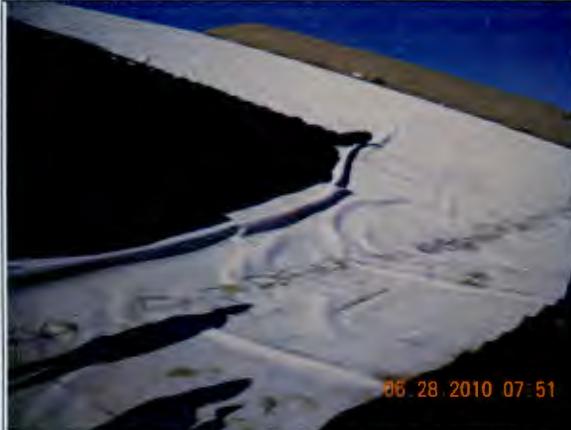
Facing W – A large wrinkle has developed at the south toe of Cell 9. ESI will repair the wrinkle prior to covering with geocomposite.

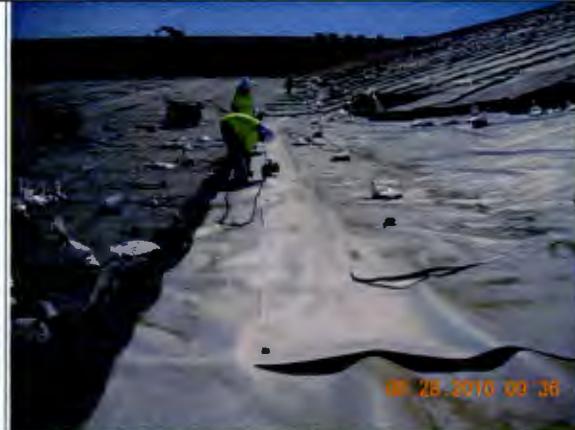
Facing E – ESI repairing a large wrinkle at the south toe of Cell 9.

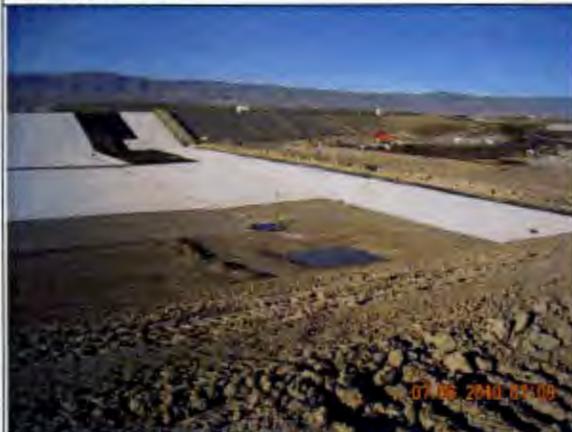
Facing SW – Weekend rainstorms caused runoff to accumulate in the Cell 9 sump.

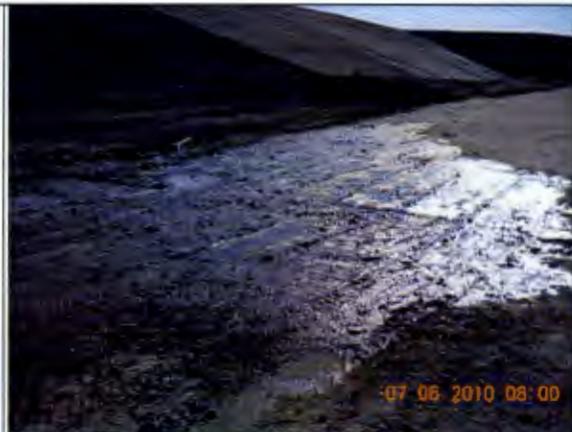
Facing NE – Saturated admix near the Cell 9 sump from weekend storms.

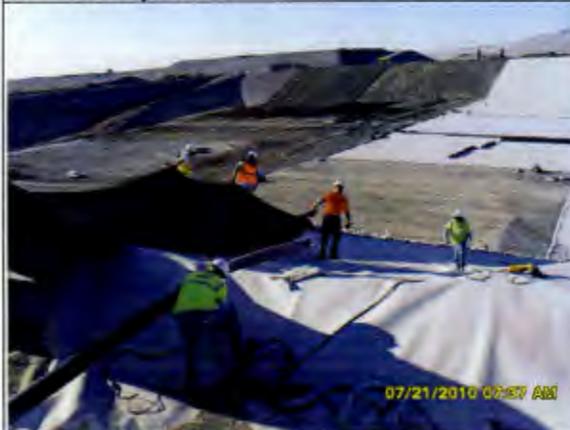
Facing SE – ESI deploying sec. geocomposite in the Cell 9 riser trench, while a technician repairs a hole in the sec. geomembrane.

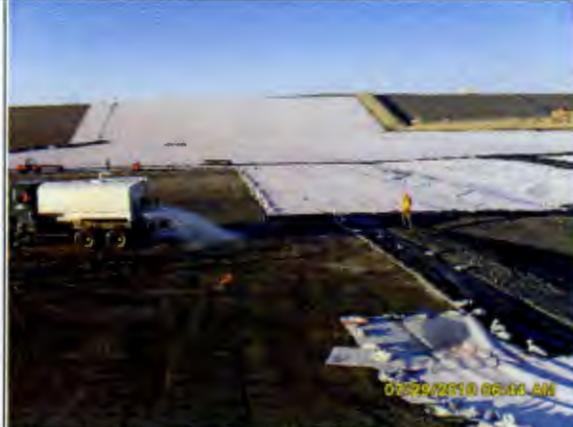
Facing S- TWS over moisture conditioned the admix near the Cell 9 sump.
