TANK 4 AND LEACHATE TRANSMISSION SYSTEM REPORT
CONSTRUCTION QUALITY ASSURANCE (CQA)

2 OF 9

TANK 4 CONCRETE TESTING

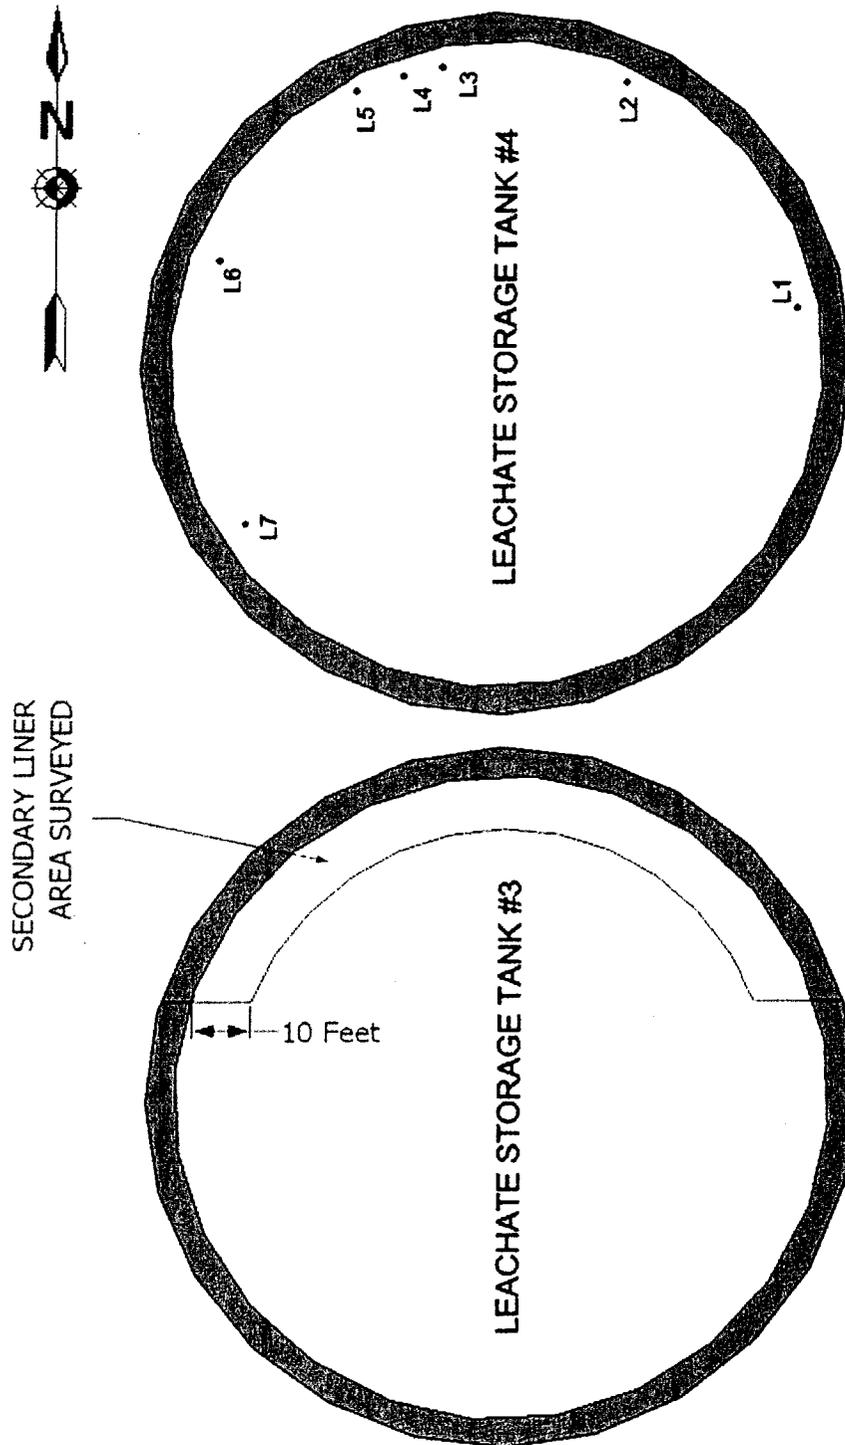
FIGURE 1. AREA SURVEYED AND APPROXIMATE LOCATIONS OF LEAKS IN LEACHATE STORAGE TANK #4

Table 1. Locations of Leaks in Leachate Storage Tank #4
