STATE OF WASHINGTON
DEPARTMENT OF ECOLOGY

Re: Dangerous Waste Compliance Inspection on October 19, 2017 at Walker Tanker
HO-64-4294, RCRA Site ID: WA7890008967, NWP Compliance Index No 17.619

Washington Department of Ecology
Nuclear Waste Program
Compliance Report

SITE: Walker Tanker HO-64-4294
RCRA Site ID: WA7890008967
Inspection Date: October 19, 2017
Site Contacts: Holly Bowers, Washington River Protection Solutions LLC (WRPS)
Bryan Trimberger, United States Department of Energy – Office of River
Protection (USDOE-ORP)
Eric Van Mason, WRPS Alternate Point of Contact
Phone: (509) 373-0333, Holly Bowers
(509) 376-2674, Bryan Trimberger
Site Location: Hanford Site, 200 West / 200 East Areas
Benton County, WA
At This Site Since: March 22, 1943 **NAICS#: NA**
Current Site Status: Large Quantity Generator

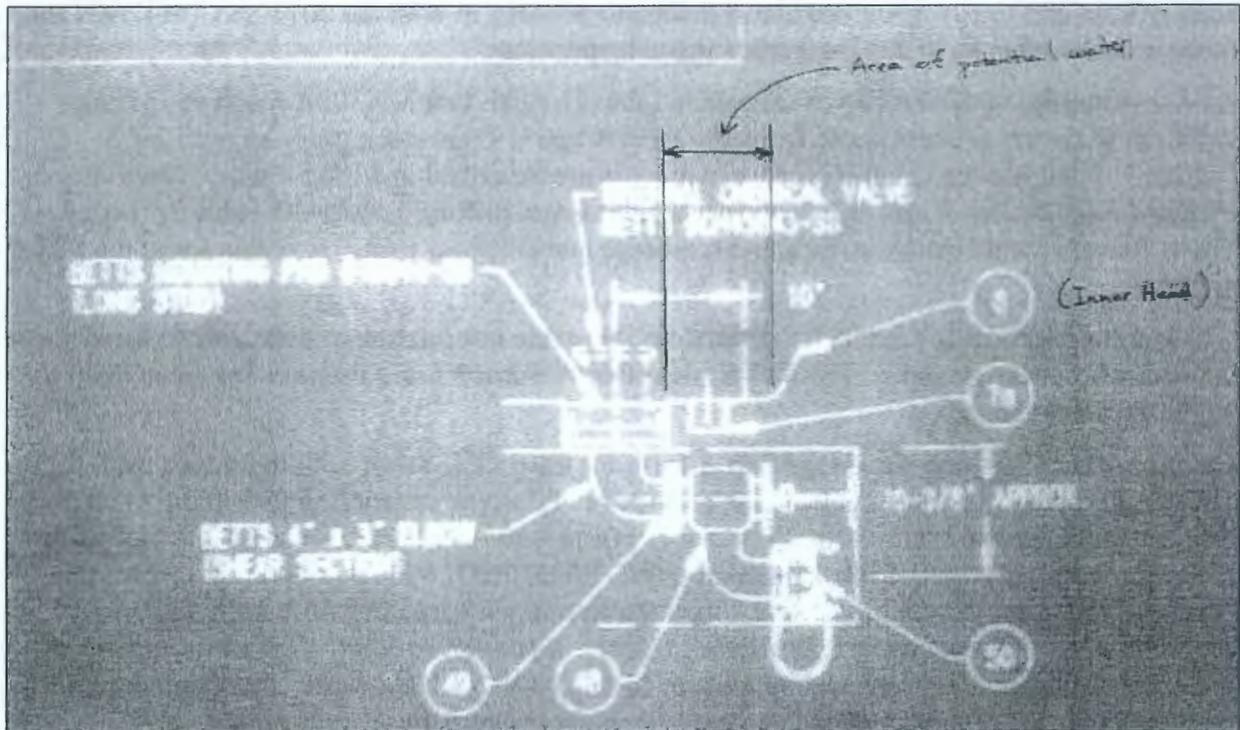
The first assumption is supported by a diagram (See Figure 1). I did not observe any supporting information for the second assumption. Figure 1 shows a recessed valve, but it also shows the top of the valve rising up several inches. I did not observe the one half inch estimate supported by any calculation or measurement.

Figure 1 – Diagram of Betts valve from *Estimate of Potential Heel in Tanker*

I observed nothing to support the assumption that residual volume would equal one half inch. I observed the strapping chart indicated its values were “theoretical.”

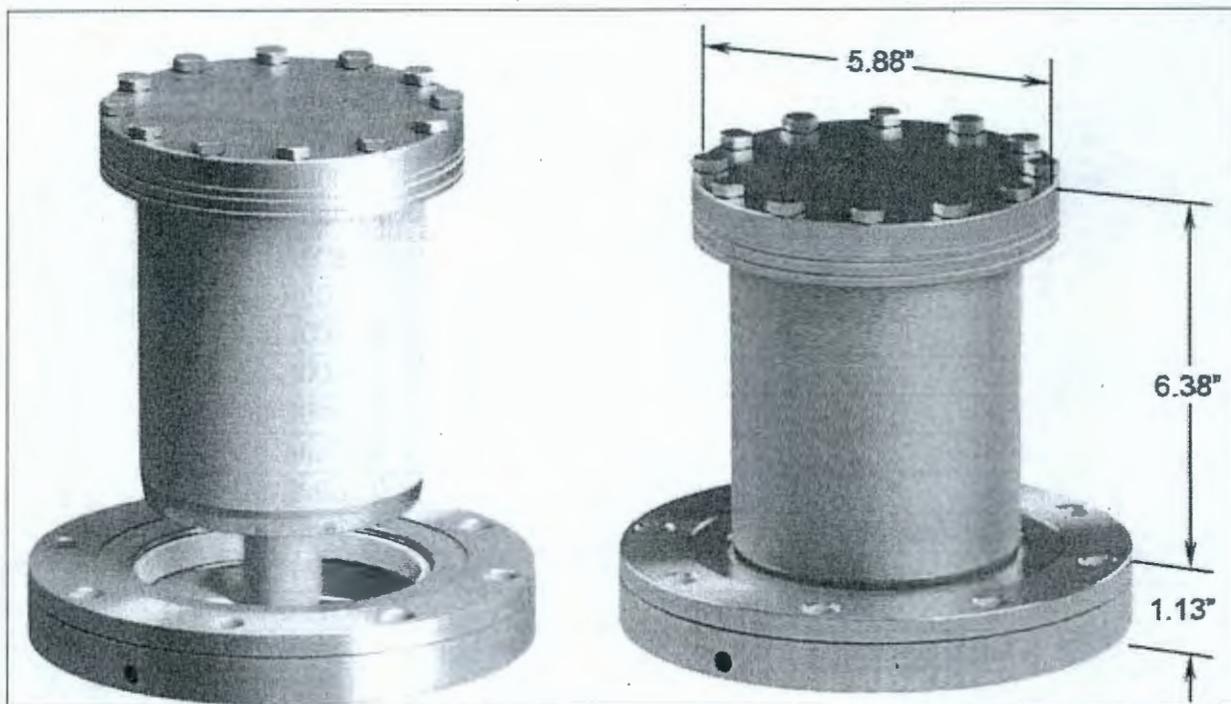
Mr. Gibbons explained the tanker's check valve operated like a plunger on a bathtub drain and that it was recessed to be flush with the bottom of the tank. He showed me a picture of a similar model of valve (see Figure 2). His explanation of the operation of the check valves made the logic of his estimate clearer. He said the one half inch estimated depth below the drain was a guess based on the angle of the liquid in the tank. I thanked Mr. Gibbons for his time and he excused himself a few moments later while we were discussing the designation.

Figure 2 – A Betts internal chemical valve.
