APPENDIX A

**PHOTOGRAPHS OF CONFIRMATORY SAMPLING
AND REMEDIATION ACTIVITIES**

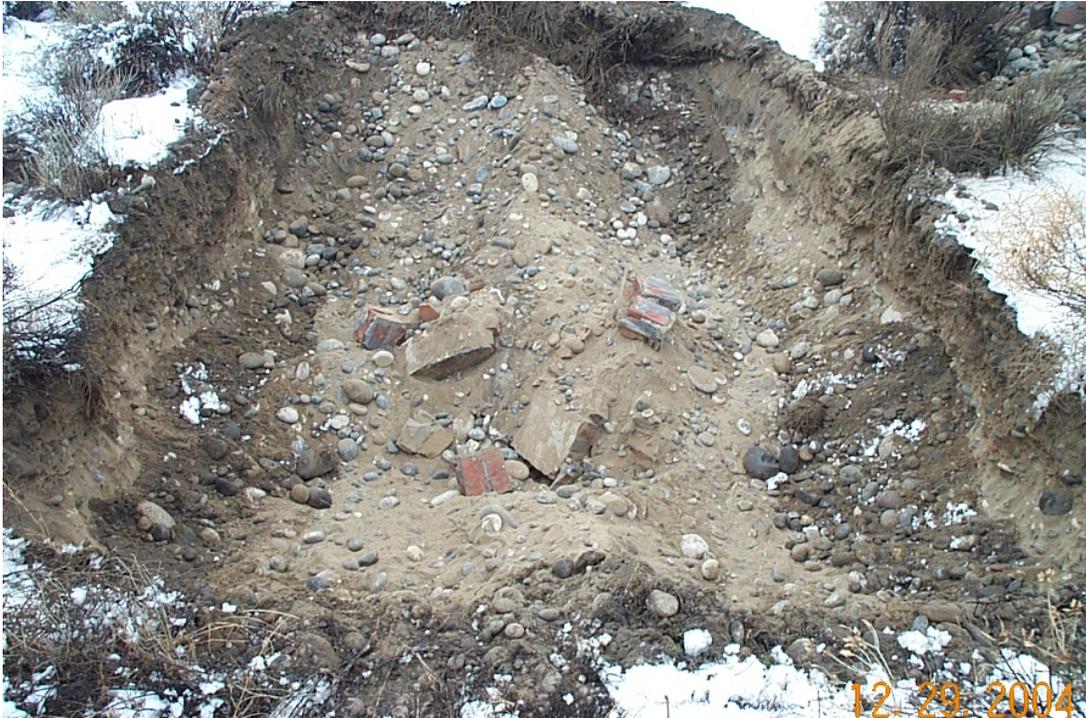
Junction Box Debris 1.2 m (4 ft) Below Ground Surface (bgs).

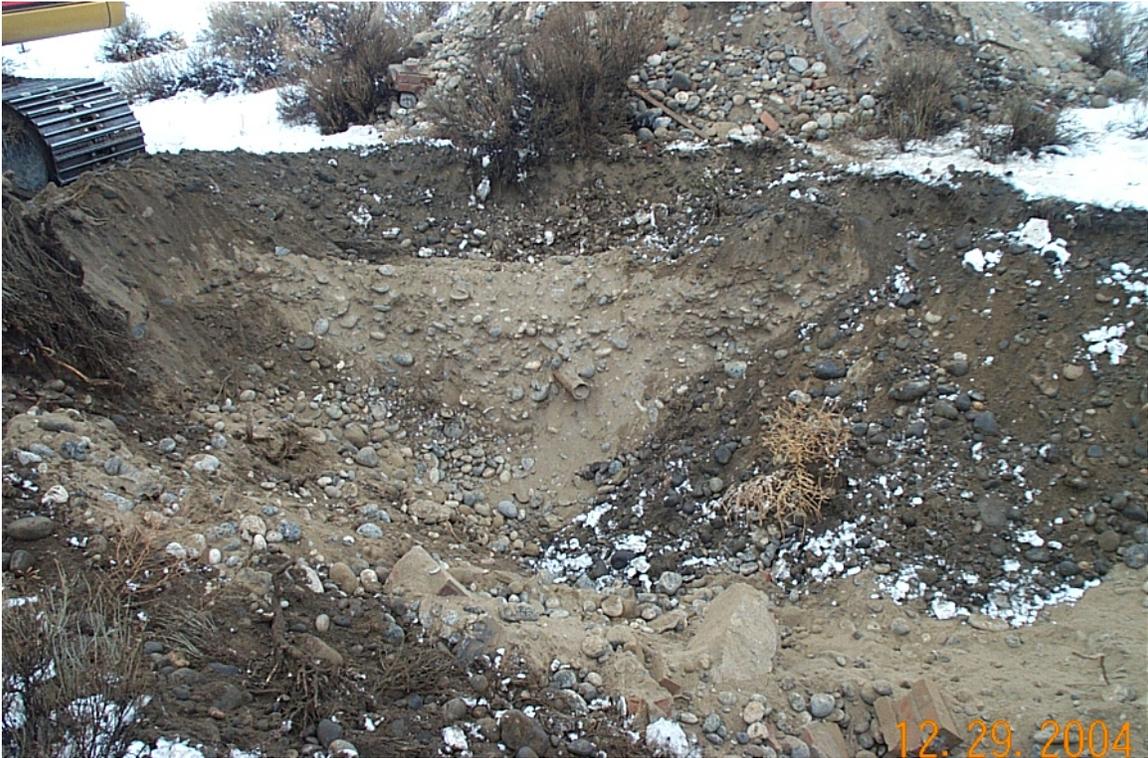
Section of 10 cm (4 in.) Cast-Iron Discovery Pipe Located in Excavation Sidewall.

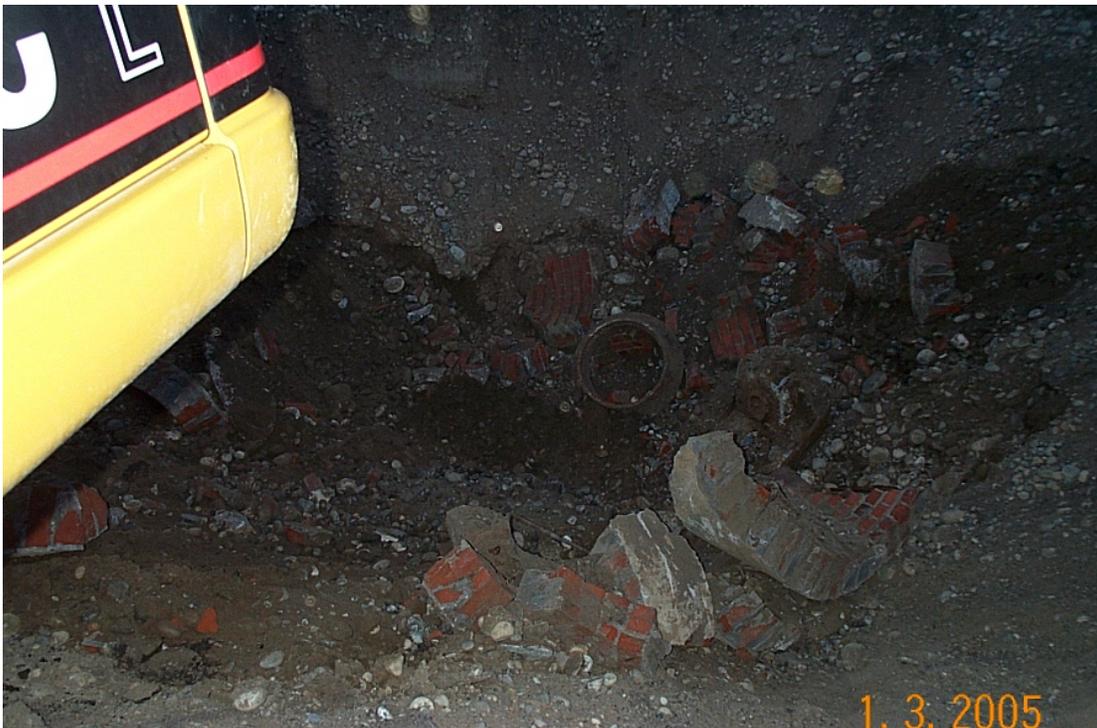
Remnants of Junction Box that was Previously Demolished in Place.

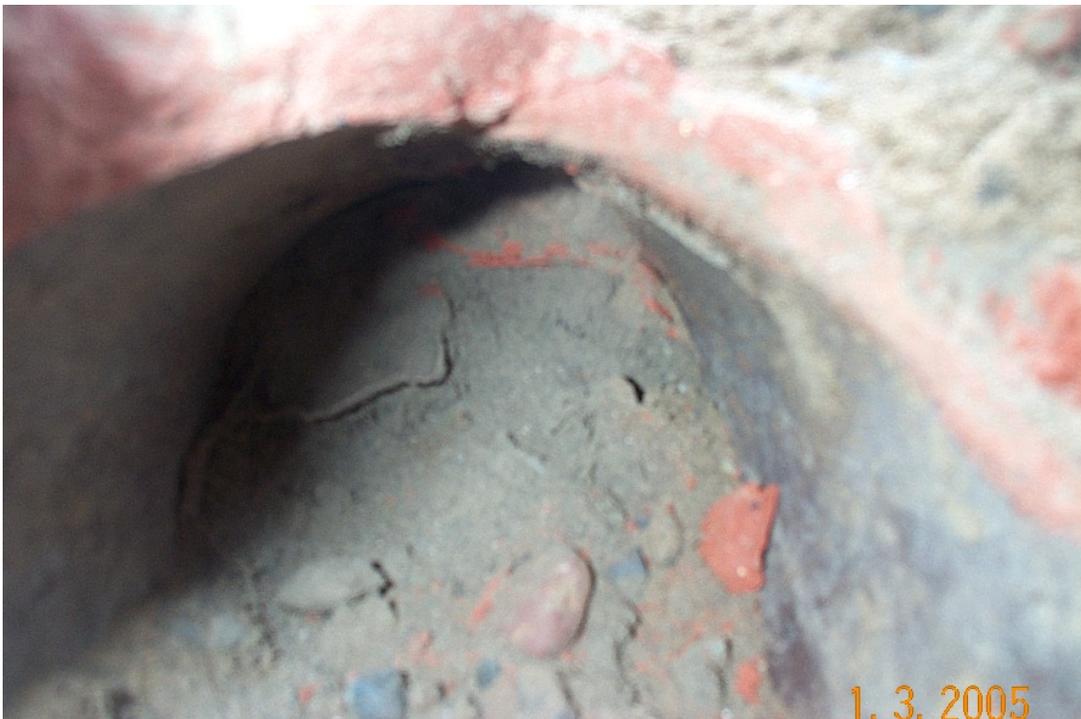
Sediment Sampled (J025K4) Inside Concrete Encased VCP.

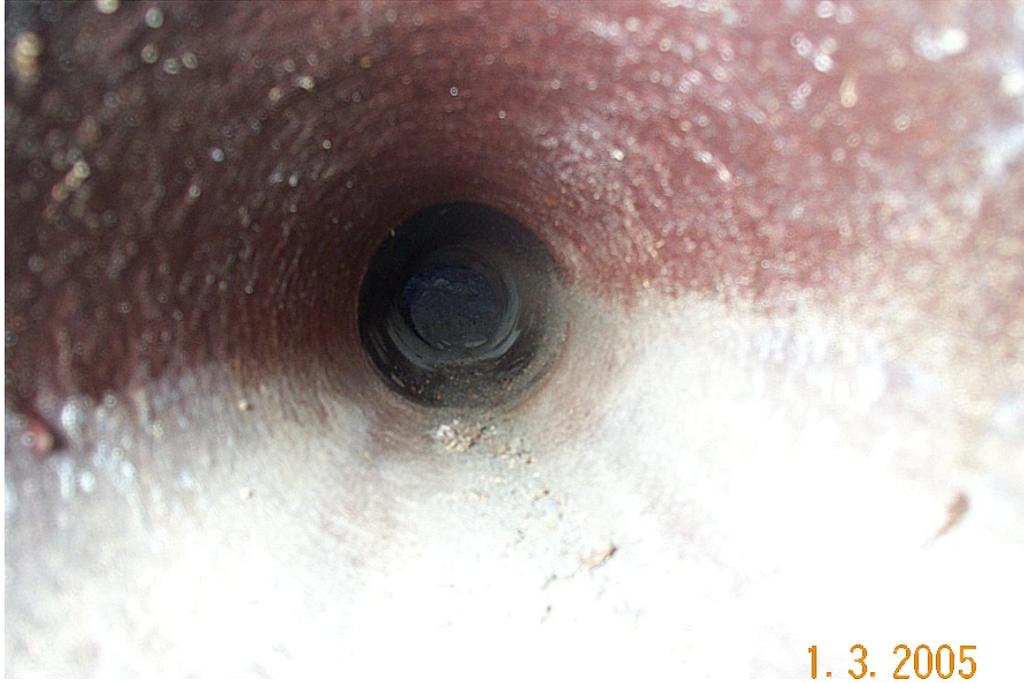
**Interior of 20 cm (8 in.) VCP Containing a Small Amount of
Debris from Excavation. No Sediment is Present.**

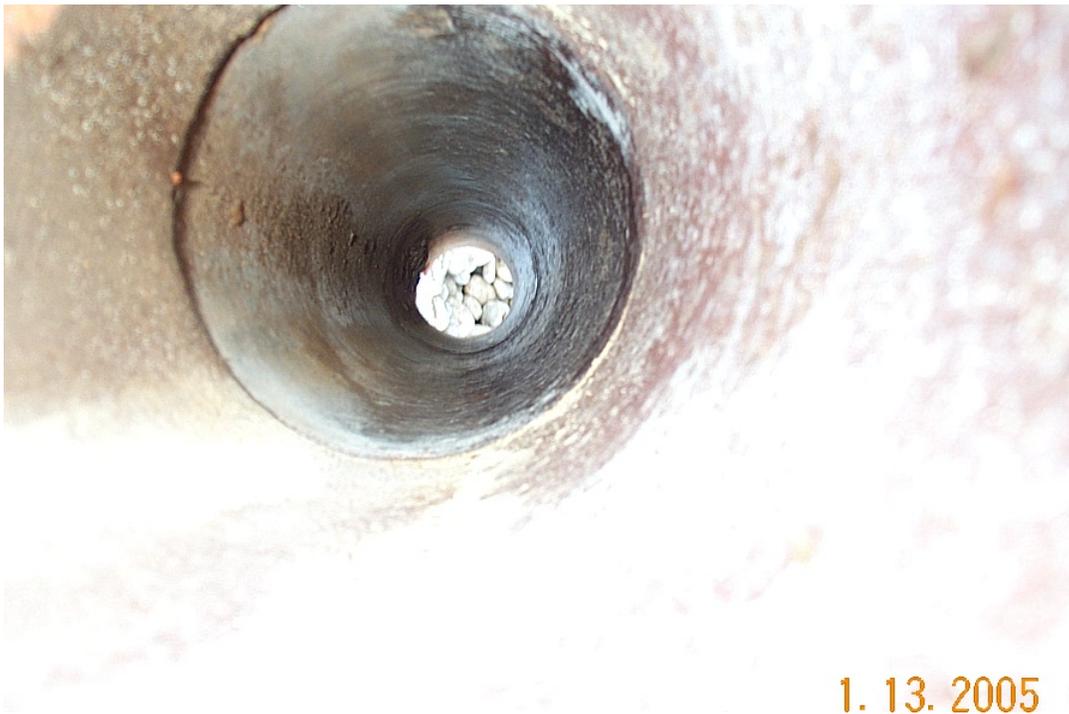
Contents of 15 cm (6 in.) VCP.

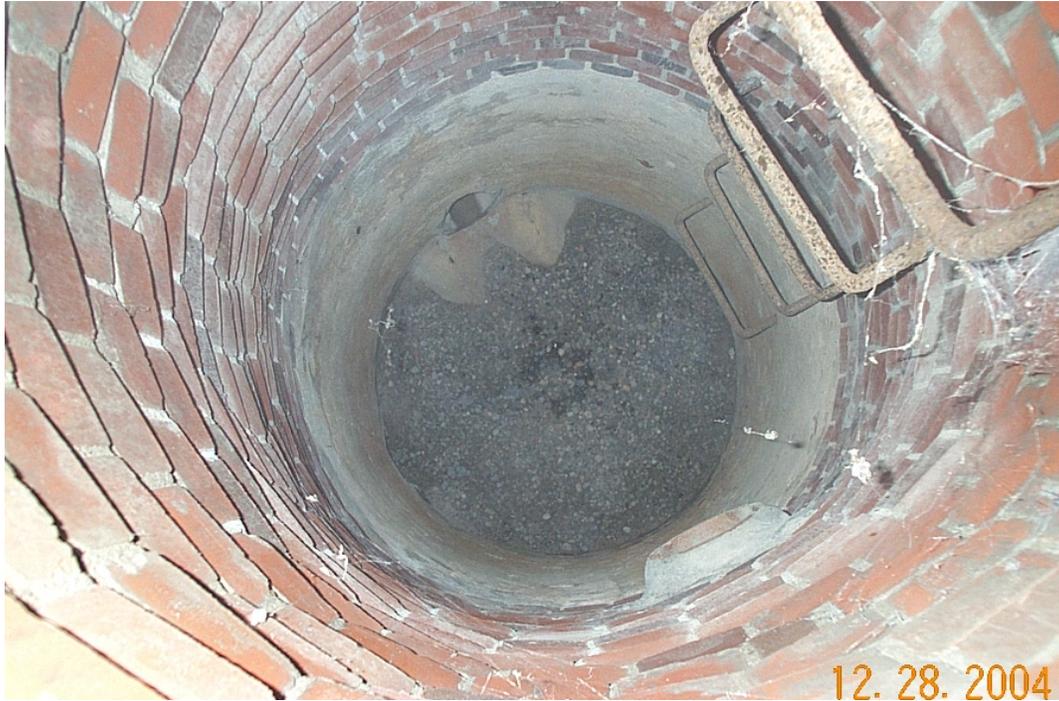
Sediment in Junction Box Prior to Sampling.

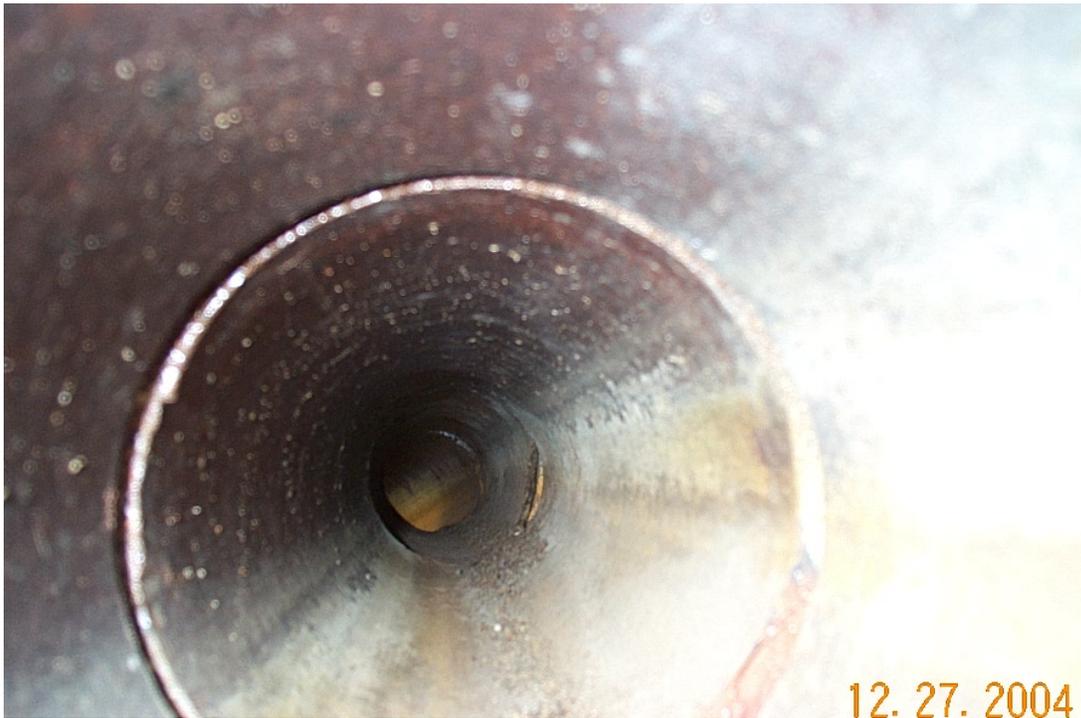
VCP 15 cm (6 in.) Contained No Sediment.

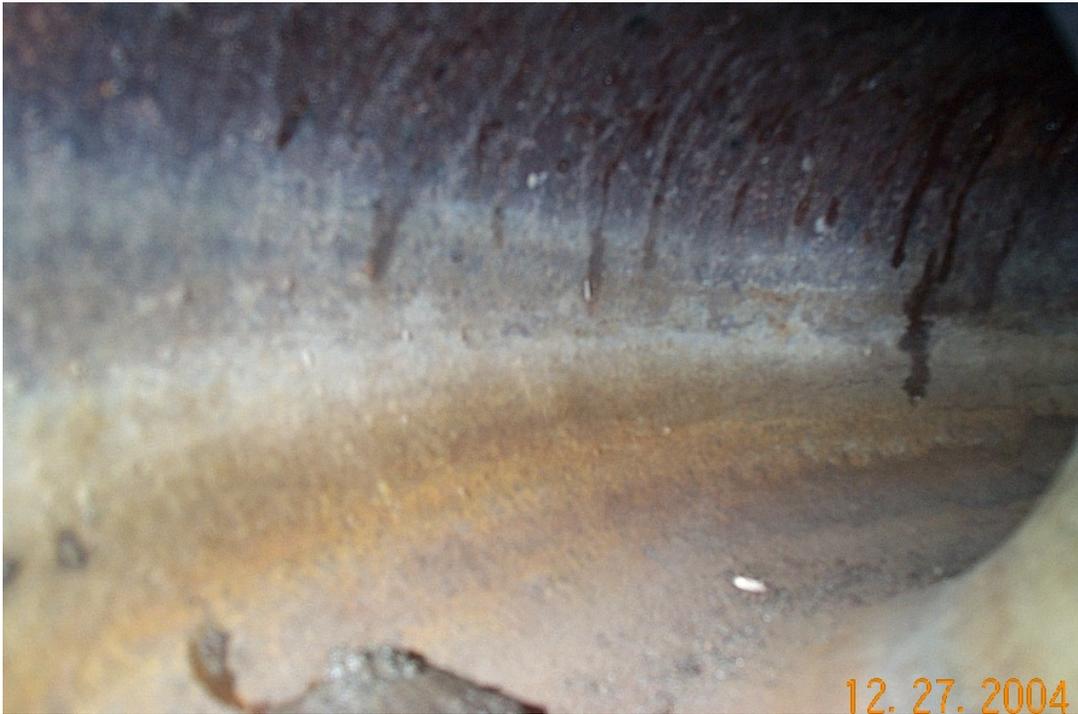
VCP 15 cm (6 in.) Contained No Sediment.

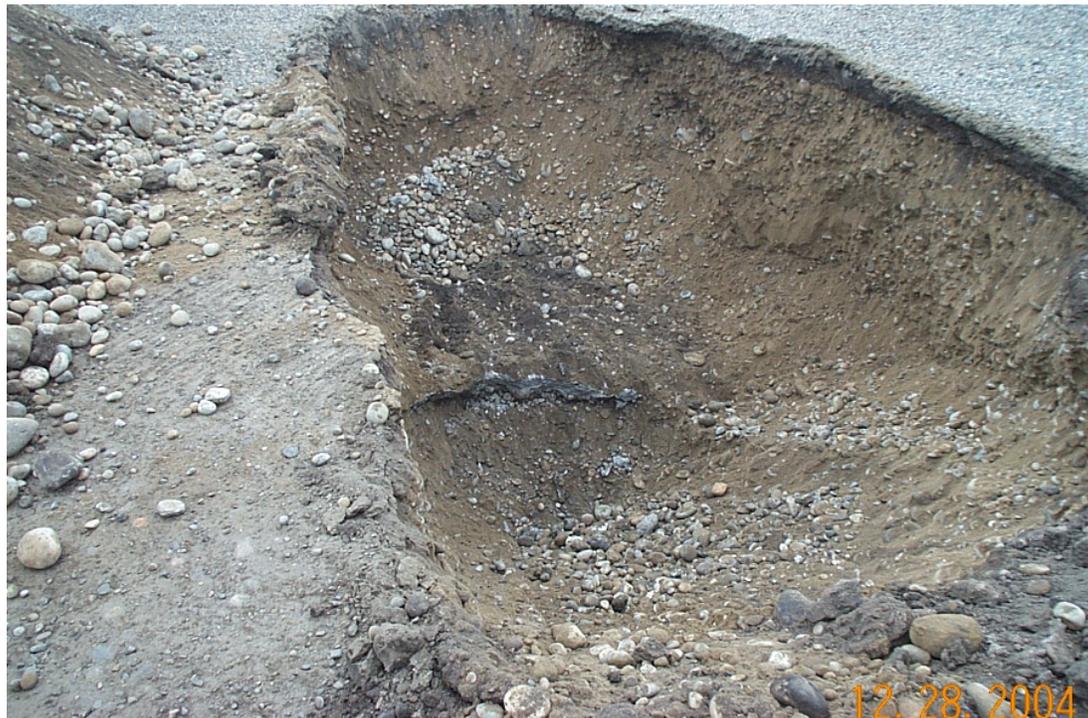
Concrete Appears to be a Layer Rather Than a Block.

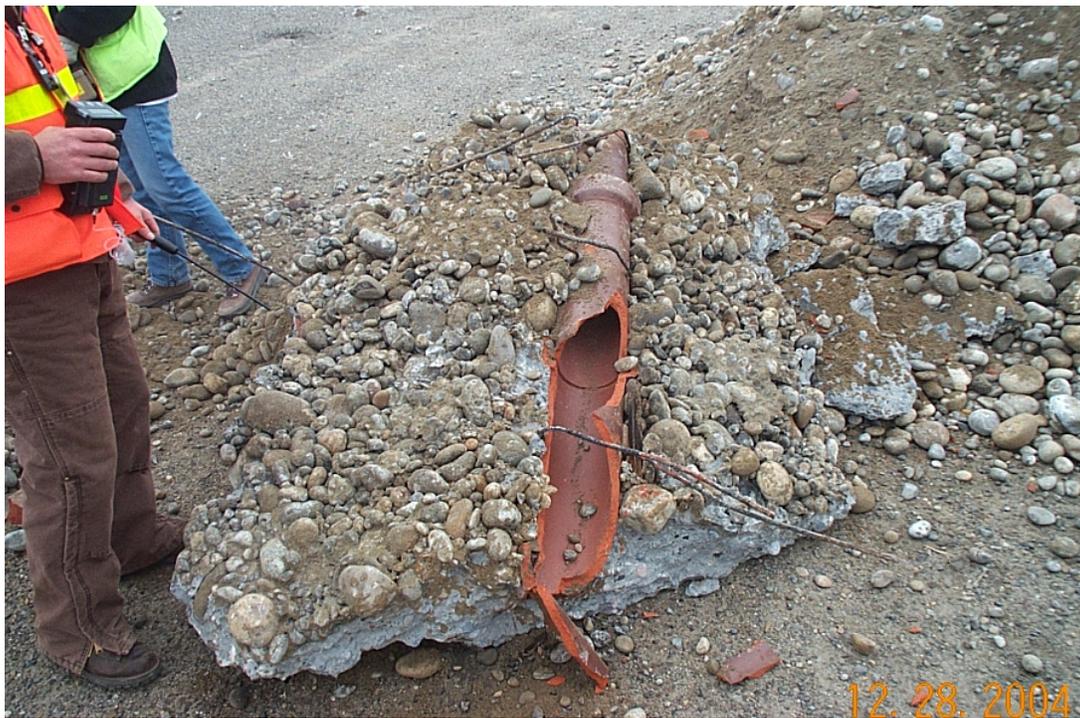
VCP 15 cm (6 in.) is Not Completely Encased in Concrete.

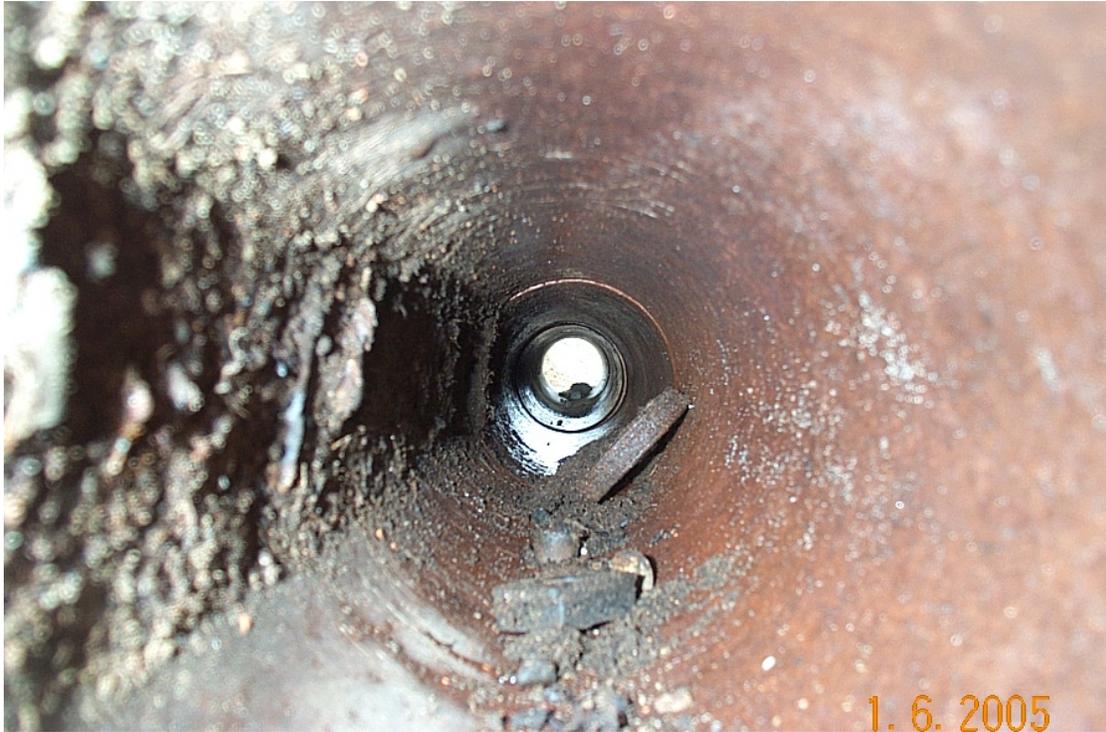
Sediment and Debris Inside 15 cm (6 in.) VCP.

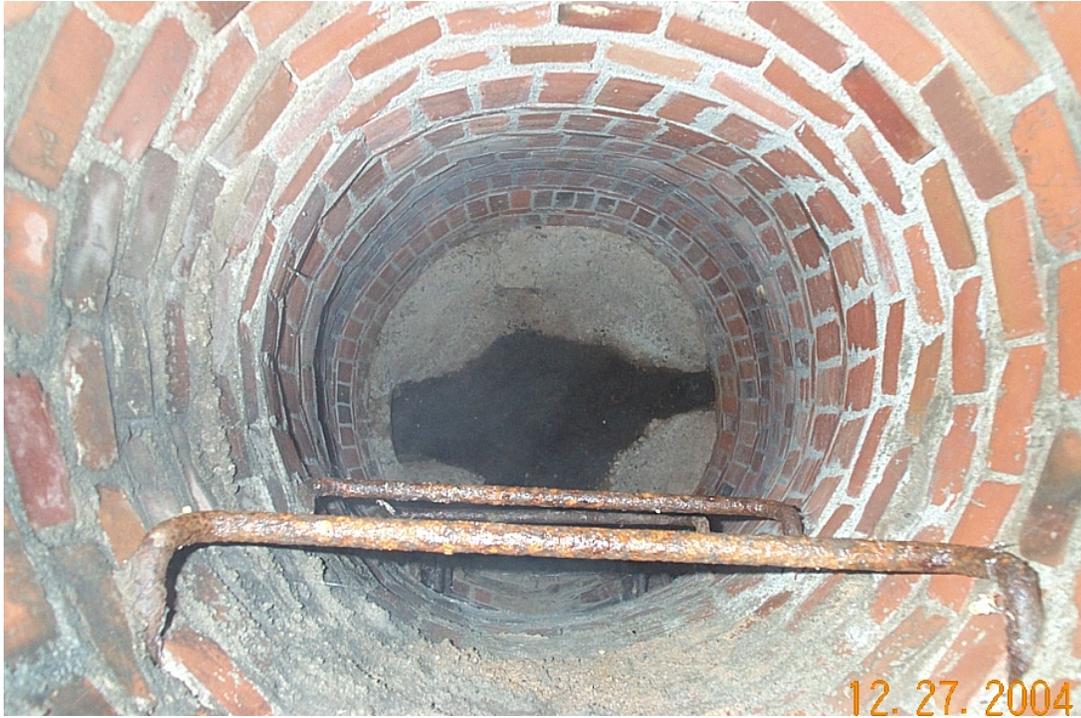
Junction Box Sediment Visible 3.7 m (12 ft) bgs.

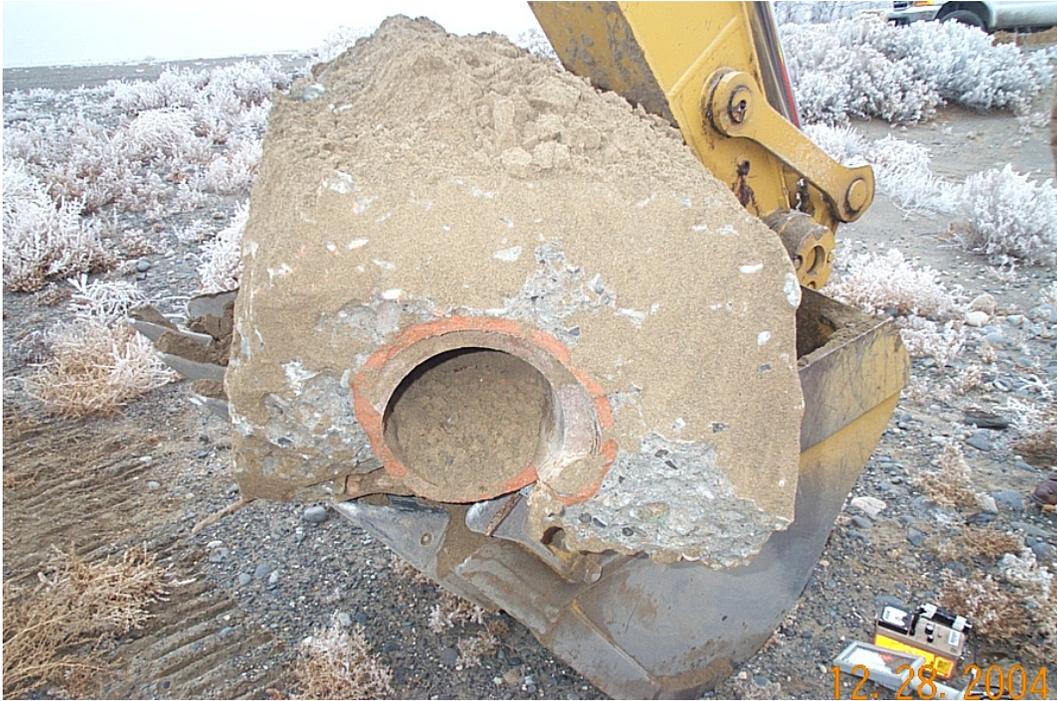
Section of 20 cm (8 in.) Concrete Encased VCP Found Loose in Test Pit.

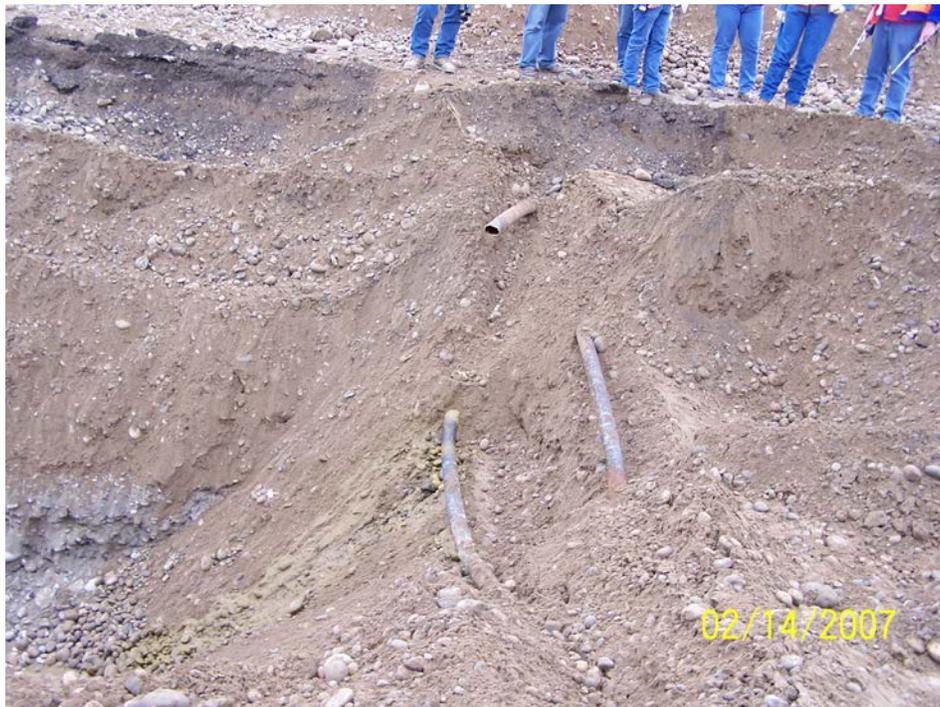
Steel Sodium Dichromate 5.1 cm (2 in.) Pipeline (100-F-26:7) was Breached.

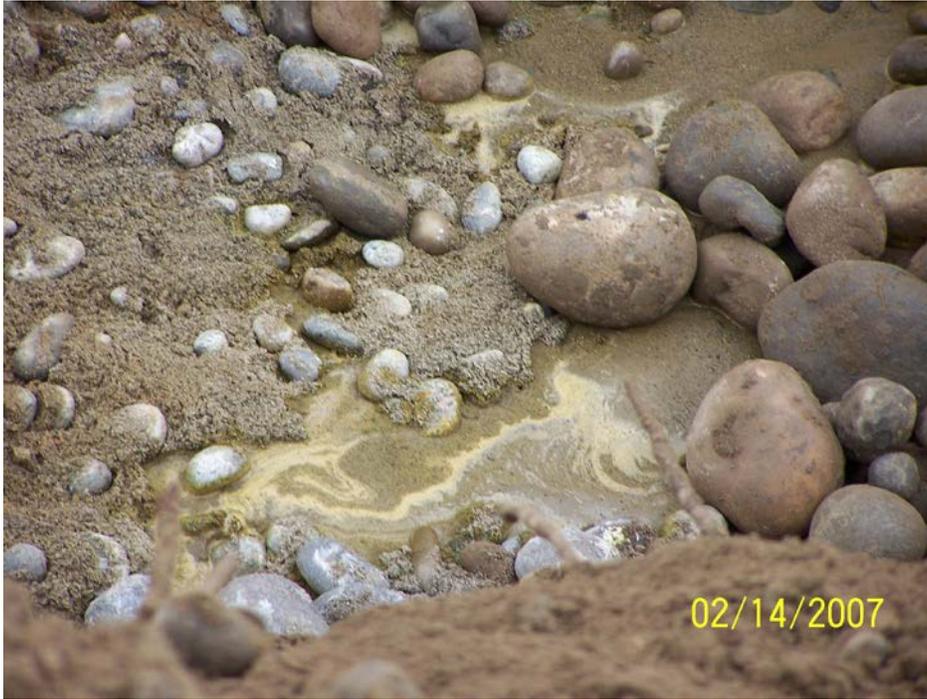
**Approximately Five Gallons of Yellowish-Green Liquid
was Released Into the Excavation.**

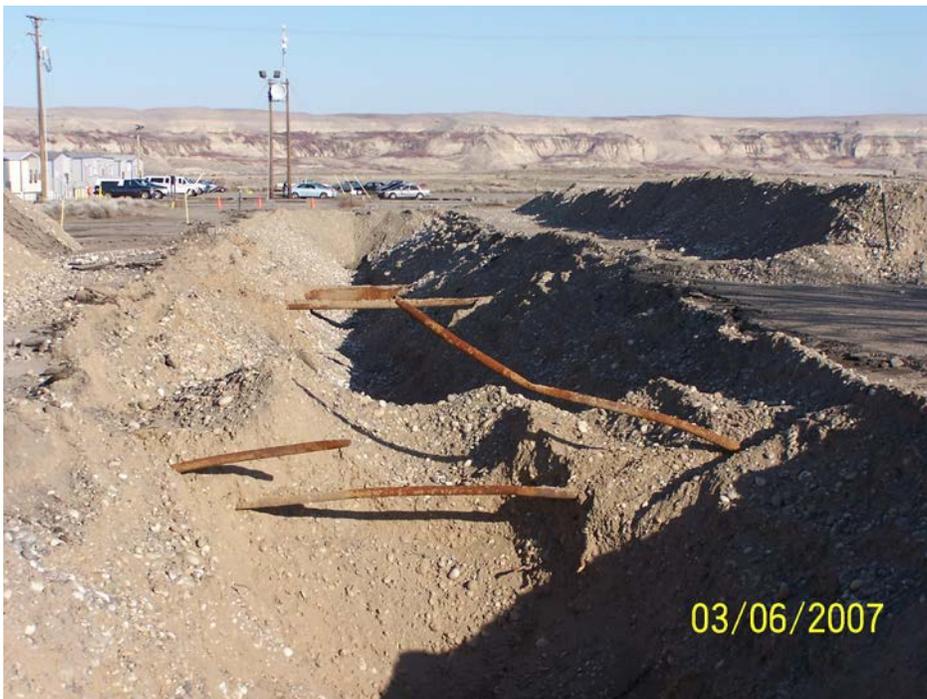
**Breached 100-F-26:7 Pipeline in Foreground of
100-F-26:9 Pipeline Excavation.**

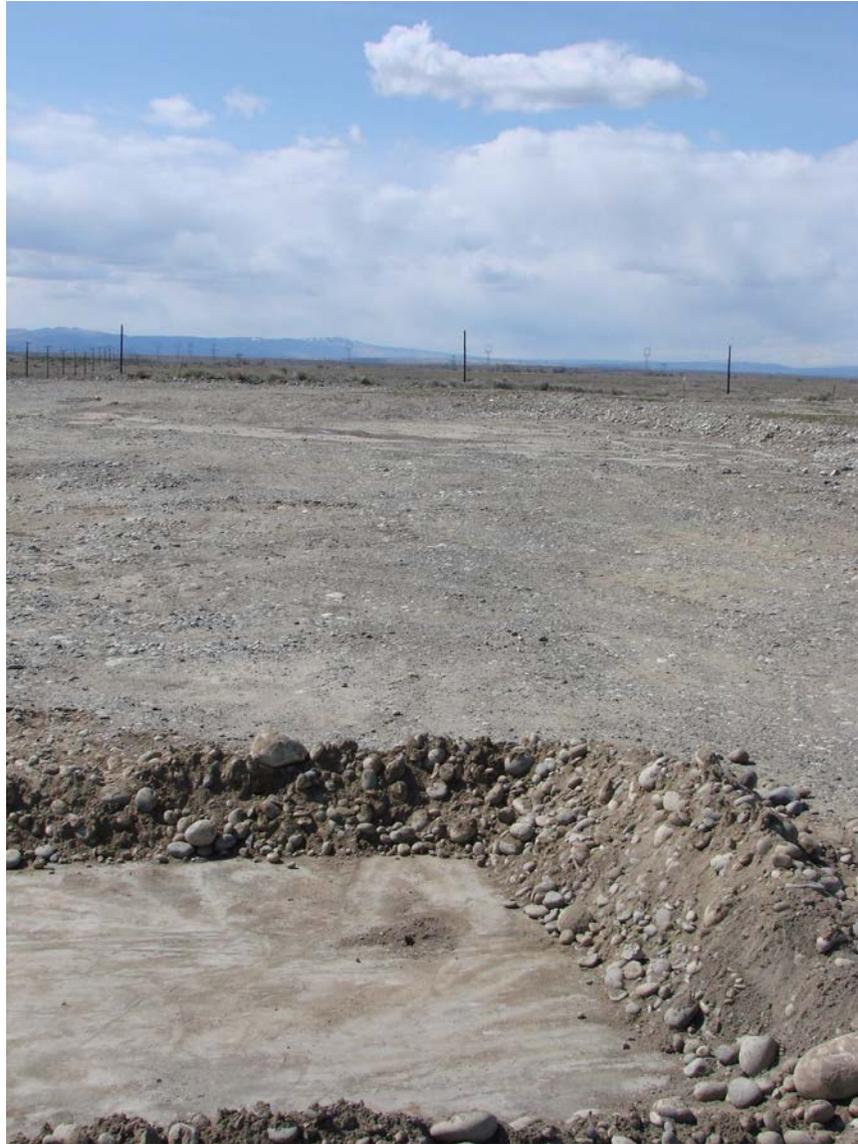
**Contaminated Soil at 100-F-26:9 Removed Beneath Area
Related to Sample SP-6. Portion of 190-F Building
Foundation was Uncovered (April 9, 2008).**
