STATE OF WASHINGTON  
DEPARTMENT OF ECOLOGY

Re: Dangerous Waste Compliance Inspection on April 20, 2020, at the Double Shell Tank System and 204-AR Waste Unloading Station, RCRA Site ID: WA7890008967, Nuclear Waste Program (NWP) Compliance Index No.: 20.699

20-NWP-147  
Double Shell Tank System and 204-AR WUS  
RCRA Site ID: WA7890008967  
NWP Compliance Index No.: 20.699  
Inspection Date: April 20, 2020

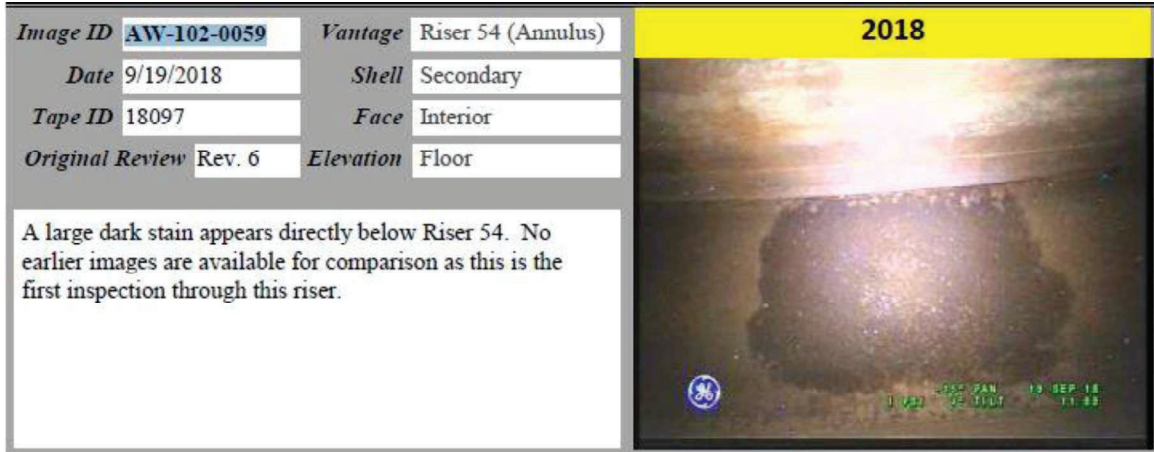
**Figure 1 Issue Found Under Riser #54 in 241-AW-102**

As seen from the inspection risers, there is evidence of beachlines on the annulus floor that is likely the result of evaporated couplant water used during ultrasonic testing examinations collecting on the annulus floor. There is no evidence of change in the condition of the existing areas of interest for the AW Farm tanks, and no evidence indicative of a primary tank leak or active water intrusion for the AW Farm tanks. There is evidence of water staining in Tank AW-102, directly below Riser 54. Riser 54 has not been used previously for inspection so there are no prior images available for comparison. The staining is attributed to condensation of annulus atmospheric water vapor due to temperature differences within the annulus, rather than intrusion.

See photo below of issue found under Riser #54 in 241-AW-102:

Future annulus visual inspections and ultrasonic testing will be continued to identify any change in the integrity of the AW Farm tanks.
