Re: Dangerous Waste Compliance Inspection on June 5, 2019 at the 222-S Laboratory,
Resource Conservation Recovery Act (RCRA) Site ID: WA7890008967,
NWP Compliance Index No.: 19:664

**Washington Department of Ecology
Nuclear Waste Program
Compliance Report**

SITE: 222-S Dangerous and Mixed Waste Treatment, Storage, and Disposal (TSD) Unit
RCRA Site ID: WA7890008967
Inspection Date: June 5, 2019
Site Contacts: Jay Warwick, Washington River Protection Solution LLC (WRPS)
Joe Sondag, United States Department of Energy – Office of River Protection (USDOE-ORP)
Site Location: Hanford Site, 200 West Area
At This Site Since: 1951 **NAICS#:** 56221; 924110, 54171
Current Site Status: Large Quantity Generator

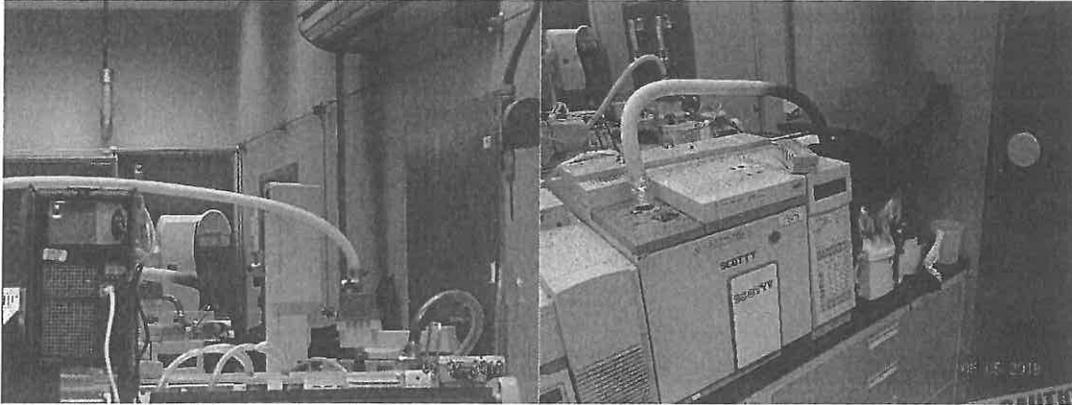
DSC02520 – Instrument fire in Room 4-TUV

DSC02521 – Instrument fire in Room 4-TUV

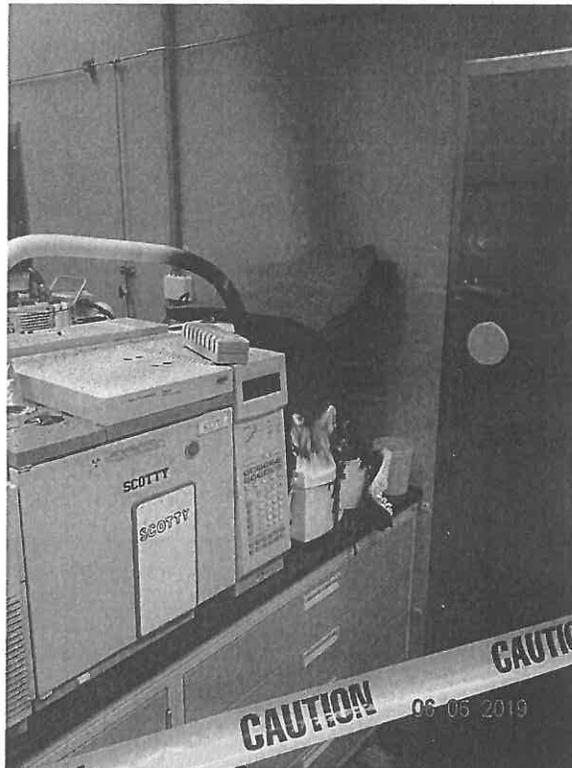
DSC02522 – Instrument fire in Room 4-TUV

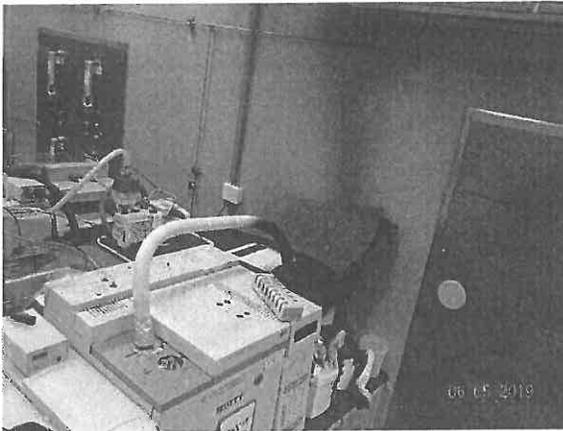
DSC02523 – Instrument fire in Room 4-TUV

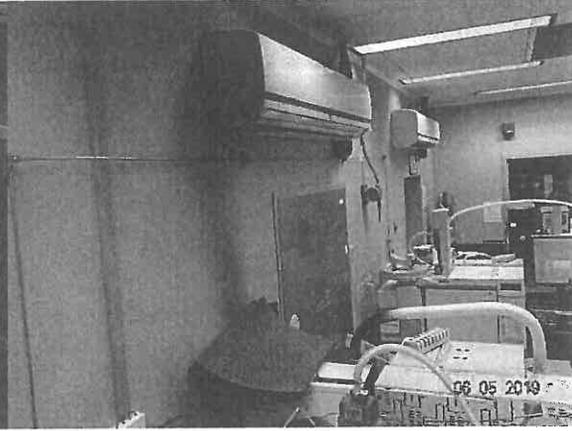
DSC02524 – Instrument fire in Room 4-TUV

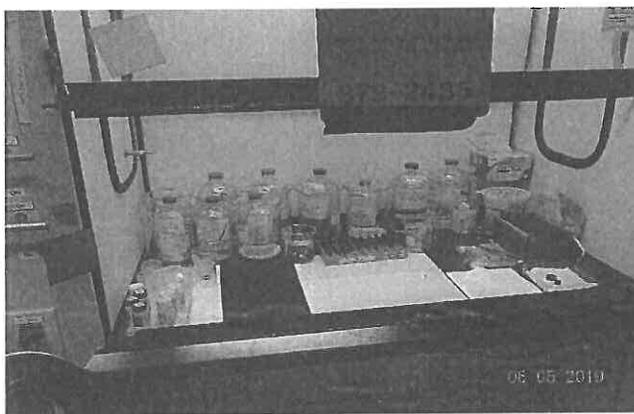
DSC02525 – Dangerous Waste Satellite Accumulation Area in Room 4-TUV

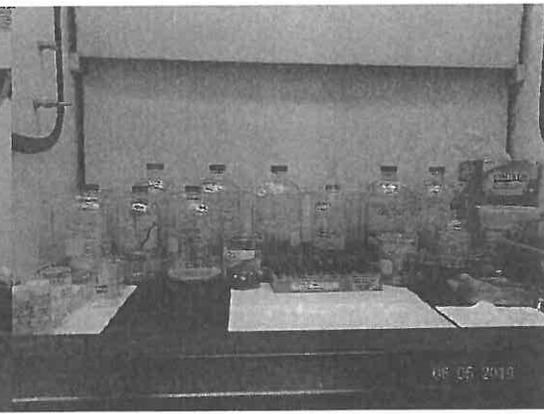
DSC02526 – Dangerous Waste Satellite Accumulation Area in Room 4-TUV

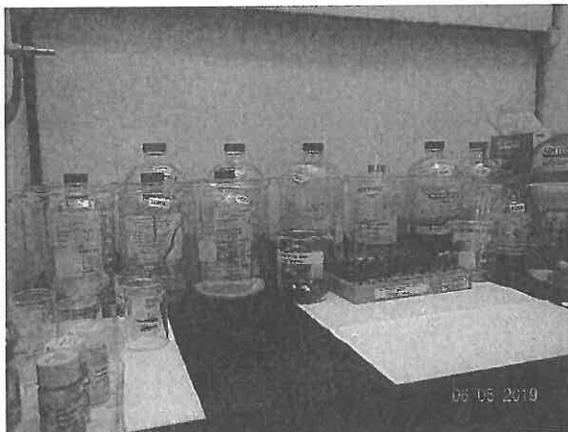
DSC02527 – Dangerous Waste Satellite Accumulation Area in Room 4-TUV

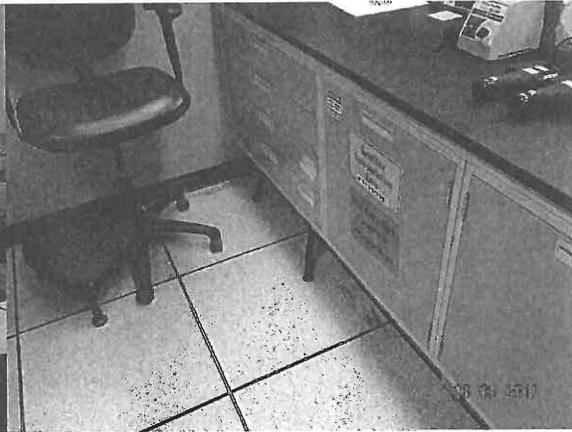
DSC02528 – Empty Dangerous Waste Satellite Accumulation Area in Room 4-TUV

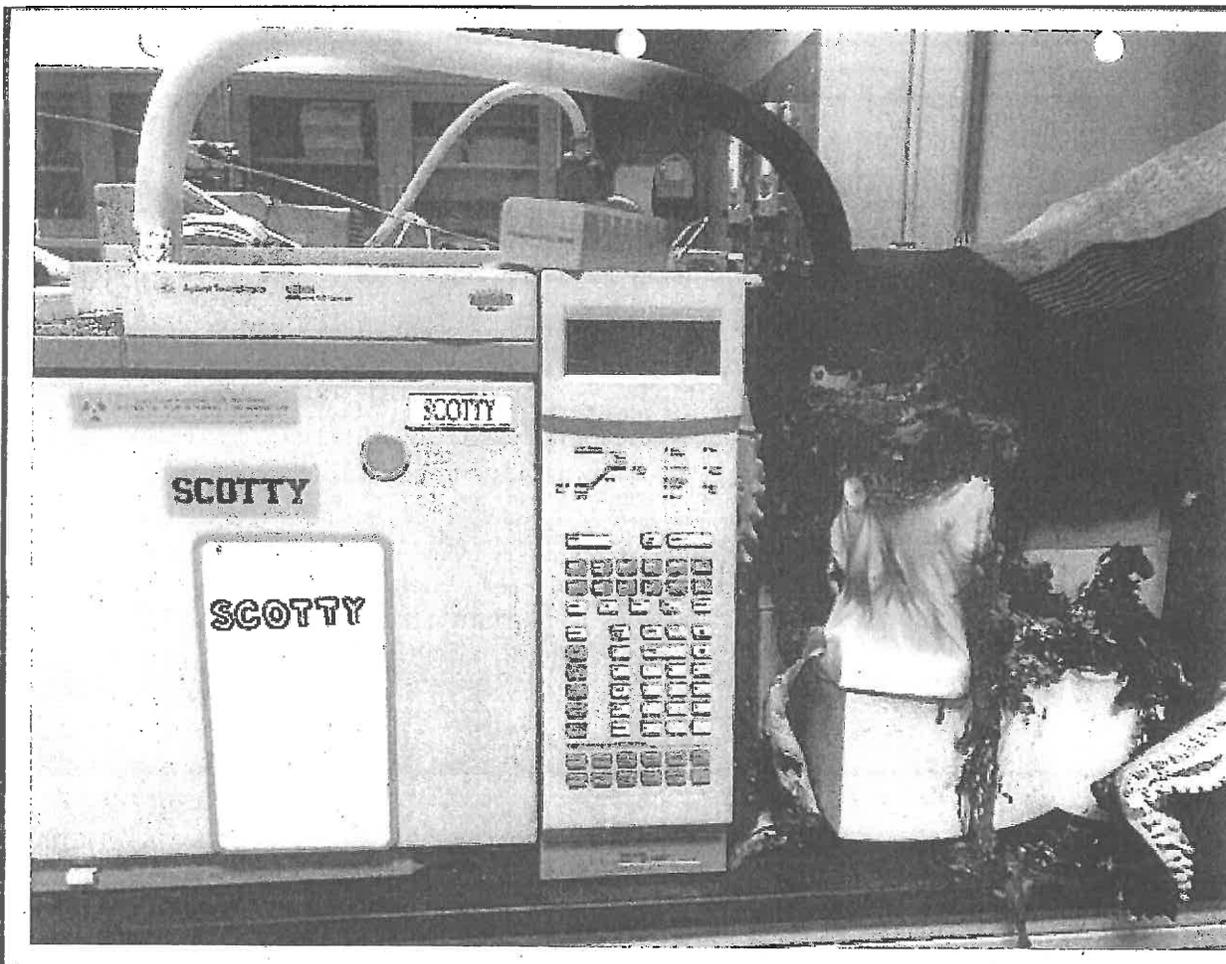
WRPS provided photo of instrument fire in Room 4-TUV
