2902Z (Water Tower) Demolition Report

As Left Characterization

Document Type: RPT Program/Project: PFP Closure

Date Published
February 2017

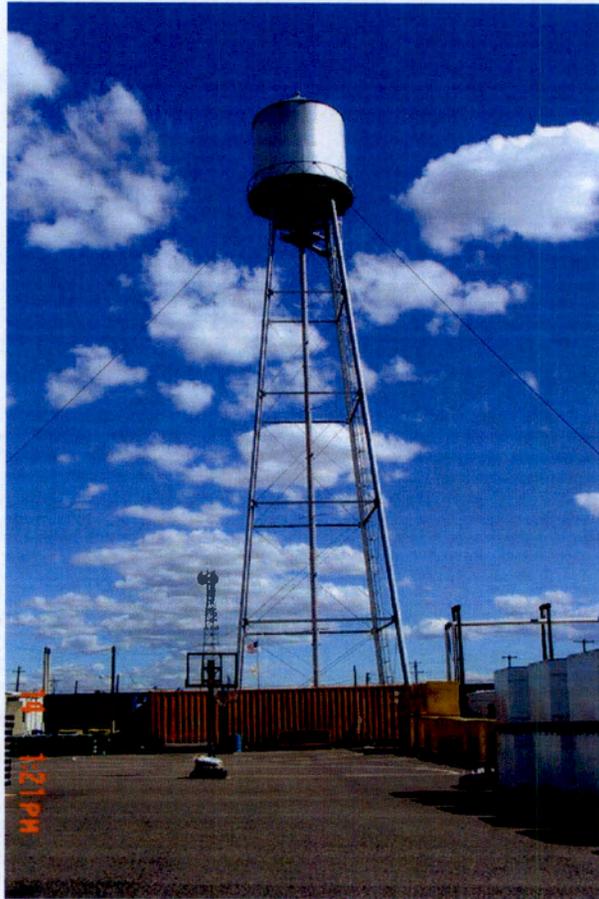
Figure 1. PFP Elevated Water Storage Tank

The PFP Elevated Water Storage Tank - Tower (Figure 1) was approximately 44.2 m (145 ft) high and constructed of steel. The tower was located inside the PFP fenced area.

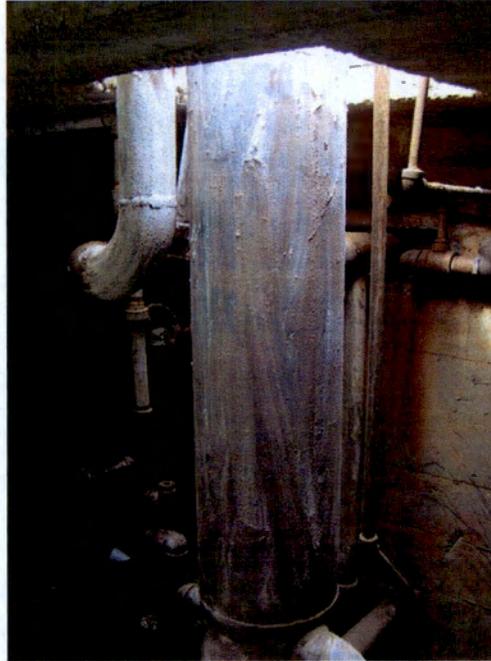
Figure 2. PFP Water Tower Valve Pit Abated Piping

The 2902Z valve pit is approximately 800 ft³ and was constructed when the tower was erected (1948). The valve pit housed all of the required pumps and piping to direct the flow of water from the water tower to the PFP facilities (Figures 2 through 5). The valve pit was constructed using reinforced concrete and measures 11ft by 14ft by 6 ft. The valve pit was located inside the PFP fenced area at longitude/latitude 119.63334/46.55131.

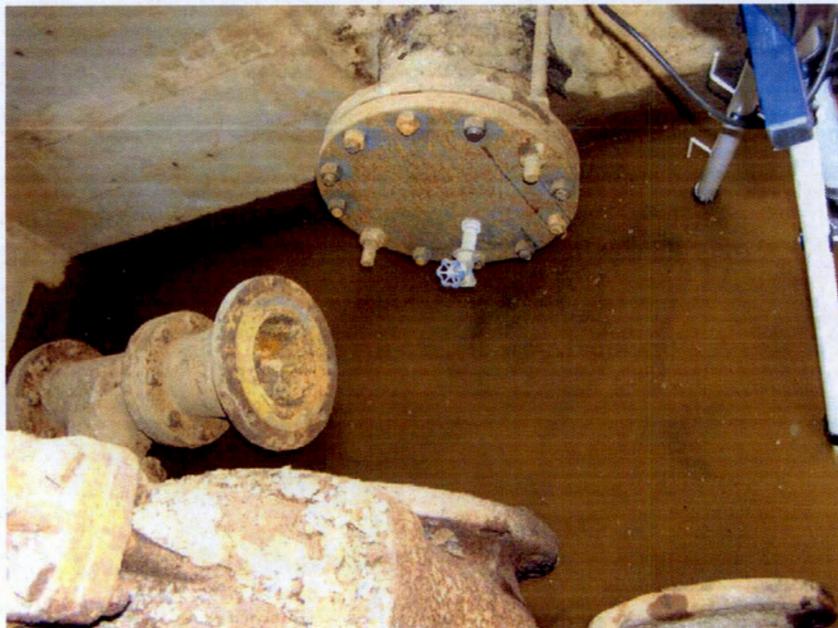
Figure 6. Sanitary Water Air Gap within Valve Pit

The piping in the Valve Pit was verified/drained and isolated per work package 2Z-04-06862, *Remove Steam Valve and Blank Off Steam Leg*. For worker protection lead paint and insulation was removed from the water tower structure prior to demolition at pre-determined pipe cut locations 15.24 cm (6 in.) on either side of the cutting locations. All piping leaving the valve pit was drained and verified isolated prior to stabilization (Figure 6).

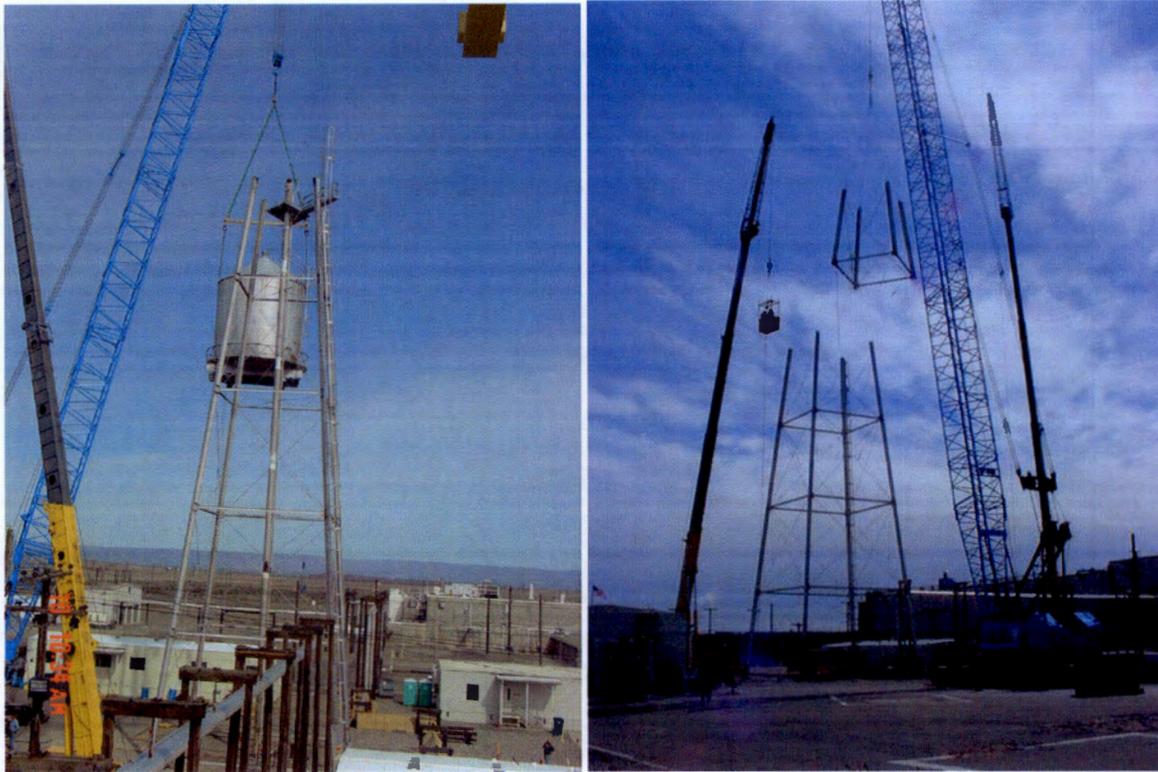
Figure 7. PFP Water Tower Disassembly

The water tower was disassembled (Figure 7) using the critical lift plan contained in work package 2Z-05-01640, and the valve pit was filled with control density fill (CDF) by work package 2Z-04-07341. The demolition and stabilization was uneventful.

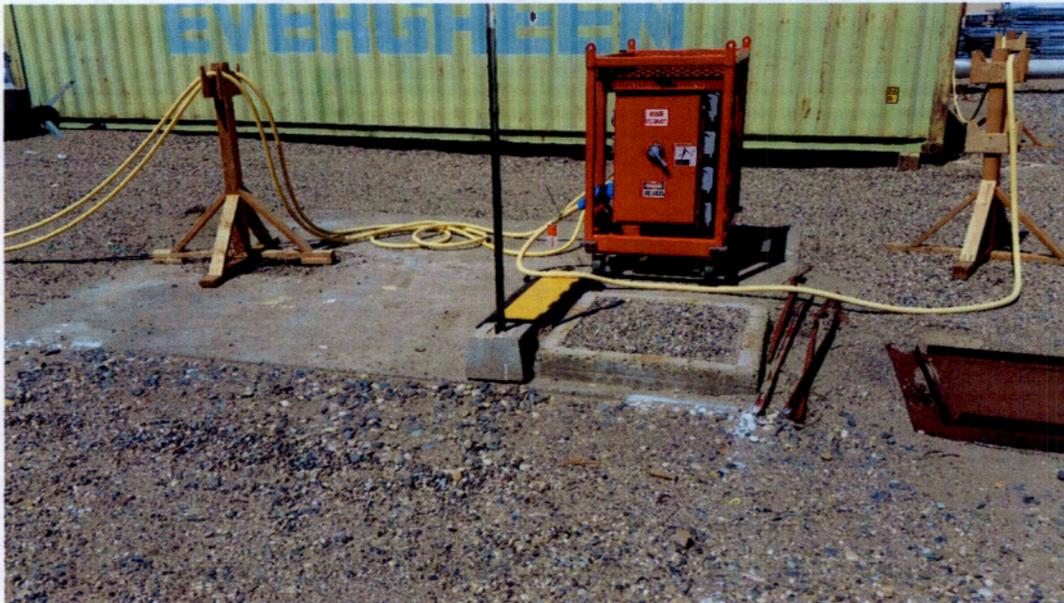
Figure 8. PFP Water Tower Slab

The facility was left in a clean slab-on-grade condition with all penetrations sealed. The valve pit was filled with CDF and the access points covered with gravel. No below-grade contamination was detected during the stabilization and the slab surveyed as free of radiological contamination.
