TANK 4 AND LEACHATE TRANSMISSION SYSTEM REPORT
CONSTRUCTION QUALITY ASSURANCE (CQA)

CQA PHOTOGRAPH LOG WEEK 22
(7/6/10 TO 7/9/10)

ERDF CONSTRUCTION CELLS 9-10

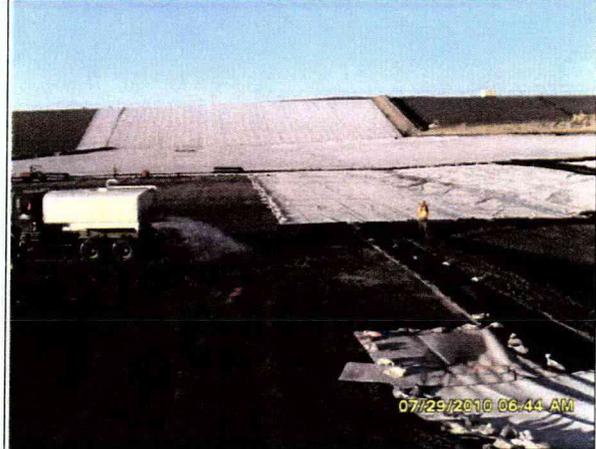
Facing S- TWS over moisture conditioned the admix near the Cell 9 sump.

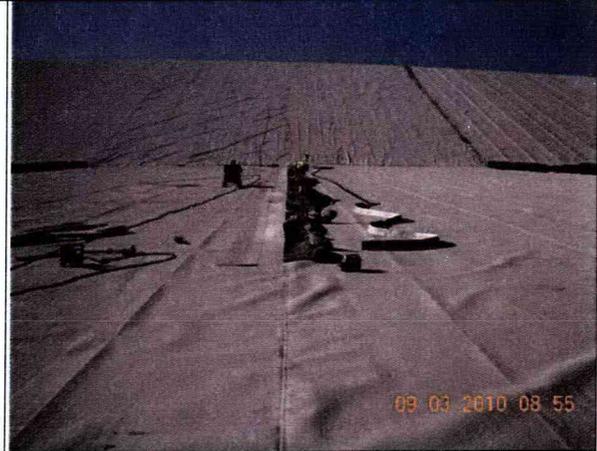
Facing S – ESI placing secondary panel S-118 on the south half of Cell 10 to repair a failed seam S4/S5.

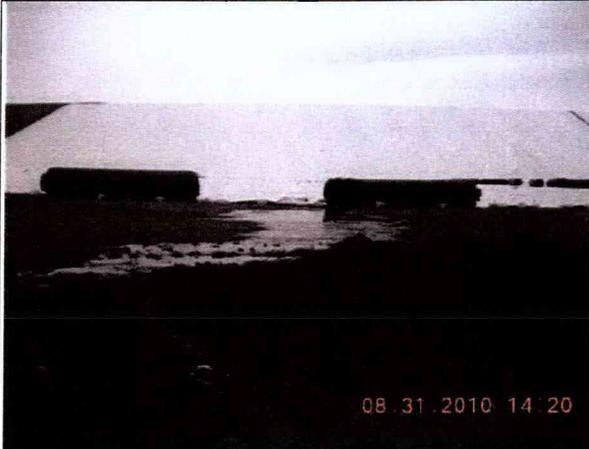
Facing S – Rain showers created small pools of water on the secondary geomembrane in Cell 10.

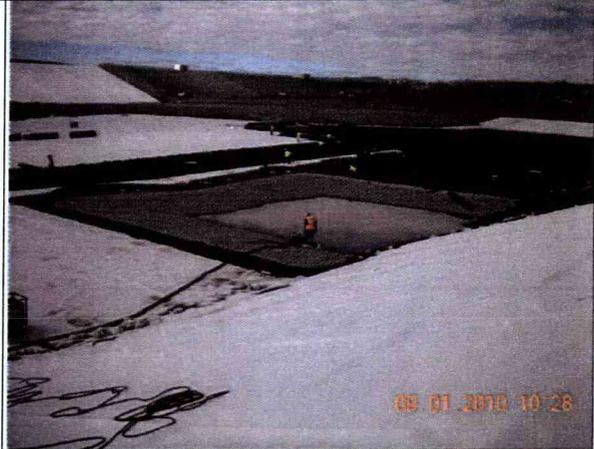
Facing SW – The storm water pooled in the Cells 9 and 10 sumps (TWS shown removing water from the Cell 10 sump).

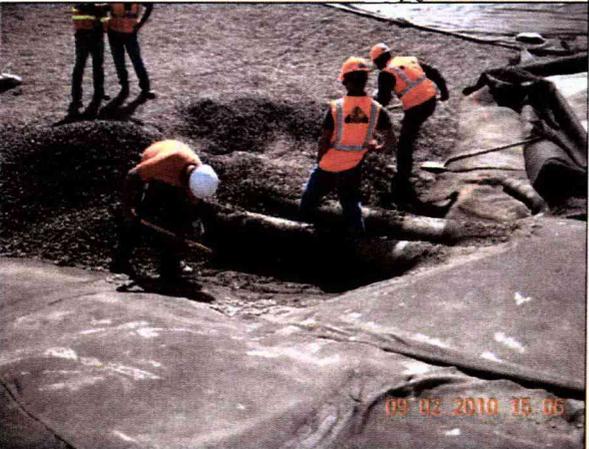
Facing E – After ESI had remove the water from the Cell 9 sump, water was discovered under the Cell 9 secondary geomembrane.

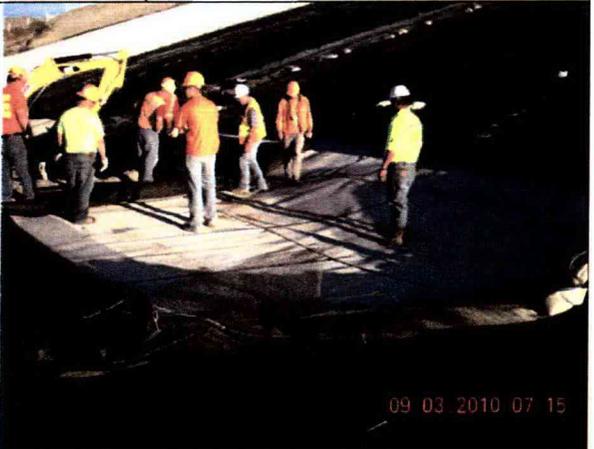
Facing W – ESI, CQA, and TWS investigation of the trapped water in the Cell 9 sump.

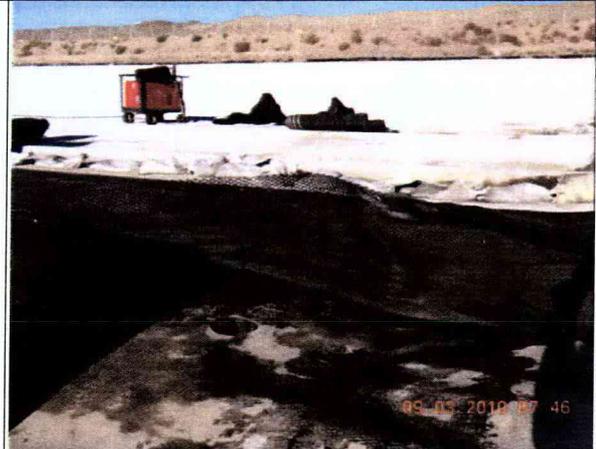
Facing SW – The source of the stormwater infiltration.

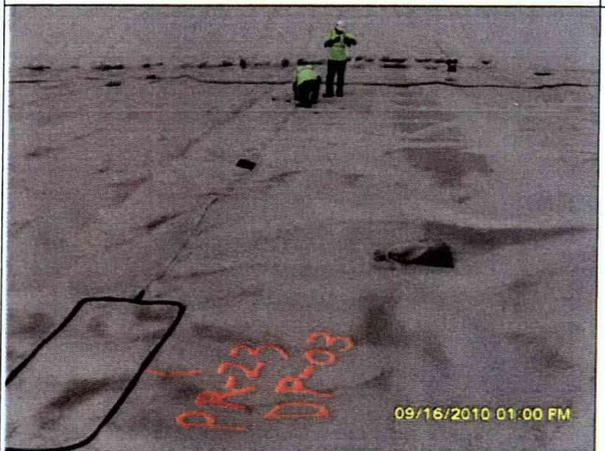
Facing N – ESI determining the extents of the failed Cell 10 primary seam P-11/P-12 (DP-03).

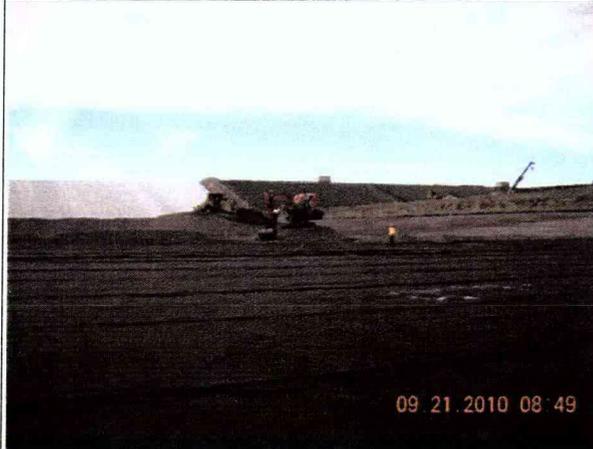
Facing SW – The Hitachi excavator accidentally tipped during gravel placement, damaging the underlying liner.

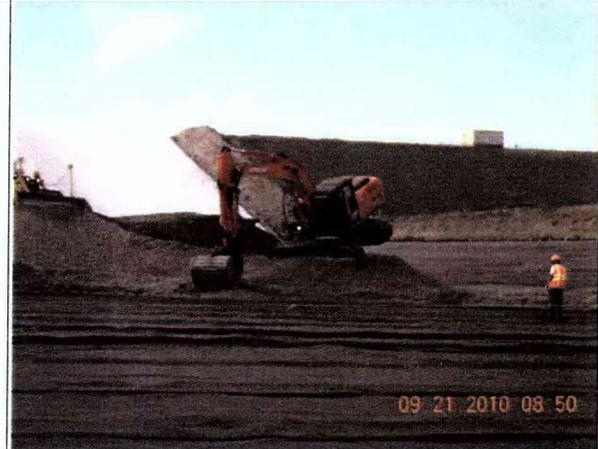
Facing SE – Although the bucket rested on drainage gravel, the force from the bucket damaged the underlying liner.

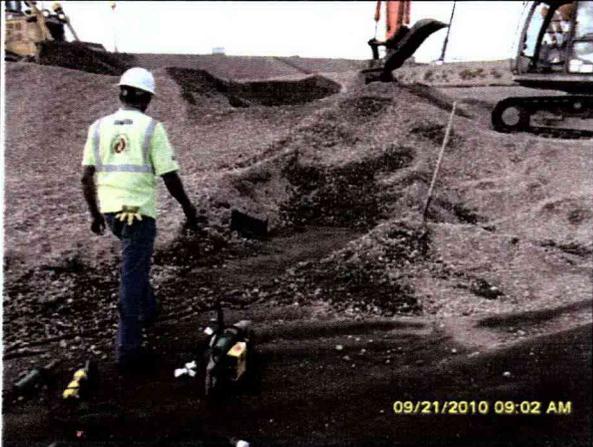
Facing SE – TWS excavated area to investigate the damage.

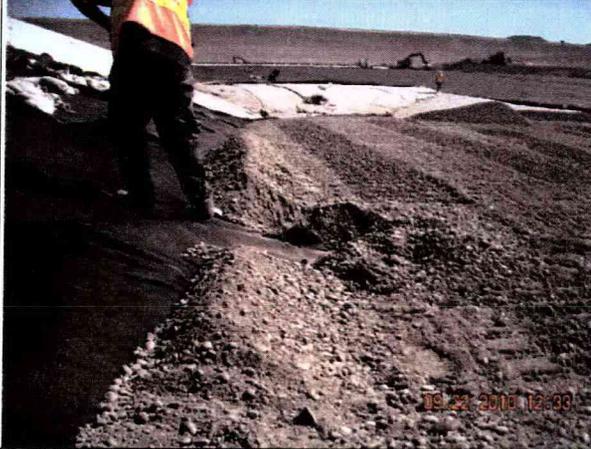
Facing E – The dozer clipped the geocomposite while placing drainage gravel on the toe of the Cell 9 slope, west of the sump.

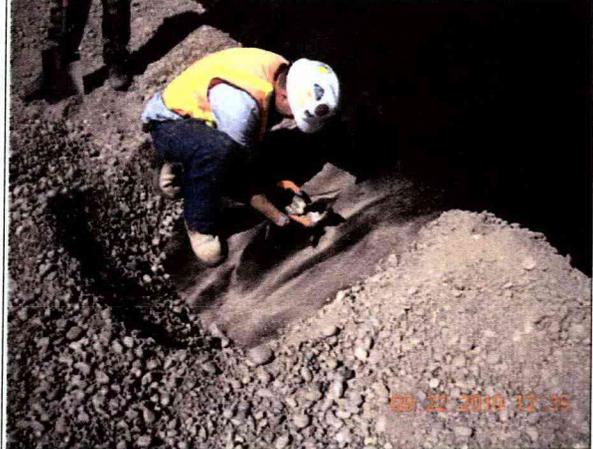
Facing NW – CQA investigation found no damage to the underlying primary geomembrane.
