TRANSMITTAL OF THE 100-F/IU-2/IU-6 AREA – SEGMENT 4 ORPHAN SITES
EVALUATION REPORT, OSR-2011-0001, REVISION 0

100-F/IU-2/IU-6 Area – Segment 4 Orphan Sites Evaluation Report

**Prepared for the U.S. Department of Energy
by Washington Closure Hanford**

November 2011

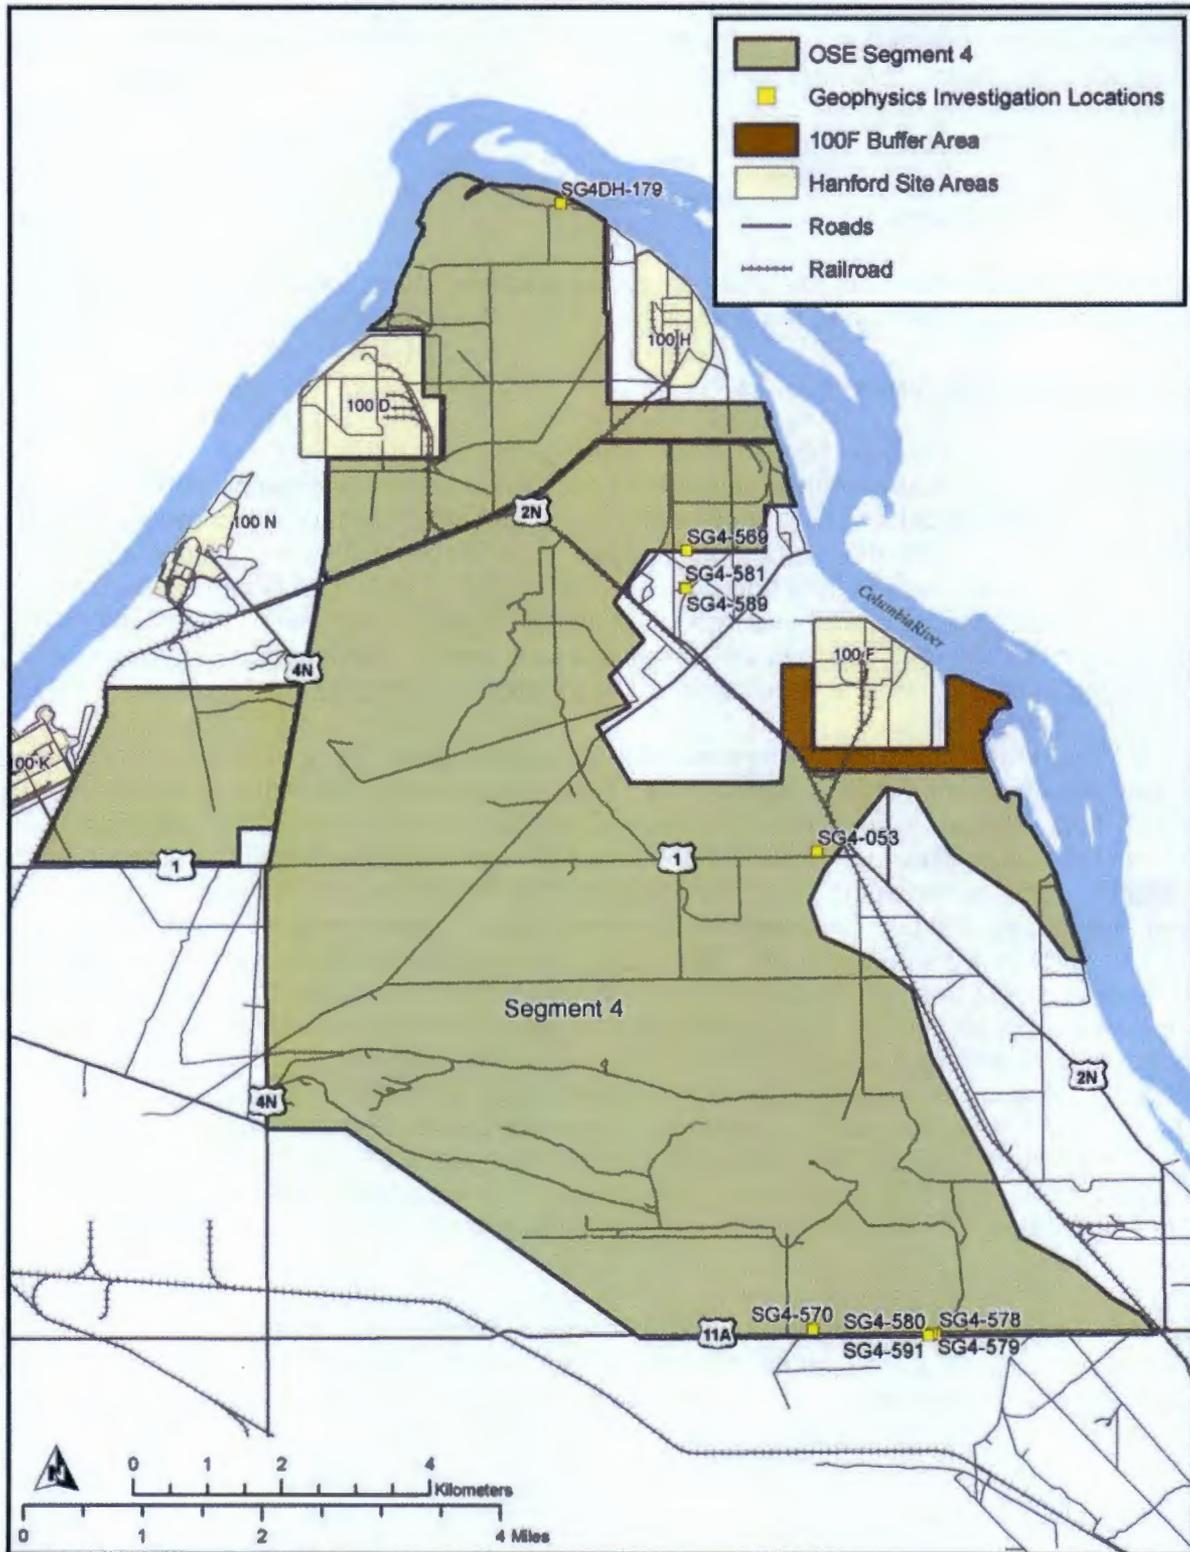
Figure 6-2. Segment 4 Geophysics.

SG4-569: The GIS data indicate that the LSCC enters Segment 4 at the selected location. Geophysics was conducted over the disturbed linear visible in orthophotography, and detected no below-grade anomalies at the selected location (WCH 2011d).

SG4-570: The GIS data indicate that the LSCC enters Segment 4 at the selected location. Geophysics was conducted over the disturbed linear visible in the orthophotography. Three below-grade anomalies were detected in the disturbed linear area that would indicate the presence of the lead sheath communication cable. Two utility lines running in an east-west direction and one line in a north-south direction converged in the area of an above-grade communication box (WCH 2011d).
