TANK 4 AND LEACHATE TRANSMISSION SYSTEM REPORT
CONSTRUCTION QUALITY ASSURANCE (CQA)

PHOTOLOG

ERDF CONSTRUCTION CELLS 9-10

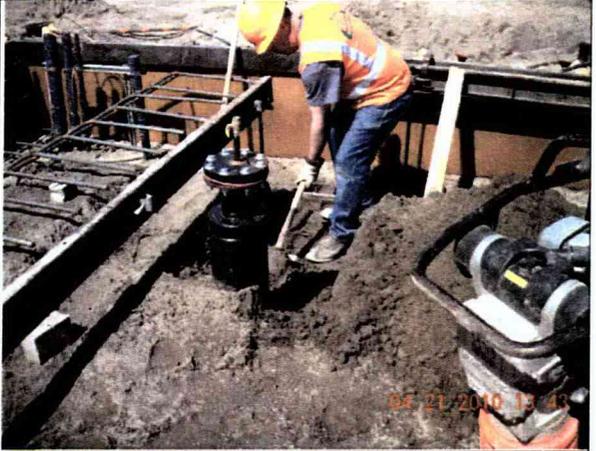
Facing W – After hydrostatic testing failed, BMWC discovered a faulty O-ring, which was replaced.

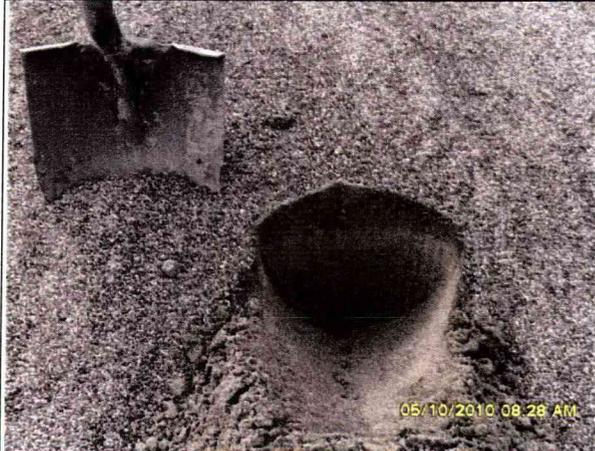
Facing Down – Subgrade acceptance test. Subgrade contains moisture 4-in below the surface.

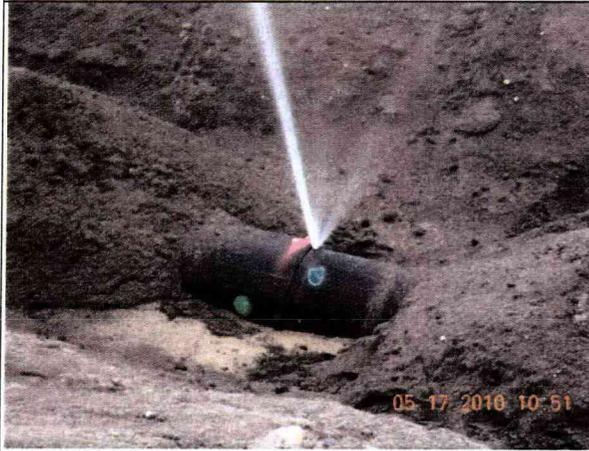
Facing Down – BMWC releasing water from the outer containment of the 10x16-in pipe between MH-32 and MH-33 after a failed weld.

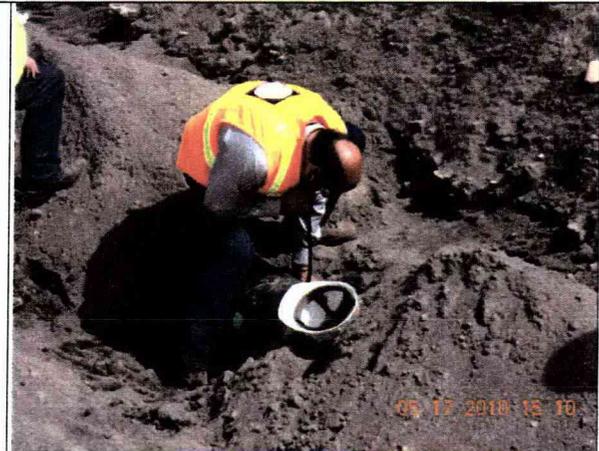
Facing Down – BMWC attempting to locate the failed weld in th 10x16-in HDPE between MH-32 and MH-33.

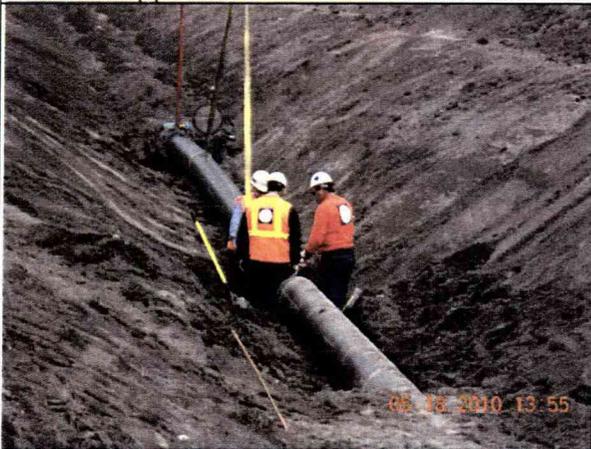
Facing W – BMWC repairing the failed portion of piping between MH-32 and MH-33.

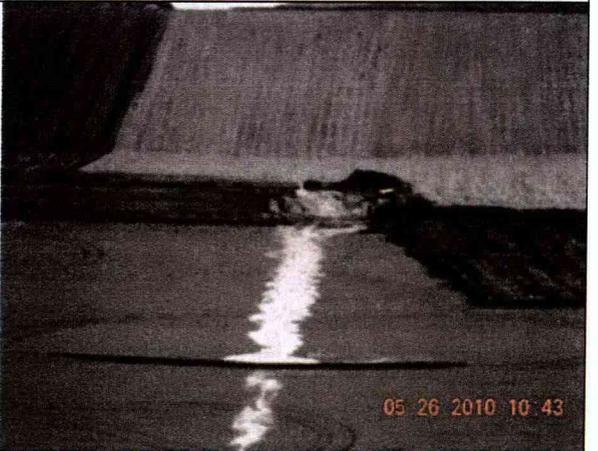
Facing S – Rainwater running off the admix through the center of Cell 9. TWS built dams to keep the water from reaching the sump.

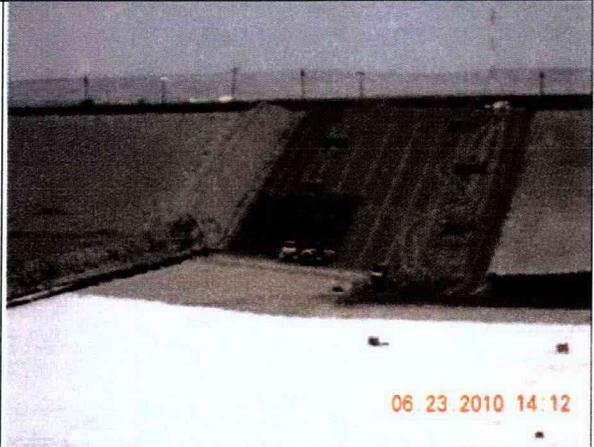
Facing N – TWS re-rolling grid C1 on the north embankment after failing density tests.

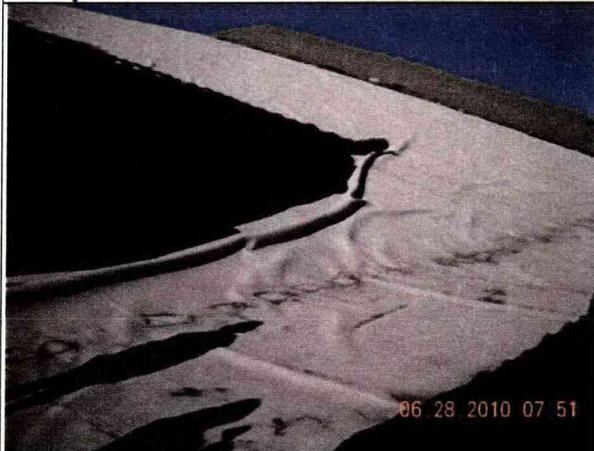
Facing W – A large wrinkle has developed at the south toe of Cell 9. ESI will repair the wrinkle prior to covering with geocomposite.

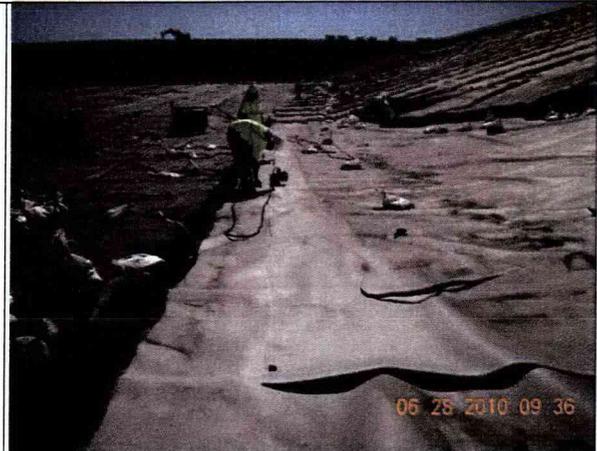
Facing E – ESI repairing a large wrinkle at the south toe of Cell 9.

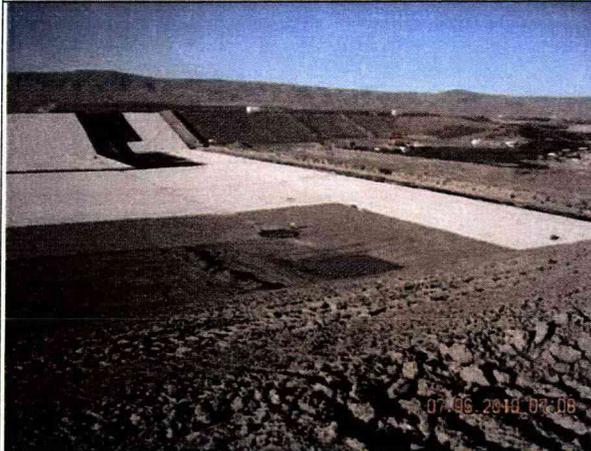
Facing SW – Weekend rainstorms caused runoff to accumulate in the Cell 9 sump.

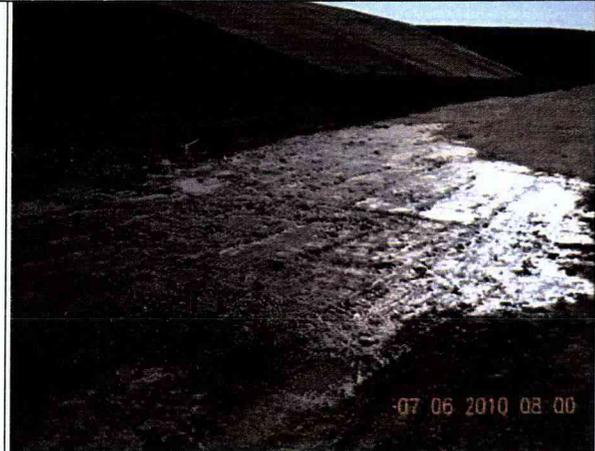
Facing NE – Saturated admix near the Cell 9 sump from weekend storms.
