FIELD SUMMARY REPORT FOR THE CENTRAL PLATEAU FISCAL YEAR 2017 AERIAL THERMAL SURVEY

CH2MHILL
Plateau Remediation Company

Date Published
January 2021

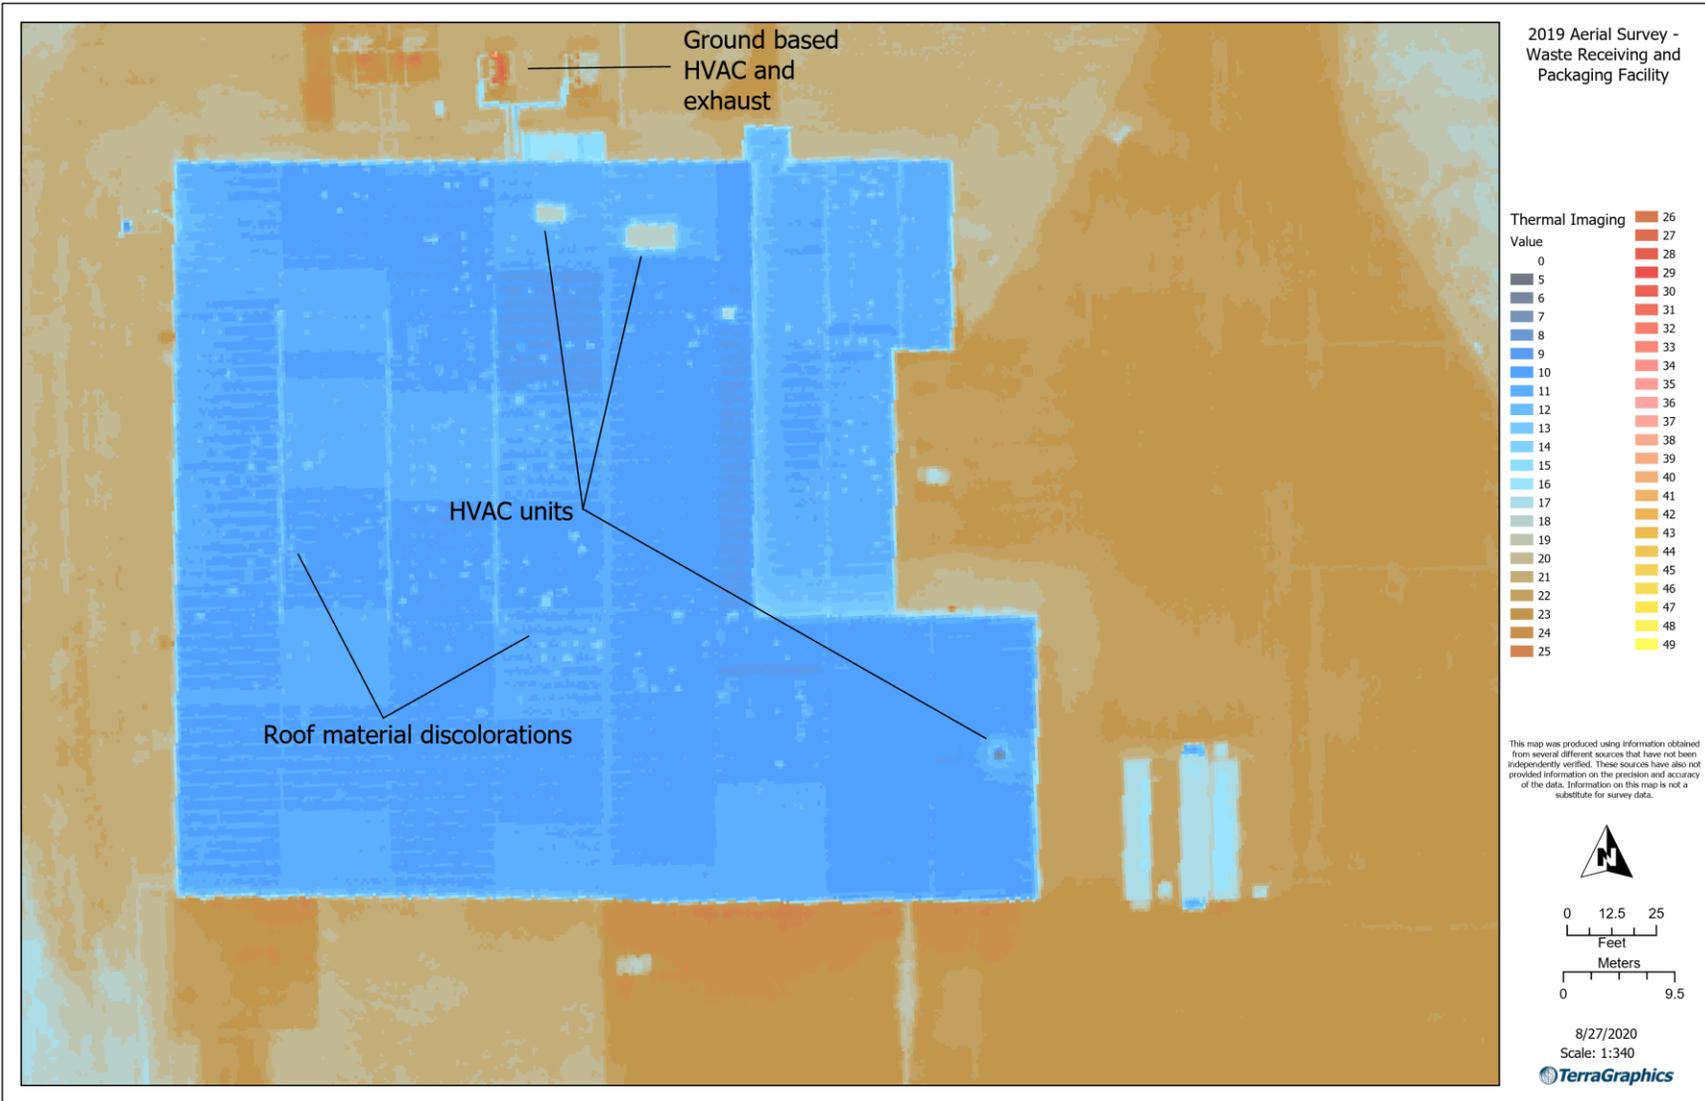
Figure 8. Thermal Imagery of the WRAP Facility

When acute or broad thermal contrasts were identified, satellite imagery and/or site resources were used to determine whether the observed temperature changes could be attributed to known surface features that made logical sense. If the contrast could not be explained in this way, then it was retained as a credible anomaly. An example of thermal contrast that can be explained are roof-mounted heating, ventilation, and air conditioning (HVAC) units, which during the summer months, do not cool down as much as the surrounding roof. Thermal imaging of this condition shows clear contrast on roofs with operating HVAC units, and review of satellite imagery confirms the location of these units. This condition is shown in Figure 8.

Figure 8 also shows the thermal imagery of the roof of the Waste Receiving and Packaging (WRAP) facility obtained during field activities performed as part of this project. The location of HVAC units associated with the roof of the WRAP facility correspond to elevated thermal signatures when compared to the rest of the facility, and thus, easily identifiable, and the temperature contrast observed is thus explainable.

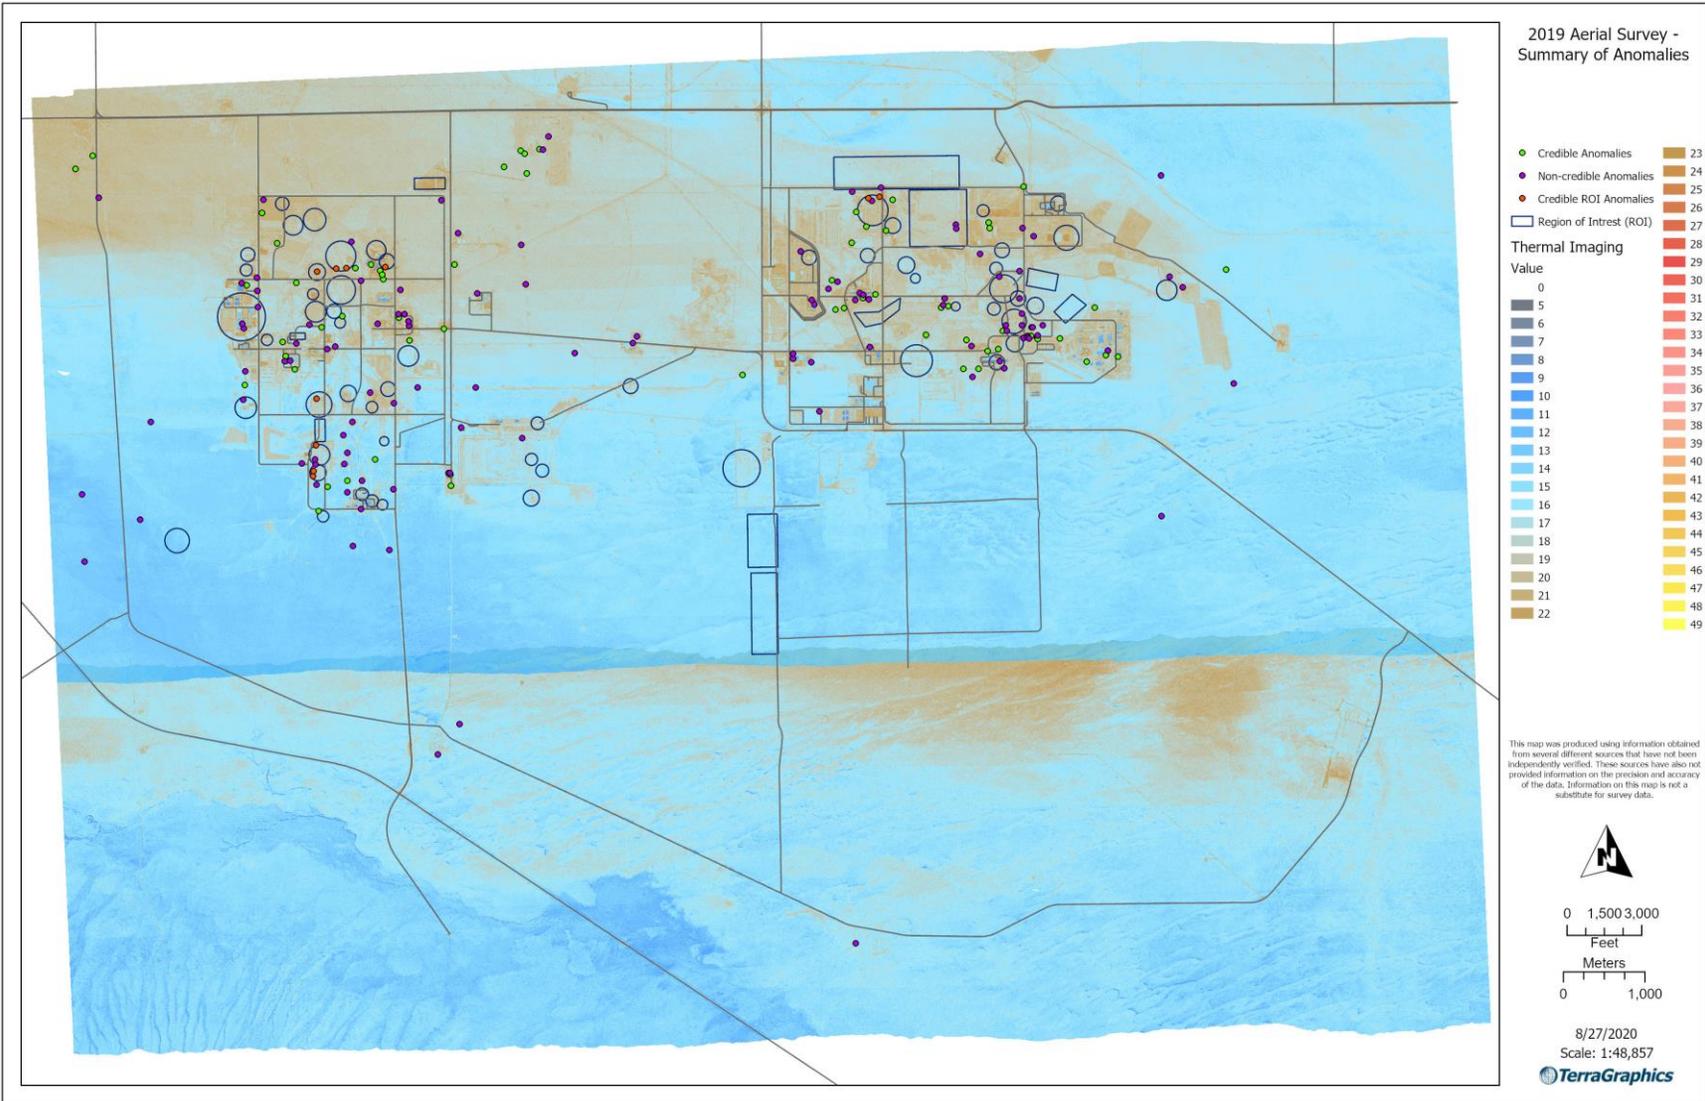
Figure 9. Credible Anomalies Identified During the FY 2017 Aerial Imaging Survey

Figure 9 shows the locations of the credible anomalies identified in Tables 1 and 2. Additional location and spatial information regarding the credible anomalies identified can be found in Appendix B.

Following spatial analysis, 74 anomalies were determined to be credible. Table 1 provides a list and brief description of credible anomalies associated with waste sites and cataloged by OU. Thirty credible anomalies were found to be associated with waste sites managed as part of existing OUs. Table 2 lists credible anomalies associated with facilities, structures, or areas of land and the responsible prime contractor. Forty-four credible anomalies were identified to be associated with facility, structures, or areas of land not part of an existing OU. The Feature Type/ID column in the tables is an alphanumeric identification system developed by the RSL team to categorize the anomalies. The identifiers correspond to the following definitions:

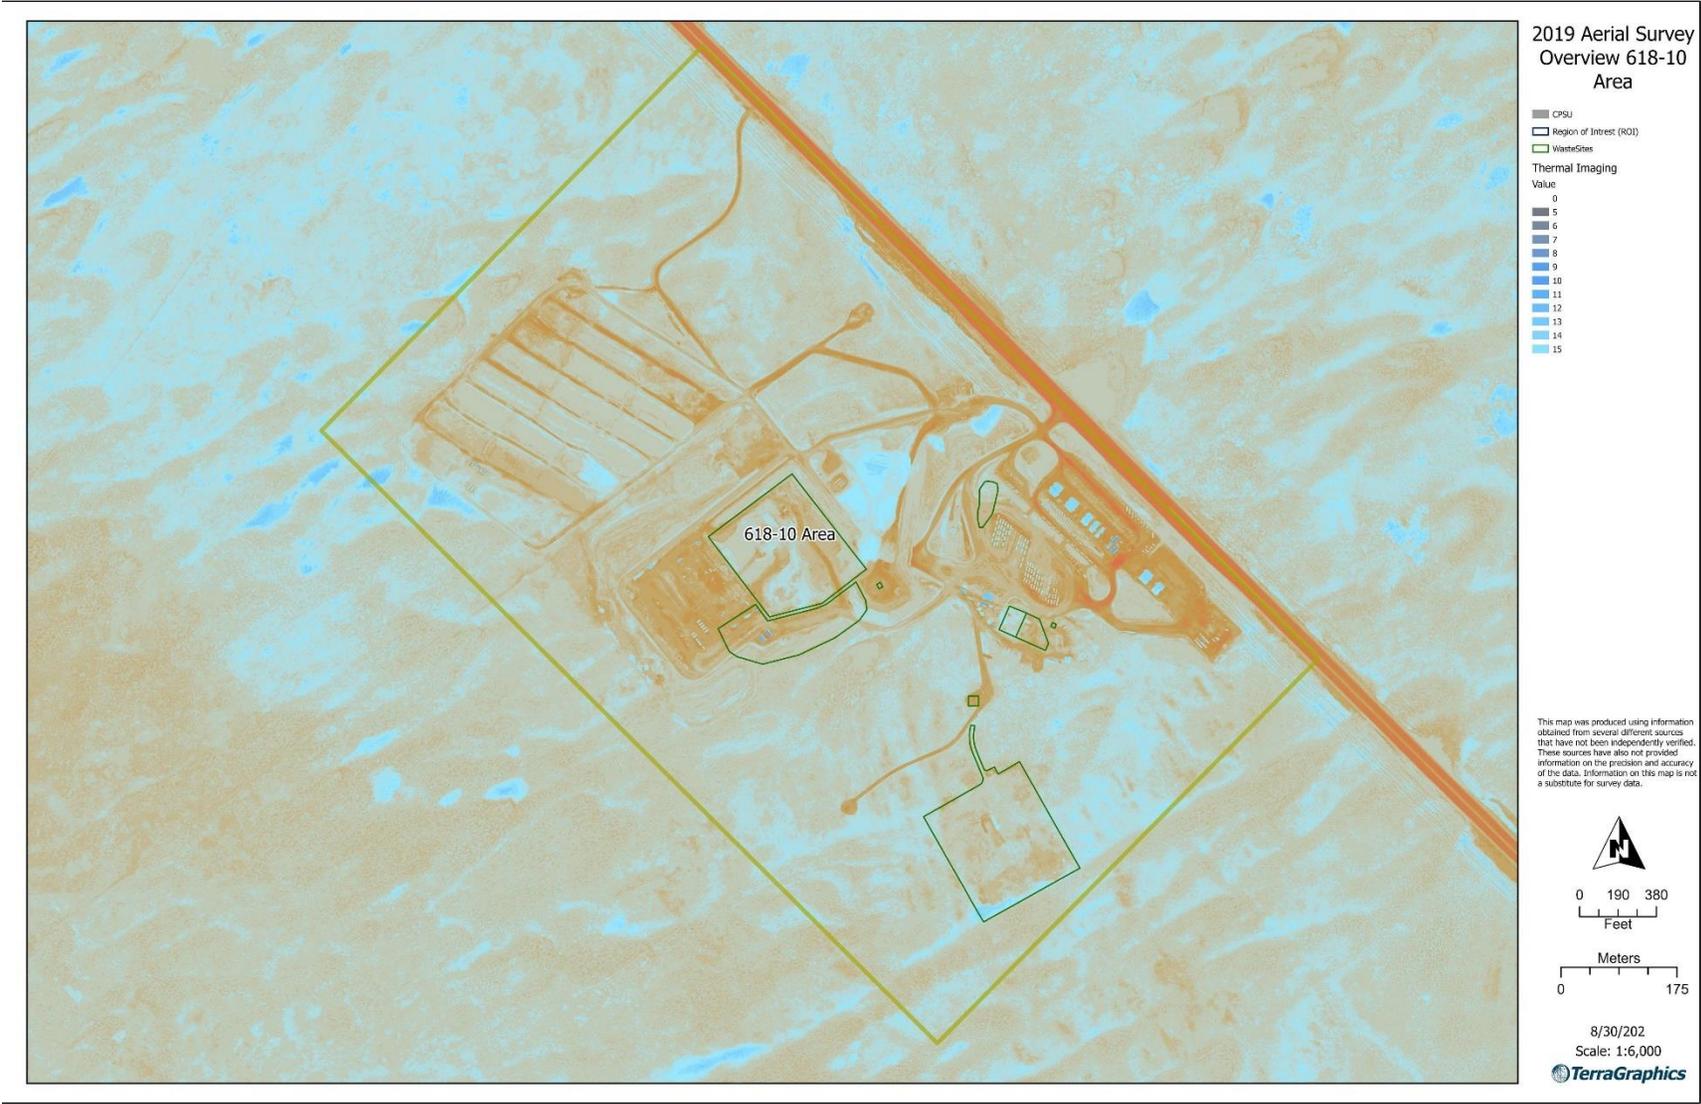
Figure B-11. FY2017 Thermal Imaging Survey Results for the 618-10 Waste Site

The area of the 618-10 waste site was specifically evaluated for anomalies and features because waste site remediation and construction activities were concluding in this area at the time of the thermal survey. Various raster image contrasting techniques were used in the review of the thermal imagery collected over the 618-10 waste site. The area surveyed is bisected by Route 4 South, a highly traveled four-lane highway. The waste site is west of the highway, and undisturbed shrub and grass vegetation is found east of the highway. All surveyed areas were evaluated thoroughly for anomalies and features that may have originated within the remediation area but migrated out of the construction zone. East of the highway, all thermal variations were attributed to the broad range of transmissivity resulting from surface grasses, sands, shrubs, and ground slopes. Proximal to the construction zone on the west side of the highway, no anomalies were identified, as all suspected thermal variations were attributed to vehicle travel, service water usage, building structures, laydown areas, and general construction activities happening at the time of the survey.
