HNF-59342  
Revision 0

# Five-Year Surveillance Report for the 105-C, 105-D, 105-H, 105-F and 105-N/109-N Safe Storage Enclosures

Date Published  
March 2016

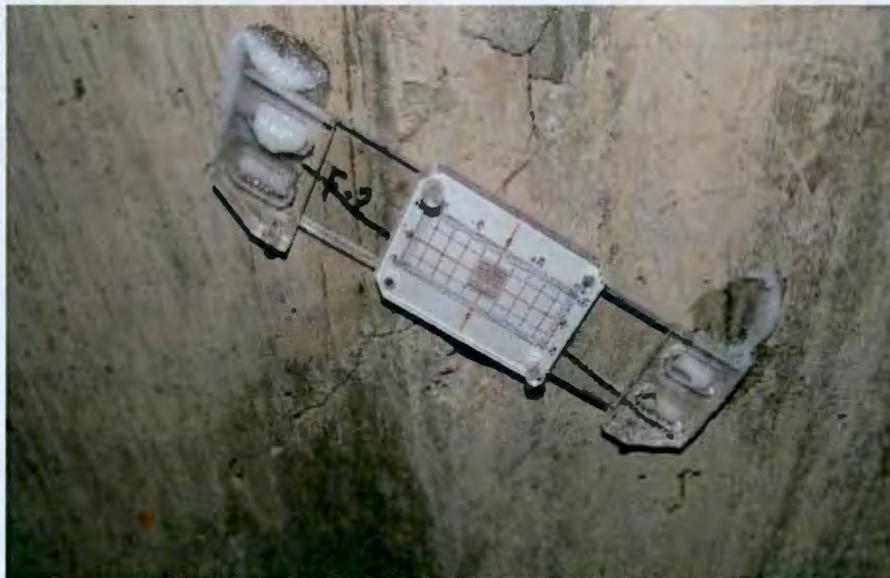
Figure 5. Crack Monitor Installed at 105-F.

Vertical cracks in the original concrete wall near and inside the vestibule were noted in the 105-F and 105-D SSEs. A crack monitor, shown in Figure 5, was installed in each of these SSEs to monitor any potential displacement along the cracks with time. It is interesting to note that similar cracks were observed in the 105-B Reactor building, which has construction very similar to the 105-F and 105-D SSEs. Bat guano and/or spider webs were present in all the SSEs. Live and dead bats were observed in some SSEs and evaluated by the IH for health and safety purposes. The inside conditions were dry in all of the SSEs and little or no evidence of water intrusion was noted. No evidence of groundwater intrusion was noted in any of the basement floors.

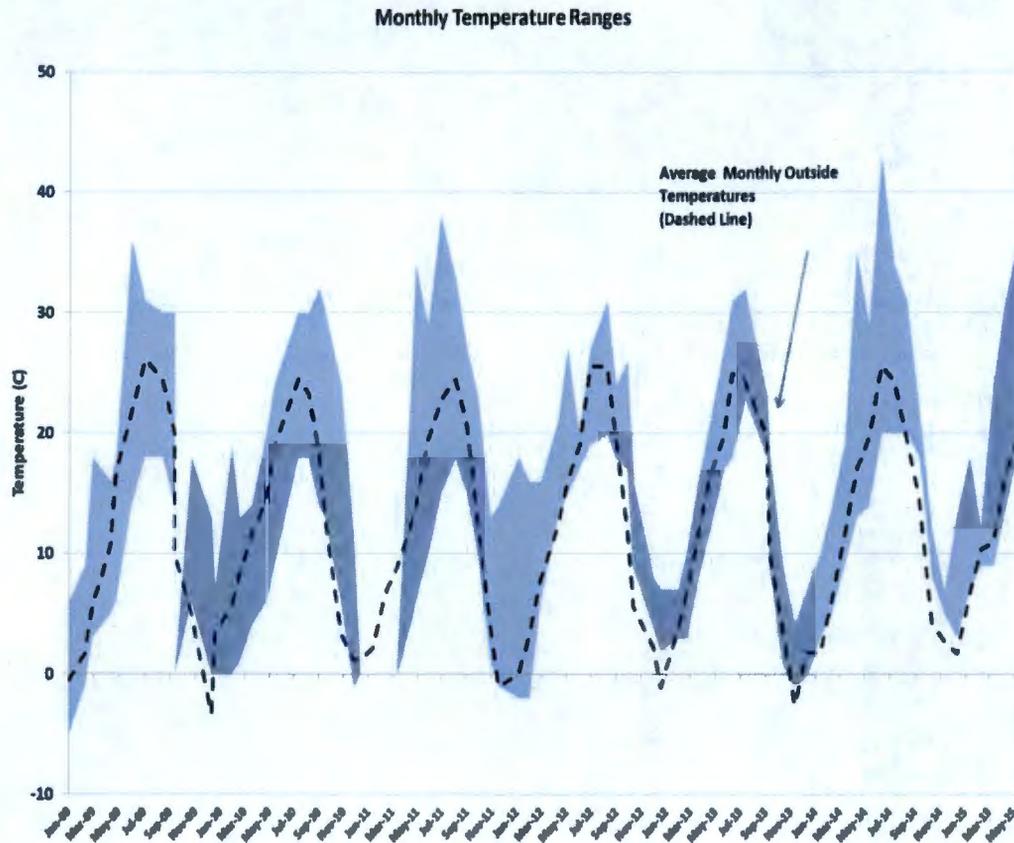
Figure 6. Monthly Temperature Readings and Average outside Temperature.

The temperature and flood-level sensors were operating within the acceptable ranges. A problem was observed with one backup temperature sensor reading in the 105-D SSE. It is not known whether the backup sensor is malfunctioning or the switch is malfunctioning. Data collected

since 2009 are presented in Figure 6. These data show that monthly maximum and minimum temperatures inside the SSE structures track with average outside temperatures. Additionally, none of the SSEs show evidence of surface water or groundwater flooding (alarm conditions) (Figure 7). Continued monthly monitoring of these systems may not provide any additional value.

4. Work with the Tri-Party agencies to discontinue the temperature and flood-level sensor monitoring. The data set to date clearly demonstrates that no upset conditions

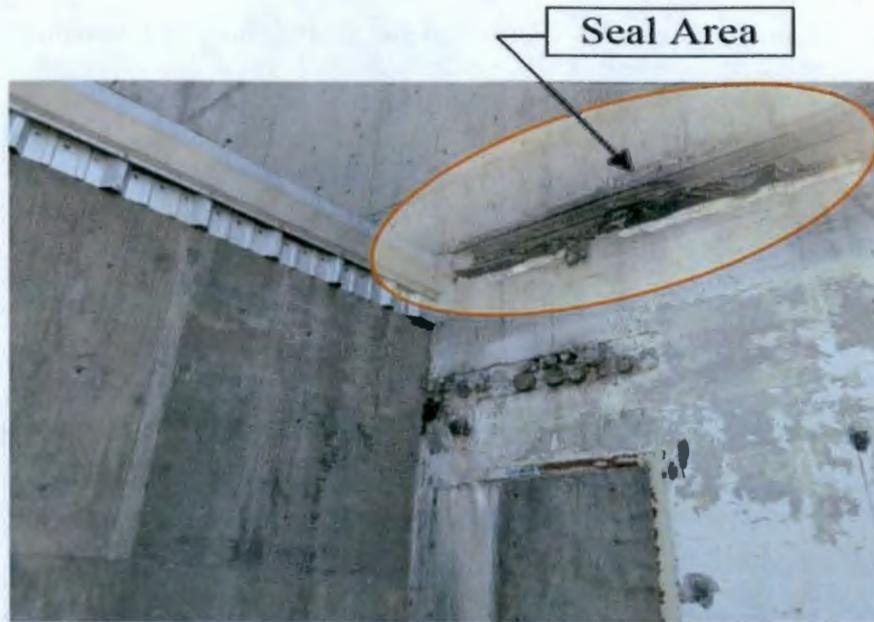
Figure 8. The Area to be Sealed at the 105-C SSE.

2. There is evidence of very slow water in-leakage at a pourback/roof structure junction at grade level; the leak is so slow as to only form white deposits, as shown in Figure 8.

The proposed action is to seal the outside area (Figure 8) where the in-leak may be occurring.

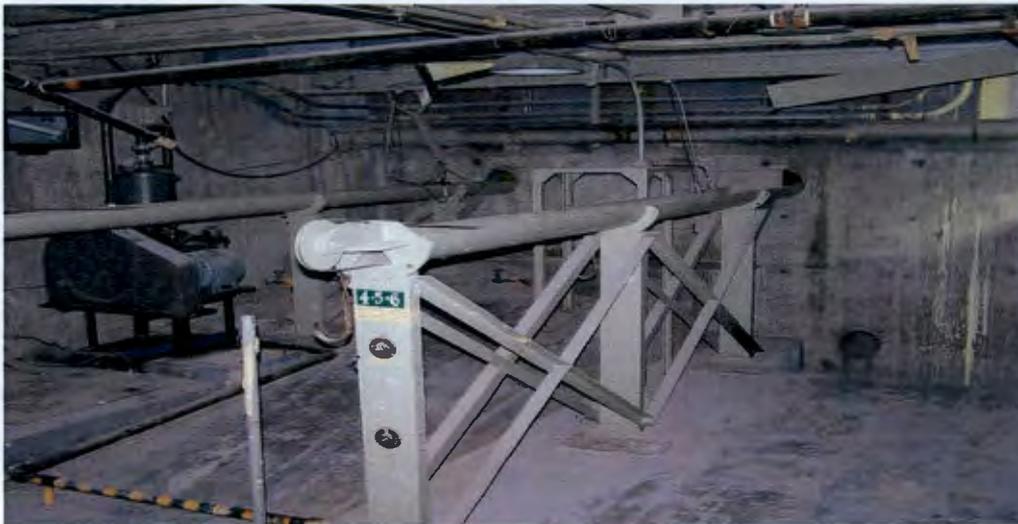
Photo 1- Showing how dusty/dirty floors are in 105 C

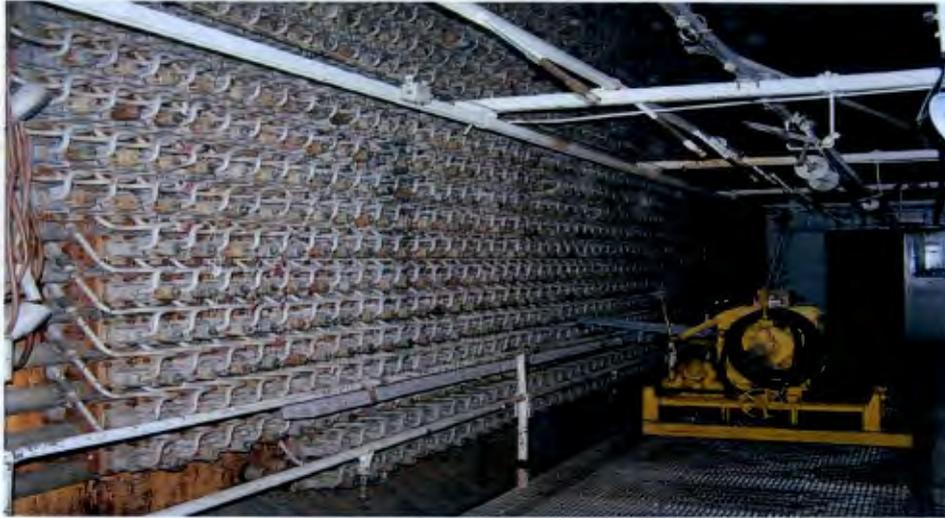
Photo 2- Rear face, only reactor that route leads to this, lots of left over items that are potentially hazardous.

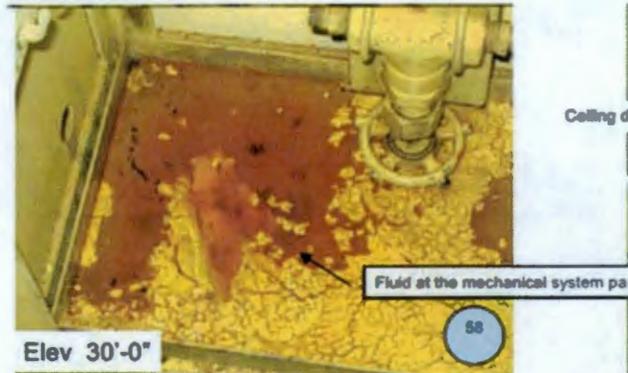
Item 58 2008 – Unknown Liquid at a Mechanical System Component, Elev. 30'-0", recommend cleanup

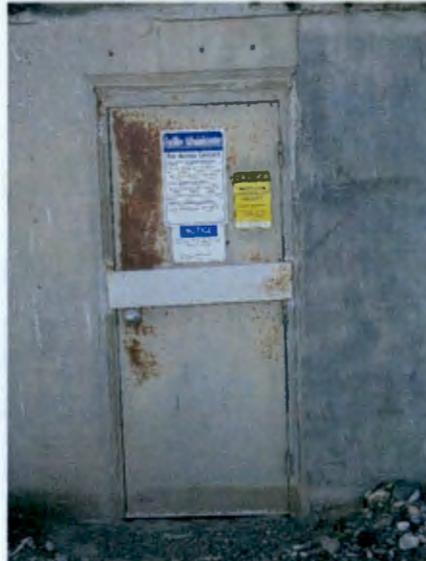
3640 Metal door @ N wall. Depression near door and mild corrosion

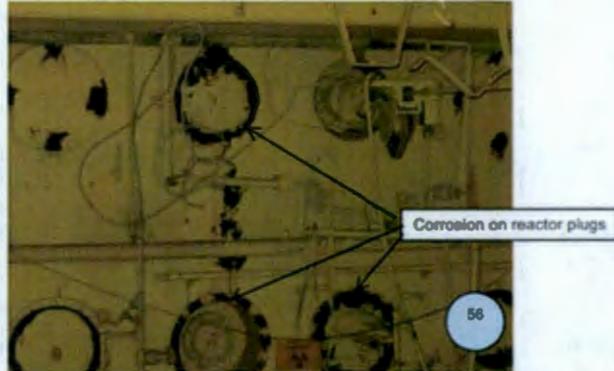
Item 56 2008 – Existing Reactor Block Wall, Elev. 30'-0", moderate corrosion

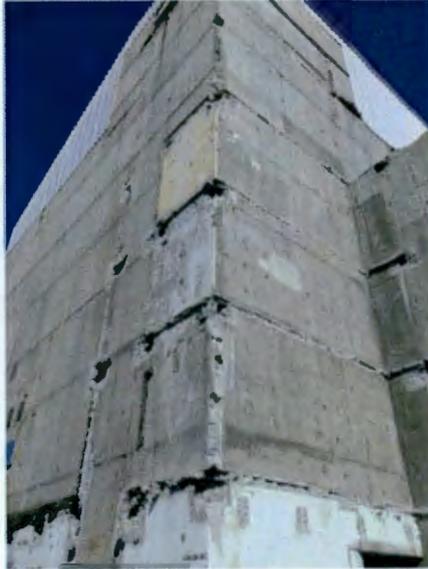
3648 demo damage no issue

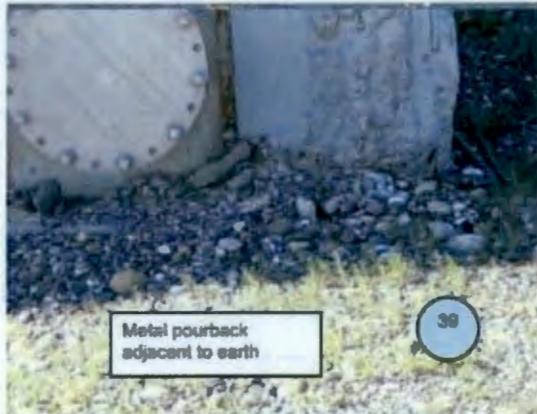
Item 39 – 2008 Detail Pourback ISS detail at N Wall of Building Exterior, Elev. 0'-0",  
recommend soil removal

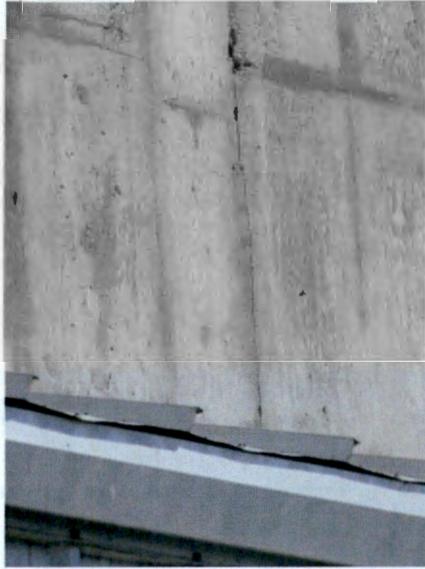
3676 Wall crack on exterior wall above vestibule

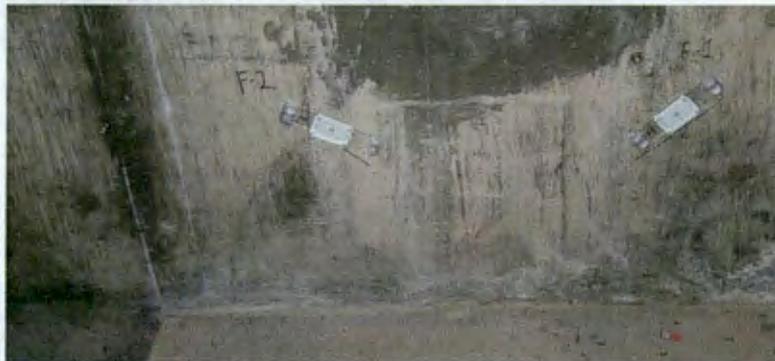
*Figure 1 – Crack Locations at top of stairs (after affixing Crack Monitors on 10/23/14)*

*May 2015 update - Similar infills and cracks have been identified at both 105-D and 105-B (i.e., all of the original construction (1943) reactor buildings), along and below this infill. This confirms that this is not a demolition related or SSE construction issue.*

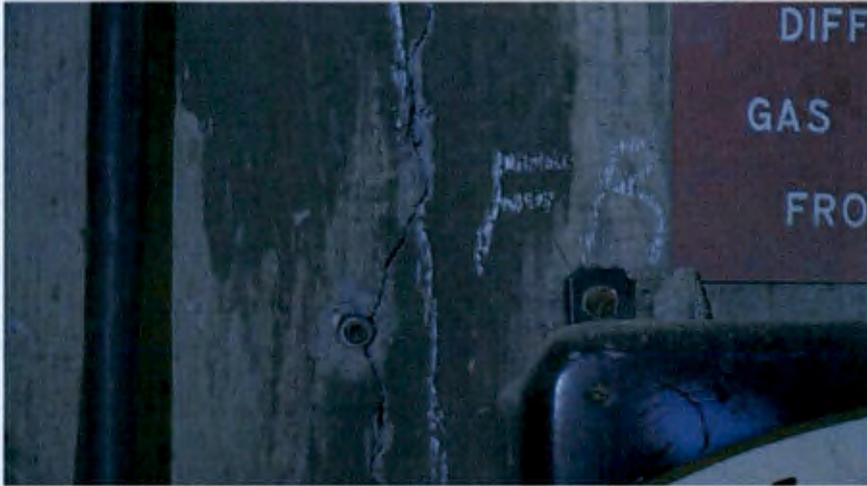
2981 Crack about 5 ft off floor

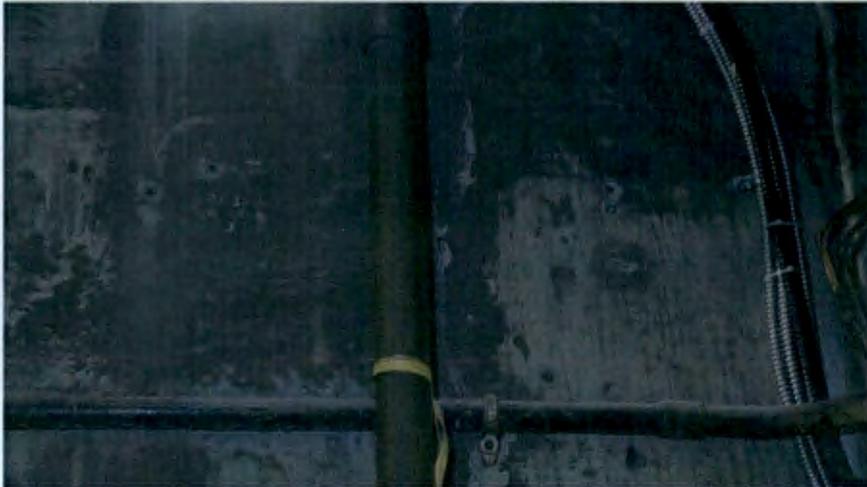
2982 Crack about 8 ft off floor

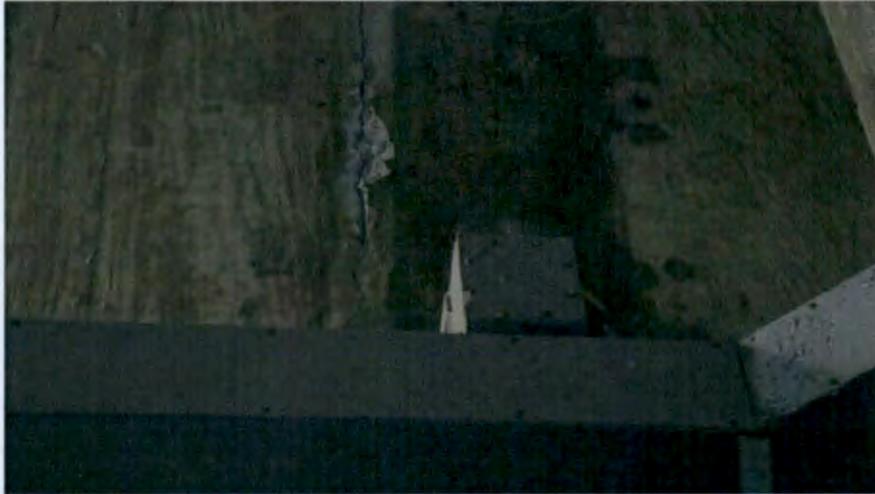
2014 Photo # 2984 Crack about 12 ft off floor

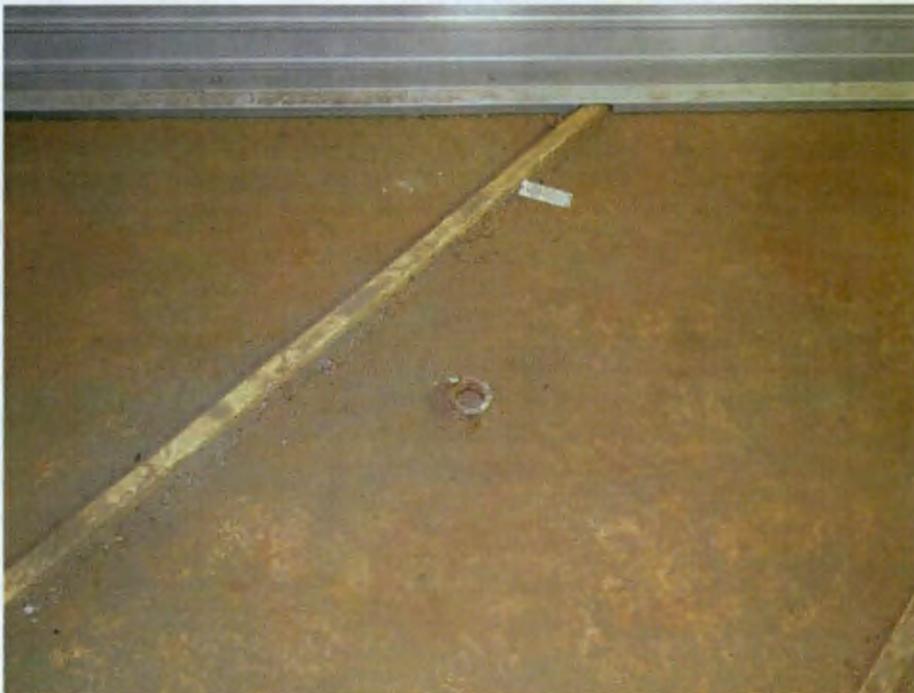
3049 25A Contamination spot on SW corner next to top hat on floor

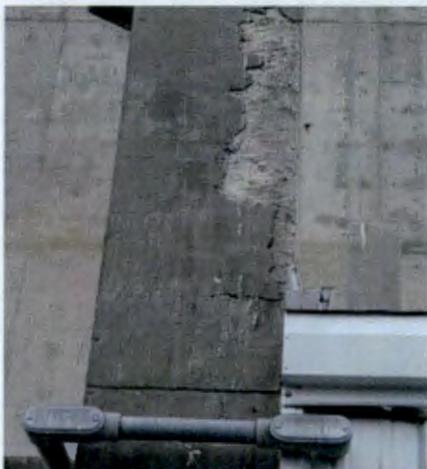
3014 2<sup>nd</sup> example of same patch failing, just above vestibule door.

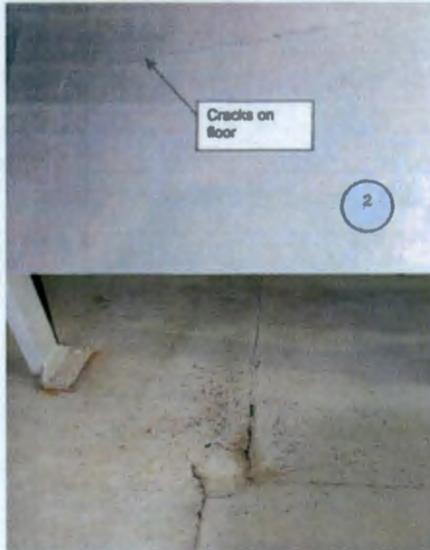
3023 Crack from 2008 was not obvious. No water stains on floor.

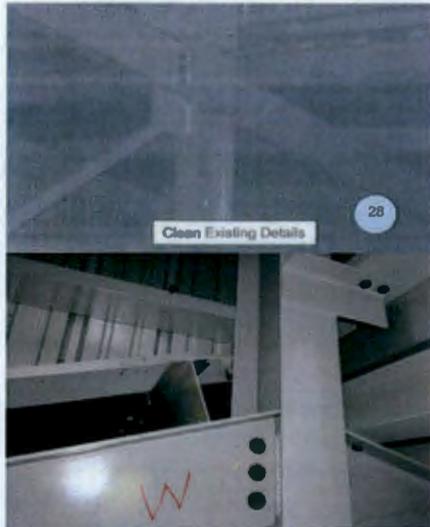
3053 No change since 2008. Opening to exterior

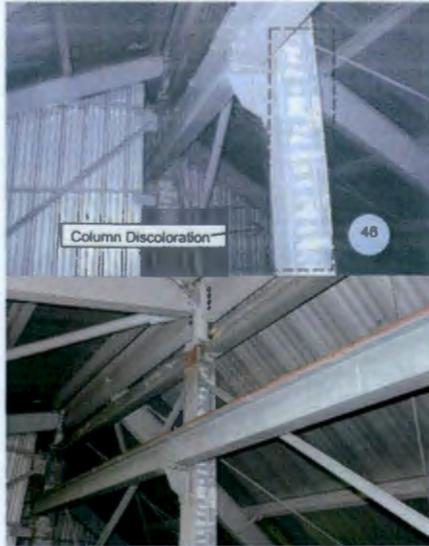
3066 no change since 2008. Discoloration confirmed to be grout stains from original CMU infill or Aged Red Lead coating. Remove from future surveillance.

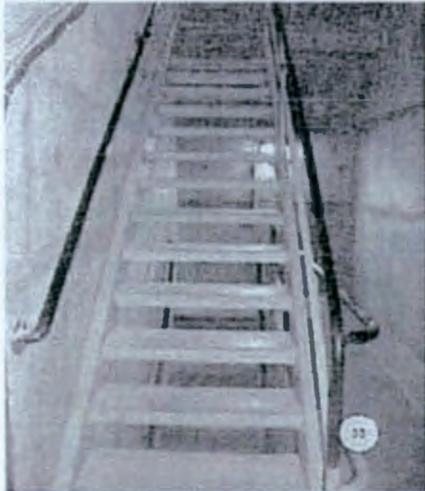
Item # 33 2010 Detail Stairs, loose steps
