**U.S. Department of Energy  
Hanford Site**

THE U.S. DEPARTMENT OF ENERGY, OFFICE OF RIVER PROTECTION,  
TRANSMITTAL OF RPP-RPT-62684, FISCAL YEAR 2019 ANNUAL INTERIM SURFACE  
BARRIER MONITORING REPORT, REV. 0, TO MEET HANFORD FEDERAL FACILITY  
AGREEMENT AND CONSENT ORDER MILESTONE M-045-92AD.

RPP-RPT-62684

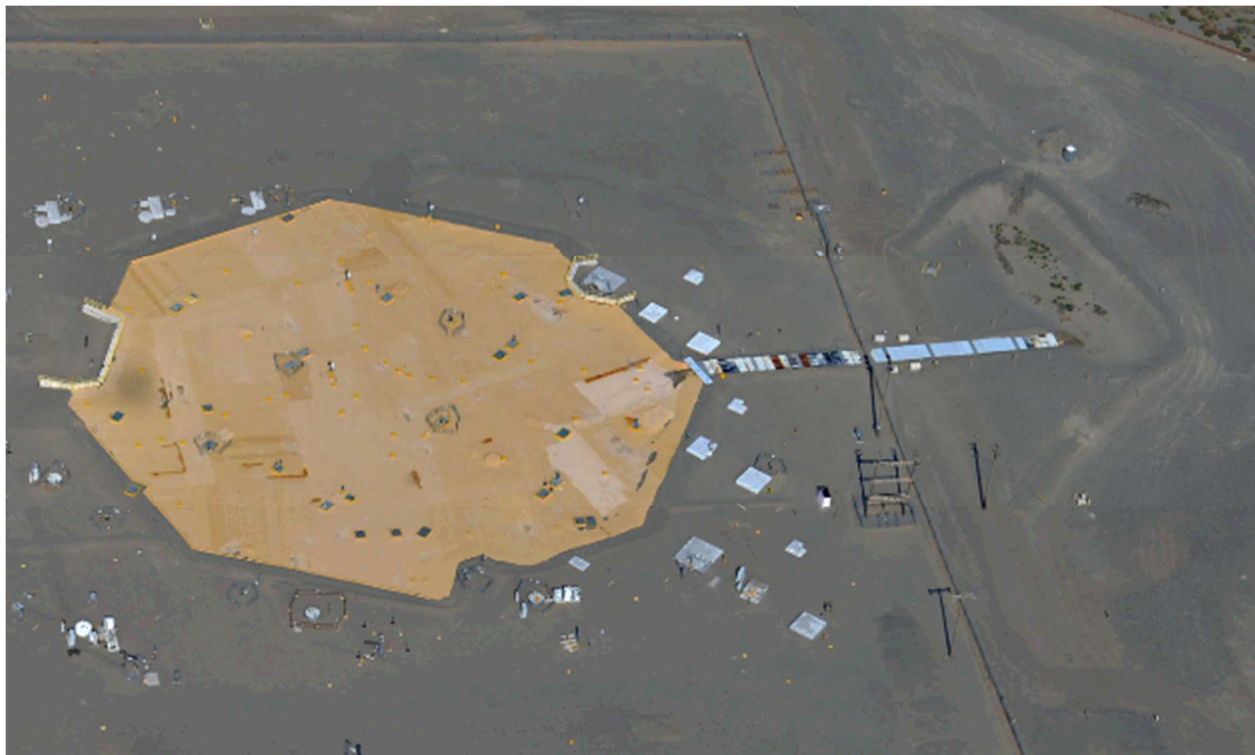
**Figure 1. T Tank Farm Interim Surface Barrier.**

Construction of the T Tank Farm interim surface barrier (Figure 1) began in October 2007 and was completed in April 2008. Approximately 0.3-m (1-ft)-thick compacted soil was added to the original ground surface before the barrier was emplaced. Above the compacted soil is a 0.6-cm (0.25-in.)-thick polyurea/geotextile as the impermeable barrier. The barrier dips slightly to the north to enable precipitation to drain along a lined runoff ditch to a runoff infiltration area.

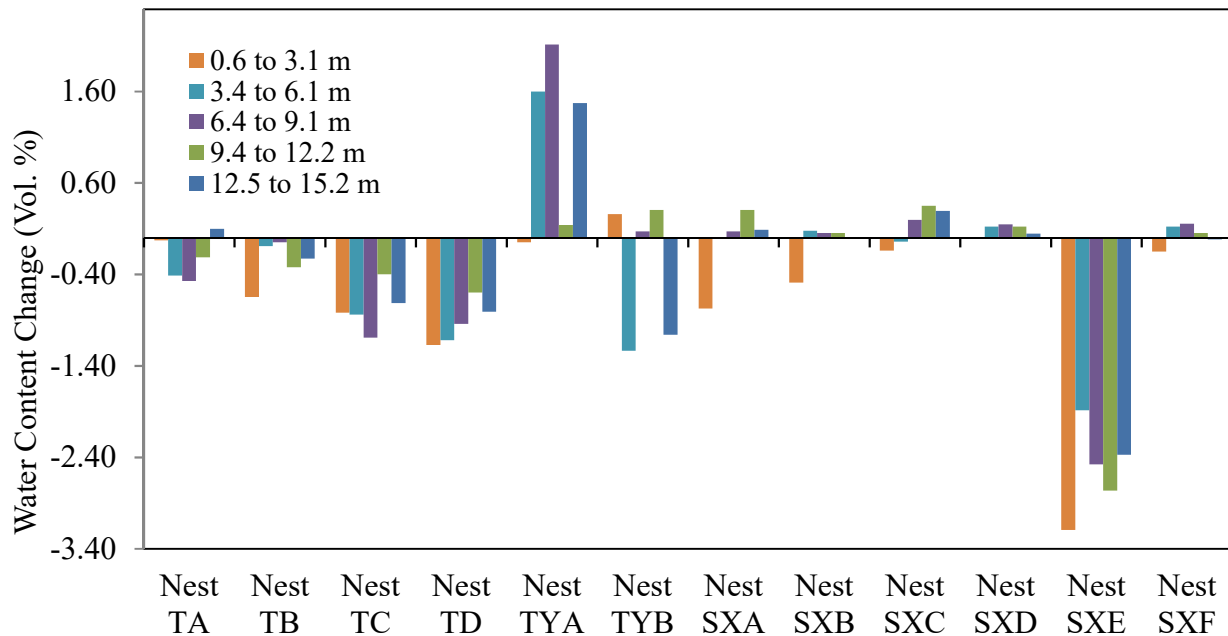
**Figure 4. Depth-Averaged Neutron Probe-Measured Soil-Water Content Changes.**

To assess the barrier impact on soil-water conditions based on the neutron probe measurements, the soil-water content was averaged over 3.1-m (10.2-ft) intervals and also over the whole profile. The changes in soil water content ( $\theta$ ), between FY 2008 and FY 2019 for T Tank Farm barrier nests, changes between FY 2010 and FY 2019 for TY Tank Farm barrier nests, and changes for FY 2019 for SX barrier nests are shown in Figure 4 and Table 5. Outside the barrier at nest TYA over the whole profile (from ground surface to depth 15.2 m [49.9 ft]), the change in soil-water content was positive, indicating the soil moisture increased. The changes for the remainder of the nests under the barrier were almost all negative, meaning that the soil became drier during this period. On average, over the whole profile (from ground surface to 15.2 m [49.9 ft] bgs), the negative change under the barriers was approximately 1 vol% in nests TC, TD, and TYB. The negative change on the edge of the barrier and outside the barrier at nests TB and TA over the whole profile was approximately 0.5 vol%. The remainder of the nest data locations do not show much of a trend due to their recent activation in 2019. An exception to this is the SXE nest which shows the most significant change of all with an average water percent decrease of 2.5%. It is suspected that the SXE values are the result of a lack of historical data and will equilibrate over time.

The analysis represented in Figure 4 and Table 5 was generated from two pairs of neutron logging events carried out per the monitoring plan (PNNL-16538; PNNL-19772); each event pair consisted of one event in T Tank Farm, one event in TY Tank Farm, and one event in SX Farm. Figure 5 through Figure 16 show the measured soil-water content. For all nests, there was little variation of the soil-water content observed between each logging event. For the 2019 sampling events, some data points were collected in October 2019 so the Calendar Year (CY) acronym is used to incorporate this difference.

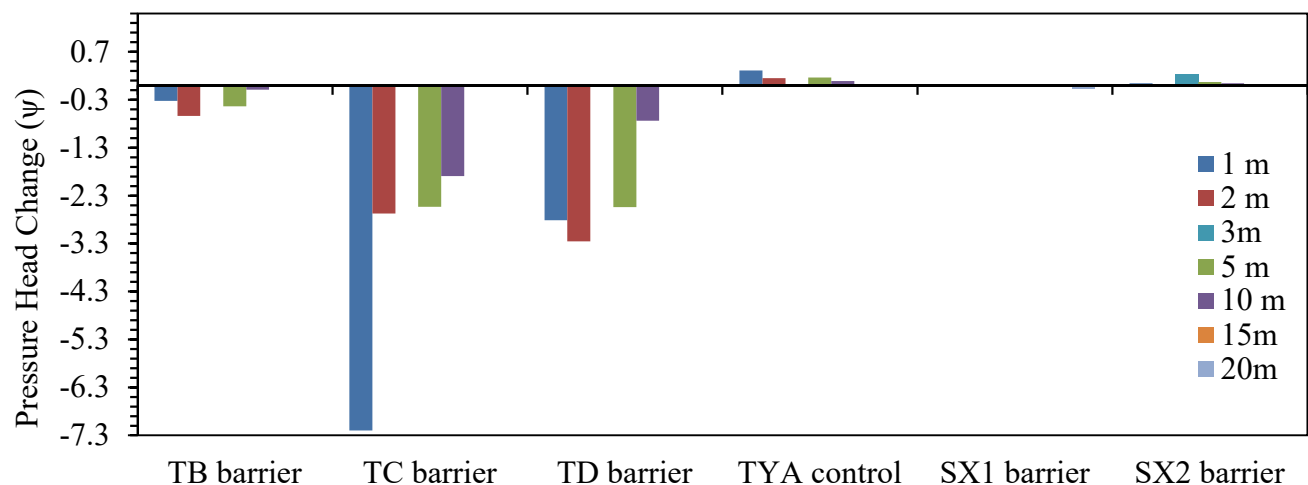
**Figure 17. Heat Dissipation Unit-Measured Soil-Water Pressure Head Change.**

Figure 17 shows the soil-water pressure measured by the HDUs at nests TB, TC, TD, TYA, SX1, and SX2 after temperature correction. The soil-water pressure head data at the interim surface barrier demonstrates the ability of the barrier to reduce soil moisture by limiting recharge. In areas where the barrier has little effect, such as TB where the probe was installed to monitor edge effects and TYA where the probe was not installed under the barrier, the nest site serves as an environmental control. At these locations the results are best approximated by a net annual slope of zero. However, nests TC and TD, which are both directly under the barrier, demonstrate a net negative trend that continues with time, indicating a continued reduction in moisture within the pore space of the vadose zone. Finally, nest TA and TYB stopped collecting data in 2017. Comparisons between areas under the barrier and areas outside the barrier are difficult to assess when one of the two probes stops working (such as TYB) or when the probe outside the barrier is no longer functioning (such as TA). Overall, it does appear that the data collected from beneath the interim surface barriers still indicates decreasing moisture year to year. Probe TYA (control) indicates that the moisture concentrations fluctuate with seasonal precipitation events. SX1 and SX2 were recently installed and have not had time to establish a visible trend.

The annual average soil-water pressure changes from FY 2008 to FY 2019 at nests TB, TC, and TD located in T Tank Farm; FY 2010 to FY 2019 at TYA located in TY Tank Farm; and FY 2019 data for SX1 and SX2 nests located at SX Farm are shown in Figure 17. No data is available for nests TA and TYB due to instrument failure. For nests TB, TC, and TD, the soil-water pressure at the 1-m (3-ft), 2-m (7-ft), and 5-m (16-ft) depths decreased, indicating that the soil beneath the barrier became drier at these depths; the changes in soil-water pressure ( $\psi$ ) at the 10-m (33-ft) depth were relatively small because the drainage water from shallower depths continues to move into the soil at this depth. Nest TB represents drying out below a barrier edge. The changes at TB are not as significant as TC and TD locations, which are directly under the barrier. Nest TYA (control) only shows a minor increase that is expected outside the barrier cover. Nest locations SX1 and SX2 are located directly under the barrier but will need time to establish a visible HDU data trend.
