Hanford Single-Shell Tank Leak Causes and Locations - 241-B Farm

Washington River Protection Solutions

Abstract: This document identifies 241-B Tank Farm (B Farm) leak cause and locations for the 100 series leaking tank (241-B-107) identified in RPP-RPT-49089, Hanford B-Farm Leak Inventory Assessments Report. This document satisfies the B Farm portion of the target (T04) in the Hanford Federal Facility Agreement and Consent Order milestone M-045-91F.

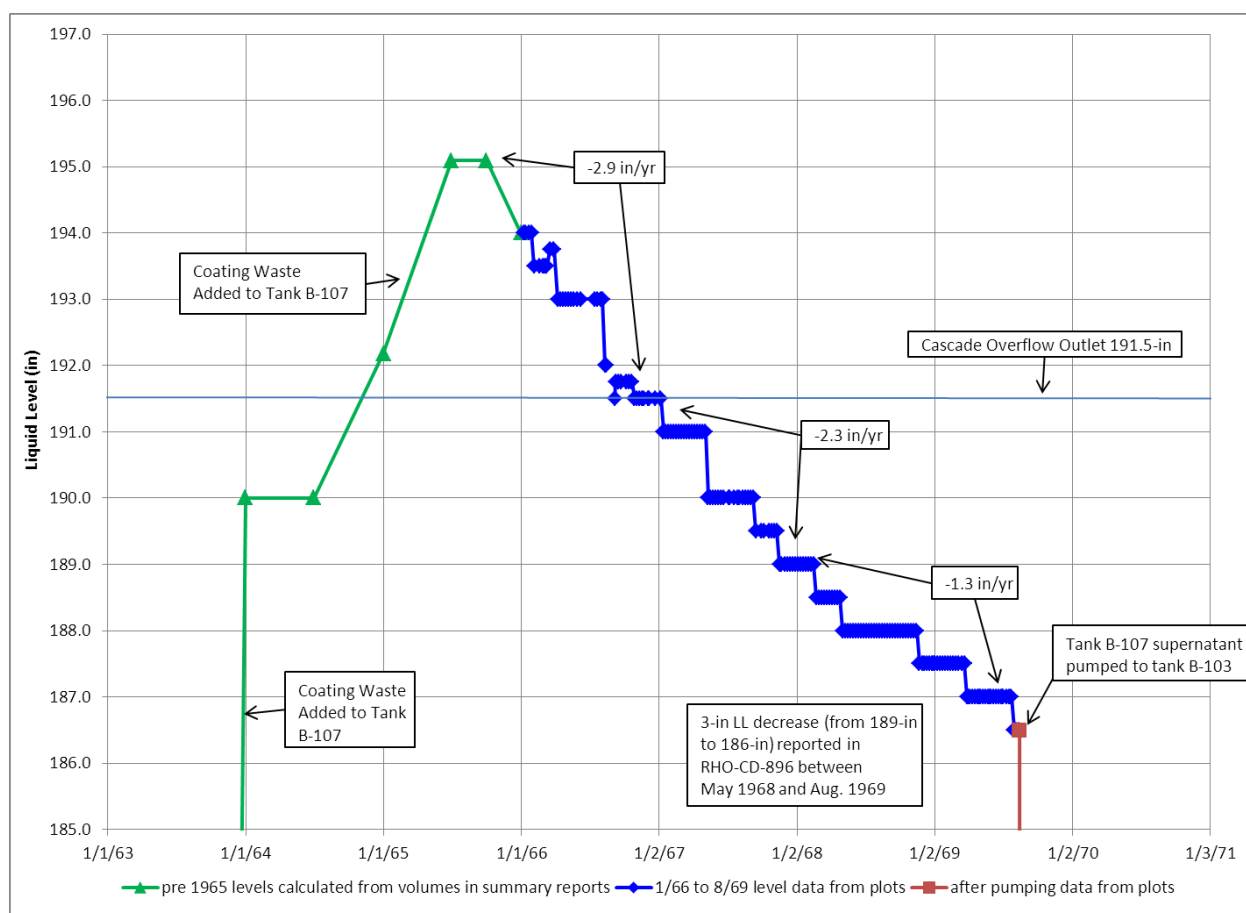
Figure 4-4. Tank B-107 Liquid Level 1963-1969 with Leak Rates

Tank B-107 was first suspected of leaking due to a 3-in liquid level drop between May 1968 and August 1969 with a reported leak loss of 8 kgal (RHO-CD-896, *Review of Classification of Nine Hanford Single-Shell "Questionable Integrity" Tanks*). However, after reviewing historic liquid level charts for tank B-107, it appears there was only a 2 ½-in decrease during this time. It also appears that the liquid level began decreasing before May 1968, as early as the fourth quarter of 1965, which is shown in Figure 4-4. It is not clear why RHO-CD-896 selected May 1968 through August 1969 for the leak determination when a plot indicates the liquid level was decreasing much earlier.

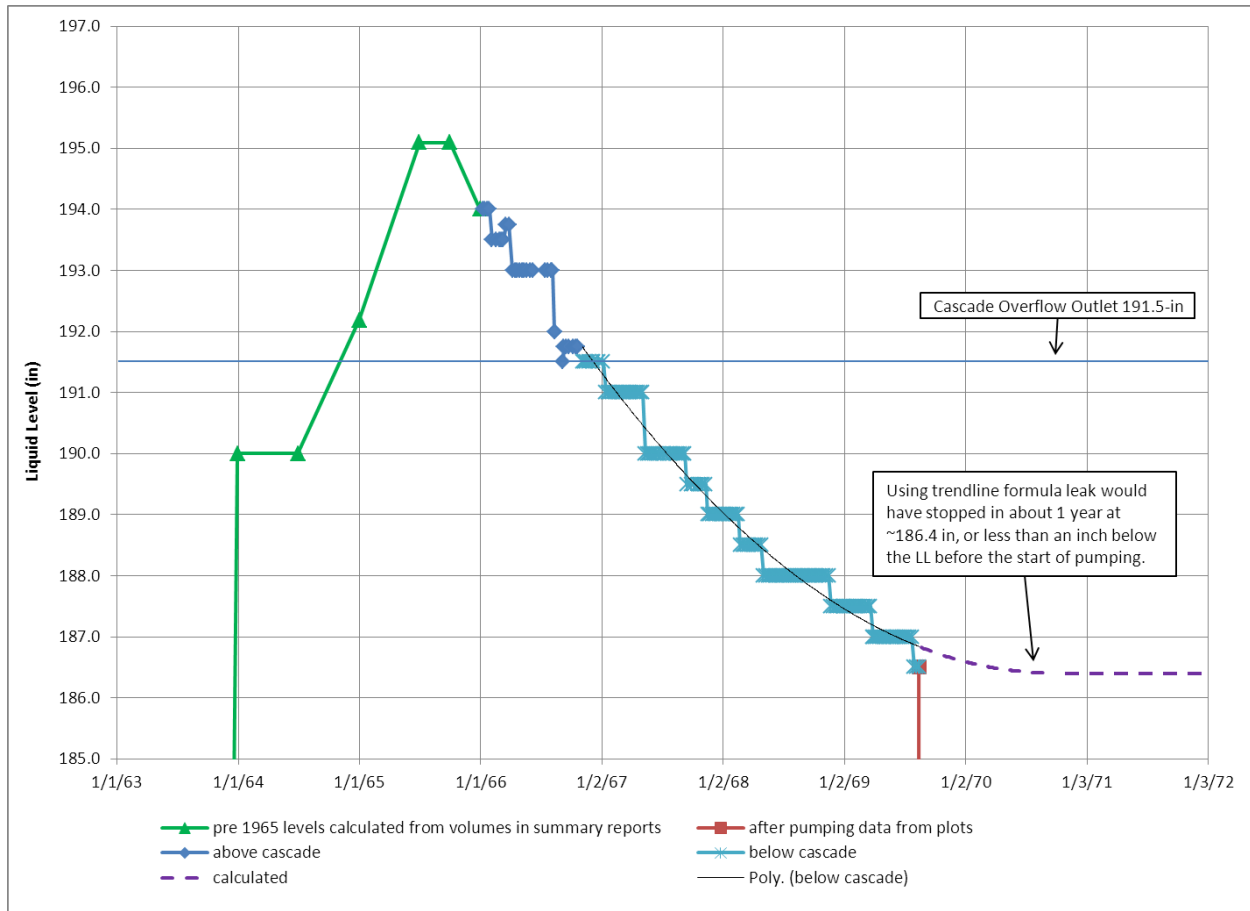
Figure 4-5. Tank B-107 Liquid Level 1963-1969 with Projected Level if Tank Not Pumped

The tank B-107 leak may have started as early as the fourth quarter of 1965, or over three years earlier than what was reported in RHO-CD-896. It appears there was minimal leakage through the cascade line or any connections as the liquid levels in tanks B-108 and B-109 were holding steady during the time the tank B-107 levels were decreasing. Thus, it appears the leak is greater than the 8 kgal reported in RHO-CD-896 and could be as large as 22 kgal disregarding evaporation, hydrostatic pressure, and possible leakage through the cascade line or inlet wall connection seals.

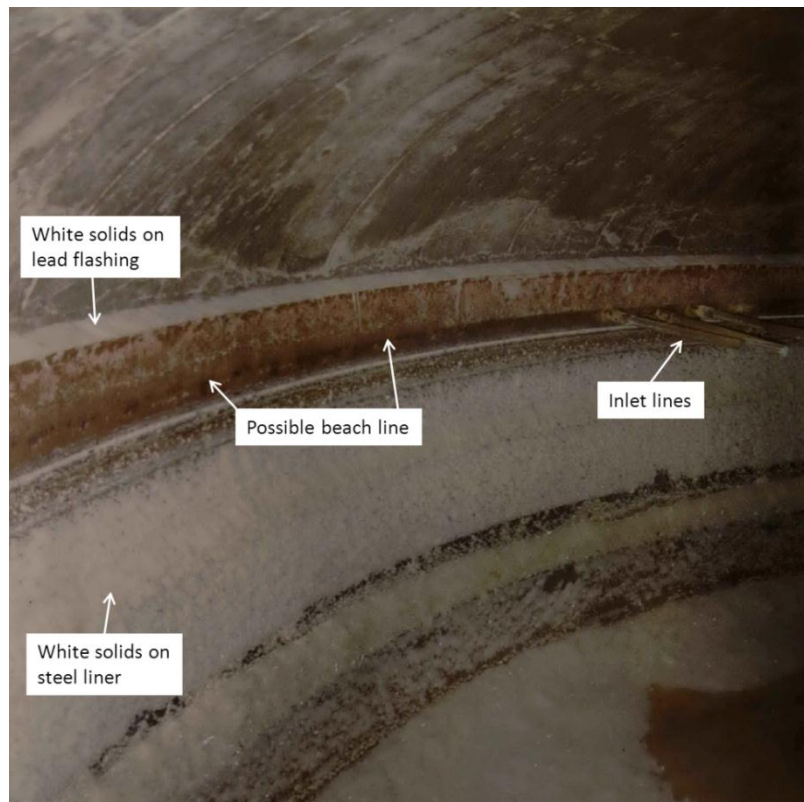
Figure 4-7. Tank B-107 Photograph March 19, 1970 (701322-6 CN)

Tank B-107 photographs do not show any evidence pointing to a tank leak.

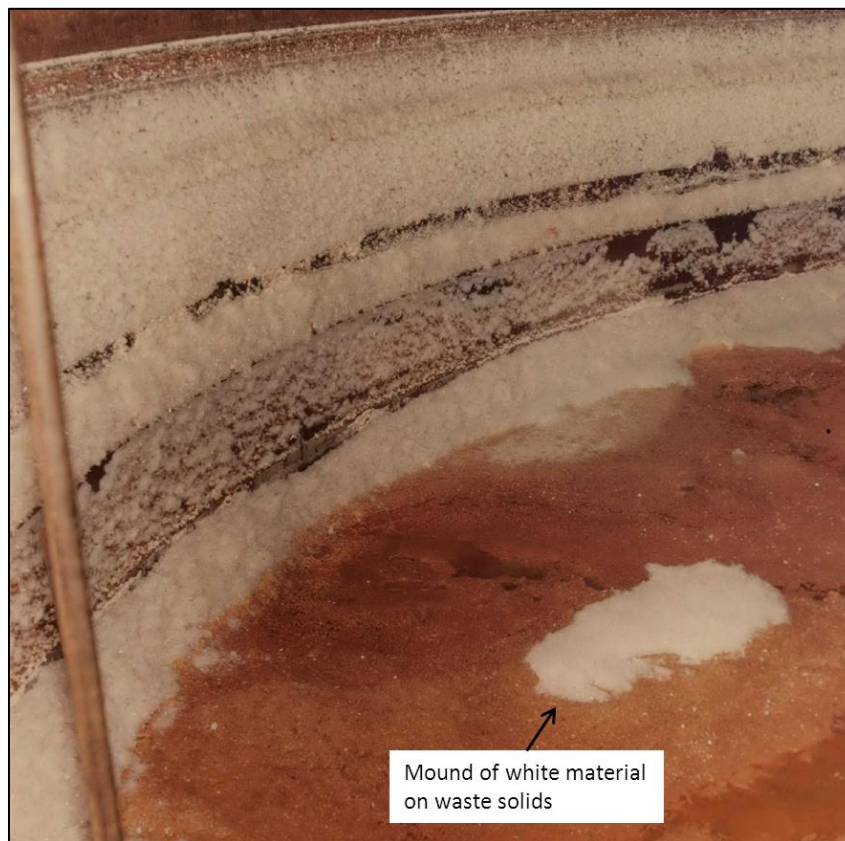
Figure 4-8. Tank B-107 Photograph April 3, 1980 (90637-2CN)

Mound of white material
on waste solids

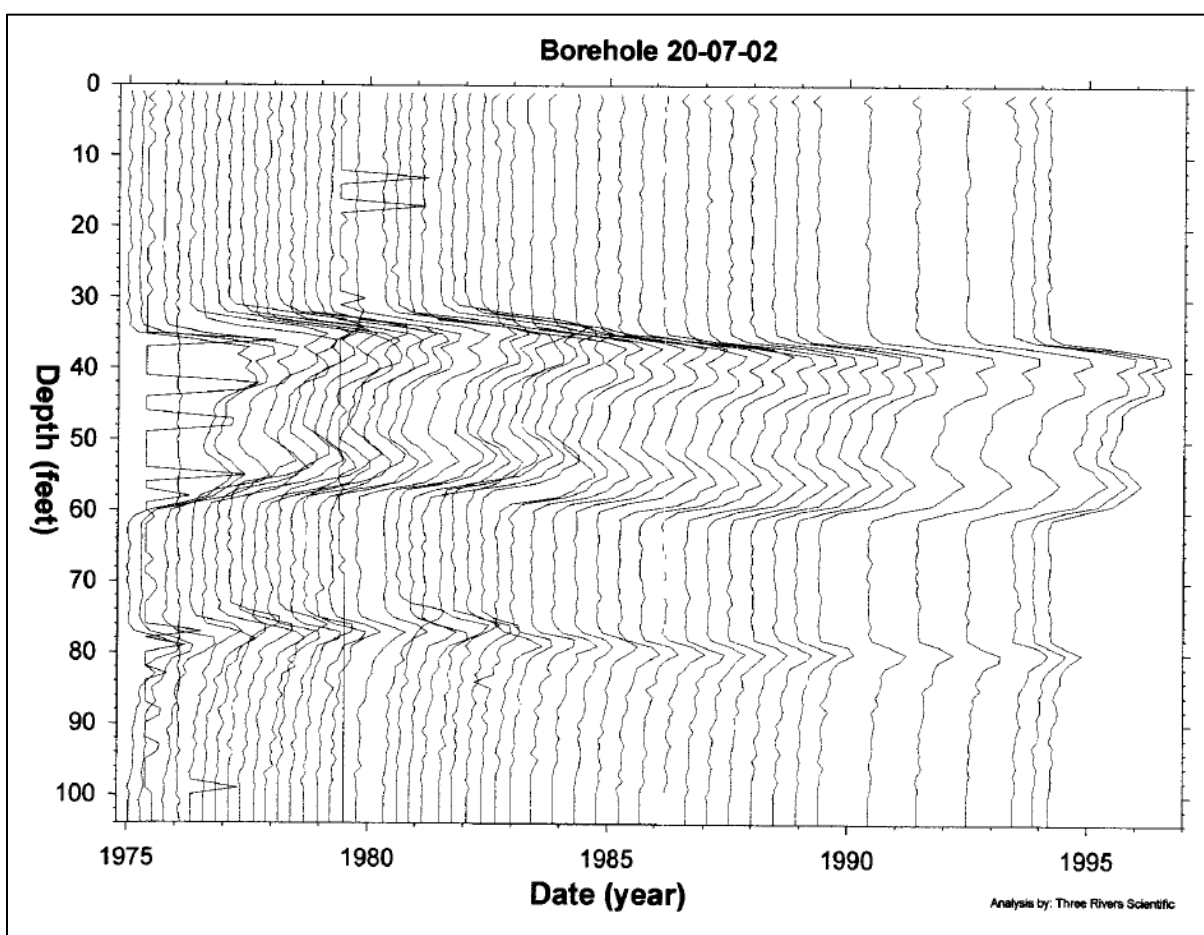
Figure 4-9. Tank B-107 Drywell 20-07-02 (HNF-5433)

In August 1999, Cs-137, Co-60, Eu-154, and Eu-152 were detected in this drywell with the highest concentrations forming a plume that occupies the region directly below the base of the tank farm excavation (GJ-HAN-128). Thick zones of continuous Cs-137 contamination were measured from 35.5 to 59.5-ft BGS and from 77 to 99-ft BGS with the maximum concentration of 1147 pCi/g at 42-ft BGS. Document GJ-HAN-128 reports, "The Cs-137, Co-60, Eu-154, and Eu-152 plume detected by the SGLS between 35 and 60 ft probably originated from a leak from tank B-107 that occurred prior to 1973." Figure 4-9 shows the depths of radioactivity from 1975 to 1995 (HNF-5433).

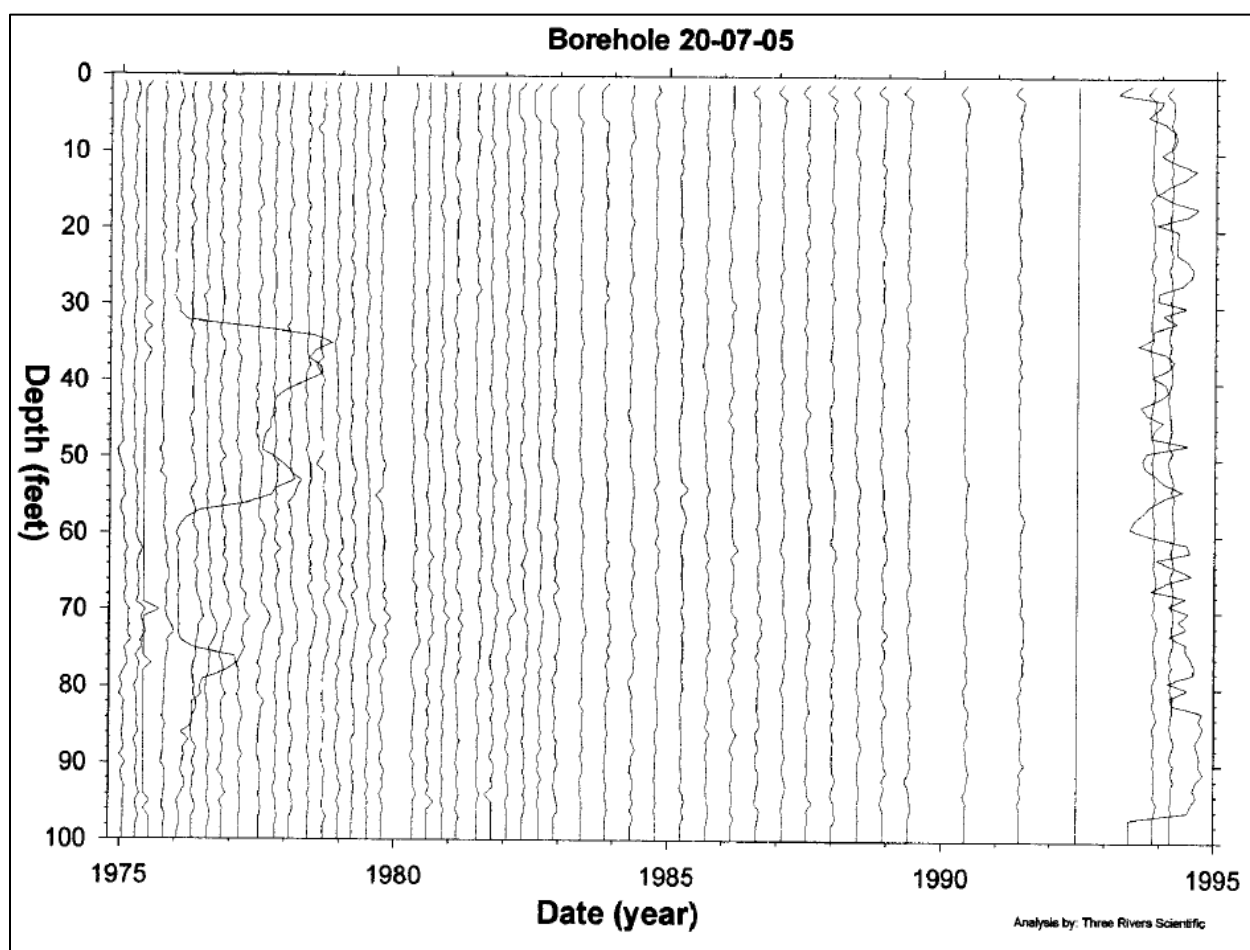
Figure 4-10. Tank B-107 Drywell 20-07-05 (HNF-5433)

In August 1999, Cs-137 was the only man-made radionuclide detected in drywell 20-07-05 (GJ-HAN-128). From the ground surface to 7-ft BGS, from 62 to 65.5-ft BGS, and at 85.5-ft BGS, Cs-137 concentrations were below 2 pCi/g. Document GJ-HAN-128 states, "The Cs-137 contamination detected between the ground surface and 7 ft may have originated from a surface spill that invaded the backfill material or has been dragged down during drilling. The minor occurrences of Cs-137 contamination deeper in the borehole may also be the result of drag down by drilling." Therefore, drywell 20-07-05 is not included as part of the leak location for tank B-107. Figure 4-10 shows the depths of radioactivity from 1975 to 1995 (HNF-5433).

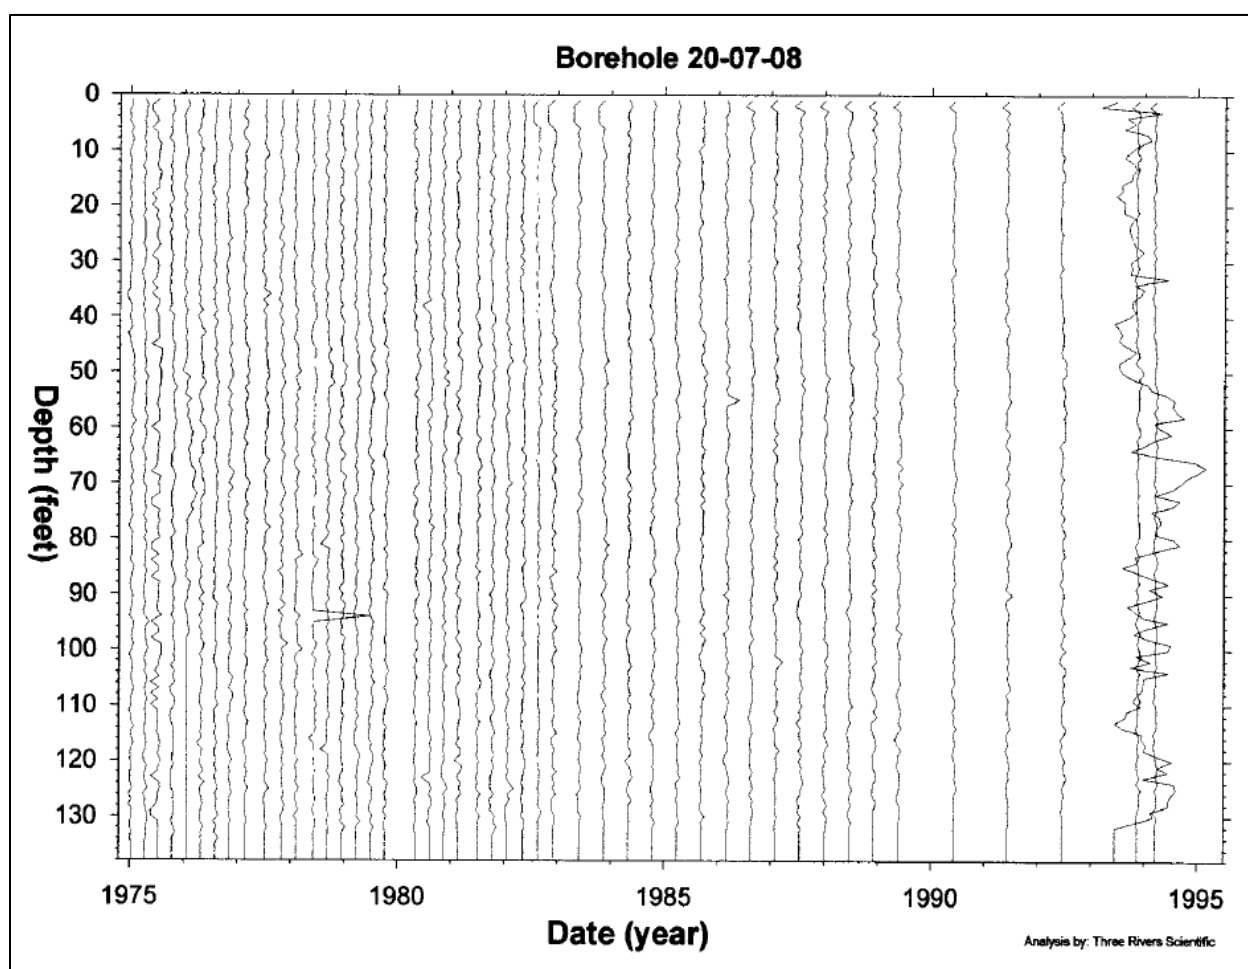
Figure 4-11. Tank B-107 Drywell 20-07-08 (HNF-5433)

In August 1999, Cs-137 was the only man-made radionuclide detected in drywell 20-07-08 from the ground surface to 8-ft BGS at concentrations ranging from 0.3 to 2.2 pCi/g (GJ-HAN-128). Document GJ-HAN-128 reports “The zone of Cs-137 contamination detected between the ground surface and 2-ft may be the result of a surface spill that migrated downward into the shallow backfill around this borehole....The lower concentrations of Cs-137 contamination detected below this zone were probably carried down during drilling.” Therefore, drywell 20-07-08 is not included as part of the leak location for tank B-107. Figure 4-11 shows the depths of radioactivity from 1975 to 1995 (HNF-5433).

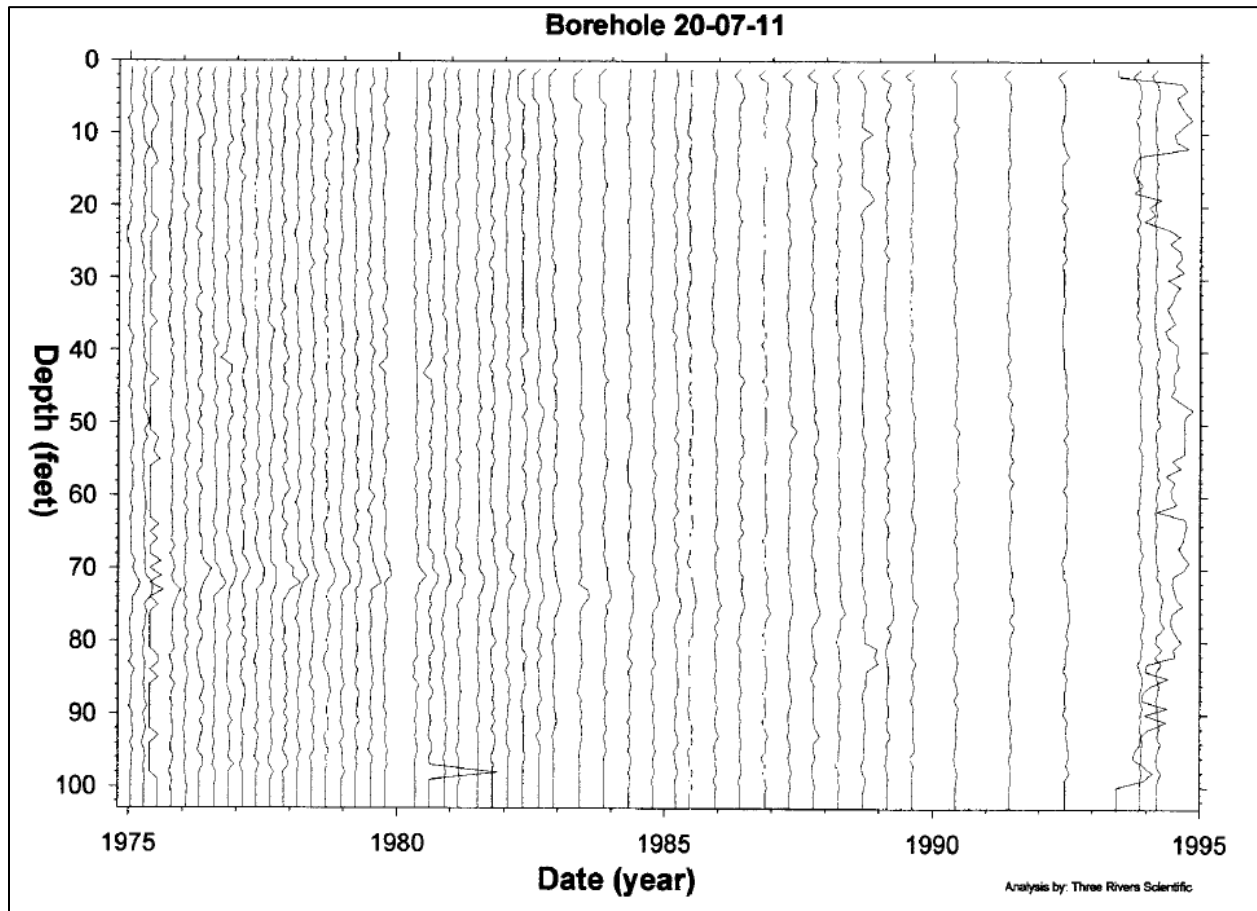
Figure 4-12. Tank B-107 Drywell 20-07-11 (HNF-5433)

In August 1999, Cs-137 was the only man-made radionuclide detected in drywell 20-07-11 and was detected from the ground surface to 13.5-ft BGS at concentrations less than 1 pCi/g (GJ-HAN-128). Document GJ-HAN-128 reports, "Some of the low Cs-137 concentrations detected by the SGLS from the ground surface to about 13.5 ft may be the result of a surface spill that has dispersed downward into the backfill and/or the result of contaminated near-surface material being dragged down during drilling to lower depths." Therefore, drywell 20-07-11 is not included as part of the leak location for tank B-107. Figure 4-12 shows the depths of radioactivity from 1975 to 1995 (HNF-5433).

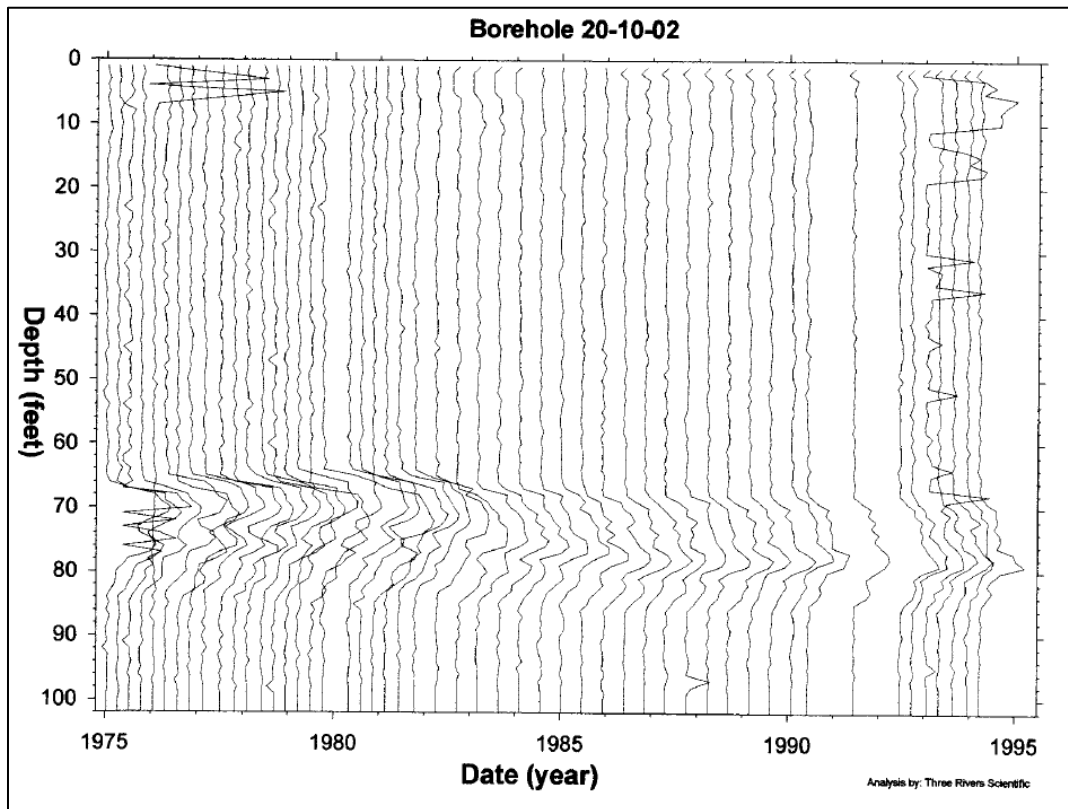
Figure 4-13. Tank B-107 Drywell 20-10-02 (HNF-5433)

In August 1999, Cs-137 and Co-60 were the only man-made radionuclides detected in drywell 20-10-02 (GJ-HAN-128). From the ground surface to 18-ft BGS and from 20.5 to 43-ft BGS, Cs-137 concentrations were recorded at concentrations ranging between 1 to 3 pCi/g. From 67 to 73.5-ft, Co-60 contamination was detected at concentrations ranging from 0.2 to 1.6 pCi/g. An anomalous SGLS detected zone occurred between 70-ft and 85-ft which had been recorded in the historical gross gamma data. It was determined that a decay curve of Ru-106 and Sr-90 closely matched the decrease in gross gamma activity between 1981 and 1994. The most likely source of the contamination was from the northern side of tank B-110 (GJ-HAN-128). Drywell 20-10-02 is 3-ft from tank B-110 where highly concentrated contamination intersects drywell 20-10-12. Drywell 20-10-02 is ~27-ft from tank B-107. Document GJ-HAN-128 indicated that the radioactivity detected above the anomalous zone in this drywell is likely associated from surface spills that migrated down into the backfill around this drywell and/or dragdown. Therefore, drywell 20-10-02 is not included as part of the leak location for tank B-107. Figure 4-13 shows the depths of radioactivity from 1975 to 1995 (HNF-5433).

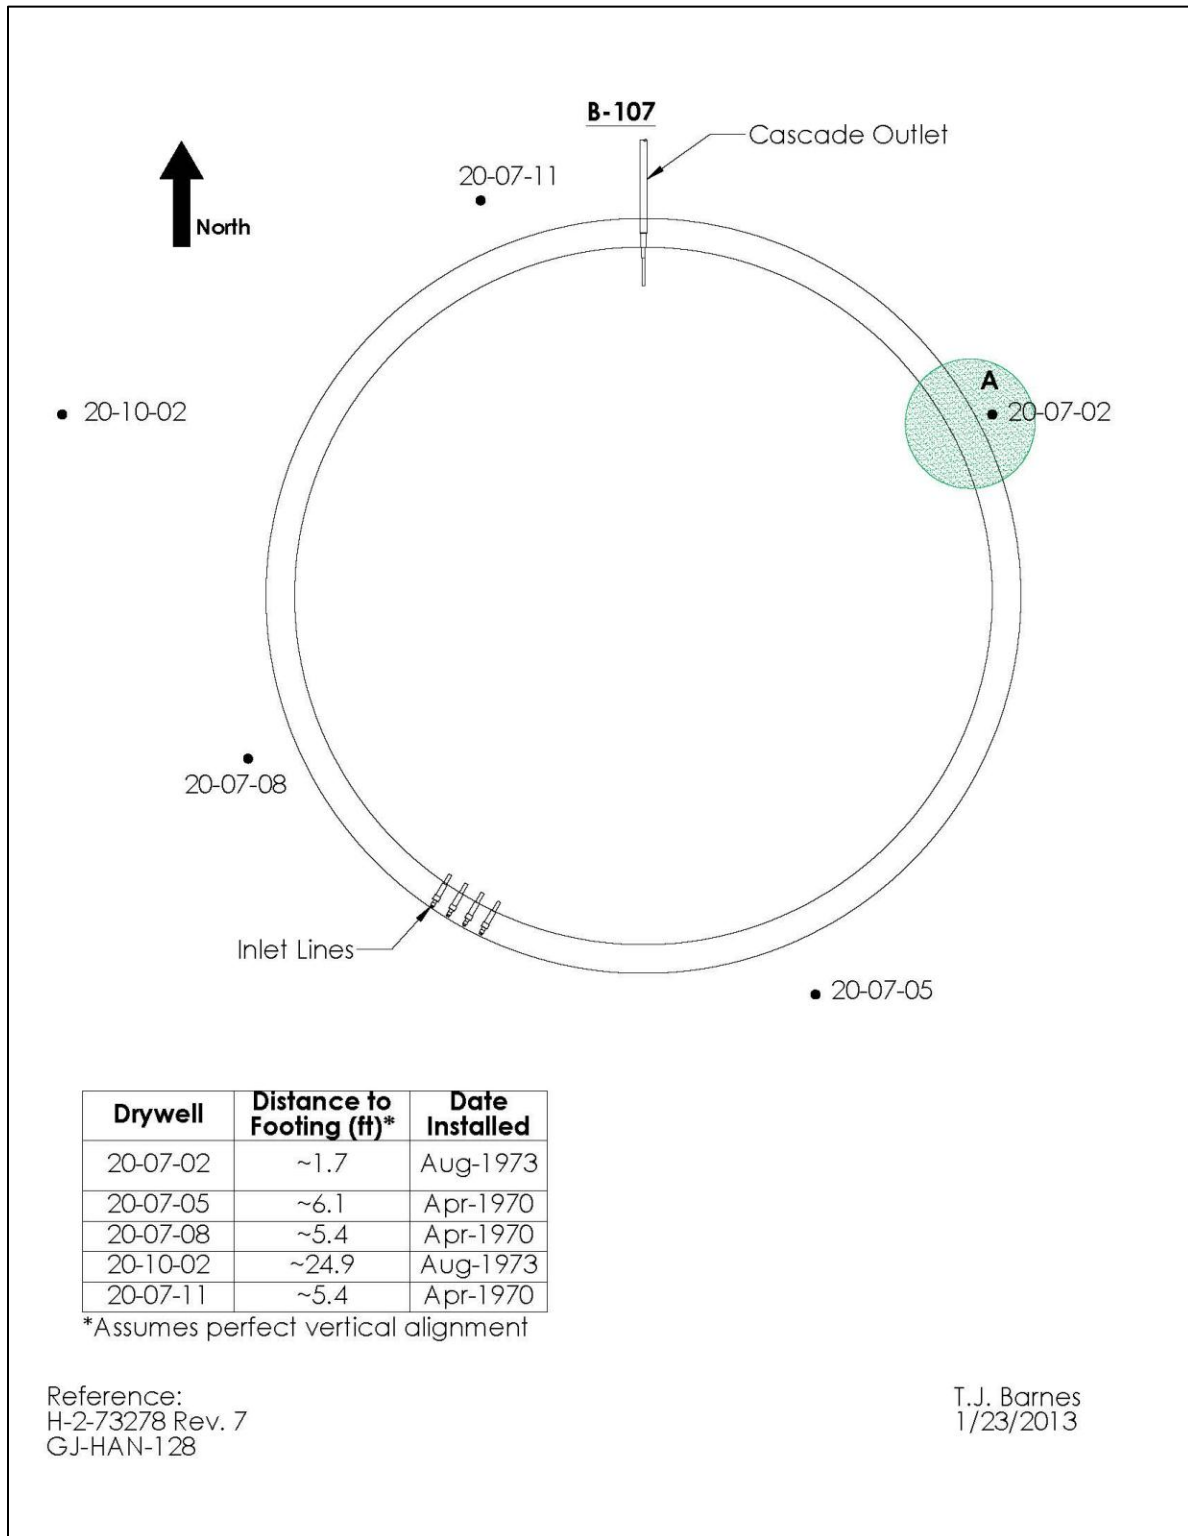
Figure 4-14. Tank B-107 Possible Leak Location (1965-1973)
 Tank inner ring is steel liner; outer ring is outer edge of tank footing

Tank B-107 was first reported as leaking due to a 3-in liquid level drop between May 1968 and August 1969 (RHO-CD-896). However, it appears the tank B-107 leak could have started as early as the fourth quarter in 1965 due to the liquid level decreasing from October 1965 until August 1969, when the supernatant was pumped out of the tank (see Section 4.4.1). The liquid level was above the cascade outlet line level in October 1965 when the liquid level initially started to drop. A review of liquid levels for tanks B-108 and B-109 indicated no increases or decreases during the time the tank B-107 was above the cascade line and decreasing. Based on a polynomial projection of the liquid level data, there appears to be a sidewall leak located at or below 186.4-in. The leak was detected in drywell 20-07-02 in the northeast portion of the tank when the drywell was drilled in 1973. No other drywells indicated a tank B-107 leak.
