Department of Energy

100 AND 200 AREA PUMP AND TREAT SYSTEMS SHUTDOWN

**TYPE C INVESTIGATION
100-HR-3 PUMP AND TREAT OPERATION
ACCIDENT WITH INJURY
DECEMBER 6, 1994**

**ISSUED
JANUARY 11, 1995**

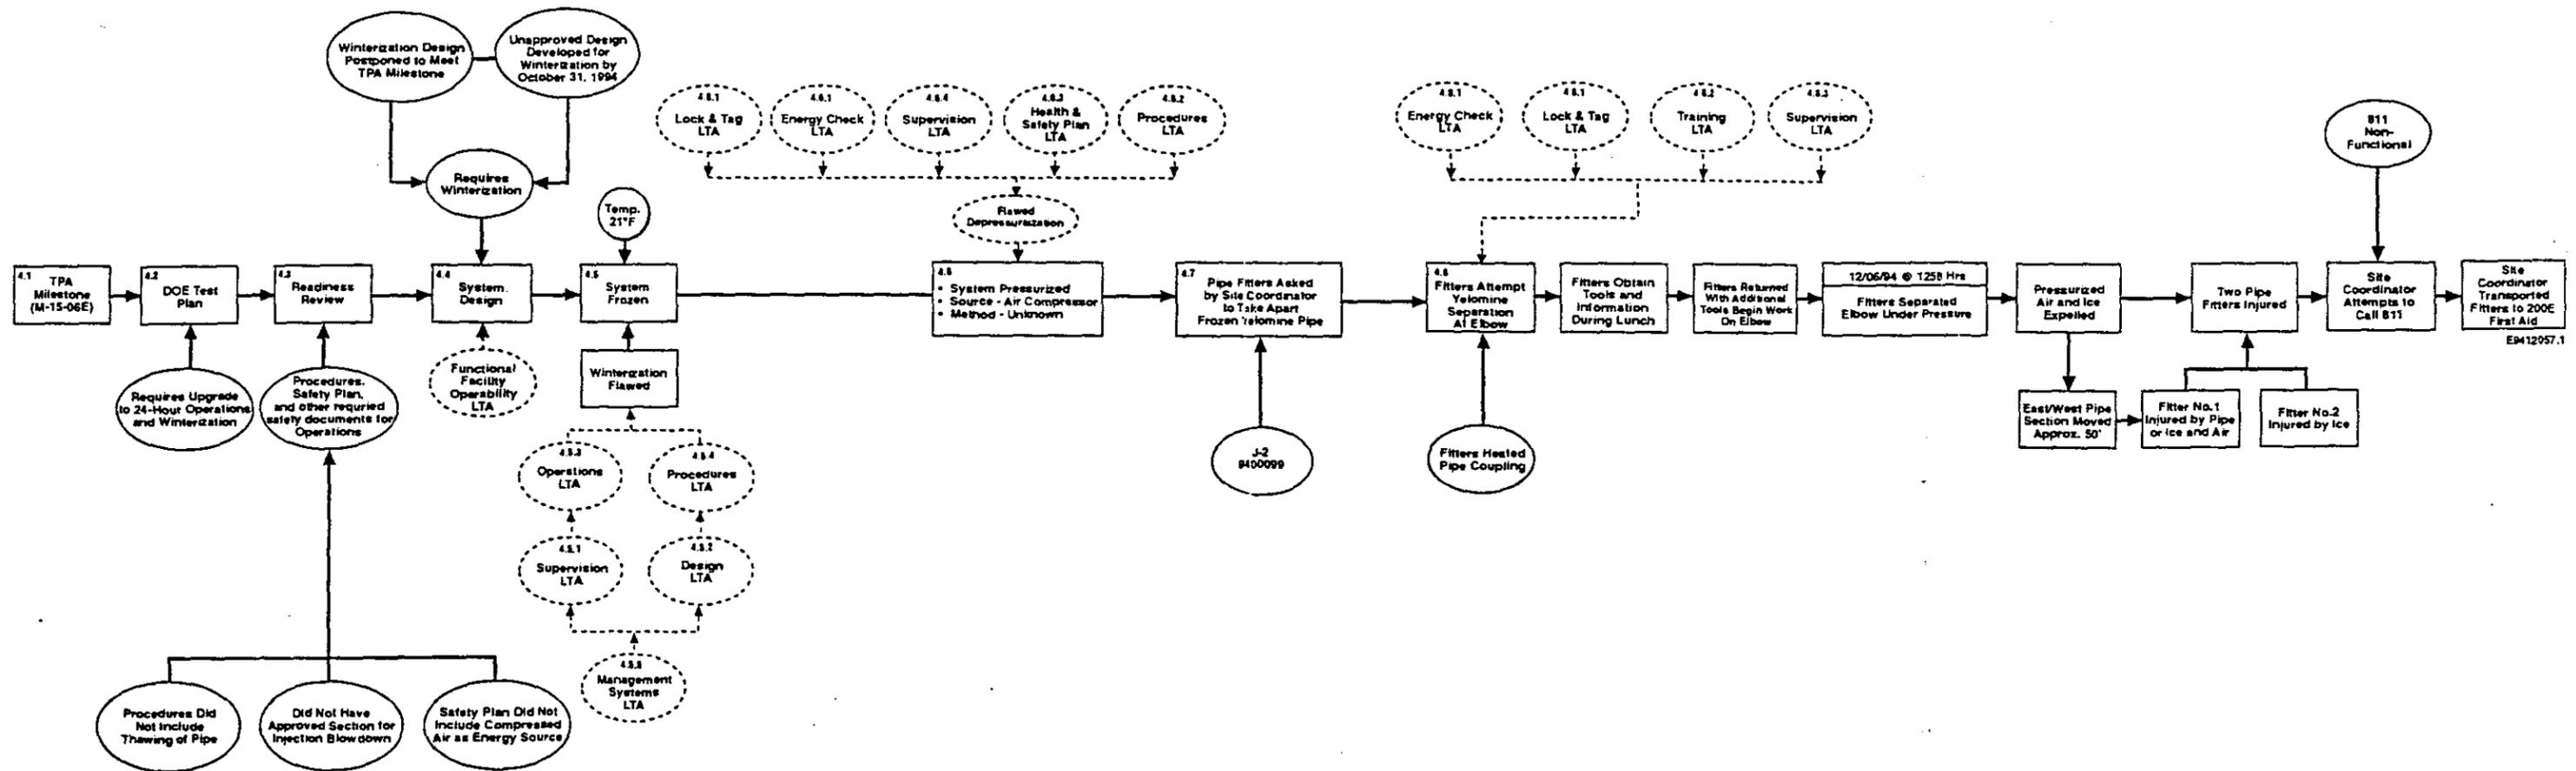
A causal factors analysis was used to identify the principal events of the accident and their probable causes. A Event and Causal Factors Chart (Attachment 2) was developed starting with the establishment of the Tri-Party Agreement (TPA) Milestone for the start-up of the 100-HR-3 Pump and Treat Facility and ending with transportation of the pipefitters to the 200 East First Aid Station.
