09-AMRC-0199

COMPLETION OF TRI-PARTY AGREEMENT MILESTONE M-094-03, "COMPLETE DISPOSITION OF THE FOLLOWING SURPLUS FACILITIES: 303M, 332, 333, 334, 334A, 3221, 3222, 3223, 3224, 3225"

FACILITY STATUS CHANGE FORM

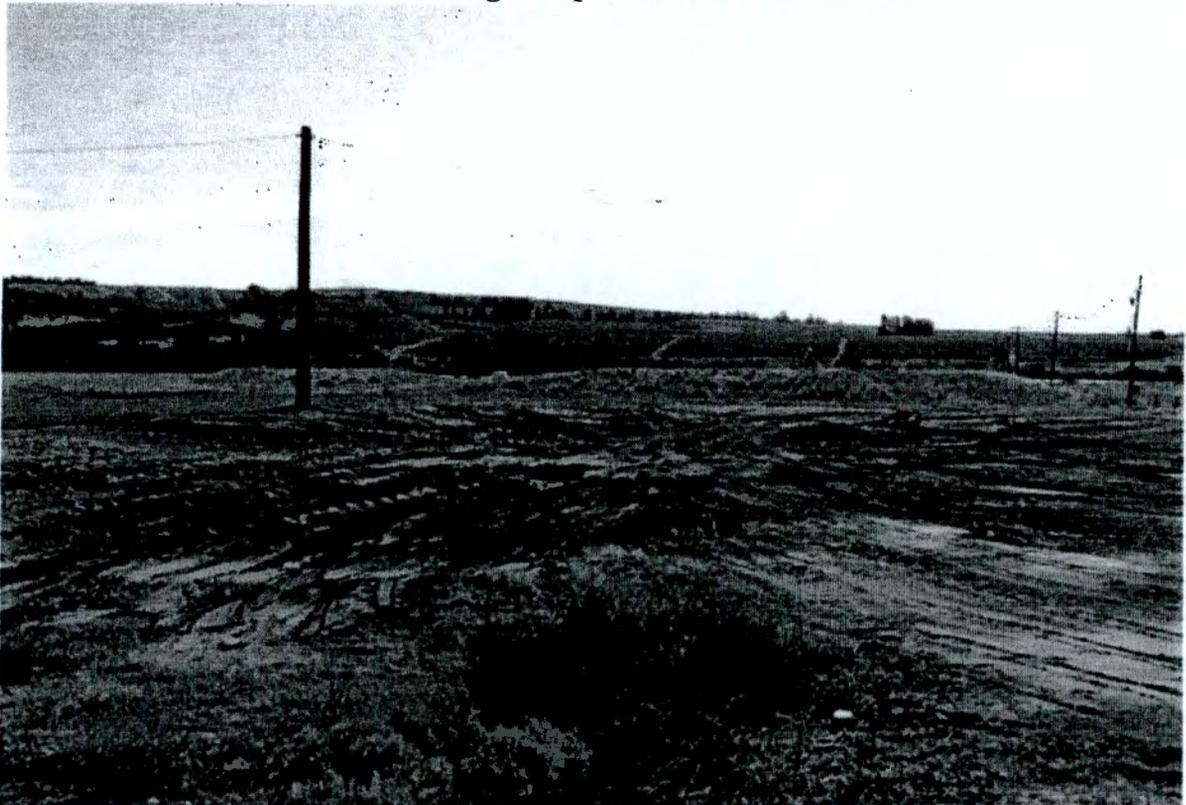
332 Building Complex Site after Demolition

The 332 building foundation and slab were removed during demolition. A post demolition radiological survey, and GPERS were conducted at the site following backfill. There are no IH or radiological postings associated with the site.

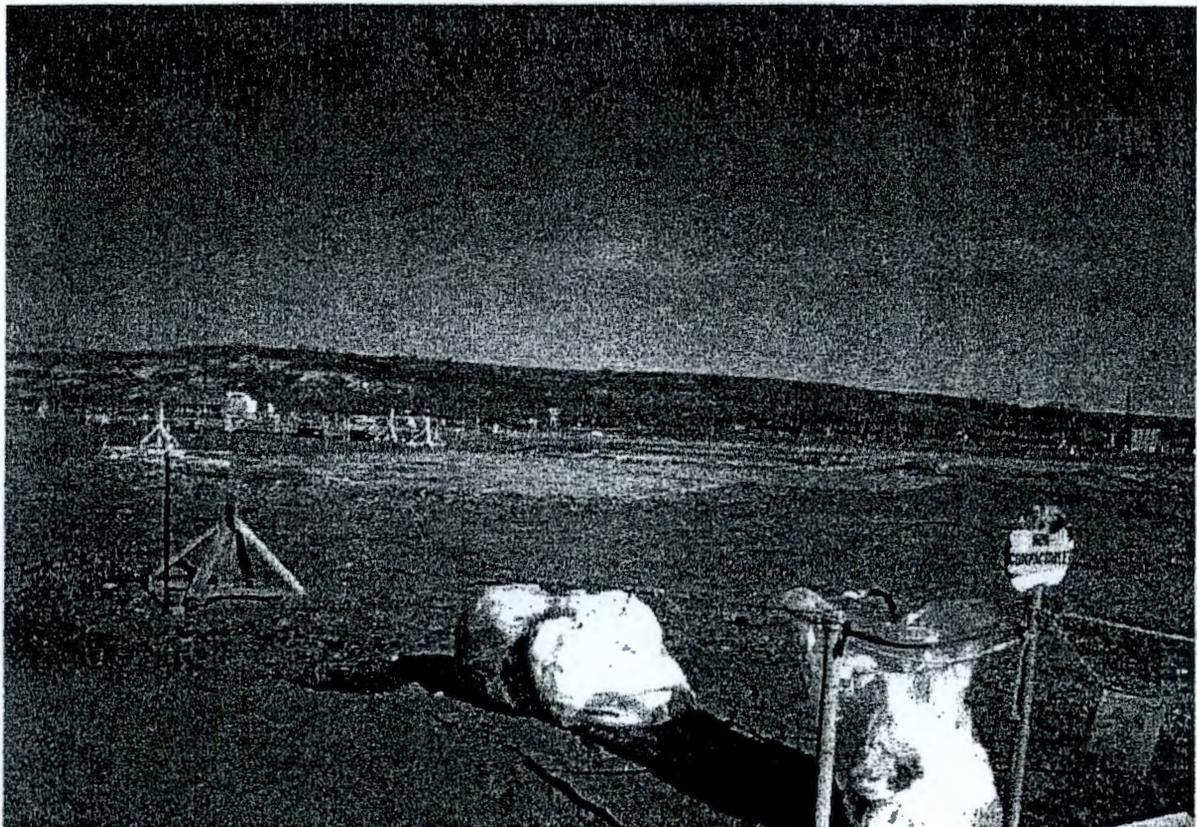
Building 333 Slab after Demolition

The 333 building foundation is currently posted as a radiological control area. Debris from trenches and pits in the foundation have been removed and disposed at ERDF. Fall hazards, as defined by OSHA 1926.501(b)(1) (i.e., unprotected sides or edges of six feet or more), will be mitigated with backfill or a barrier.

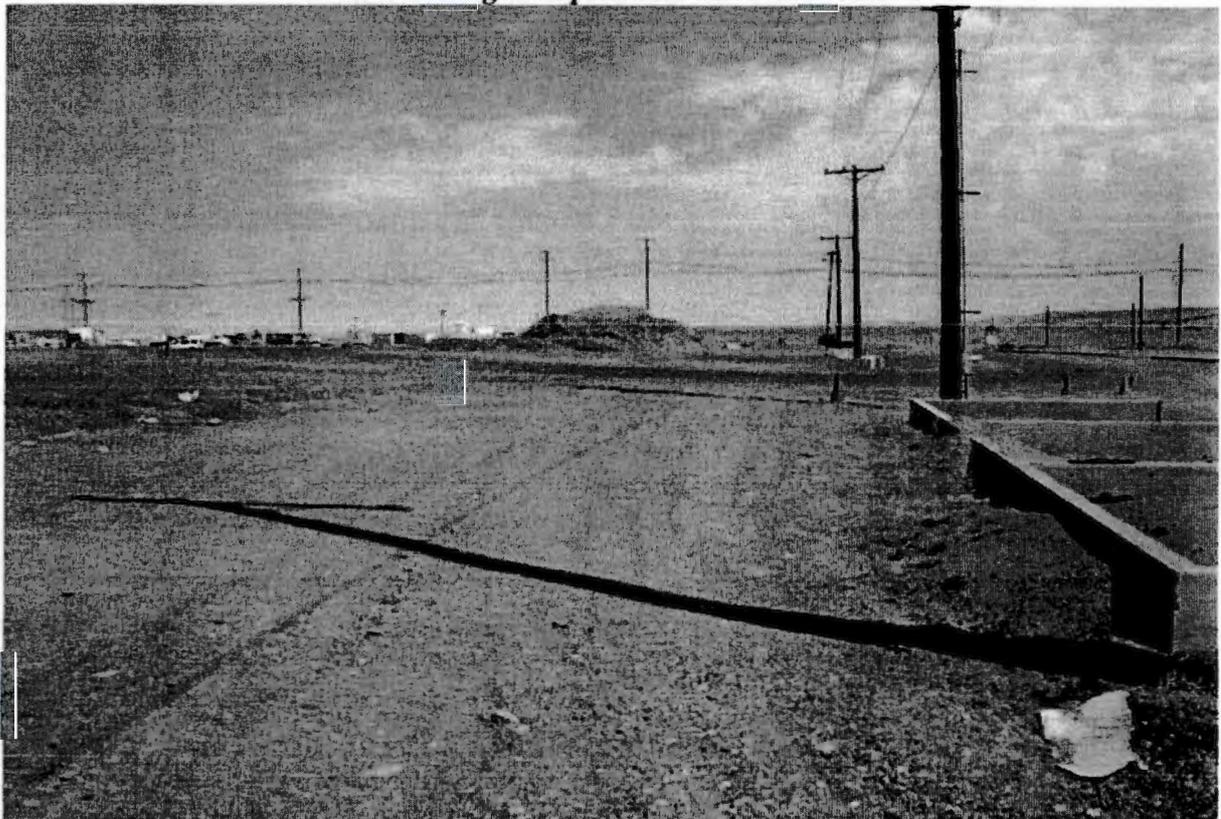
3225 Building Complex Site after Demolition

The 3225 building foundation and slab were removed during demolition. A post demolition radiological survey was not conducted at the site as it was never posted as a radiologically contaminated area. The site is currently posted URMA (Underground Radioactive Material Area) under the 300 area general fenceline URMA posting. There are no IH postings associated with the site.
