COMPLETION OF THE M94-06 TRI-PARTY AGREEMENT MILESTONE

D4 PROJECT FACILITY COMPLETION FORM

FACILITY STATUS CHANGE FORM

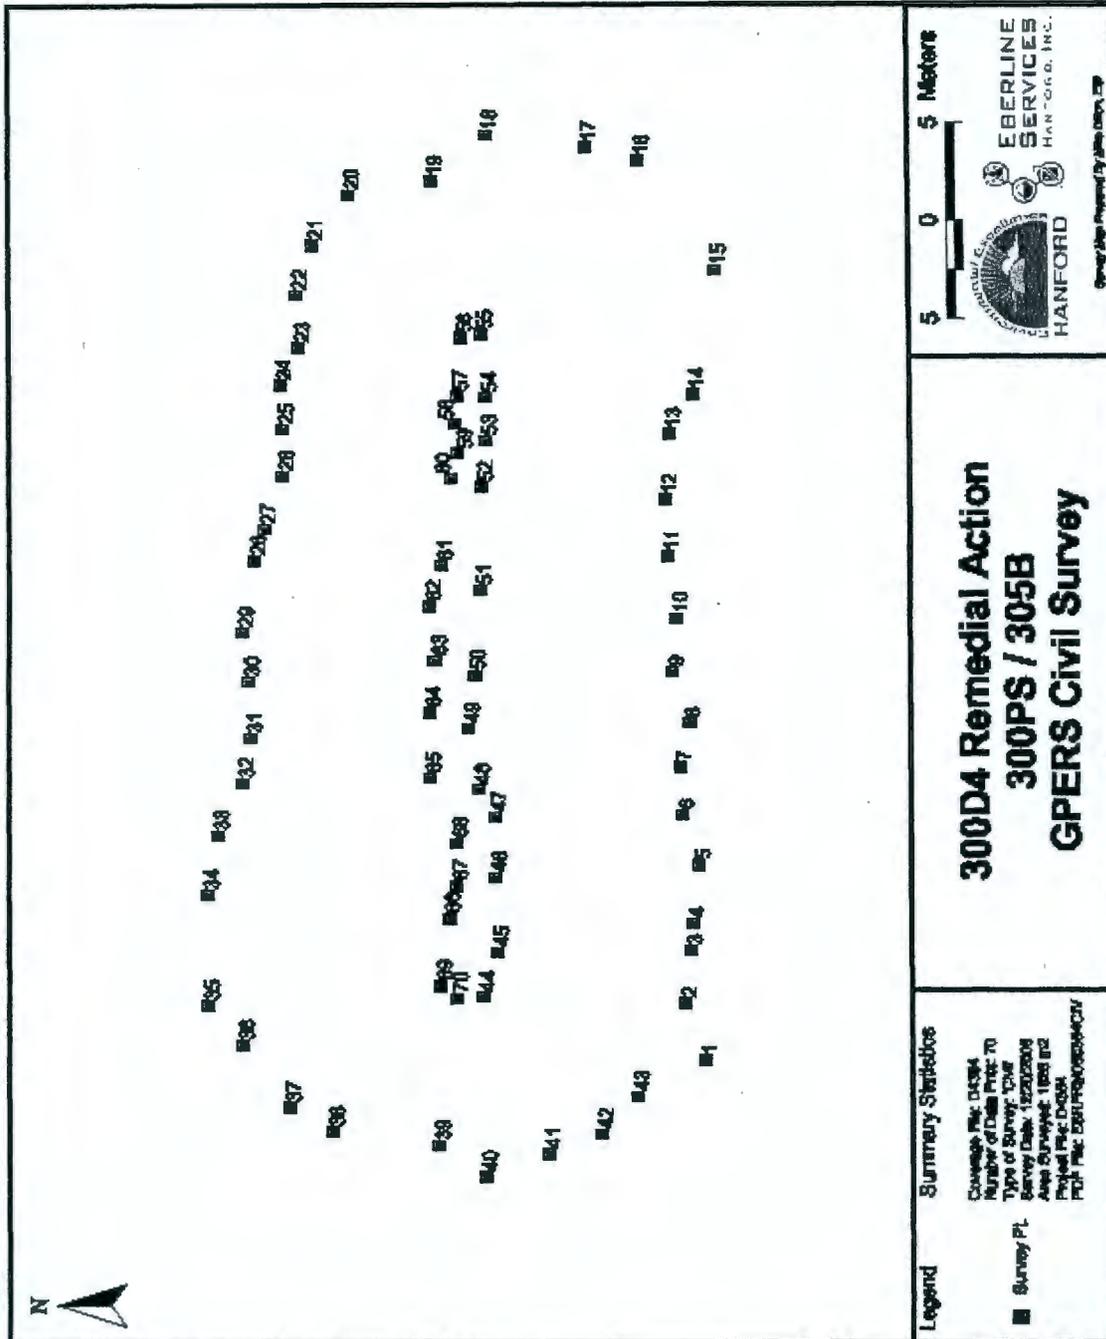
Figure 1. 305B Building Complex Excavation GPR Survey Map

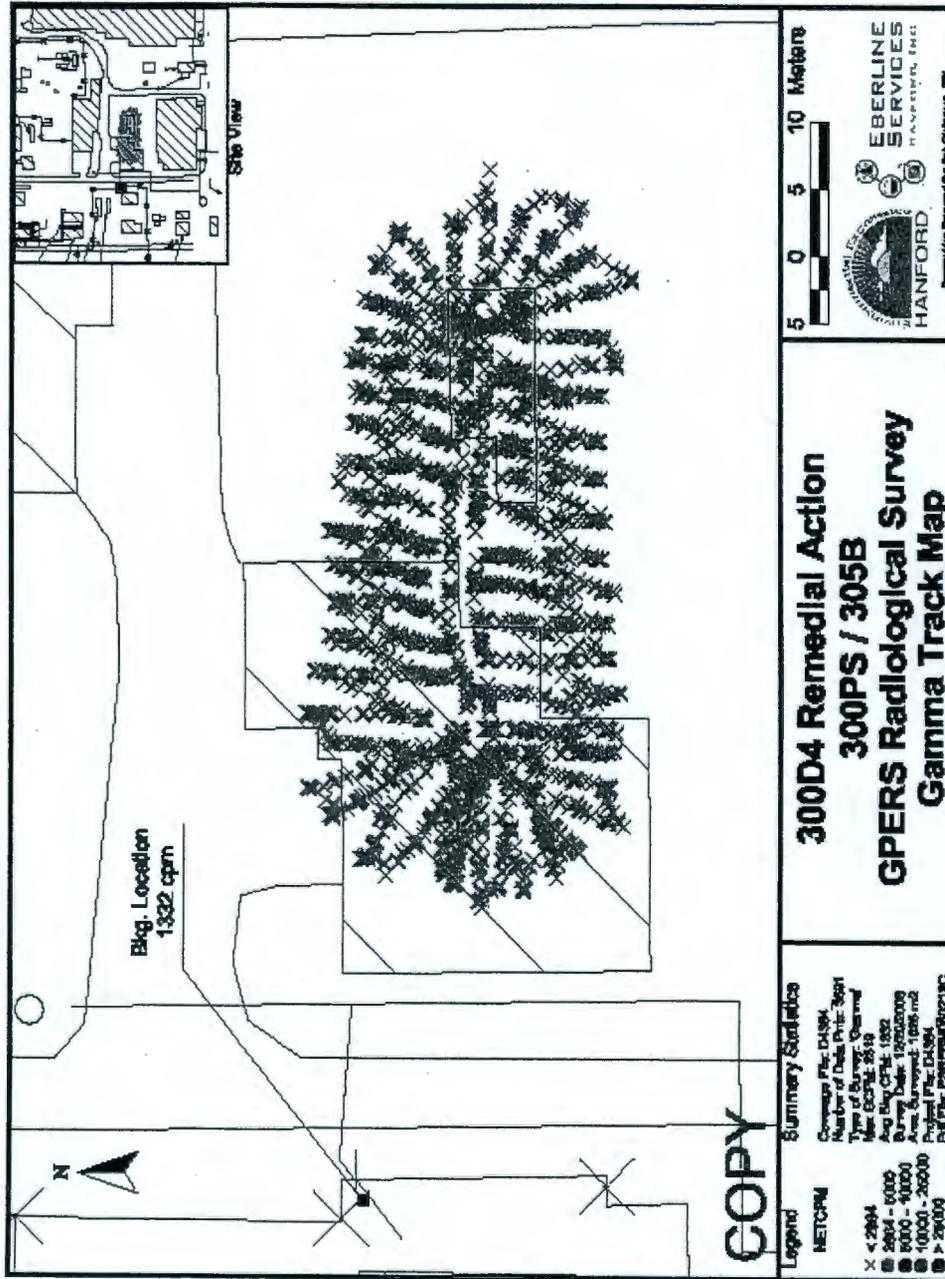
Figure 2. 305B Building Complex Excavation GPERS Survey Results – Gamma Track Map

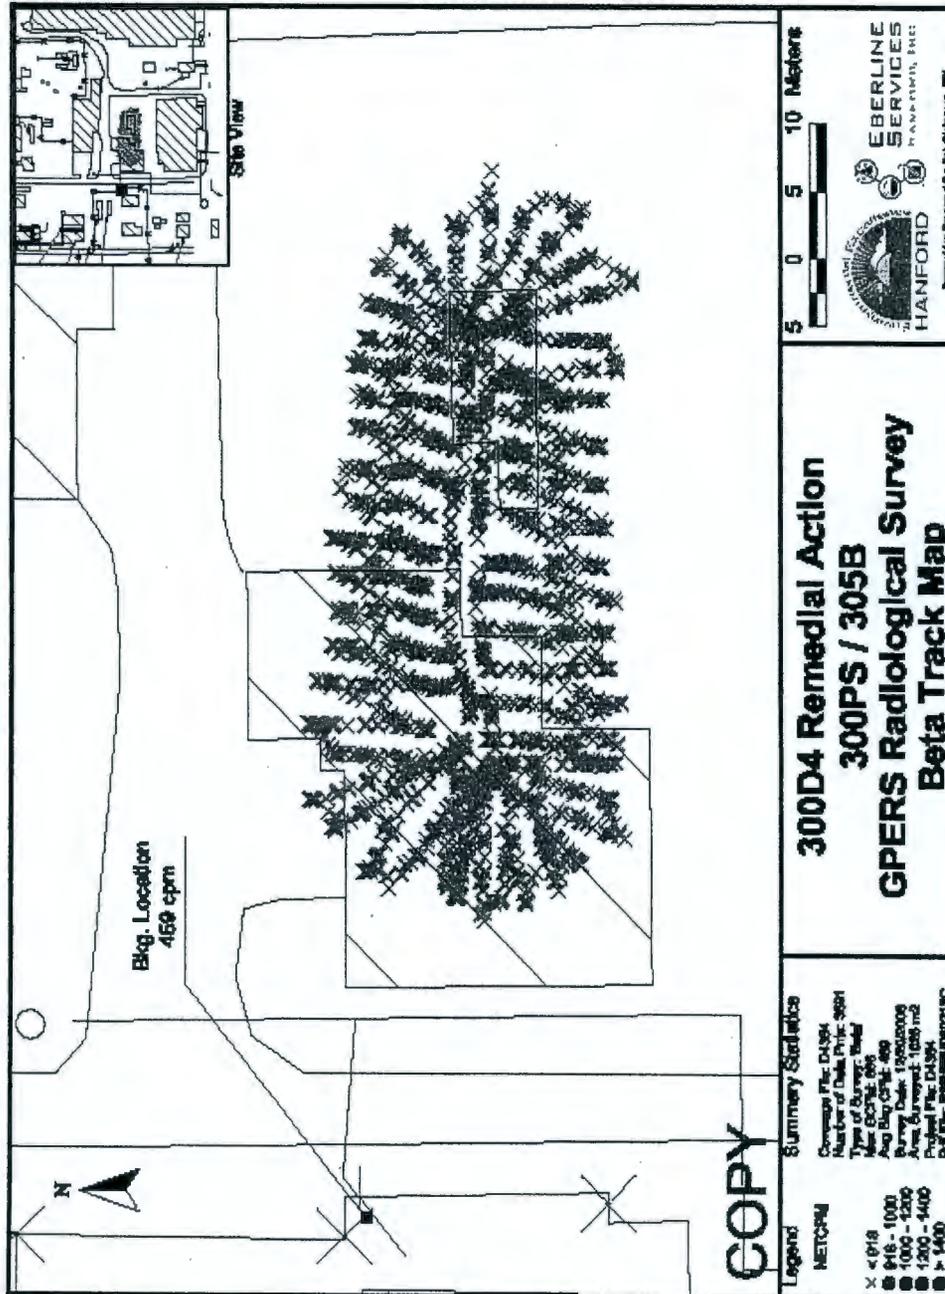
Figure 3. 305B
 Building Complex Excavation GPERs Survey Results – Beta Track Map

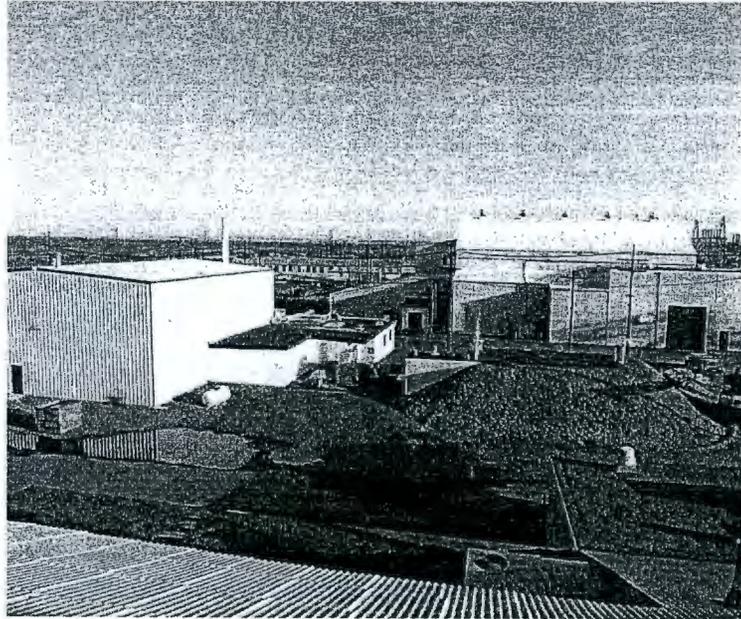
Figure 4. 305B Building Complex in Foreground (facing north).

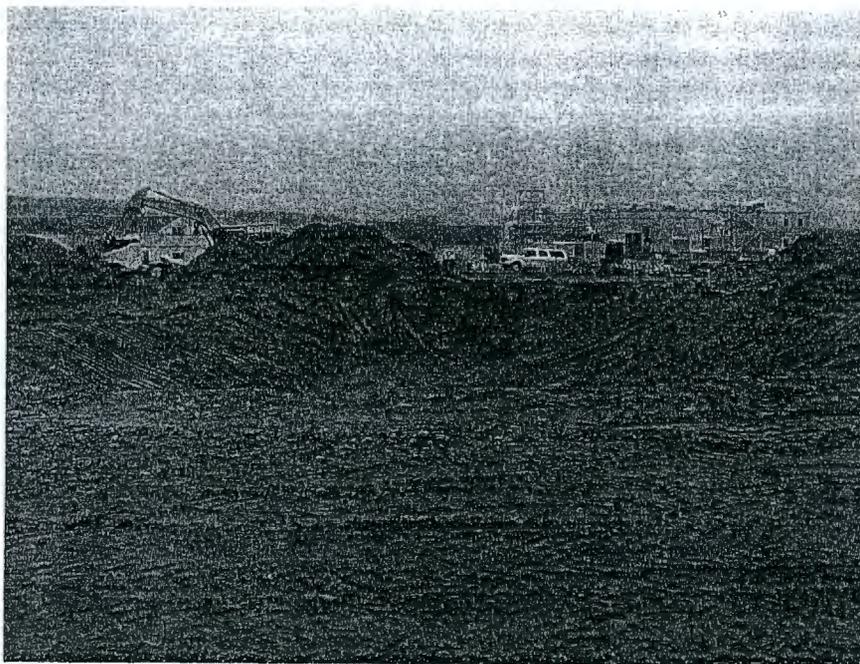
Figure 5. 305B Building Complex Site after Demolition prior to Backfill (facing east).

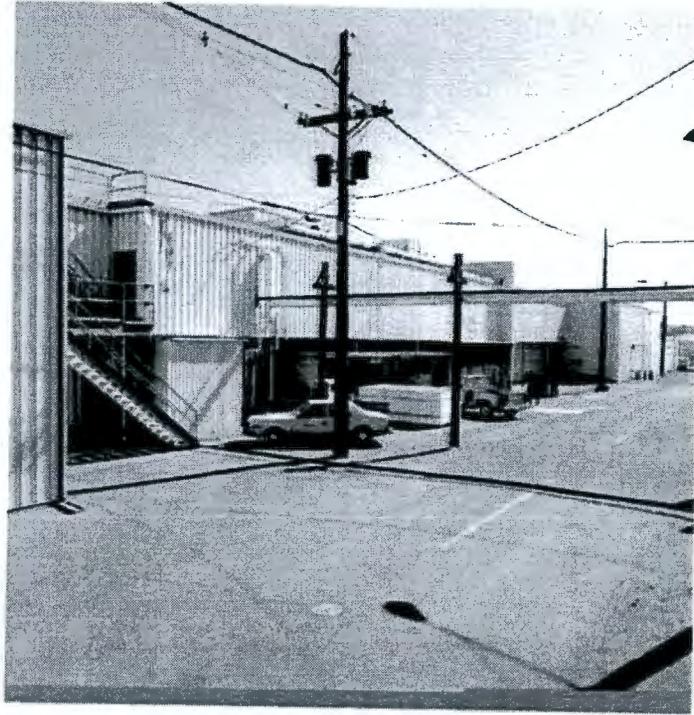
306 E Prior to Demolition

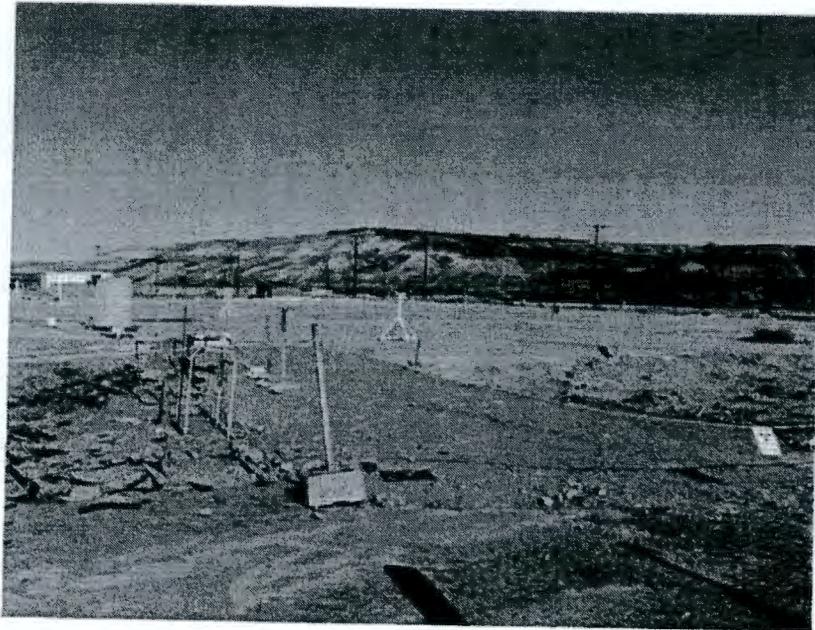
The 306E foundation is currently posted as a radiological control area.

306 E After Demolition

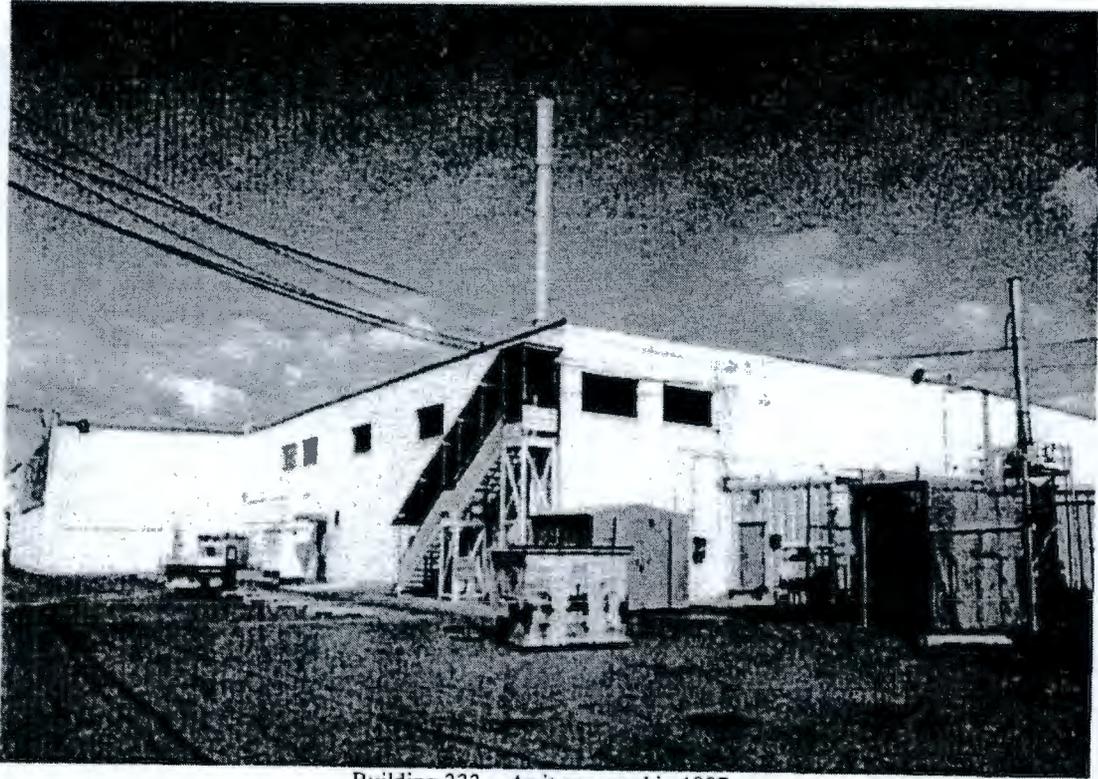
Building 333 - As it appeared in 1987.

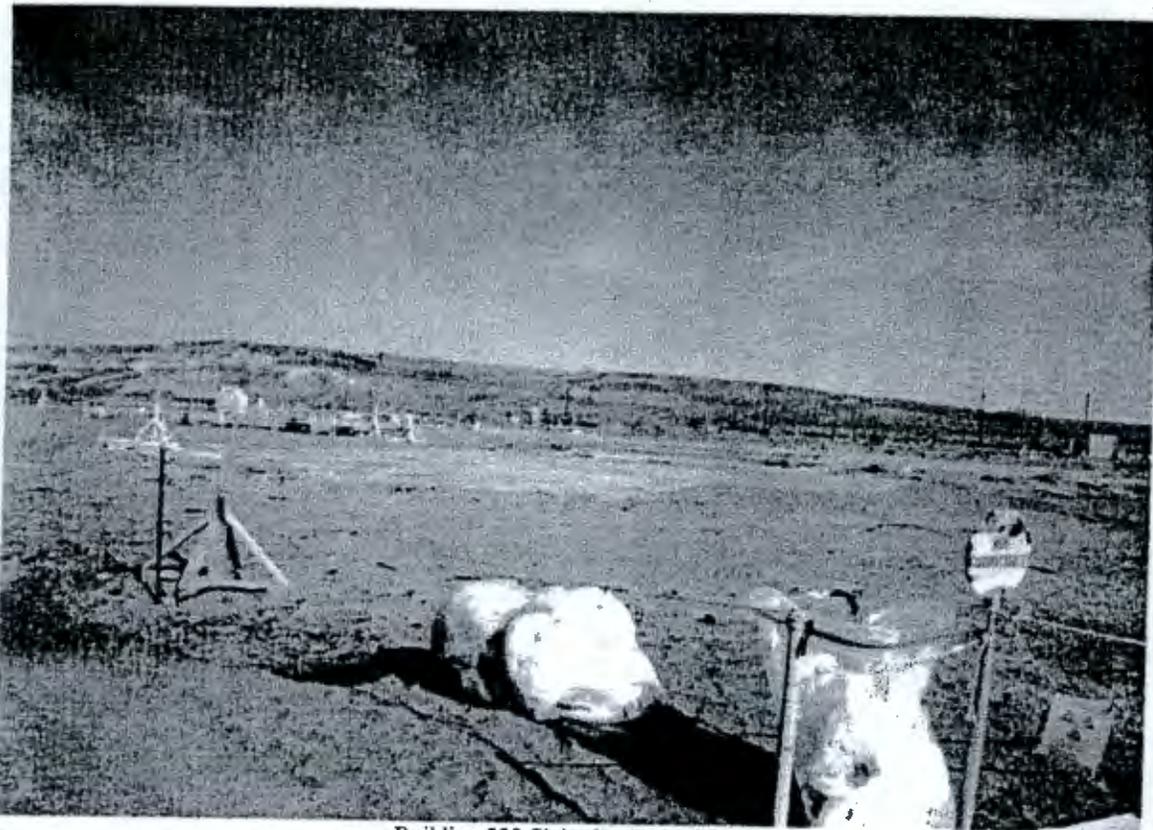
The 333 building foundation is currently posted as a radiological control area. Debris from trenches and pits in the foundation have been removed and disposed at ERDF. Fall hazards, as defined by OSHA 1926.501(b)(1) (i.e., unprotected sides or edges of six feet or more), will be mitigated with backfill or a barrier.

Building 333 Slab after Demolition
