Appendix D  
Conceptual Site Models

6 Figure D-1. Waste Type Area Maps..... D-5

7 Figure D-2. Landfill Types Descriptions & Locations ..... D-7

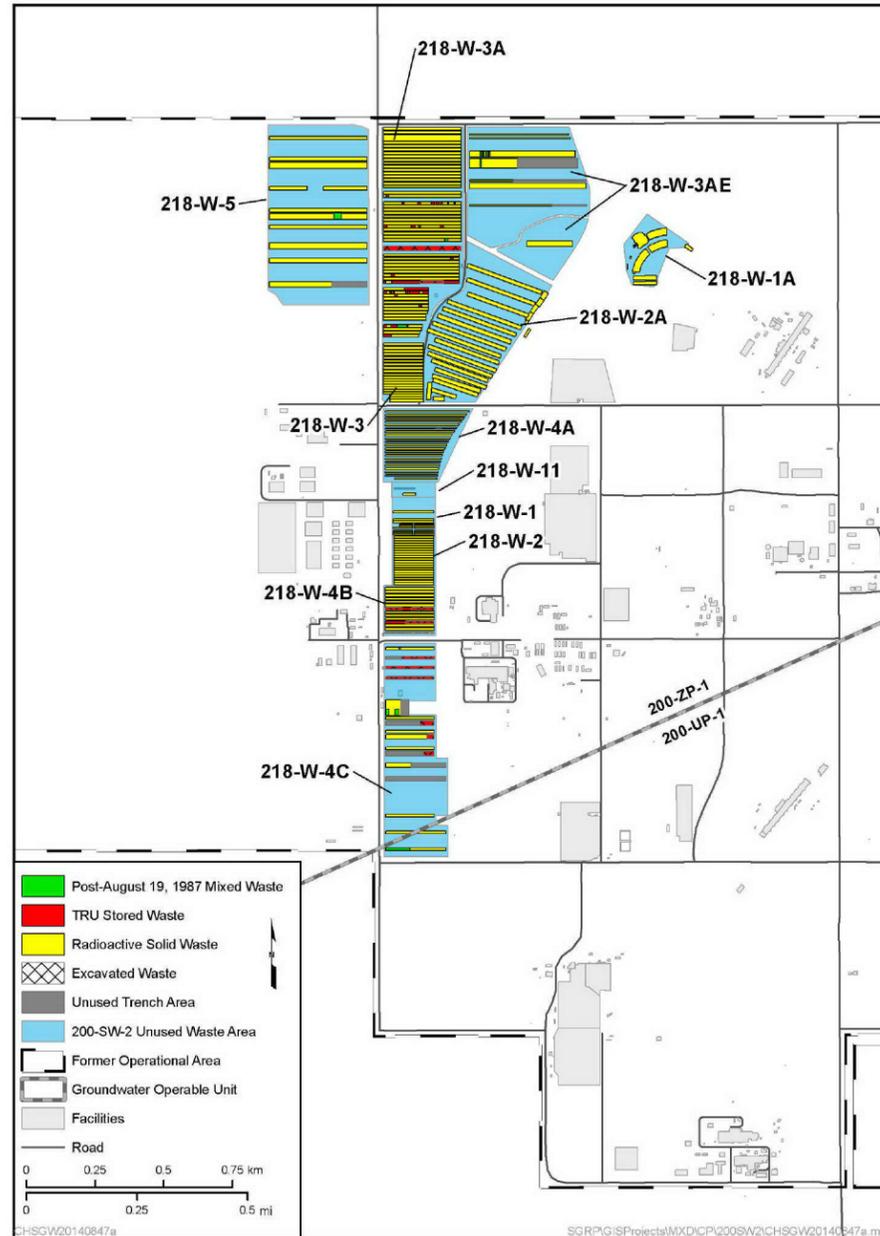
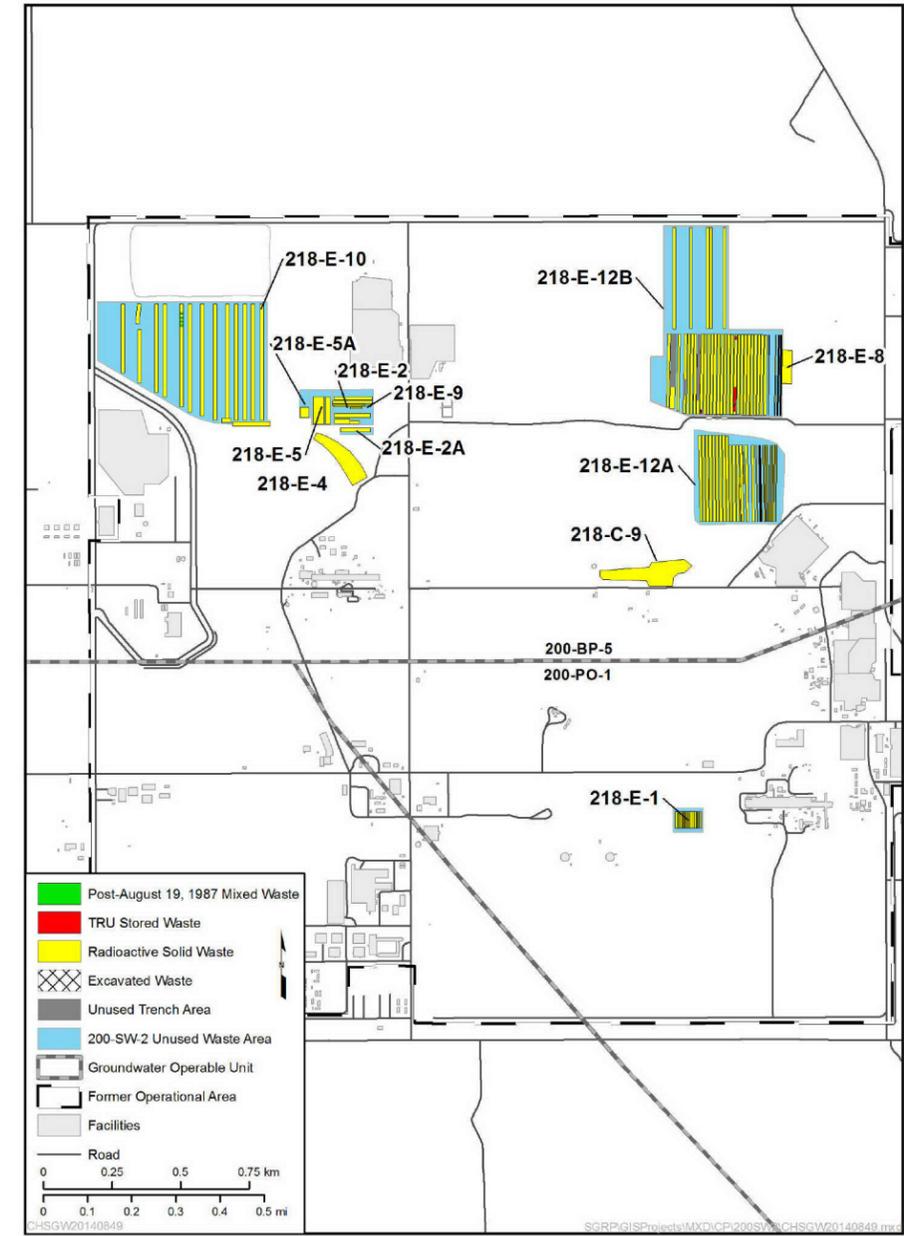
Each landfill trench is color coded based on known waste type. More detailed information on landfill characterization is provided in the Conceptual Site Models for the individual landfills.

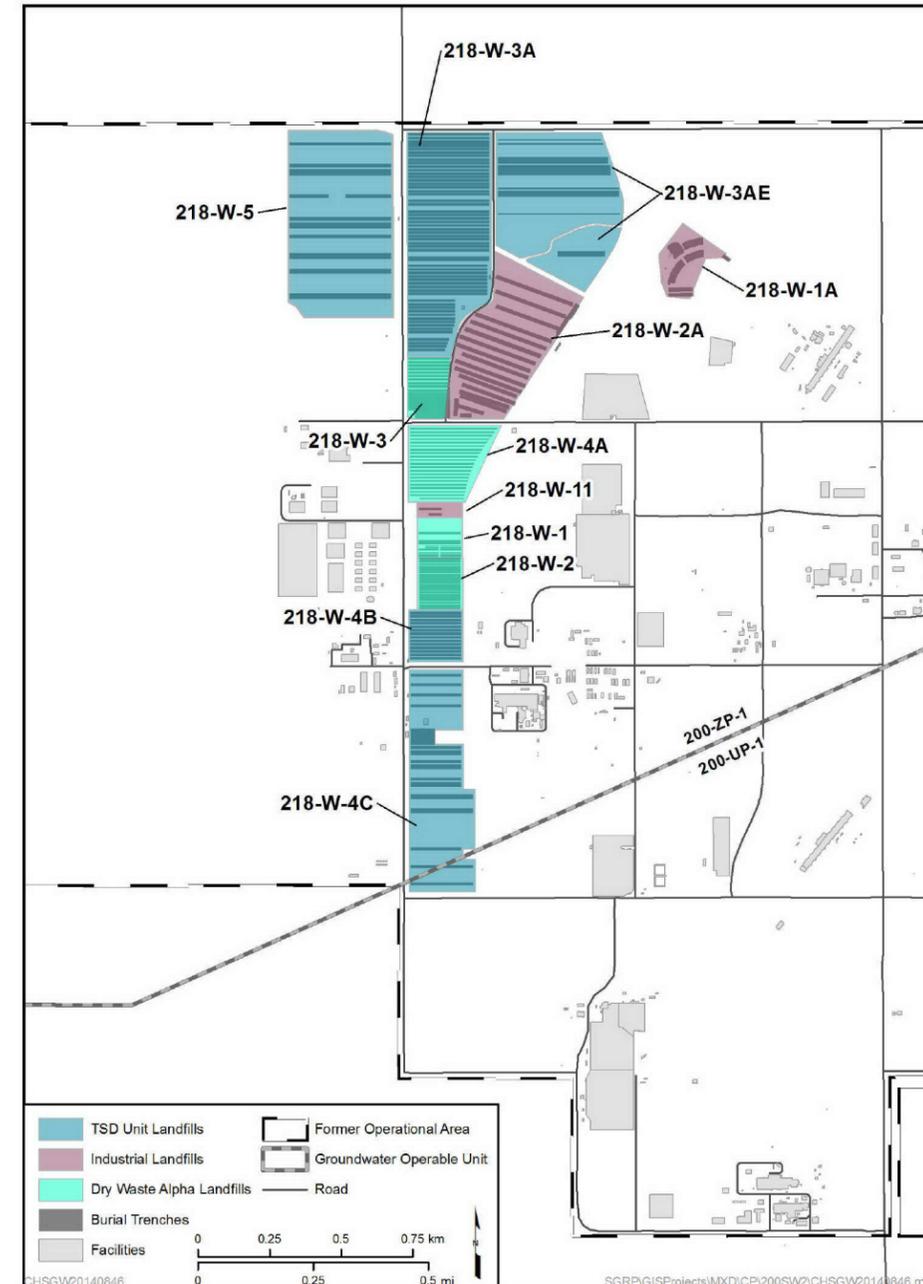
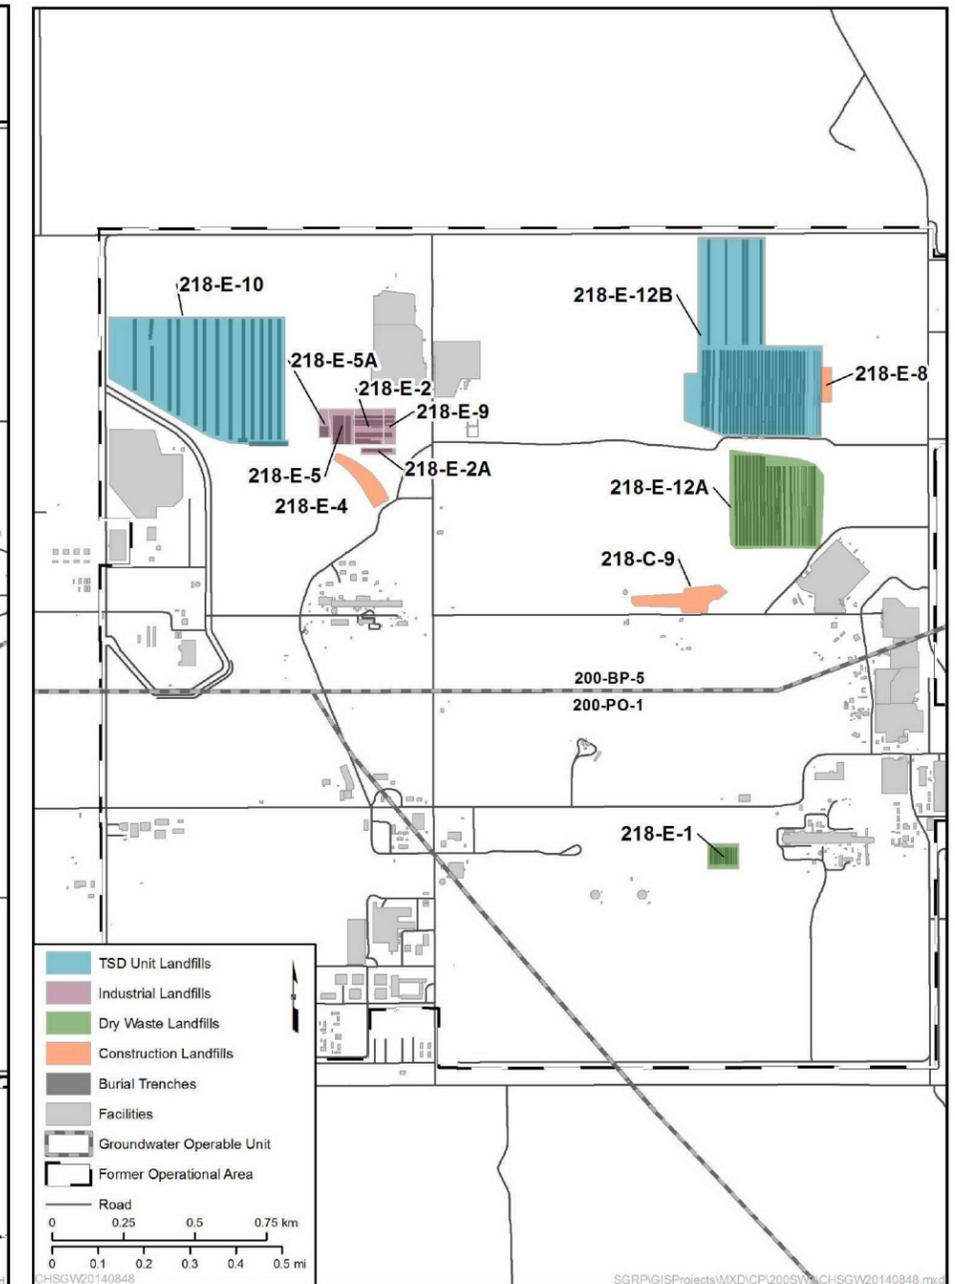
Each landfill is color coded based on type. Descriptions of each type and associated landfills is provided on page D-4. More detailed information on landfill characterization is presented in the Conceptual Site Models for the individual landfills.

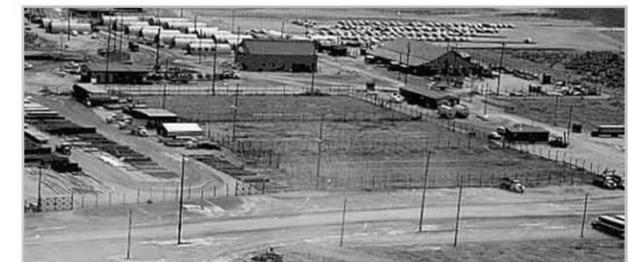
1987 photo shows the 218-E-1 landfill. Trench locations are still visible.

No photos of the 218-E-1 trench contents have been found. This photo of the completely backfilled and fenced site, dated June 8, 1954, corroborates the WIDS and SWITS descriptions of operating dates of 1945-1953.

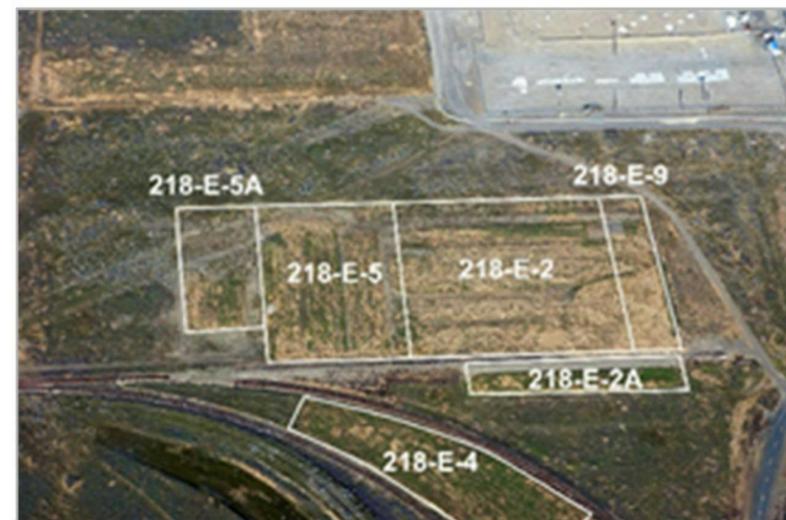
A 2007 photo shows the landfills' recent appearance.

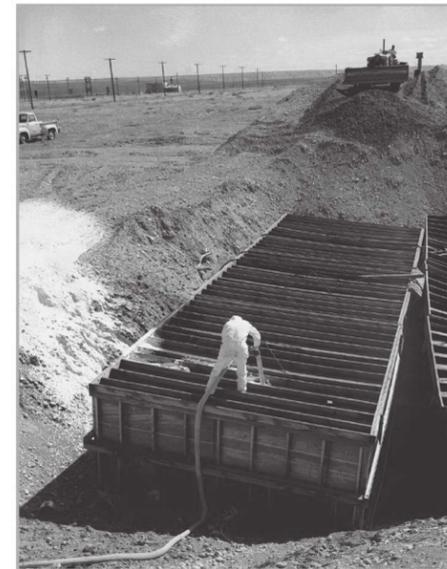
In a 1961 photo, worker is backfilling the stabilized and foamed box.

April 19, 1961 photos of 218-E-5A correlate well with the WIDS description of the backfilling operation for deteriorating wooden boxes, which occurred that date and which used foam as contamination control. Operator is foaming pit and interior of box.

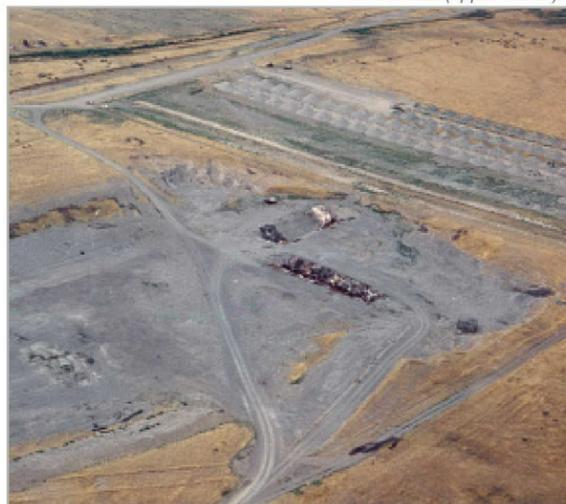
June 1969: aerial photo looking southwest shows waste in the 200-E Burn Pit (non-radioactive) adjacent to 218-E-8. The photo suggests some overlap between the locations of the landfill and burn pit. The photo shows open trenches in 218-E-12B (top right), the 216-B-2 ditches (top), the 200-E Burn Pit (center), and the 218-E-8 landfill (upper center).

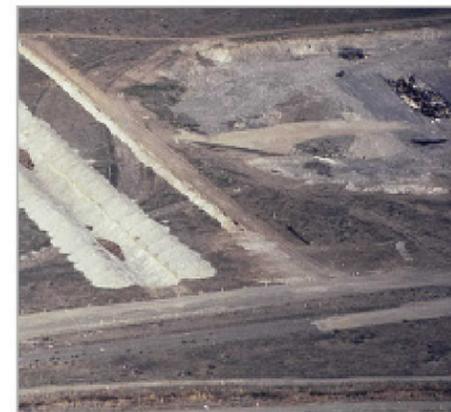
Undated aerial photo, probably about 1970, looking northeast. Shows open trench in 218-E-12B, 200 East Burn Pit, and possibly waste stored on surface of 218-E-8.

Photos from the late 1960s through late 1980s show the non-radioactive 200 East Burn Pit adjacent to the radioactive 218-E-8 landfill. The burn pit was still in use during that period but the landfill was backfilled. The landfill footprints of the two waste sites appear to overlap in places. Geophysical investigations of 218-E-8 have been difficult to interpret because of the close proximity of the two waste sites.

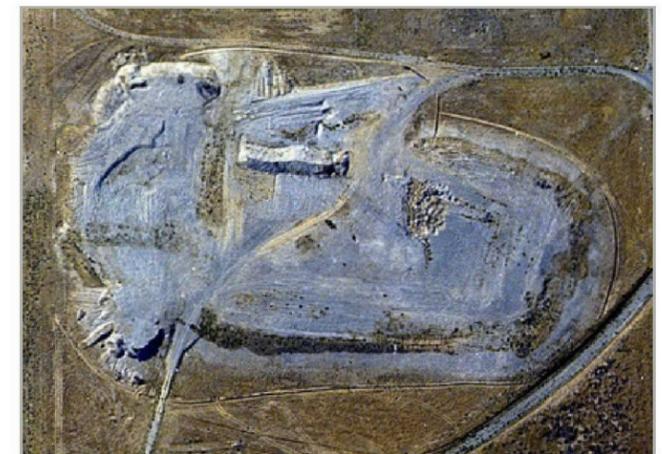
1975 photo (top is north) shows backfilled trenches in the 200 East Burn Pit (center) adjacent to the 218-E-8 landfill (left).

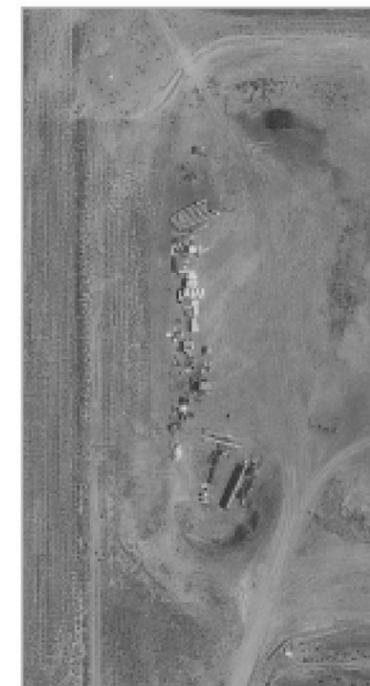
1988 photo (top of photo is north) shows waste stored on surface of 200 East Burn Pit adjacent to 218-E-8

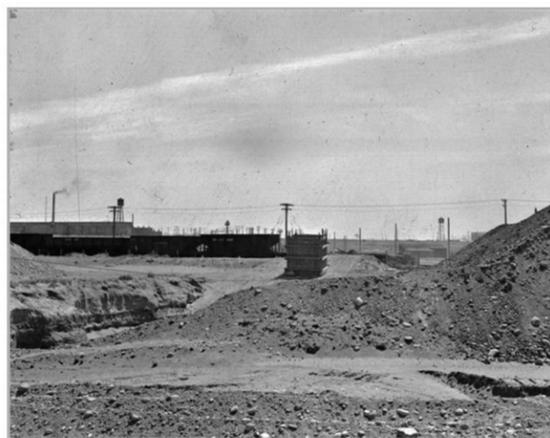
1954 photo of large wooden dragoff box placed in 218-W-2A industrial landfill.

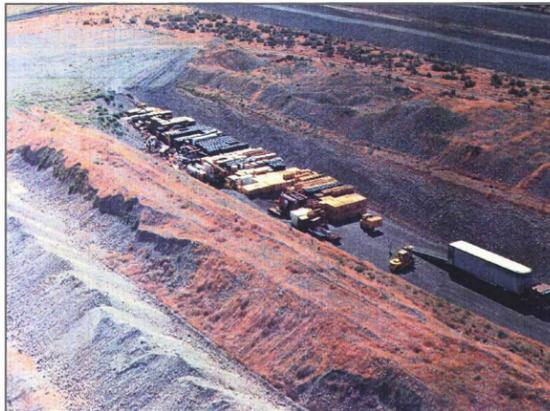
Undated photo showing workers placing waste in a trench in 218-W-3AE.

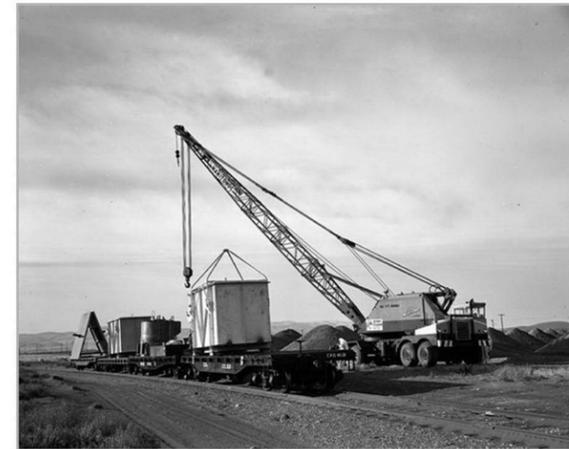
Photo (January 30, 1964) of waste destined for burial in Trench 10 of 218-W-4A landfill.

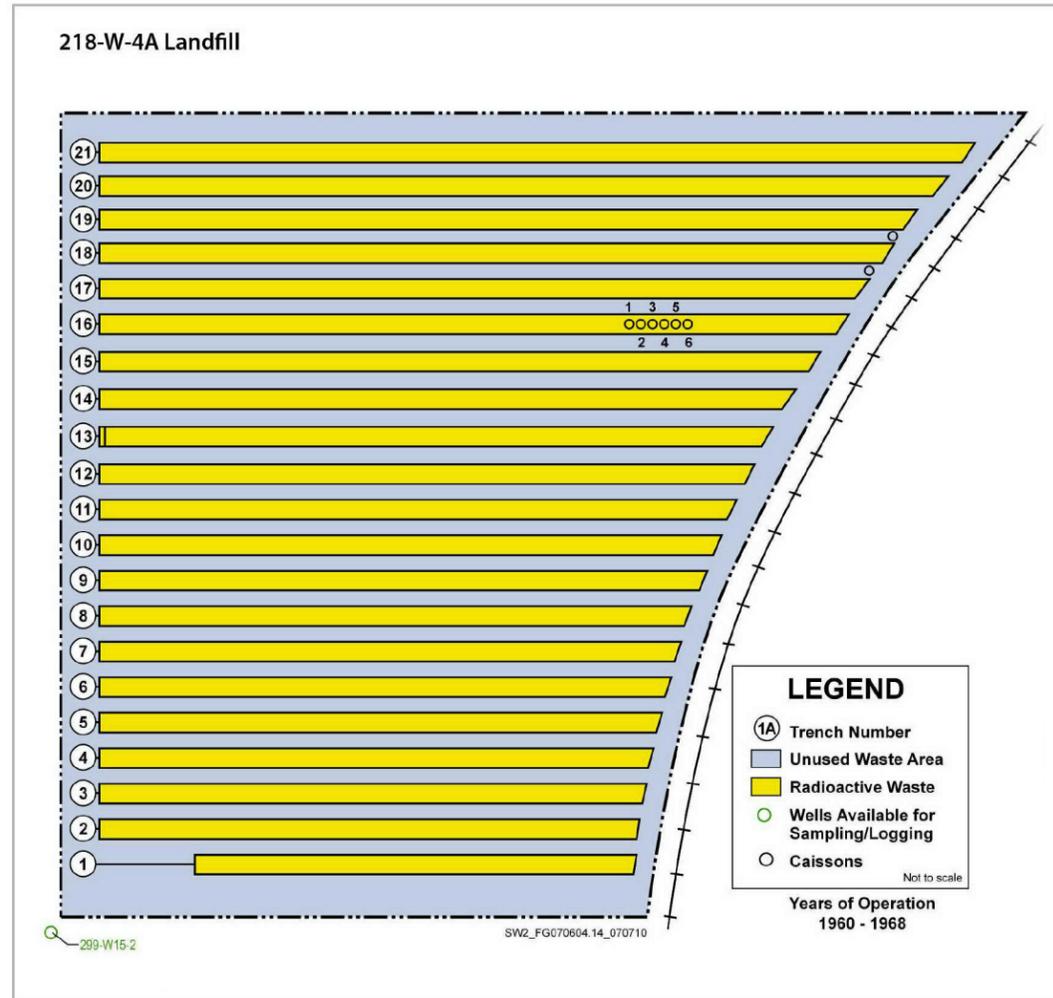
- High dose rate (up to 10,000 mR/hr)
- Typically remote handled waste
- Small containers (1-5 gallons)
- High beta-gamma radiation
- Potential for small volumes of sorbed organics (lab packs)
- 4 caissons believed unused

The 218-W-4A landfill contains 21 miscellaneous dry waste trenches oriented east to west and 6 or 8 vertical pipe units or drywells, also known as caissons. The vertical pipe units were installed near the east end of Trench 16 and consist of two to five 55-gal drums welded together with the lids and bottoms removed. They were placed 4.6 m (15 ft) below ground surface. Two deeper caissons may be located between Trenches 17, 18, and 19.

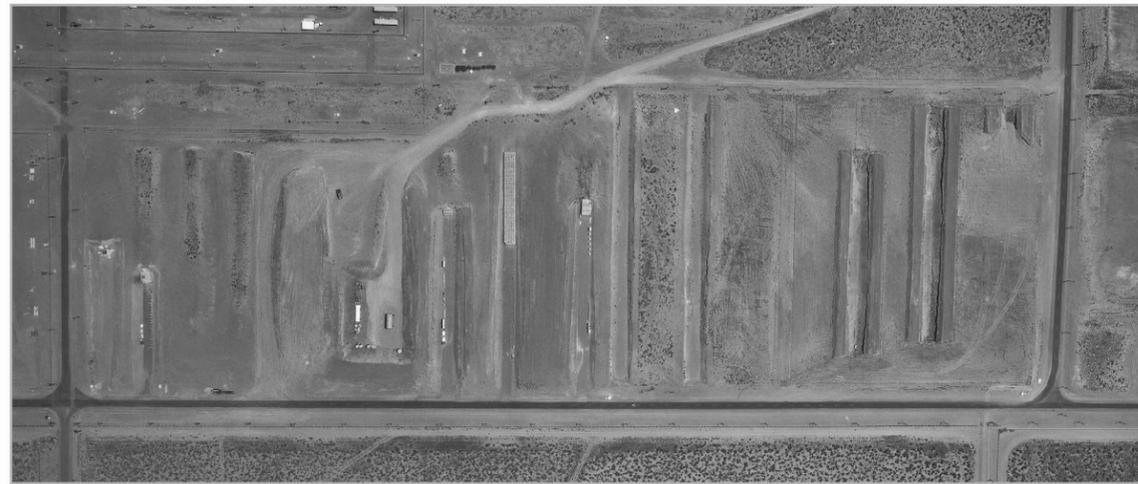
This June 1989 photo of 218-W-4C shows the layout of the landfill.
