TRANSMITTAL OF APPROVED WASTE SITE RECLASSIFICATION FORM AND  
SUPPORTING DOCUMENTATION FOR THE 600-349, UNEXPLODED ORDNANCE  
(UXO) OUTSIDE OF 600-149, REVISION 0

## WASTE SITE RECLASSIFICATION FORM

Waste Site Code(s)/Subsite Code(s): 600-349

**ATTACHMENT B**  
**MUNITIONS AND EXPLOSIVES OF CONCERN (MEC)**  
**SUMMARY REPORT**

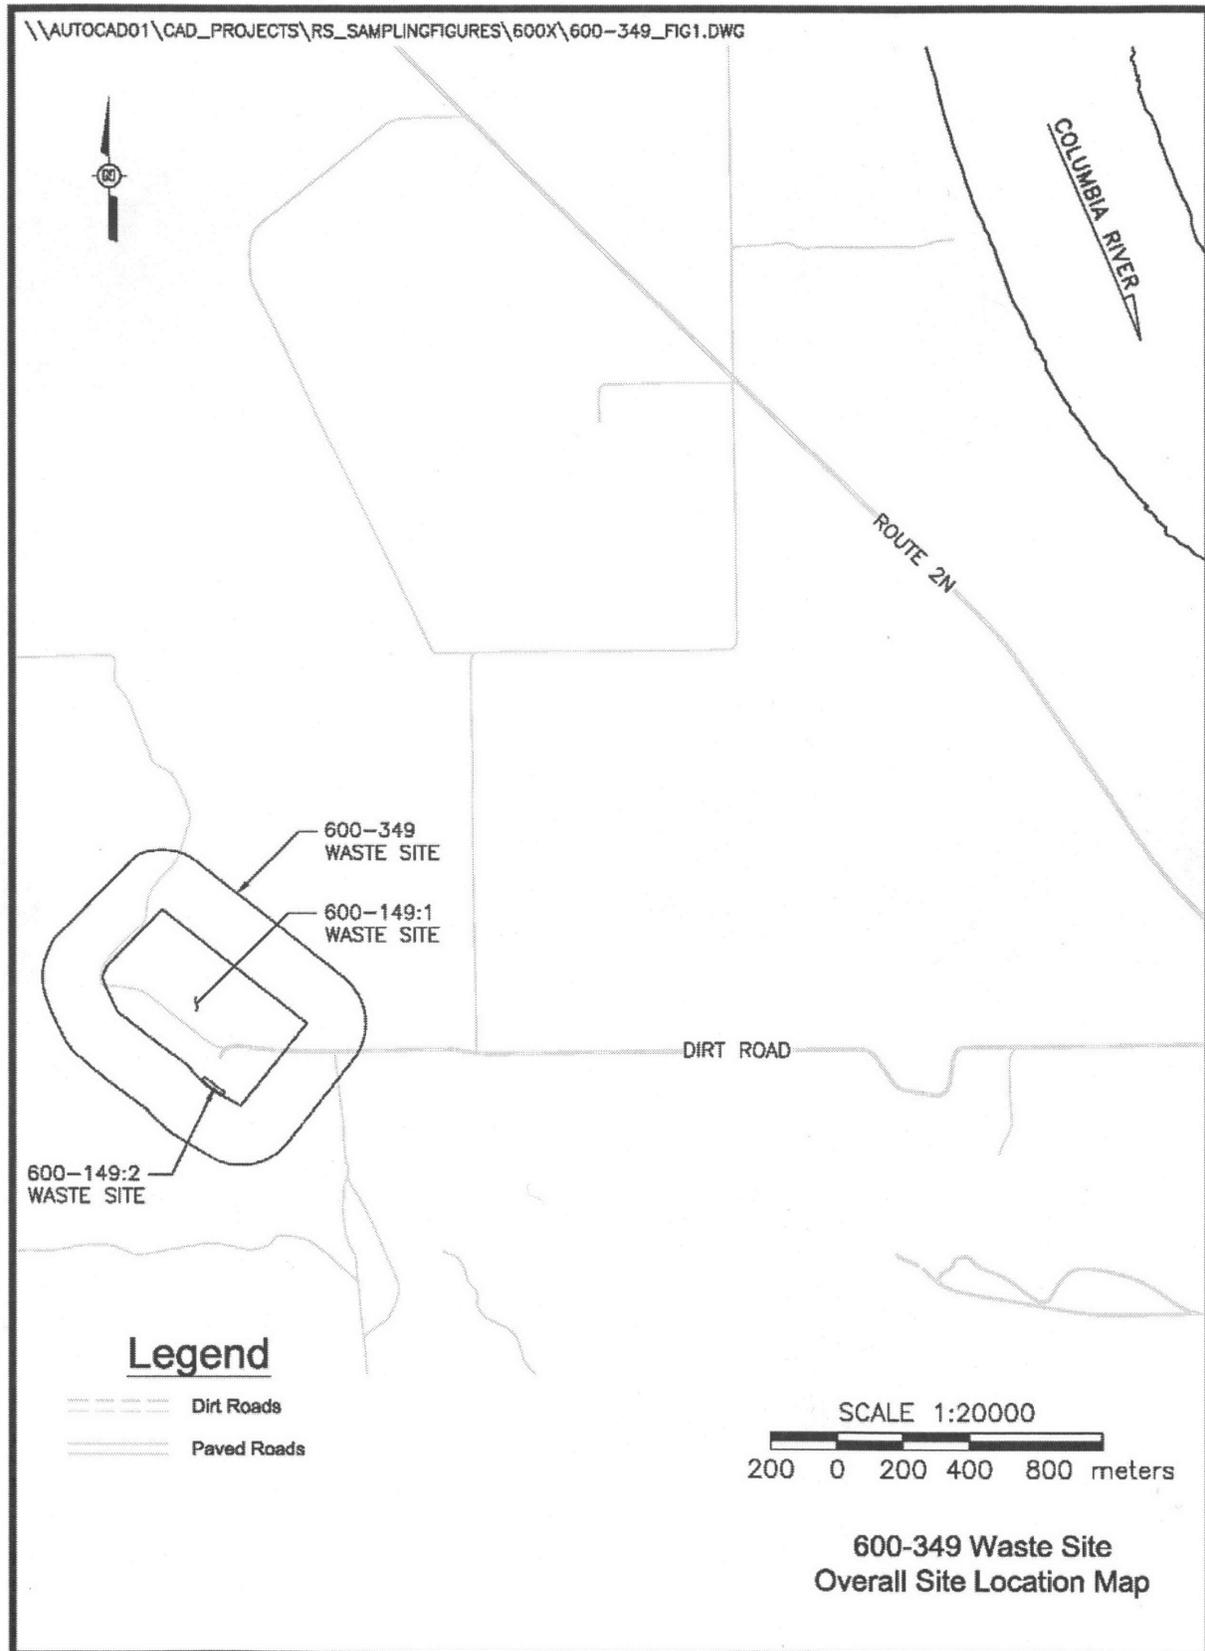
Figure A-1. The 600-349 Waste Site Location Map.

The 600-349, Unexploded Ordnance (UXO) Outside of 600-149 waste site is located in the 100-IU-6 Operable Unit of the Hanford Site, north of the east end of Gable Mountain (Attachment A, Figure A-1). The site covers 49.2 ha (121.51 ac) and is identified as a buffer around the former 600-149 Small Arms Range waste site. The 600-349 waste site consisted of potential unexploded ordnance (UXO) in an area southwest of the 600-149 waste site, extending from the perimeter of the 600-149 waste site as far as a fired rifle grenade could travel. The Small Arms Range operated from the mid-1940s through the 1950s as a practice range for handguns, rifles, shotguns, machine guns, hand grenades, smoke bombs, and other small arms and incendiary devices.

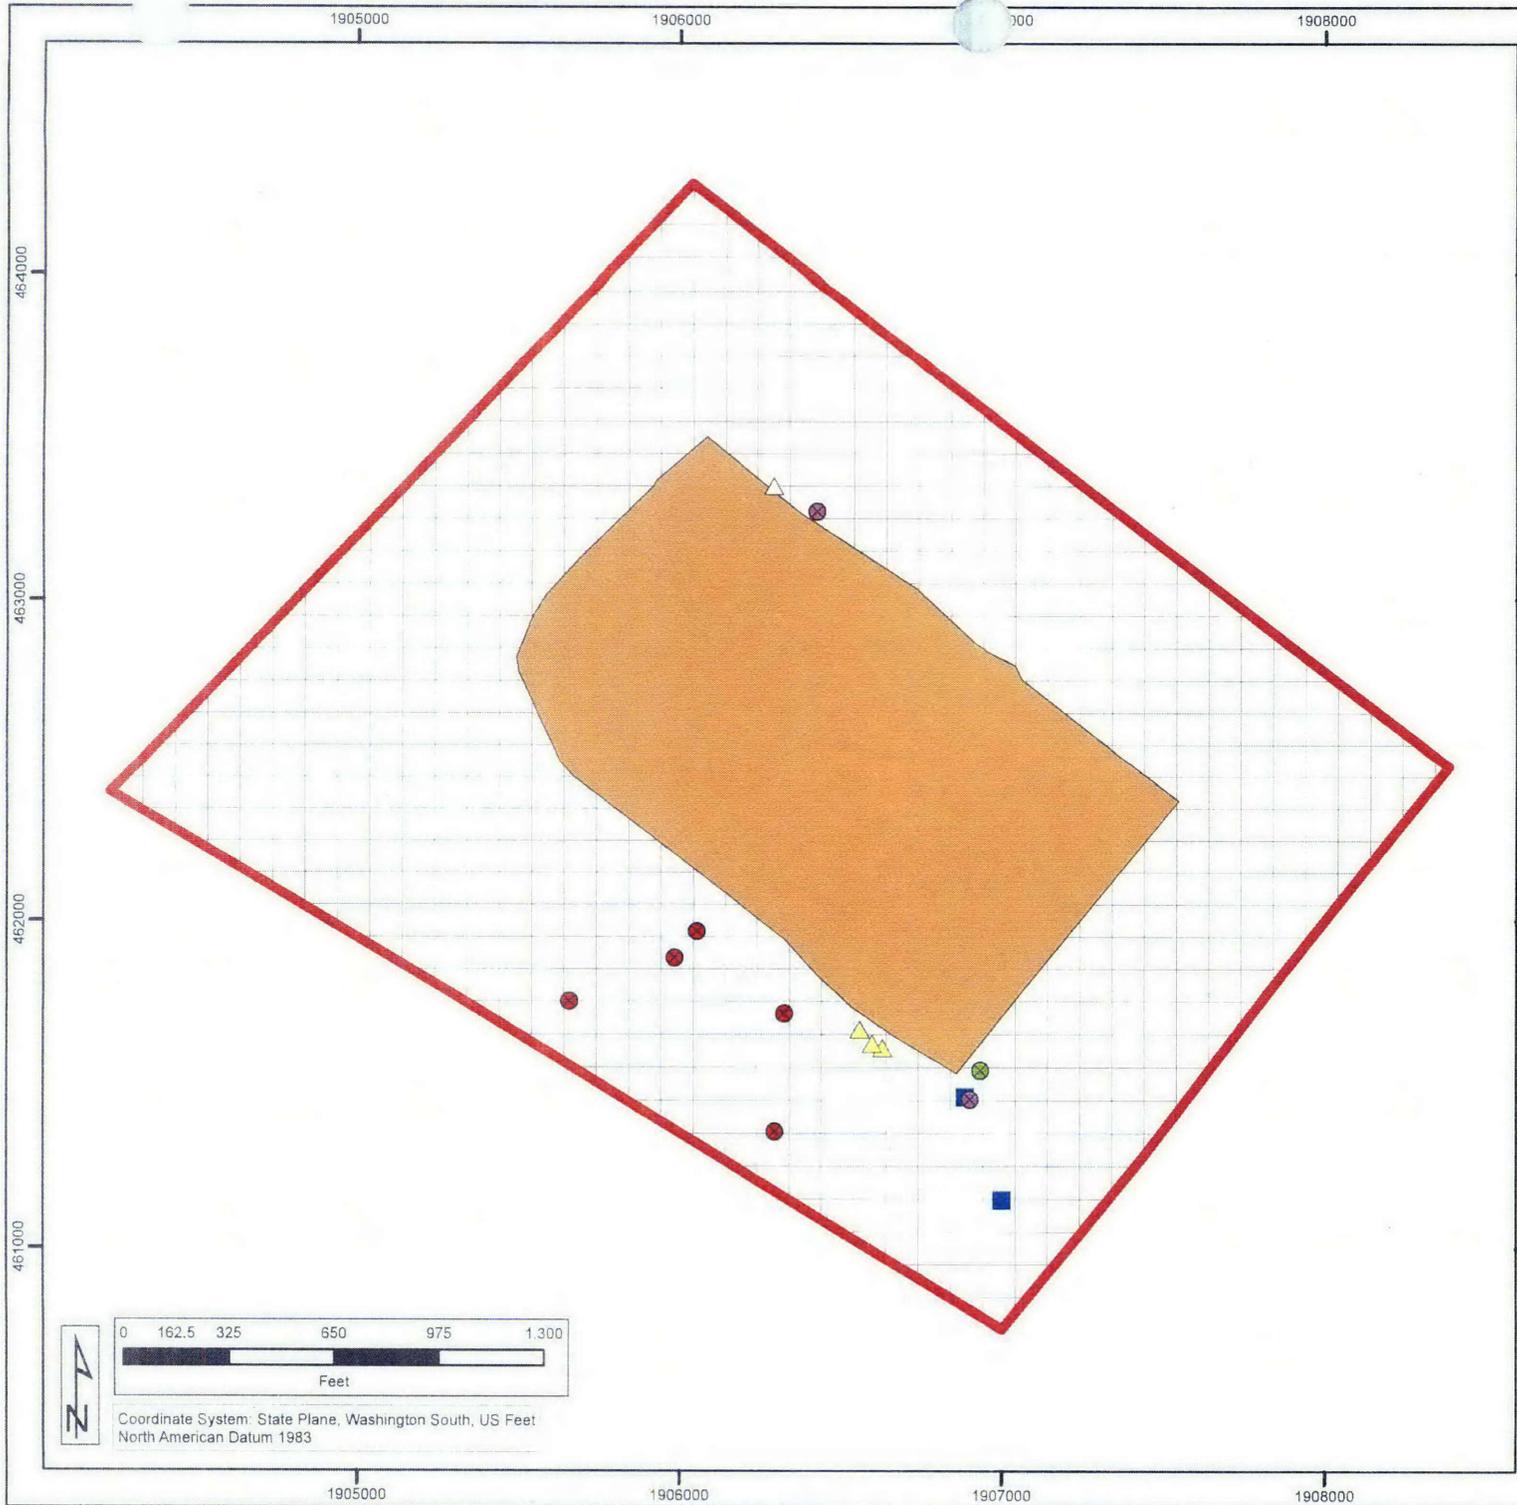
<b>A-8</b>	
<b>MEC Finds</b>	
Hanford Federal Reservation Washington	
	Date: 12/12/2014 Rev: Drafted by: TPMC

TPMC completed a surface clearance of the entire project site covering 573 partial and full grids (121.51 acres). MPPEH consisted of expended small arms, metal cans, nails, screws and steel drums, or parts thereof. Two MEC items were identified including a tear gas candle and 37mm projectile. Approximately 3.3 pounds of MD consisting of grenade fragments and expended small arms were also removed during the surface clearance. Figure A-4 shows the grid layout. Table 8-1 summarizes the MEC items found on the surface. Figure A-8 shows the location of the identified MEC items. Photos of the MEC items are shown in Appendix D, Photographic Log.

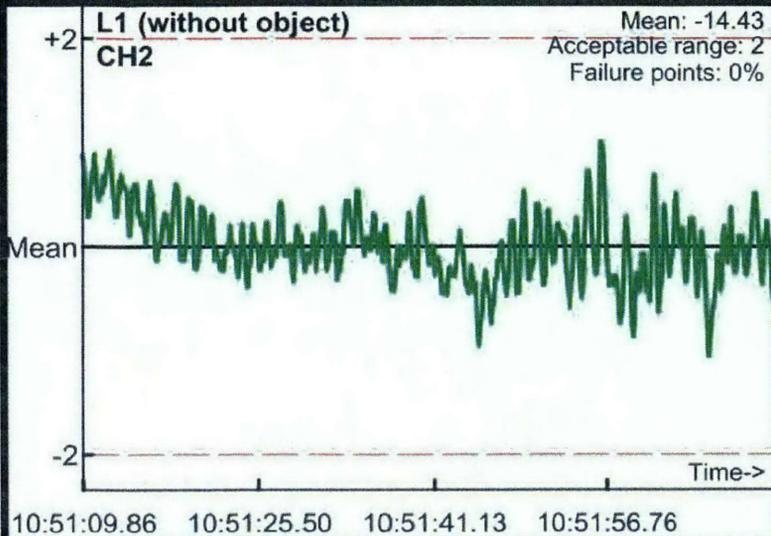
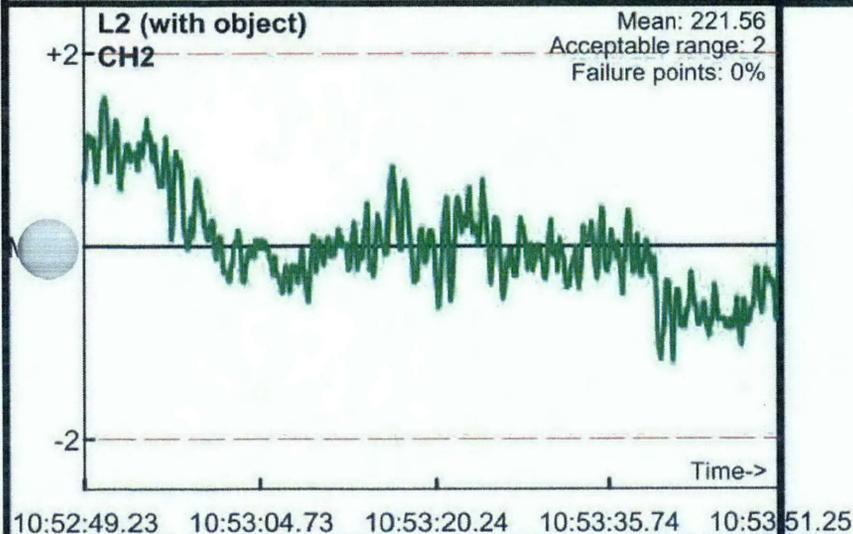
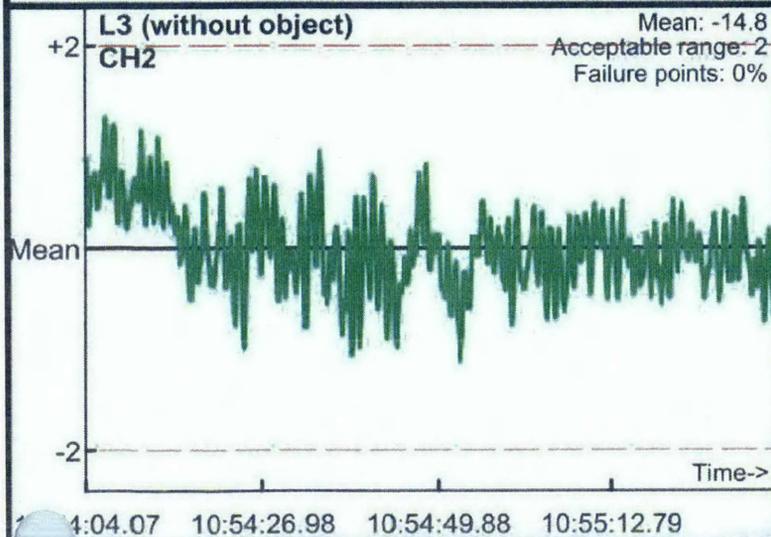
# Static Calibration Test

Project: 600-349 MEC Removal Action  
Equipment: EM-61 Mark II  
Grid/Location: IVS

Allowable failure (%): 100%  
● Outside range  
--- Acceptable limits

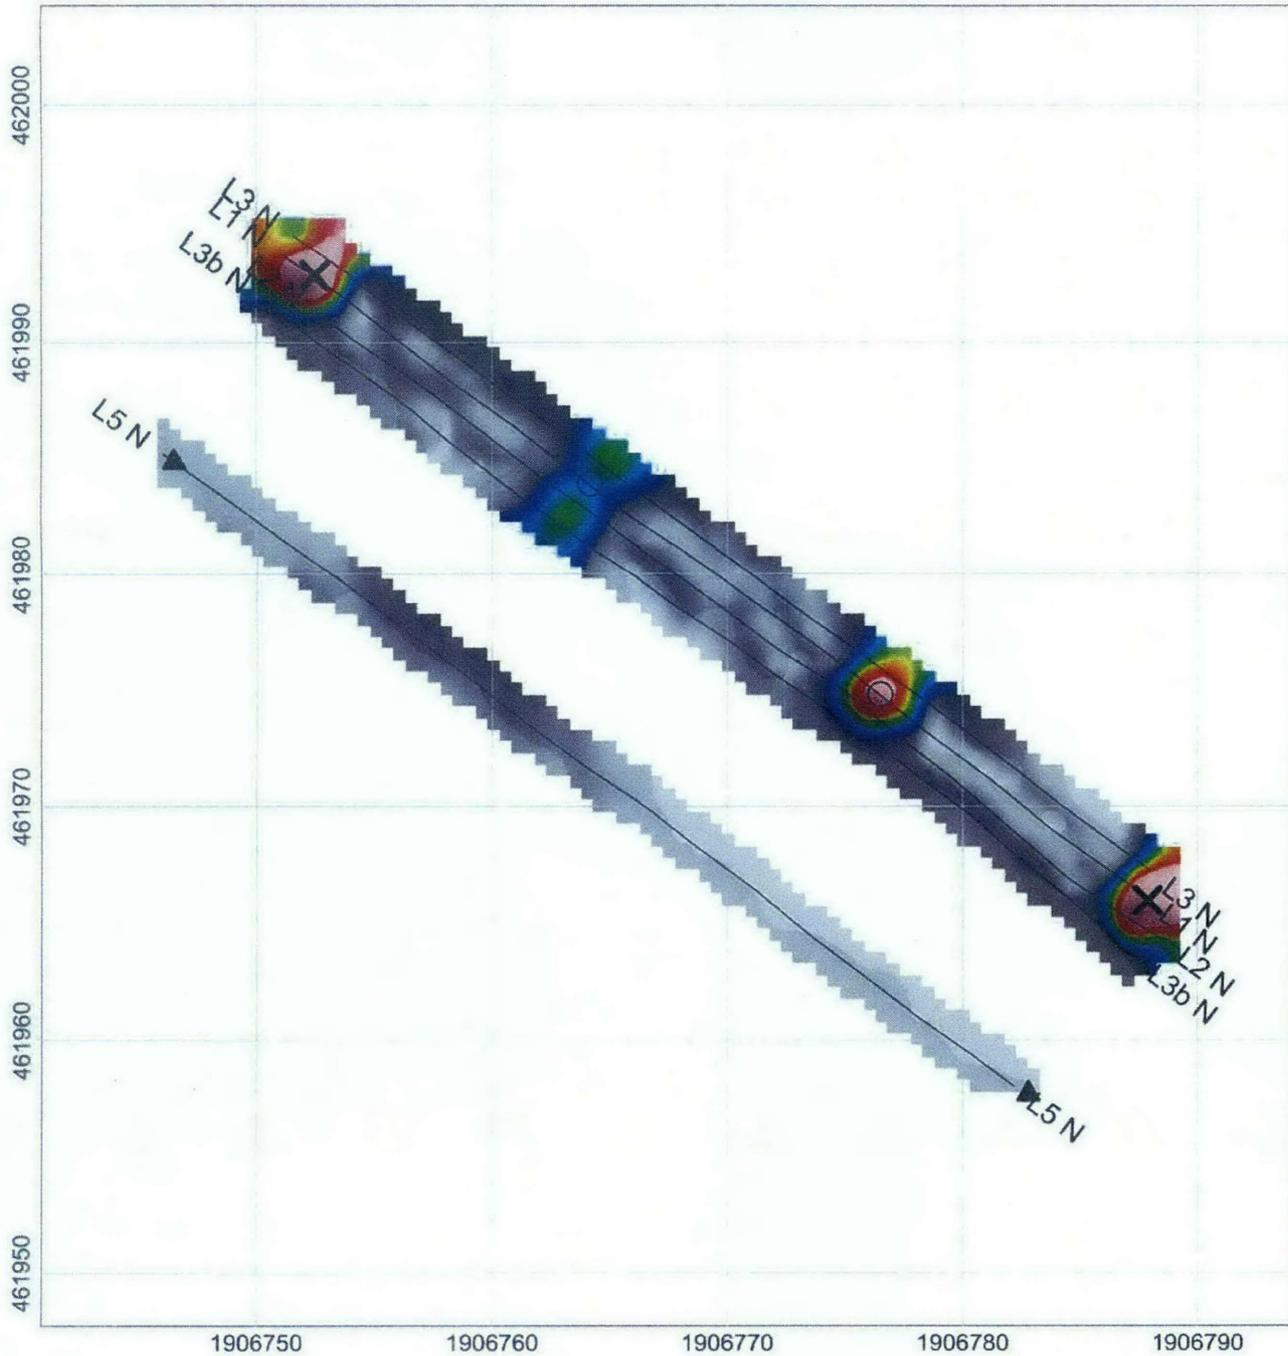
# MAF Team 1 IVS

- ISO Seed Locations
- ✕ Survey Nail Locations
- ▲ Background End Locations

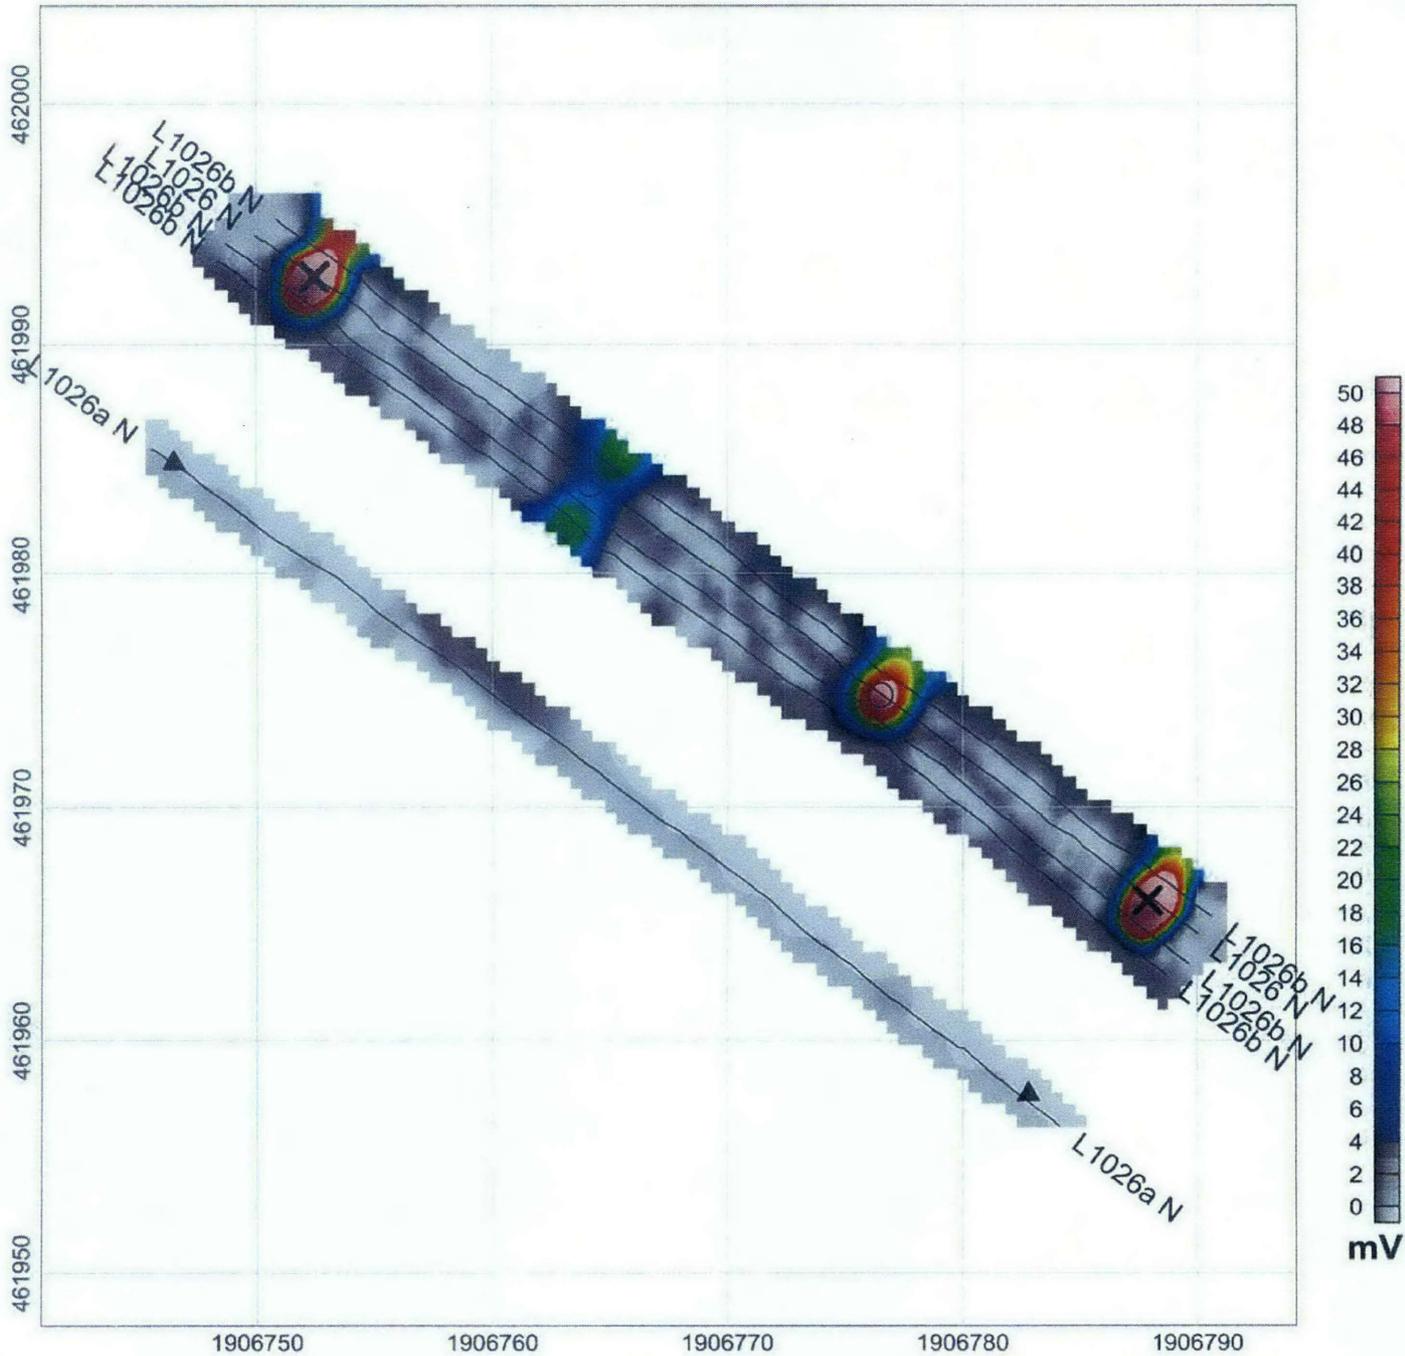
# MAF Team 2b IVS

- ## Legend
- ISO Seed Locations
  - ✕ Survey Nail Locations
  - ▲ Background End Locations
