2. Document Title			
Common Factors Relating to Liner Failures in Single-Shell Tanks			
3. Design Verification Required			
<input type="checkbox"/> Yes <input type="checkbox"/> No

Common Factors Relating to Liner Failures in Single-Shell Tanks

Abstract: This report fulfills the requirement for target T04 for Hanford Federal Facility Agreement and Consent Order milestone M-045-91F. The goal of this report is to identify the common factors that may have contributed to liner failures in single-shell tanks. The tanks with probable liner failures are identified through the process identified in RPP-32681, Rev. 0, "Process to Assess Tank Farm Leaks in Support of Retrieval and Closure Planning."

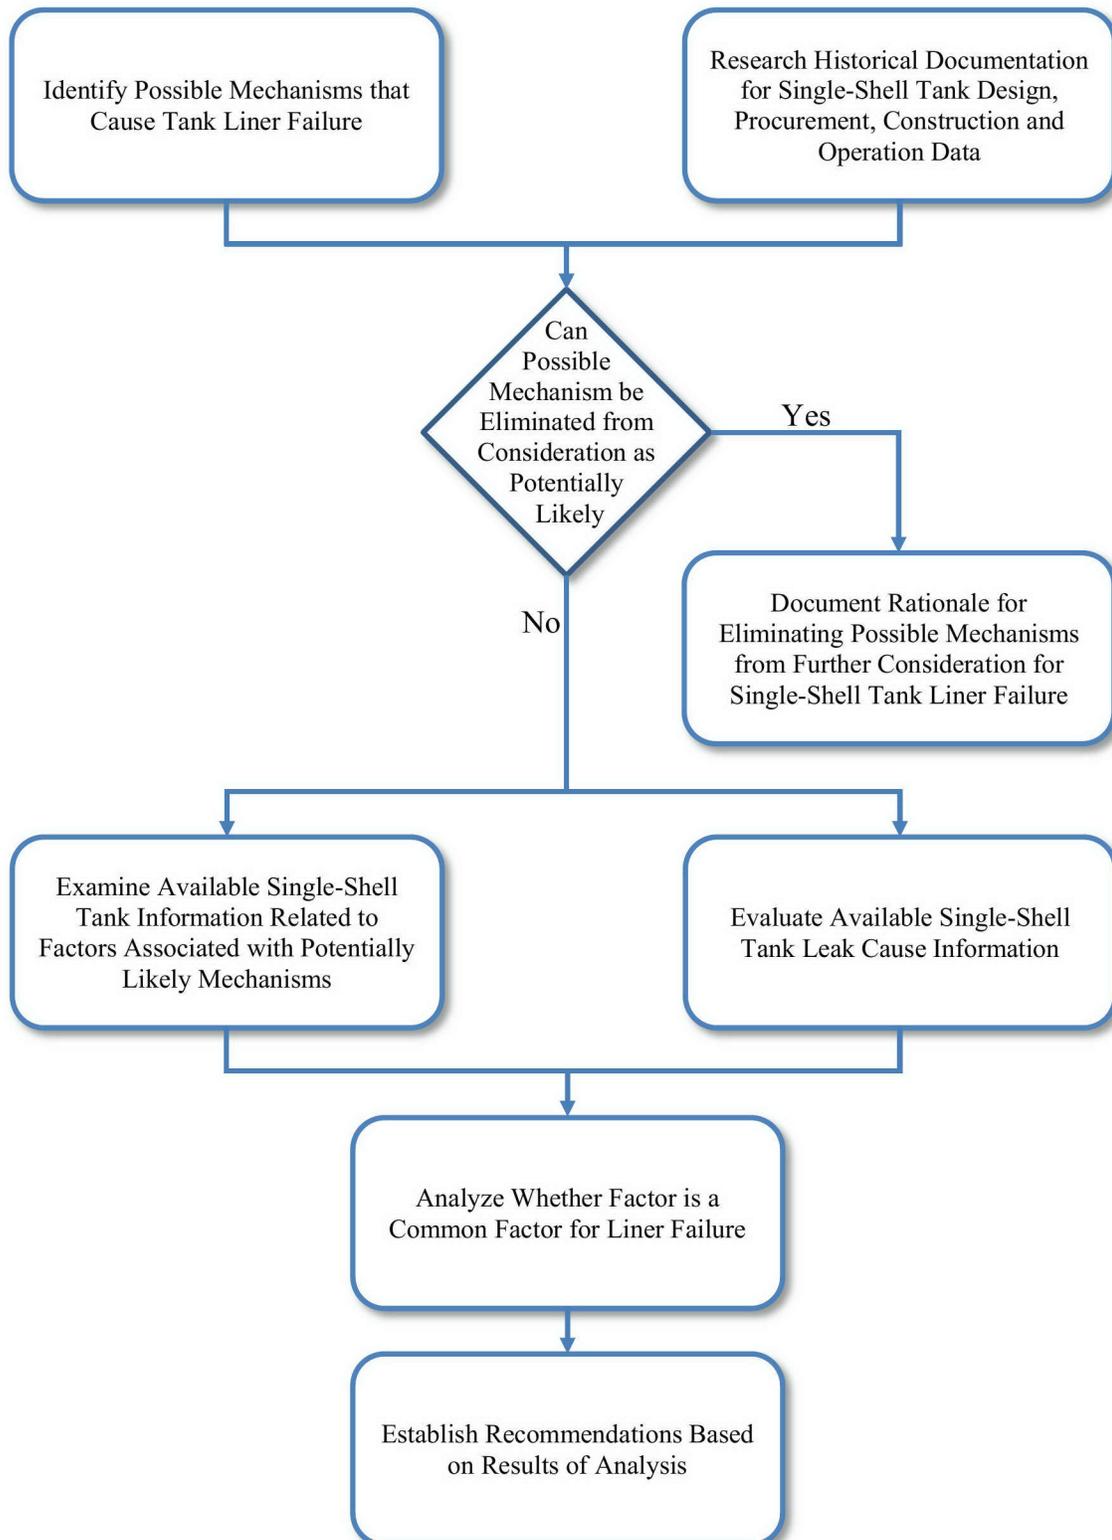
Figure 3-1. Methodology for Identifying Common Factors Contributing to Liner Failures

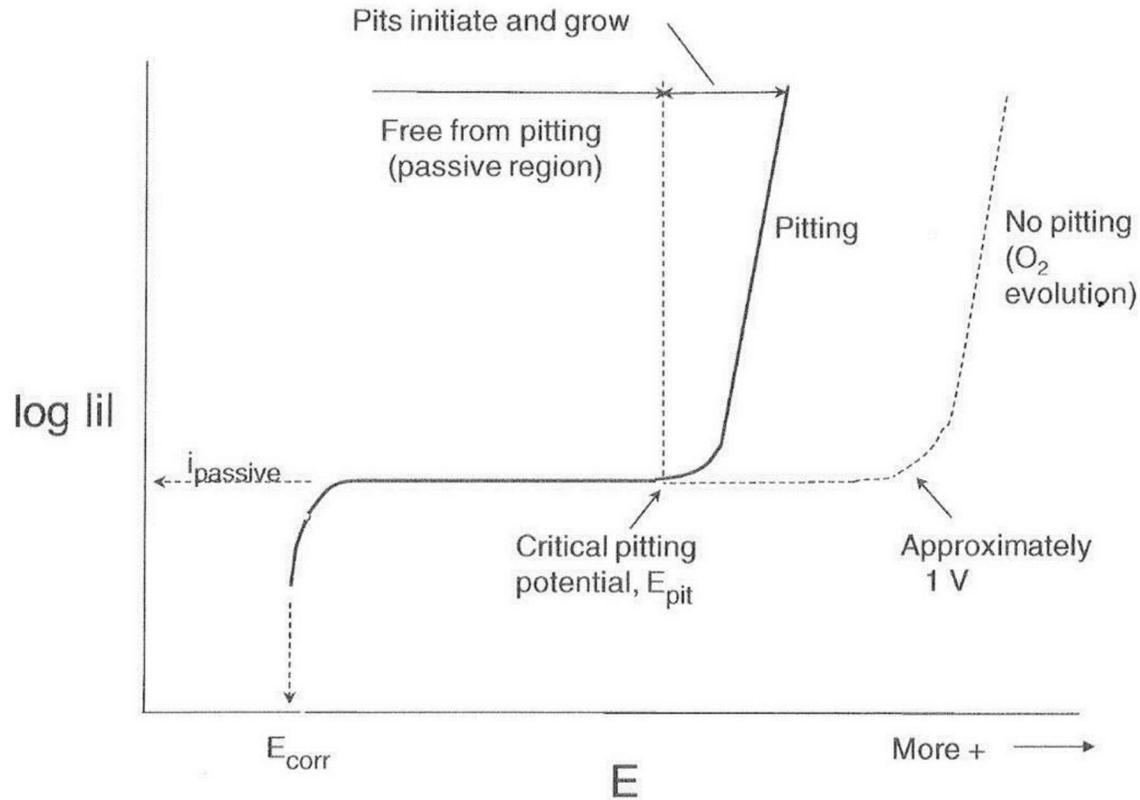
Figure 4-1. Schematic Illustration of Anodic Polarization Curve Showing Critical Pitting Potential (McCafferty 2010)

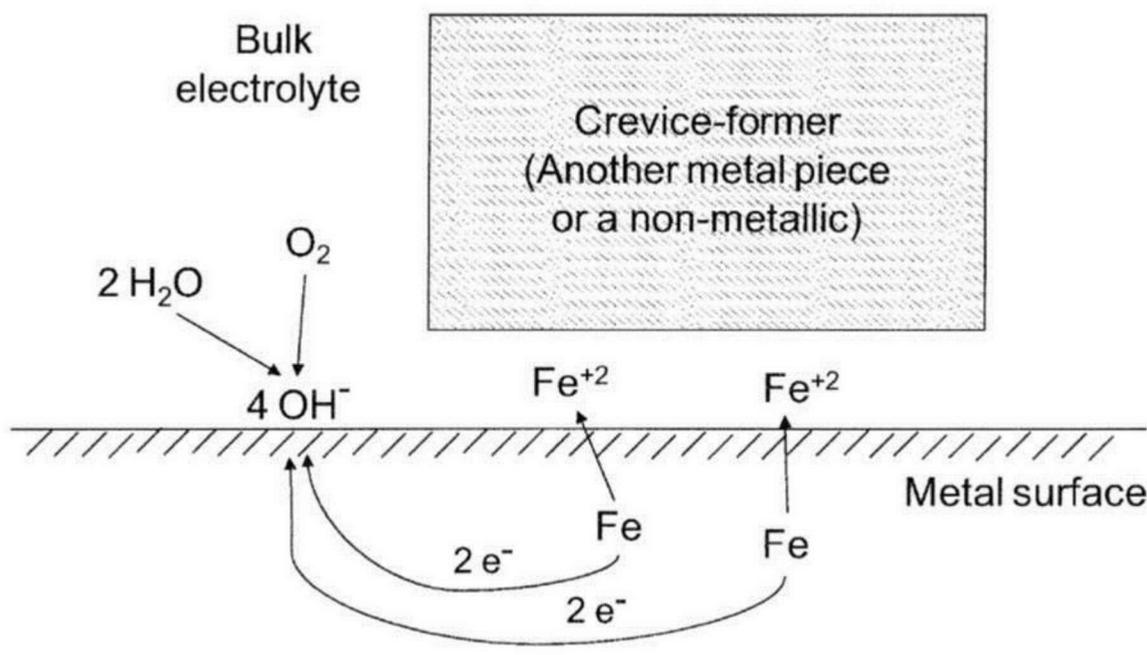
Crevice corrosion often starts as a differential oxygen cell, where corrosion processes consume the dissolved oxygen in the solution within the crevice and the potential of the metal in that region becomes more active than the surfaces outside the crevice. Oxygen reduction occurs both on the metal surface which is exposed to the bulk electrolyte and also on the portion of the metal surface which is contained within the crevice. However, when oxygen is consumed within the narrow clearance of the crevice, it is not easily replaced due to the narrow diffusion path formed by the crevice. This results in oxygen becoming depleted in the crevice. The metal in the crevice with the lower oxygen concentration has a more negative potential than the bulk metal and the limiting current density for oxygen reduction, which is proportional to oxygen concentration, within the crevice is decreased relative to the bulk solution. Figure 4-2 schematically illustrates the initiation of crevice corrosion. Once initiated, crevice corrosion proceeds by the same mechanism as pitting corrosion (RPP-RPT-33306, *IQRPE Integrity Assessment Report for the 242-A Evaporator Tank System*).

Figure 4-2. Schematic Illustration of Initiation of Crevice Corrosion (McCafferty 2010)

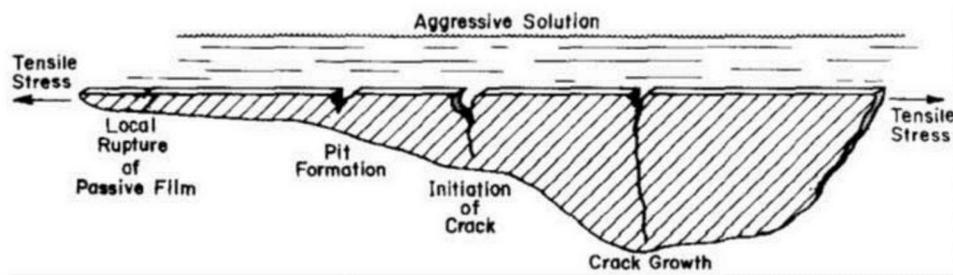
Stress corrosion cracking (SCC) requires a susceptible material with the simultaneous presence of a sustained tensile stress and an aggressive environment (BNL-52527). Figure 4-3 portrays the process involved in SCC.

Figure 4-3. Progression of Process that Causes Stress Corrosion Cracking (Reference DP-1476)

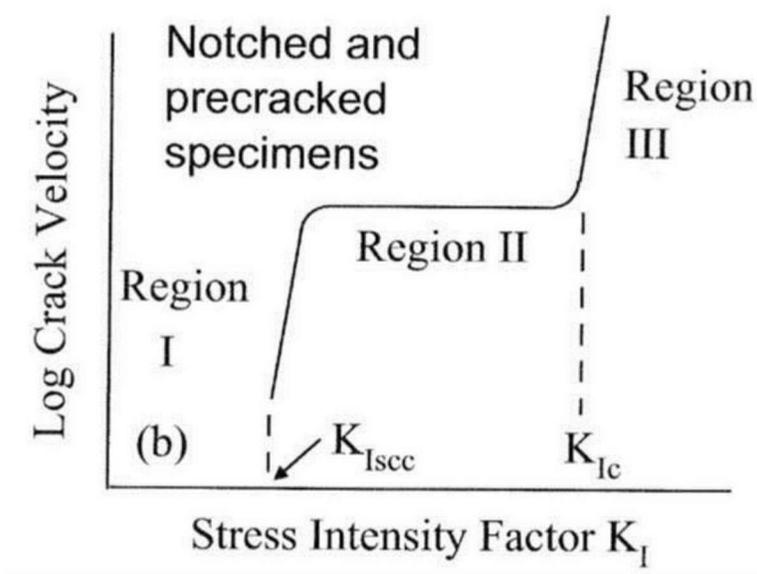
Figure 4-4. Stress Corrosion Cracking as a Function of Stress Intensity Factor (McCafferty 2010)

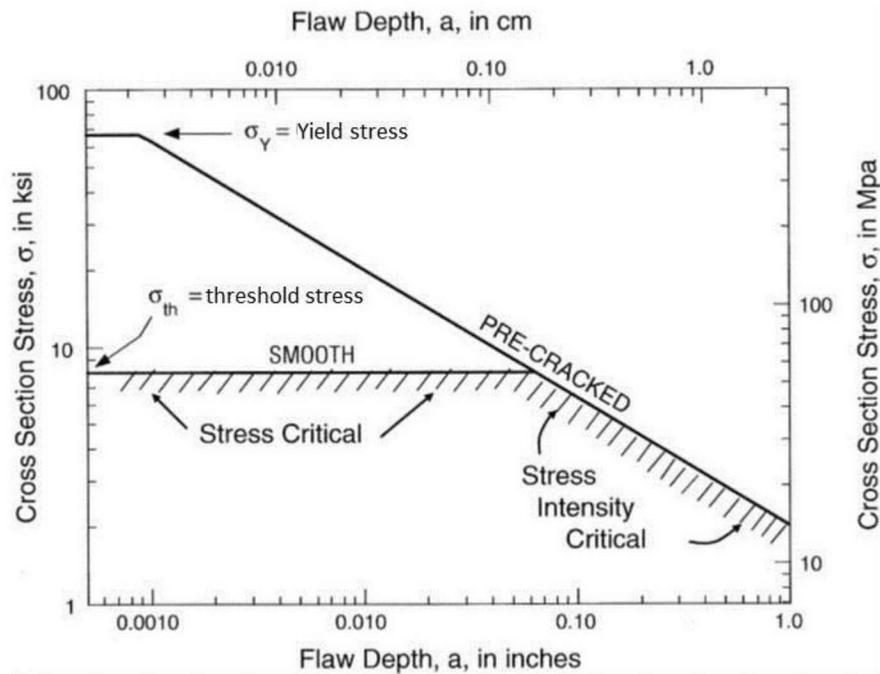
Figure 4-5. Stress Corrosion Cracking Zone for Smooth and Pre-Cracked Material (Adapted from McCafferty 2010)

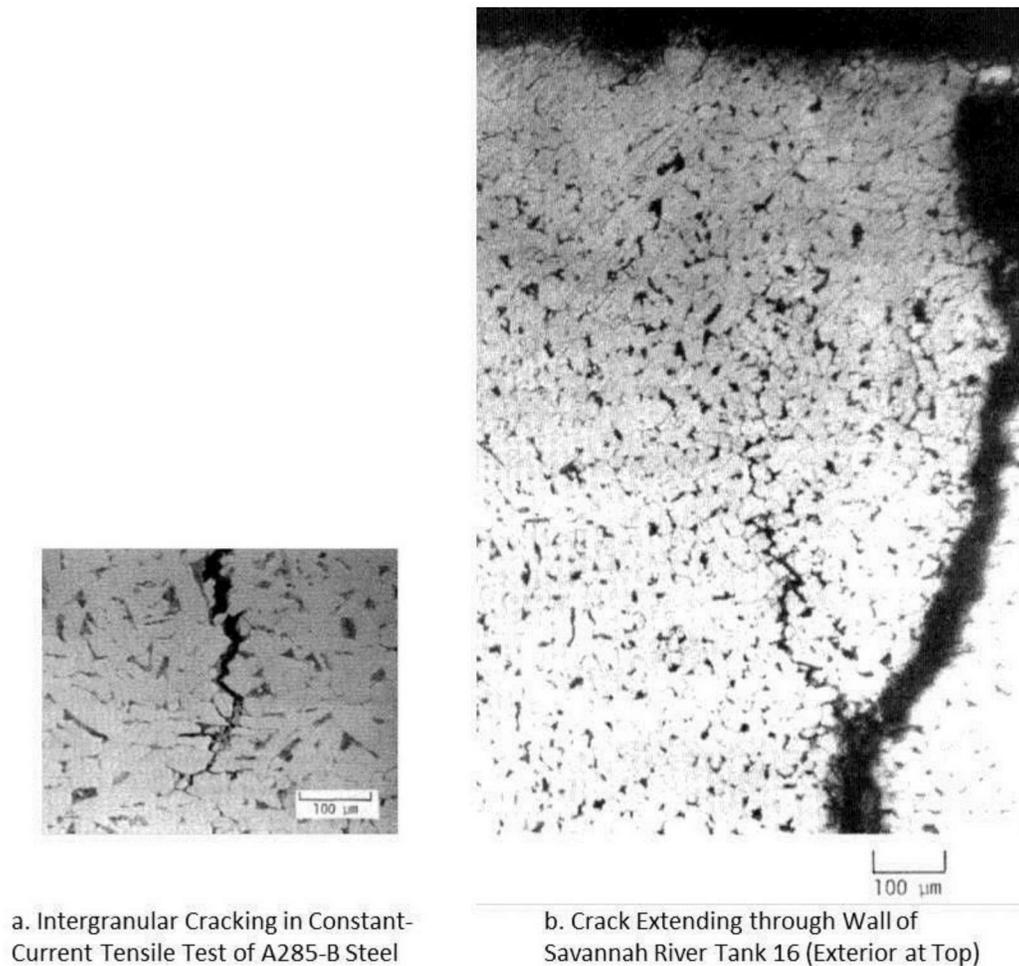
Based on these experiences nitrate-induced SCC of the steel liner plate during operational service life is considered a viable failure mechanism for SSTs.

**Figure 4-6. Nitrate-Induced Intergranular Stress Corrosion Cracking
(Reference from DP-1476)**

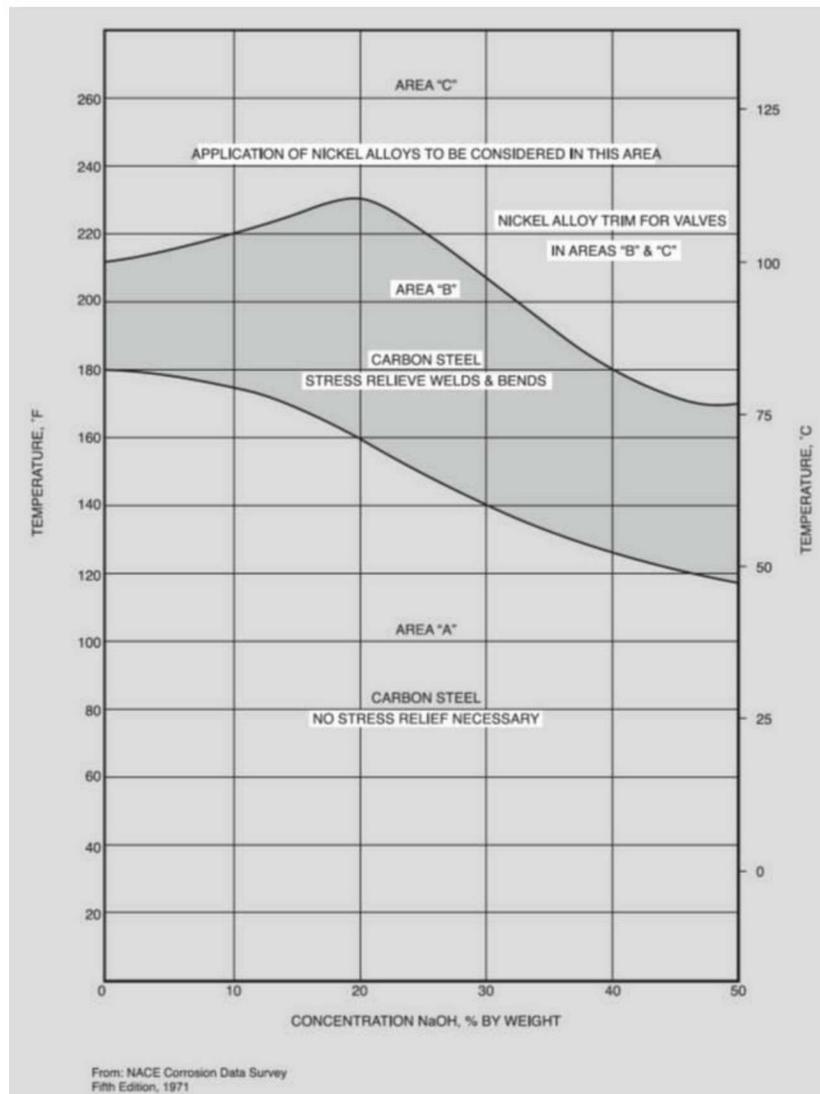
Figure 4-7. Caustic Soda Service Chart of Metallurgical Requirements

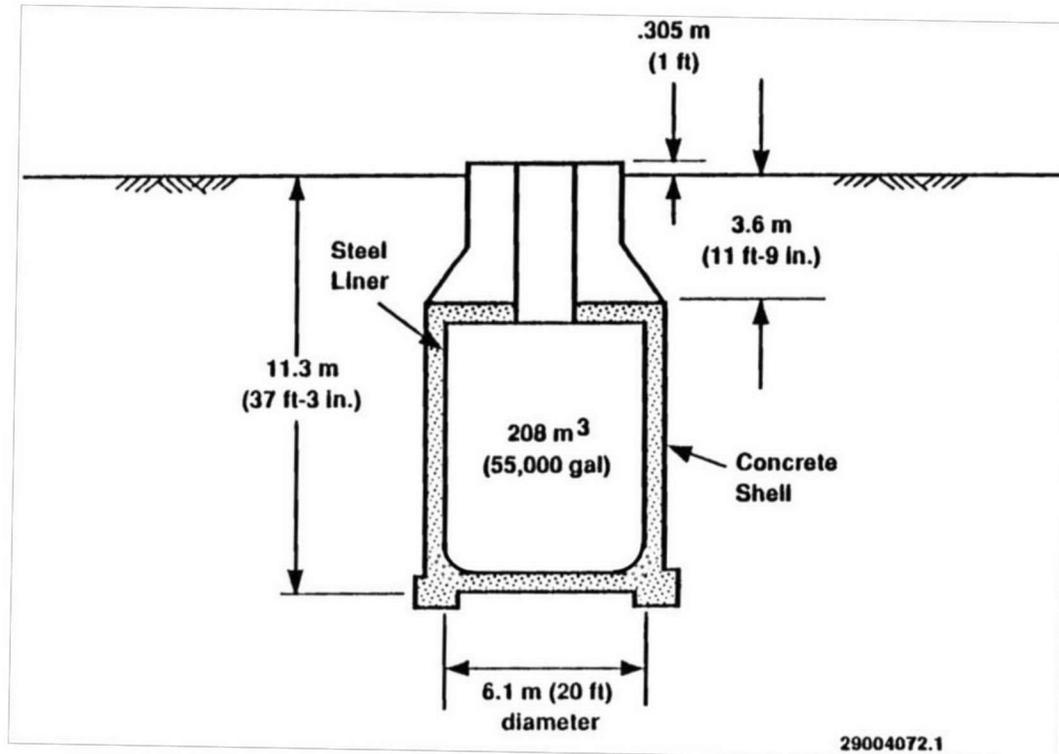
Figure 5-1. 200-Series, Type I, Twenty Feet Diameter, Single-Shell Tank

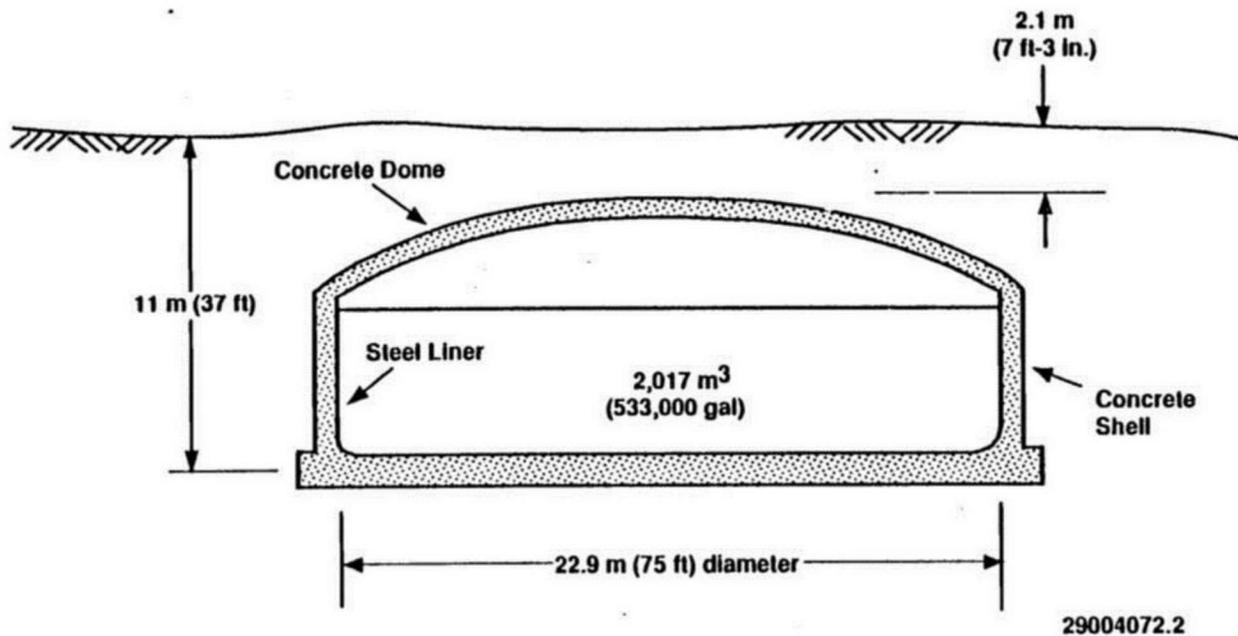
Figure 5-2. 100-Series, Type II, Seventy-Five Feet Diameter, Single-Shell Tank

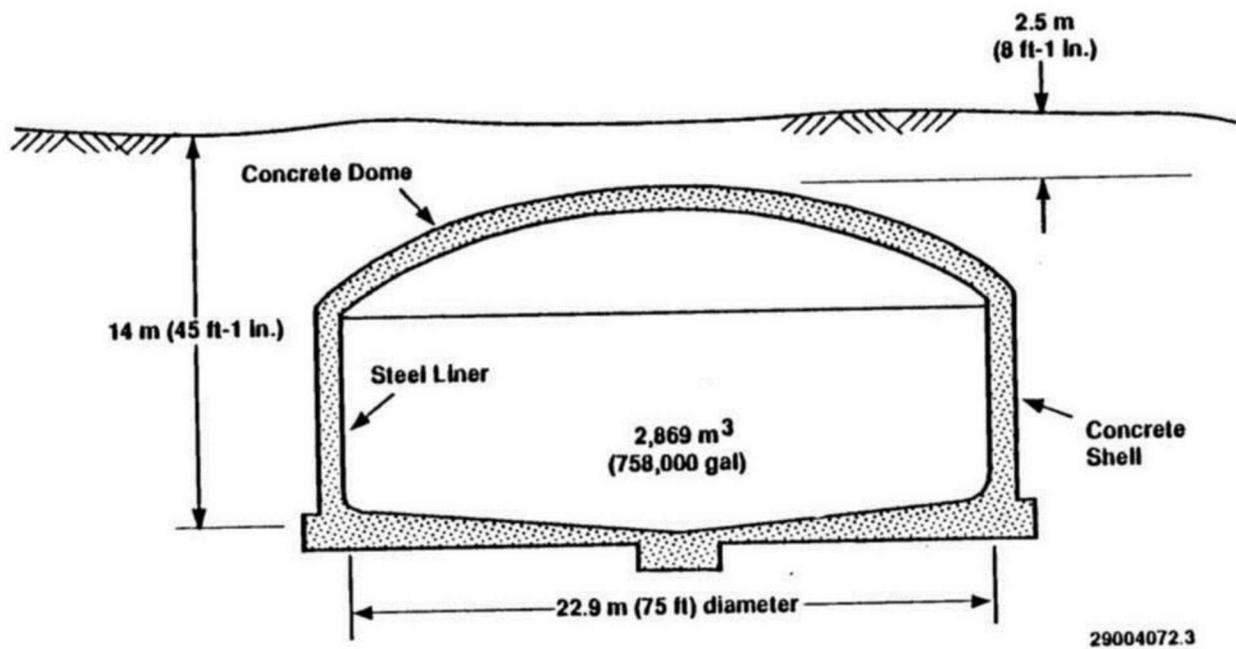
Figure 5-3. 100-Series, Type III, Seventy-Five Foot Diameter, Single-Shell Tank

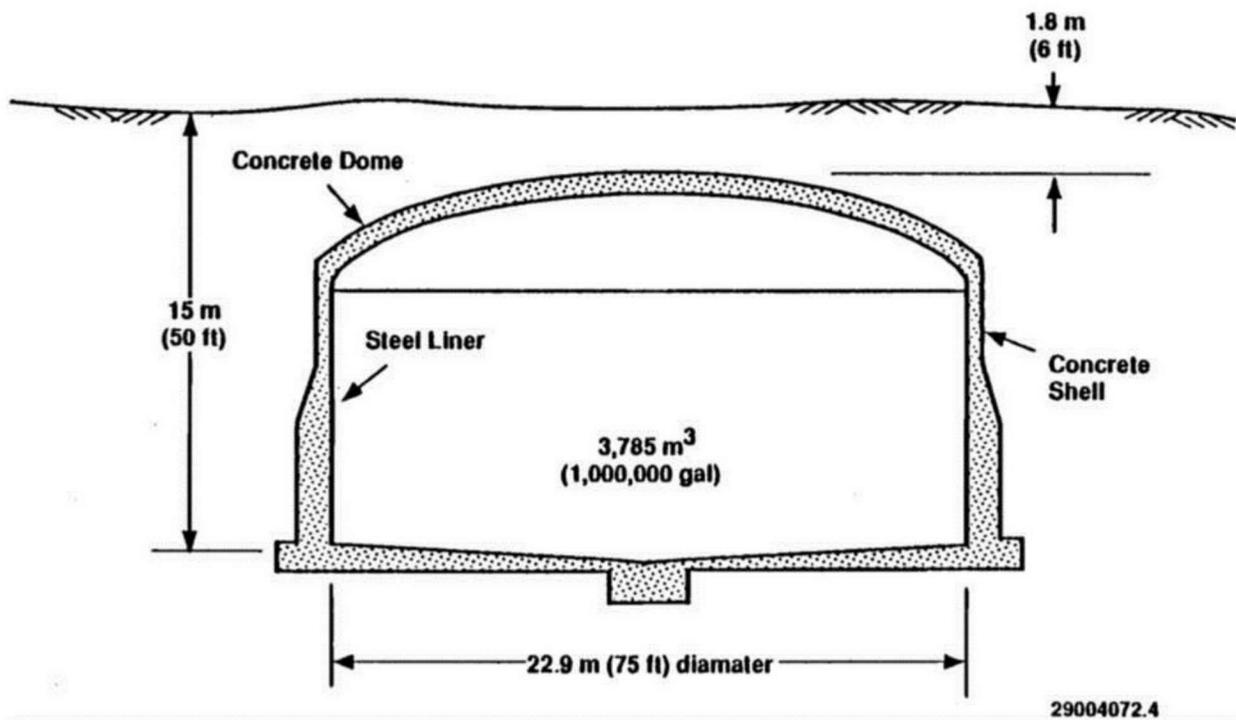
Figure 5-4. 100-Series, Type IV, Seventy-Five Foot Diameter, Single-Shell Tank

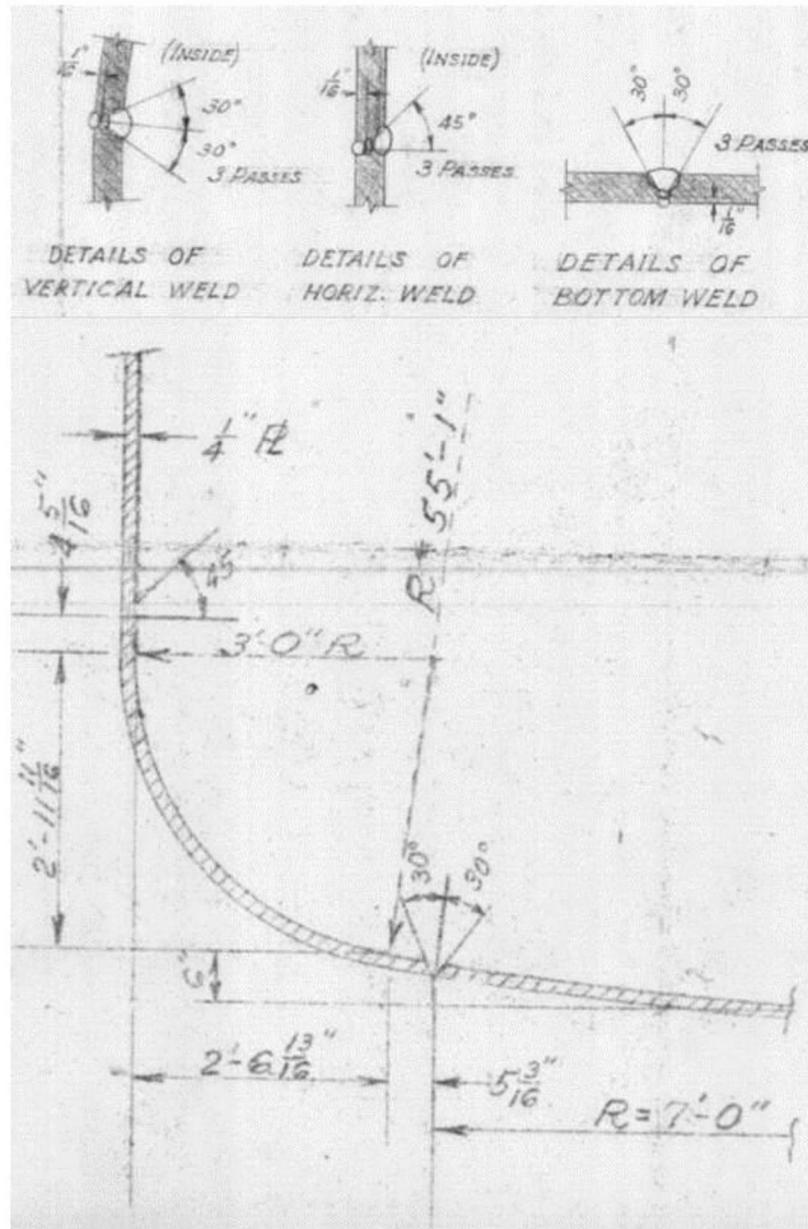
of the 3-pass, beveled, double welded, butt joint weld for the bottom and horizontal welds for the knuckle as well as the vertical wall weld.

Figure 5-5. Construction Drawing for 241-B, -C, -T, and -U Farm, 200-Series Tanks Bottom Knuckle Weld (Drawing D-23)

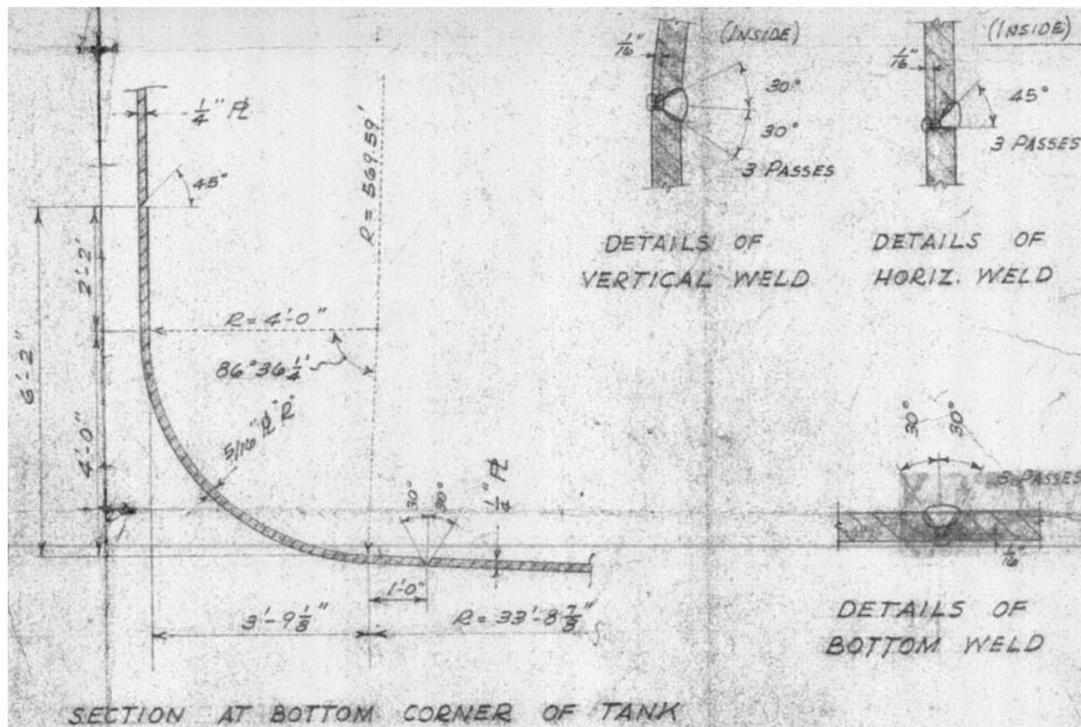
knuckle as well as the vertical wall weld. The 100-Series, Type II tanks are similar to the 200-Series, Type I tanks with the exception of the knuckle radius and material thickness.

Figure 5-6. Construction Drawing for 241-B,-C,-T,-U, and -BX Farm, 100-Series, Type II Tanks Bottom Knuckle Weld (Drawing D-3)

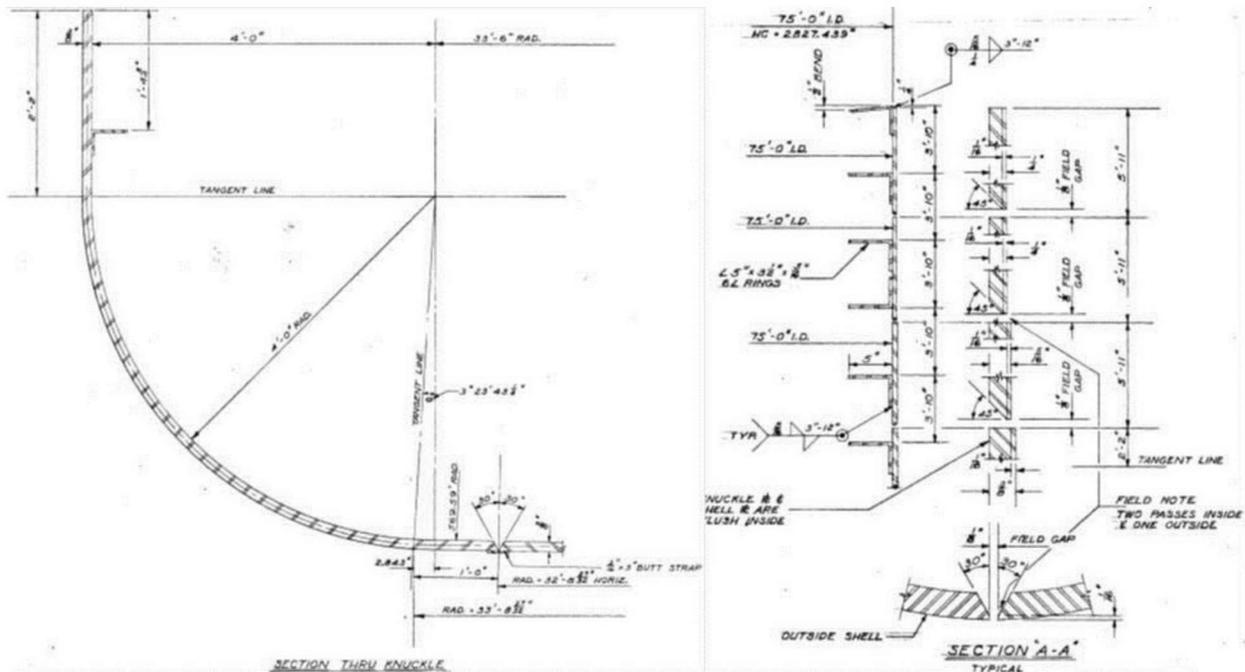
Figure 5-7. Construction Drawing for 241-TX Farm, 100-Series, Type III Tanks Bottom Knuckle Weld
(Drawing H-2-809, 75 Foot Tank Steel Plate Details, 241-TX)

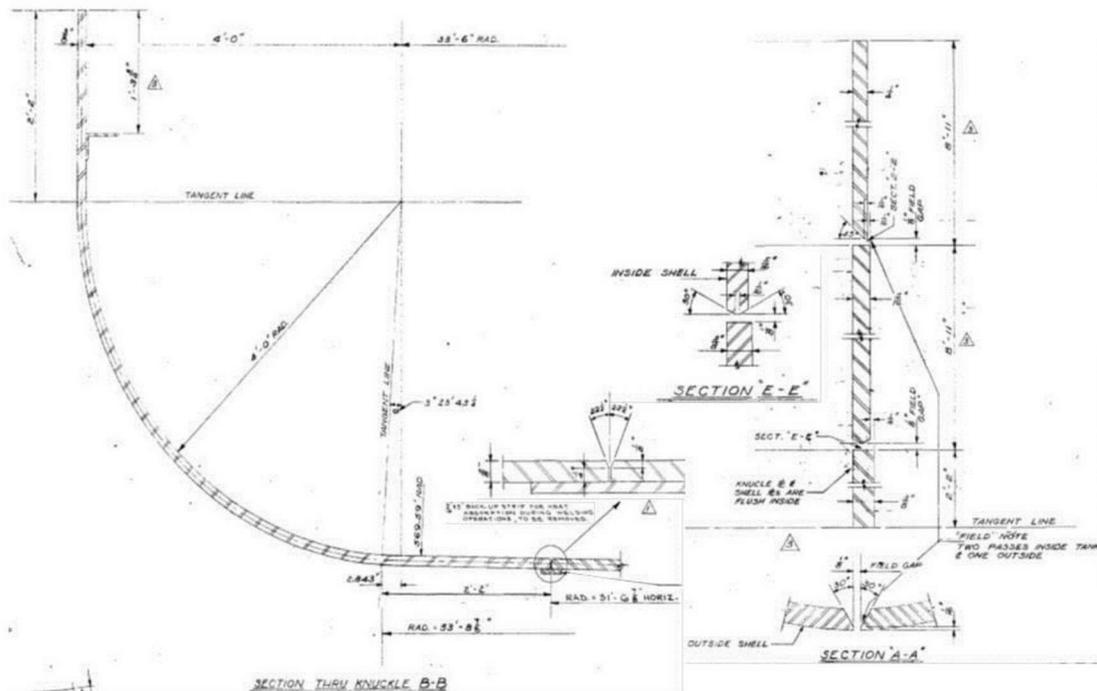
Figure 5-8. Construction Drawing for 241-BY Farm, 100-Series, Type III Tanks Bottom Knuckle Weld
(Drawing H-2-1313, 75 Foot Tank Steel Plate Details)

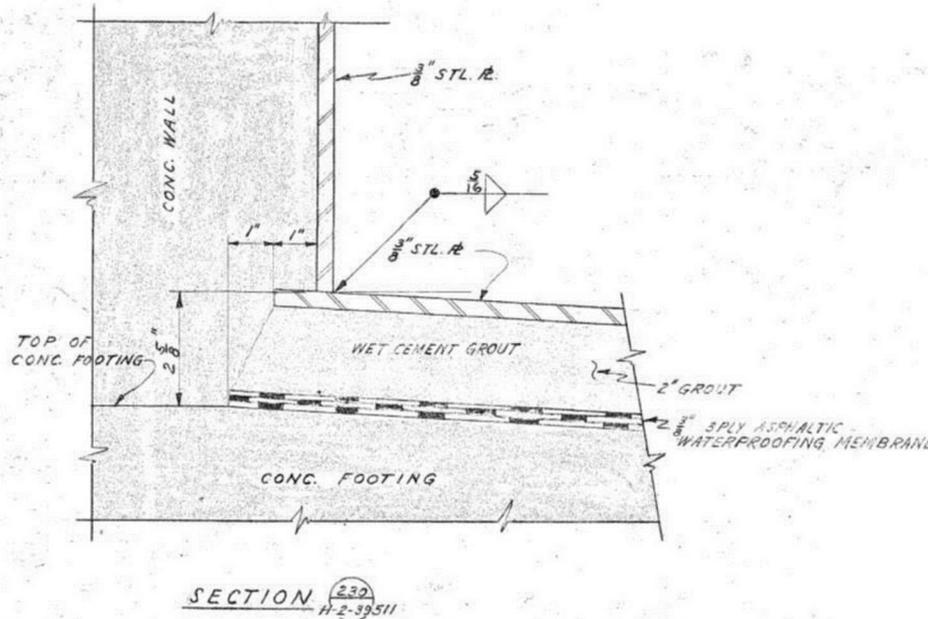
Figure 5-9. Construction Drawing for 241-SX Farm, 100-Series, Type IV Tanks Bottom to Wall Transition Weld
(H-2-39511, 75 Foot Storage Tanks Composite Section Waste Disposal Facility 241-SX)

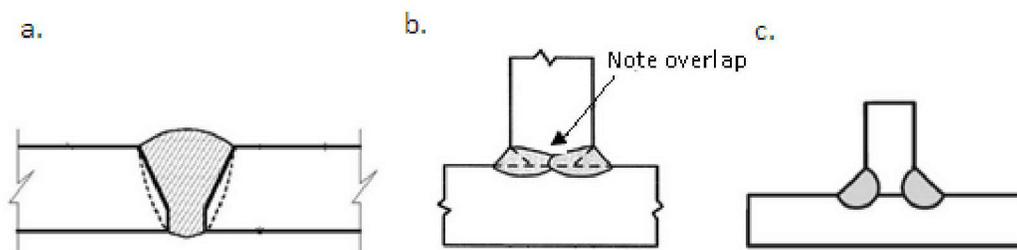
Figure 5-12. Weld Types used in Tank Liners (a) 3-pass full penetration square butt weld, (b) double bevel fillet weld, (c) double fillet weld (AWS B1. 10M)

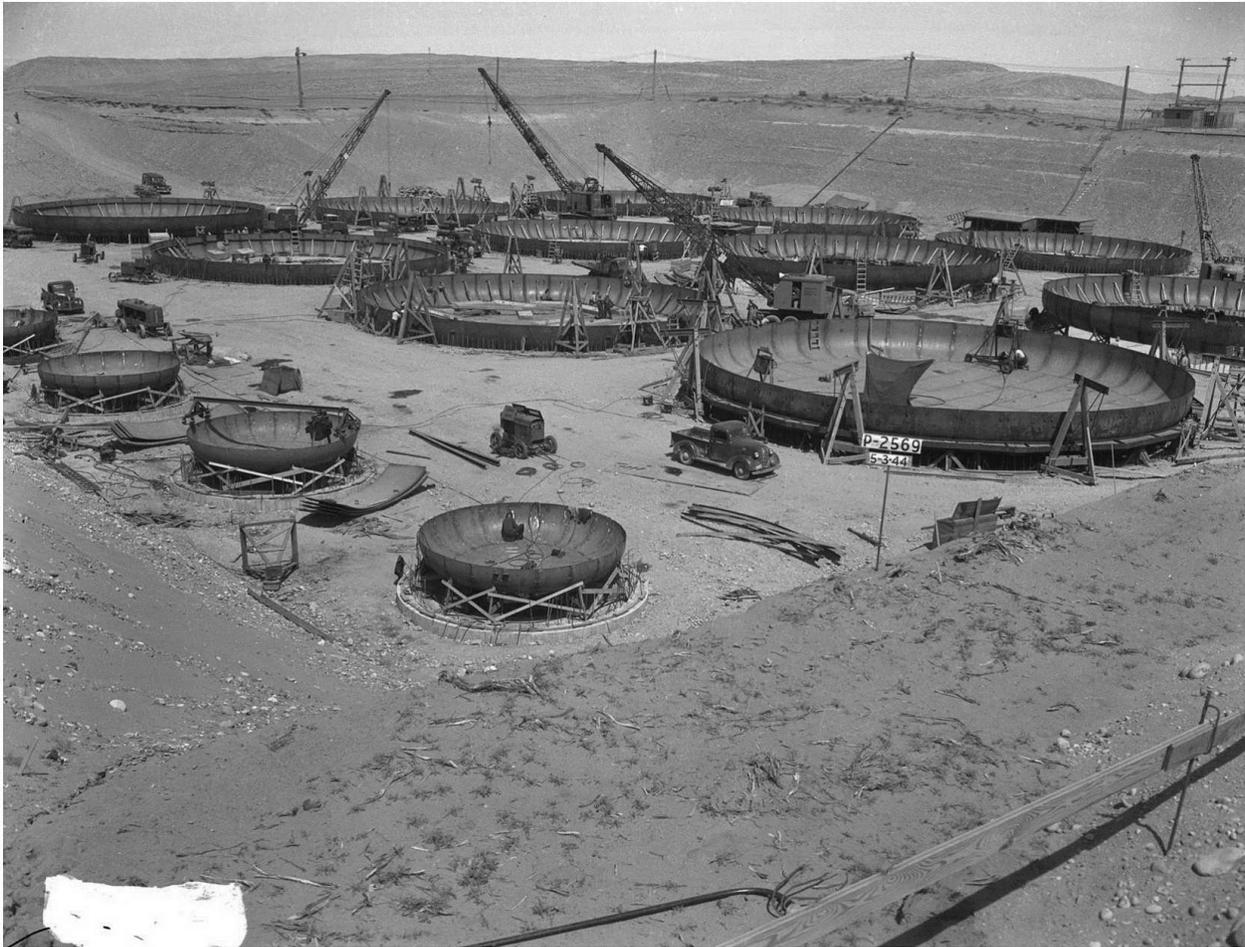
Figure 5-13. 241-T Farm Construction Showing the Bottom Knuckle Transition in 200-Series (Front) and 100-Series (Back), Photo P2569, May 3, 1944

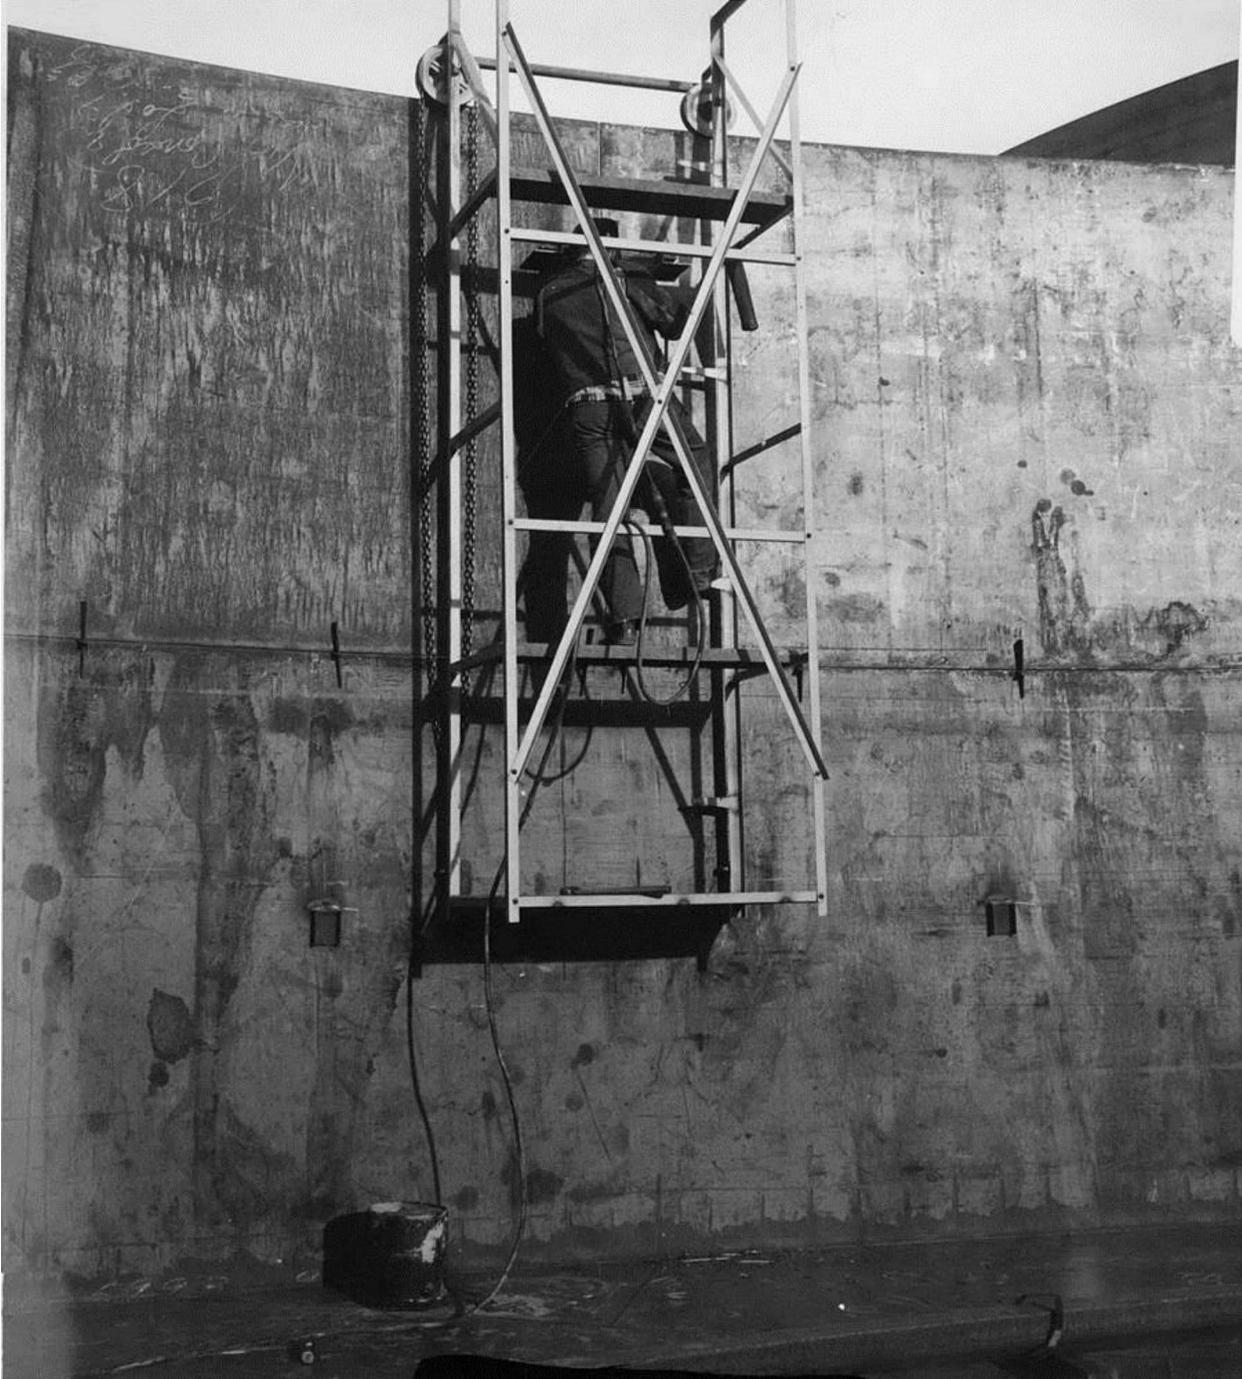
Figure 5-14. 241-SX Farm Construction Showing Welding of Vertical Wall and the Bottom to Wall Transition, Photo 2367, November 9, 1953

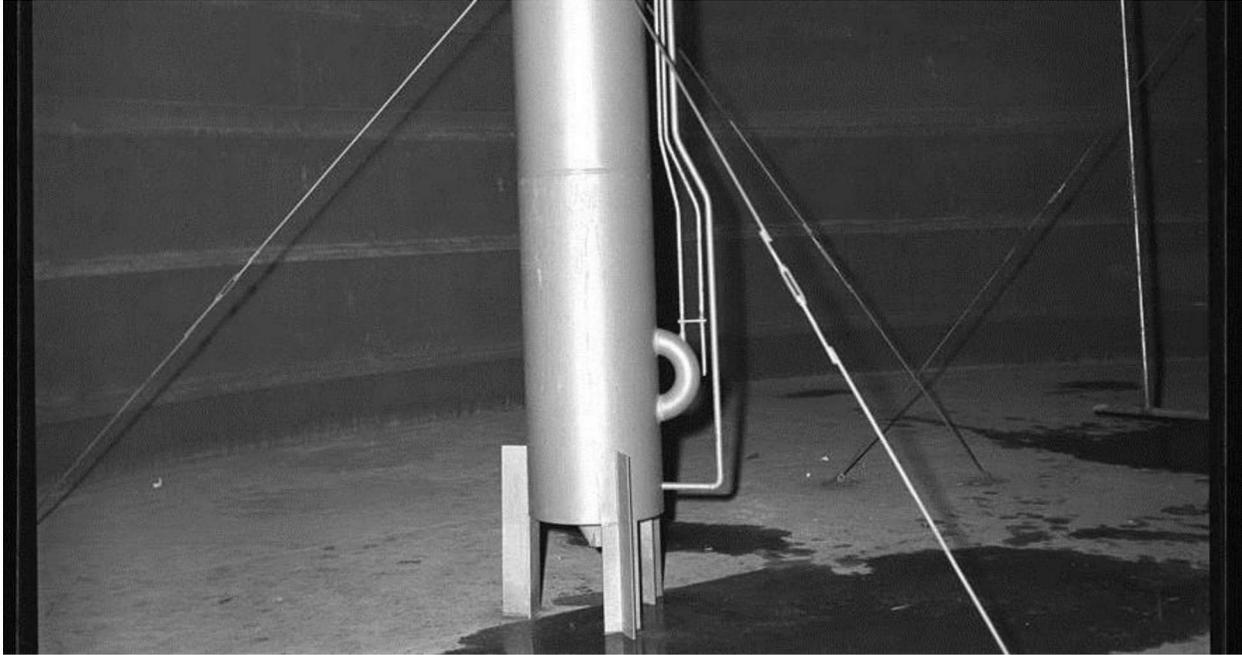
Figure 5-15. 241-A Farm Internal Tank Bottom, Wall and Air-Lift Circulator Showing the Corner Joint between the Sidewall and Bottom Liner

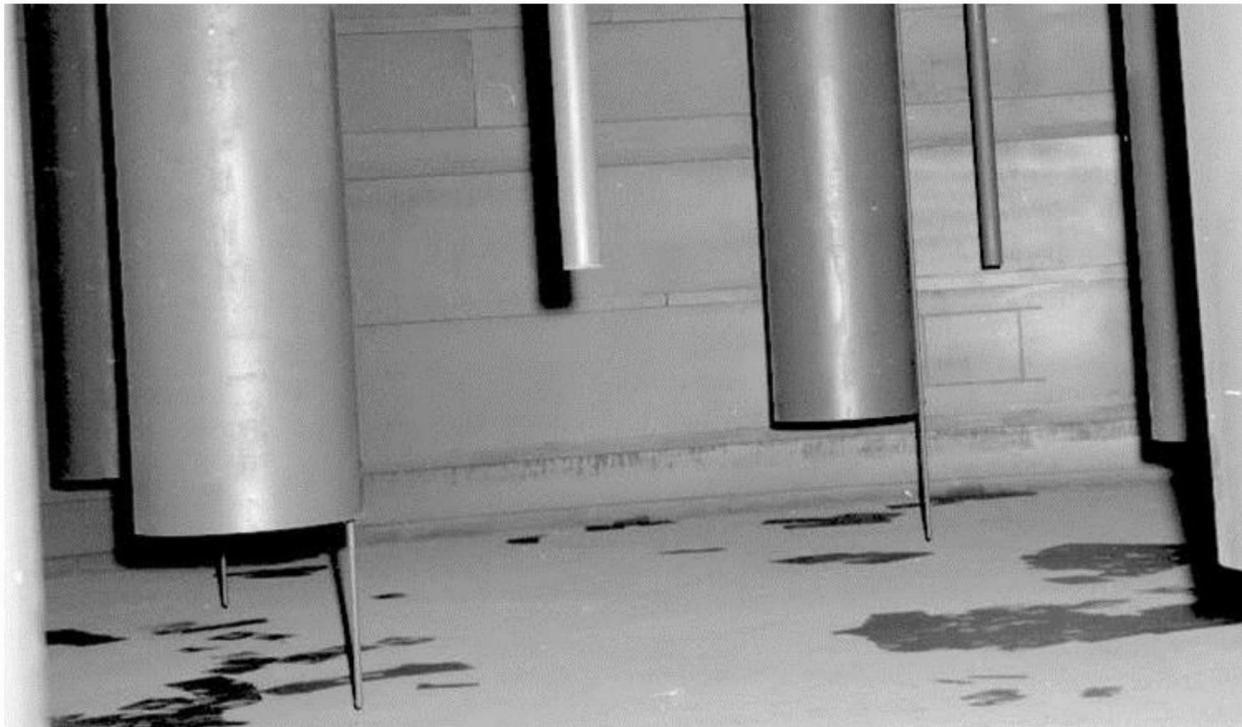
Figure 5-16. 241-AX Farm Internal Tank Bottom, Wall and Air-Lift Circulators Showing the Bottom to Wall Transition, Photo 37937-2, October 26, 1964

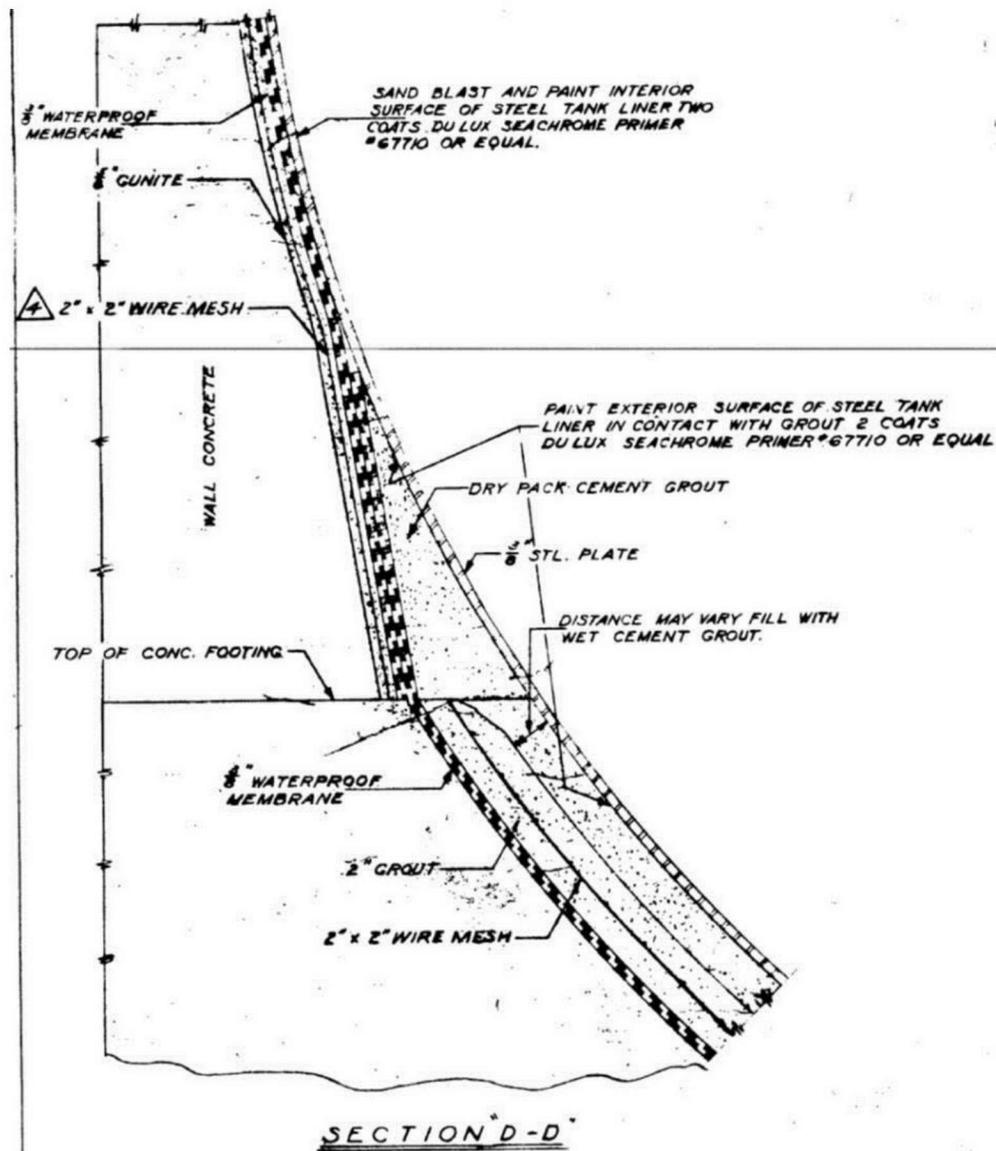
Figure 5-17. 241-TX Farm Asphalt Membrane, Typical of External Tank Liner for 100-Series Tanks Constructed Prior to 241-SX Tank Farm

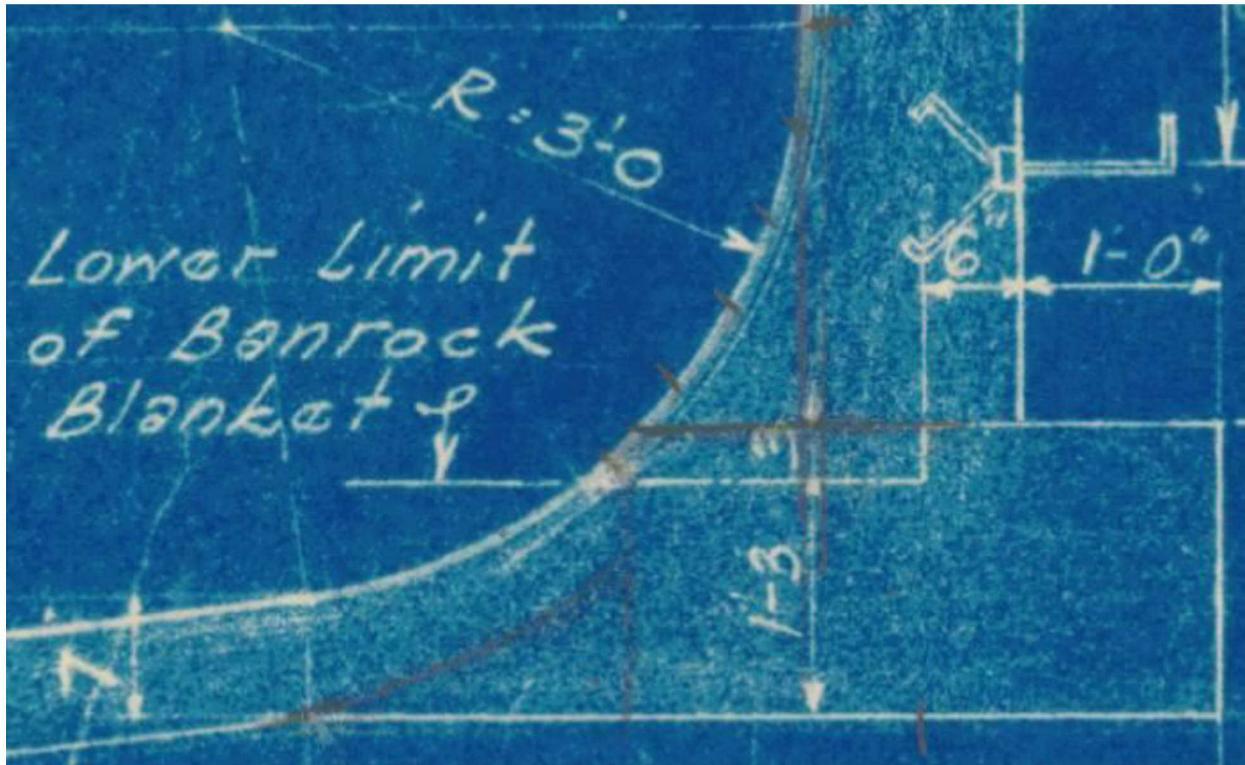
gunite prior to placement of the concrete wall. There is no indication from the available information whether the blanket material is yielding or rigid. The extent of the wire mesh blanket material is shown in Figure 5-18.

Figure 5-18. 200-Series Tank Wire Mesh Blanket Lining Material on the External Tank Liner for 200-Series Tanks
