2. Document Title			
Common Factors Relating to Liner Failures in Single-Shell Tanks			
3. Design Verification Required			
<input type="checkbox"/> Yes <input type="checkbox"/> No

Common Factors Relating to Liner Failures in Single-Shell Tanks

Abstract: This report fulfills the requirement for target T04 for Hanford Federal Facility Agreement and Consent Order milestone M-045-91F. The goal of this report is to identify the common factors that may have contributed to liner failures in single-shell tanks. The tanks with probable liner failures are identified through the process identified in RPP-32681, Rev. 0, "Process to Assess Tank Farm Leaks in Support of Retrieval and Closure Planning."

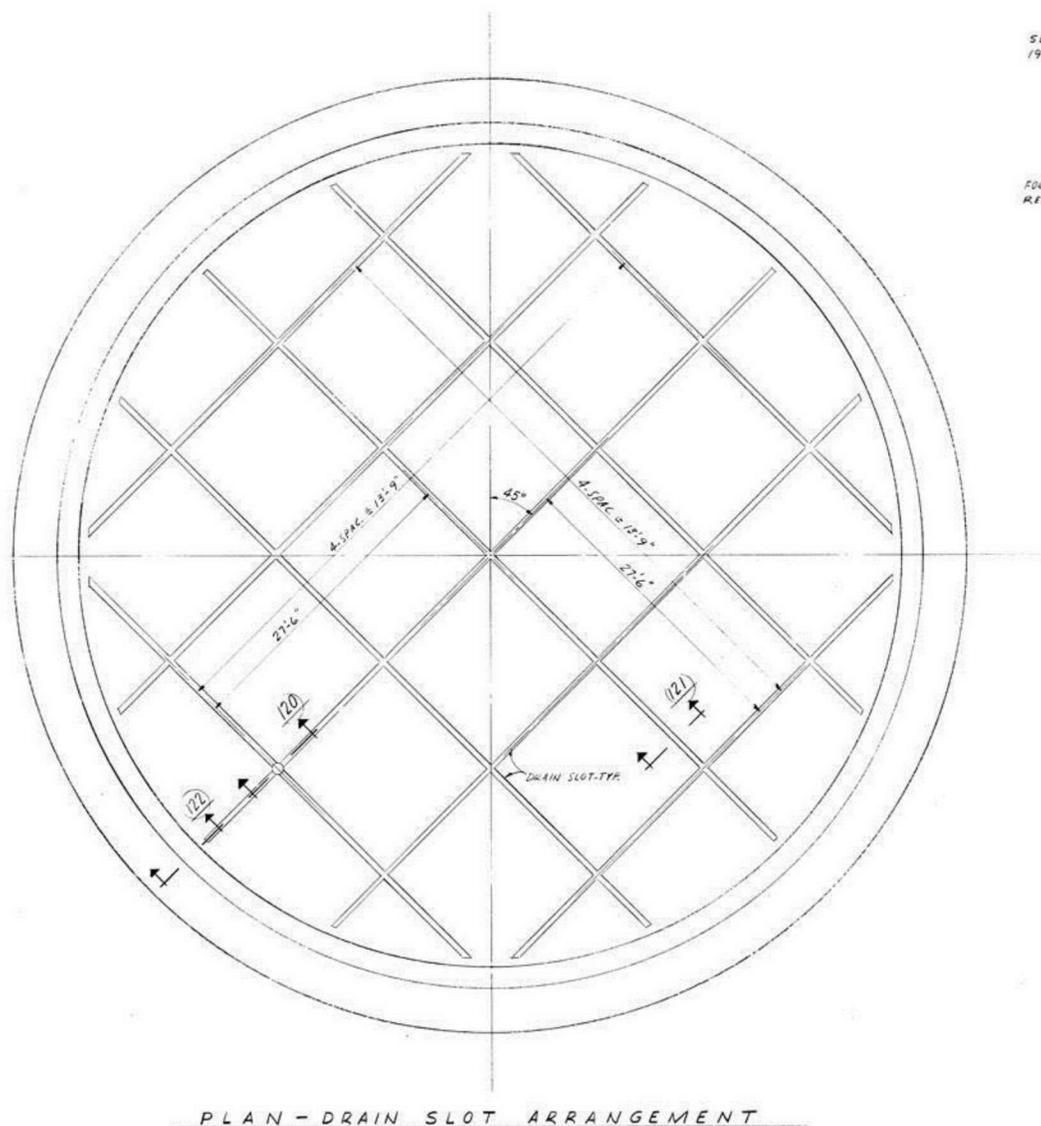
One design aspect that differentiates AX Farm from the other SST farms is the presence of drain slots underneath the tank bottom liner. These drain slots are 5 in. wide, 2 ½ in. wide, and spaced 13-ft 9 in. apart (square array). Although the intention of the drain slots was to direct and collect any liquid that may be present underneath the tank to a detection sump, the drain slots also provide an engineered vent path for any gases that may be present or form underneath the tank bottom liner. Figure 5-19 shows a plan view of the base mat with the drain slot arrangement (H-2-44563, *Structural Waste Storage Tanks Drain Arrangement and Details 241-AX*). These slots connect, via a 12-in. pipe that travels under the foundation, to a 24-in. diameter leak detection well. This well extends up to grade where it is enclosed within a leak detection pit. Vapor or gas formed under the bottom liner could eventually make its way through the drain collection pipe and to the leak detection well.

Figure 5-19. 241-AX Farm Tank Basemat Drain Slot Arrangement

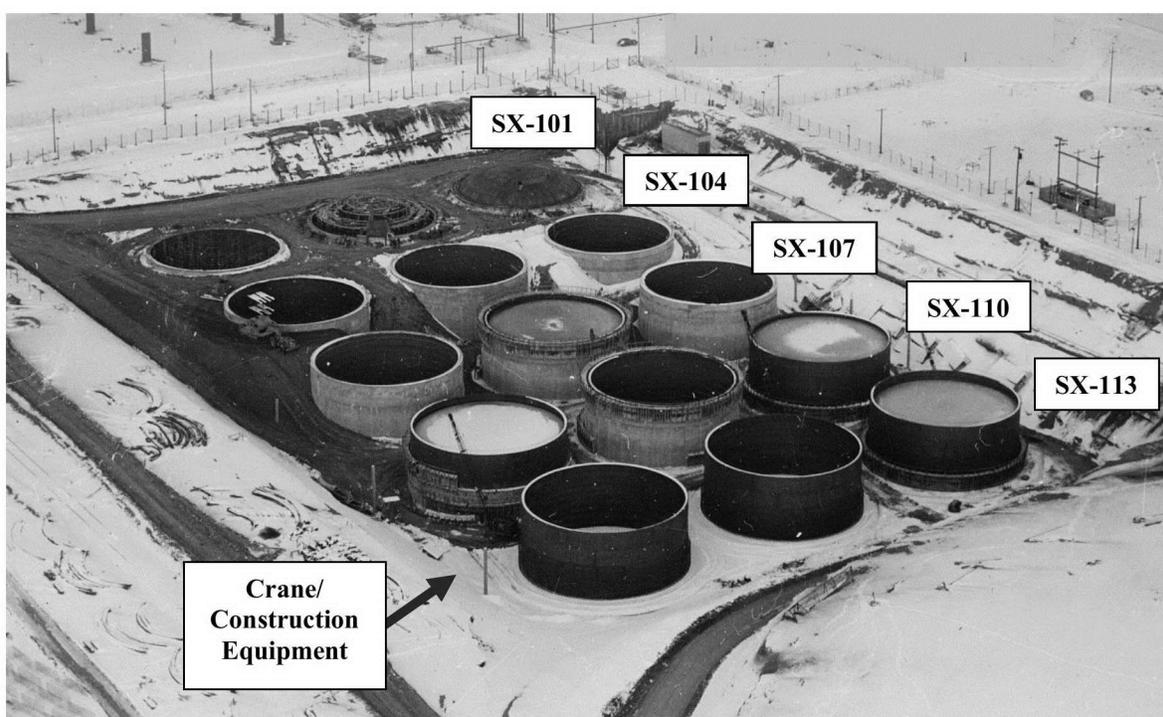
One of the most severe examples of the potential risk from brittle fracture was found in SX Farm. Figure 5-20 below is a picture taken of SX Farm during construction (IDMS Photograph 2471-PHOTO). The photograph was taken on January 20, 1954 on a day when the high temperature was 11°F and the low was -6°F. The winter of 1953-1954, during which this picture was taken, was one of the coldest and harshest recorded at the Hanford Site. Specifically, during the two week period surrounding this photograph (1/16/1954 to 1/29/1954) the temperature rarely reached above freezing with an average daily high temperature of 24°F and dipped into single digits throughout the period with an average daily low temperature of 9°F.

Figure 5-20. 241-SX Tank Farm Construction Photograph Taken January 20, 1954

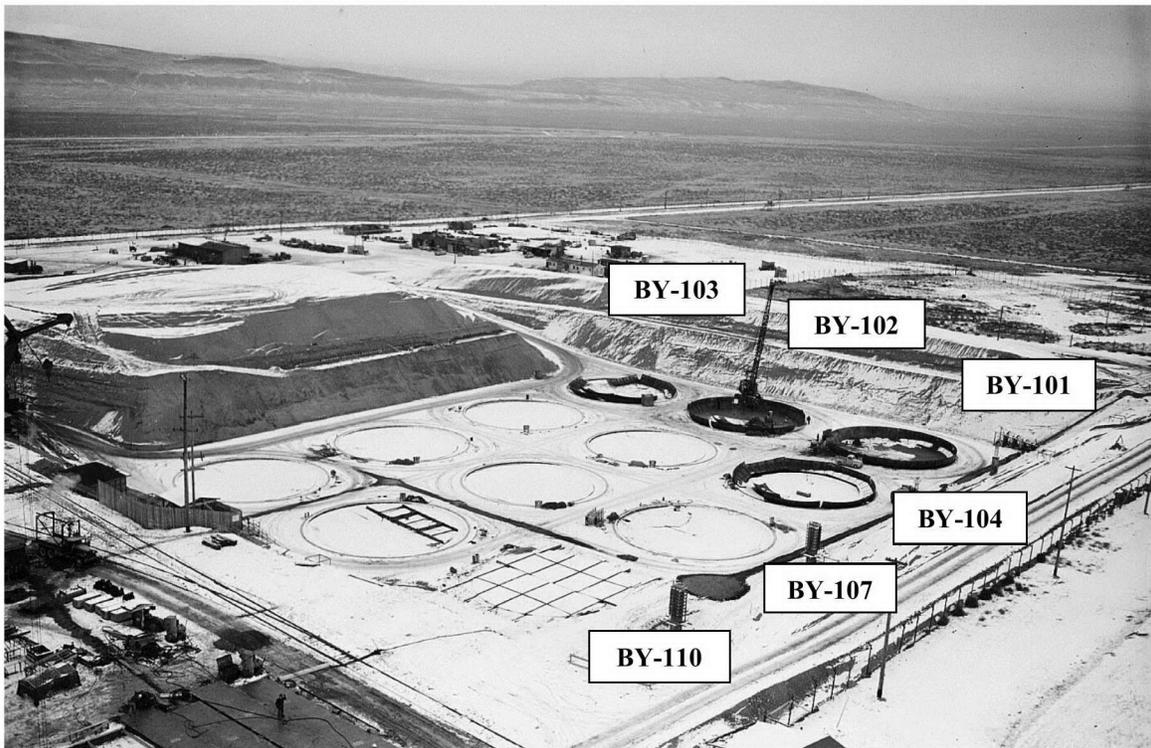
Another extreme example of cold weather construction was found in BY Farm. Whereas the extreme cold weather hit SX Farm during the concrete wall pouring portion of the construction, the cold weather hit BY Farm construction through ongoing liner fabrication. Figure 5-21 and Figure 5-22 show that significant construction activities, including welding of the steel plates, were taking place through January and February 1949. Similar to the conditions found in SX Farm, during the time period between January 19, 1949 and February 9, 1949, the daily high temperature was rarely above freezing with an average of 26°F and the daily average low temperature of 7°F, at one point dropping to -11°F. The extremely cold temperatures coupled with the clear evidence of ongoing construction activities suggest a significant opportunity to develop cracks with impacts to the steel.

Figure 5-21. 241-BY Tank Farm Construction Photograph Taken January 19, 1949

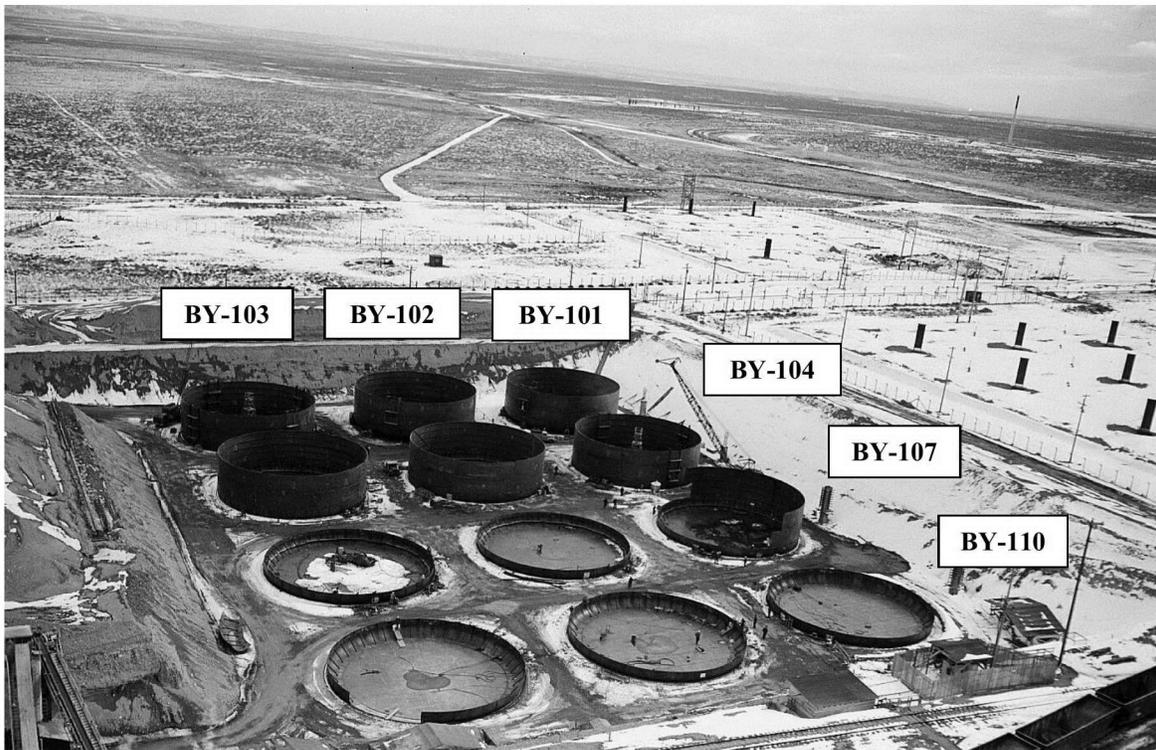
Figure 5-22. 241-BY Tank Farm Construction Photograph Taken February 9, 1949

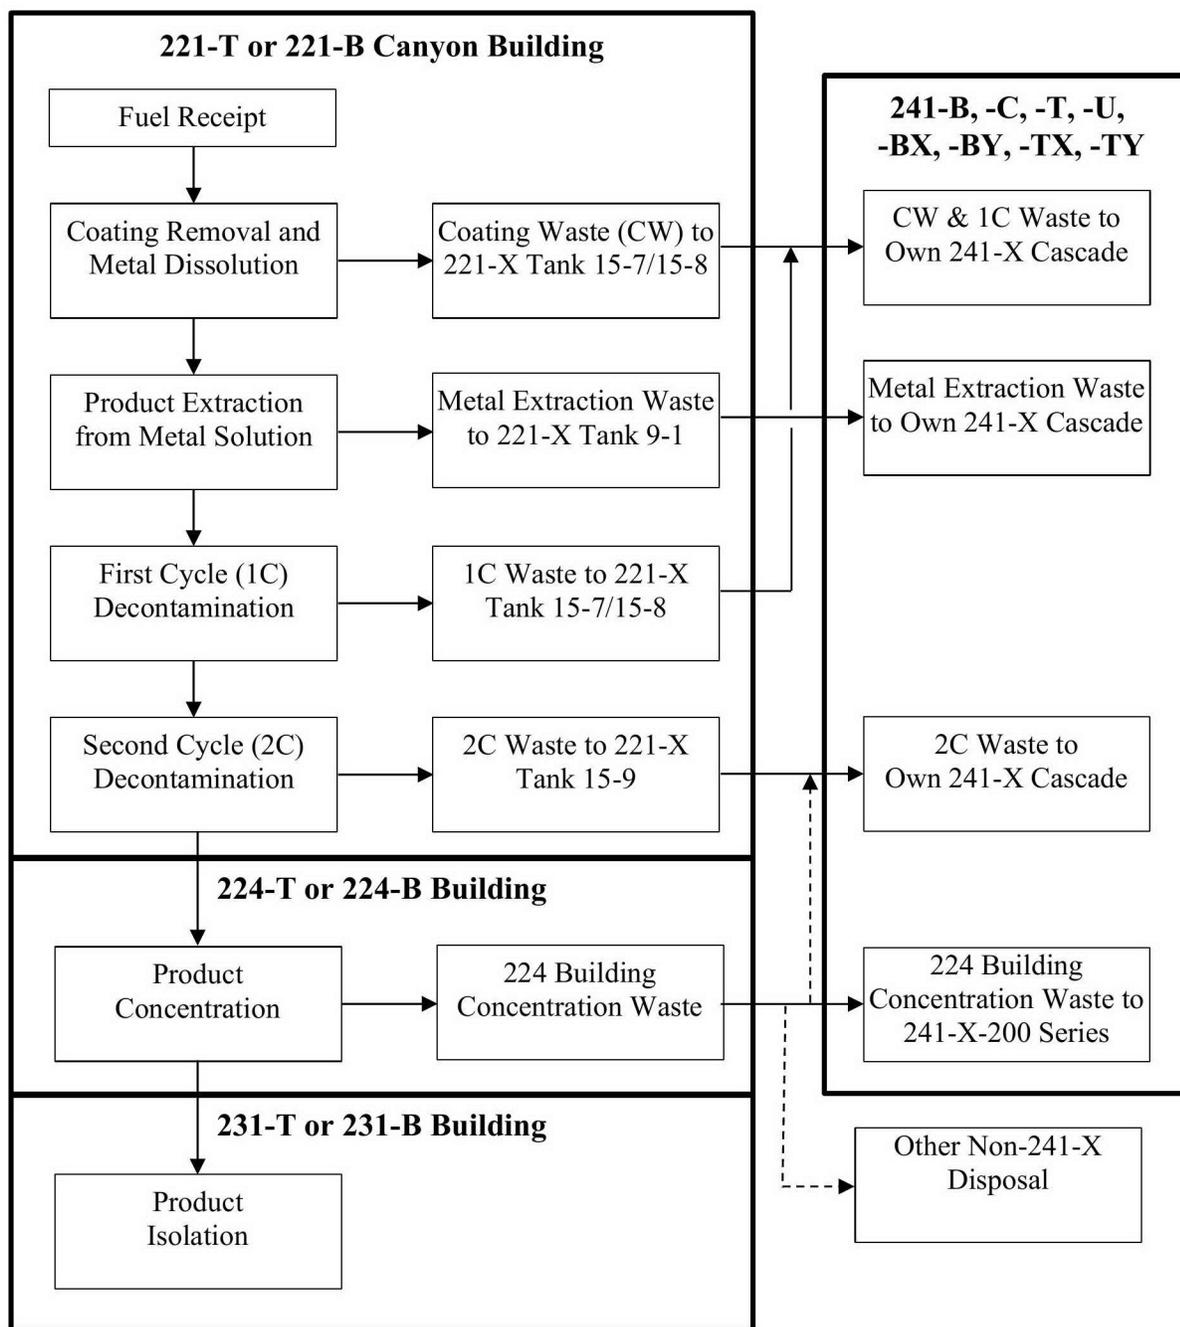
Figure 5-23. Bismuth Phosphate Simplified Schematic Showing Major Waste Streams Sent to Single-Shell Tanks

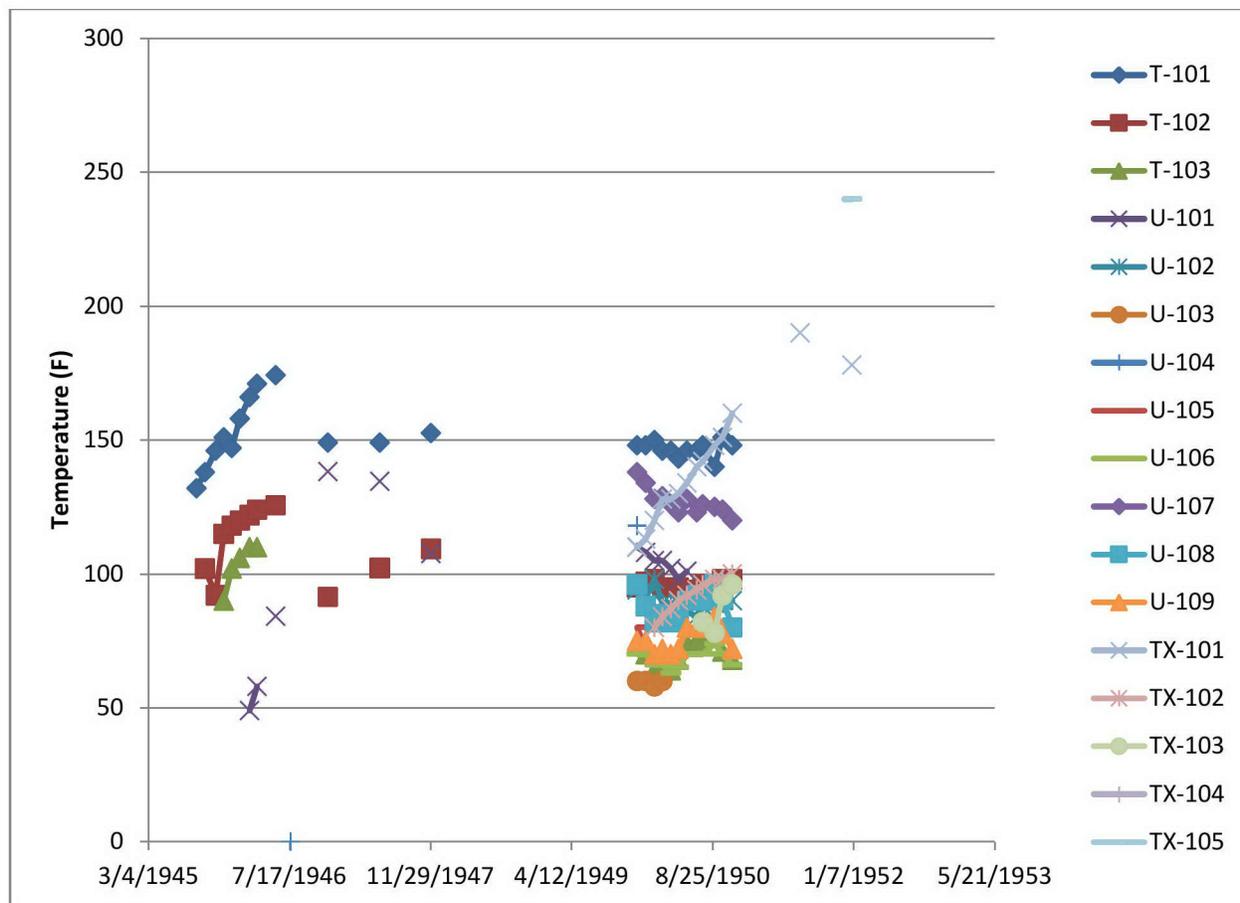
Figure 5-24. 200 West Area Metal Waste Tank Temperatures, 1945-1952

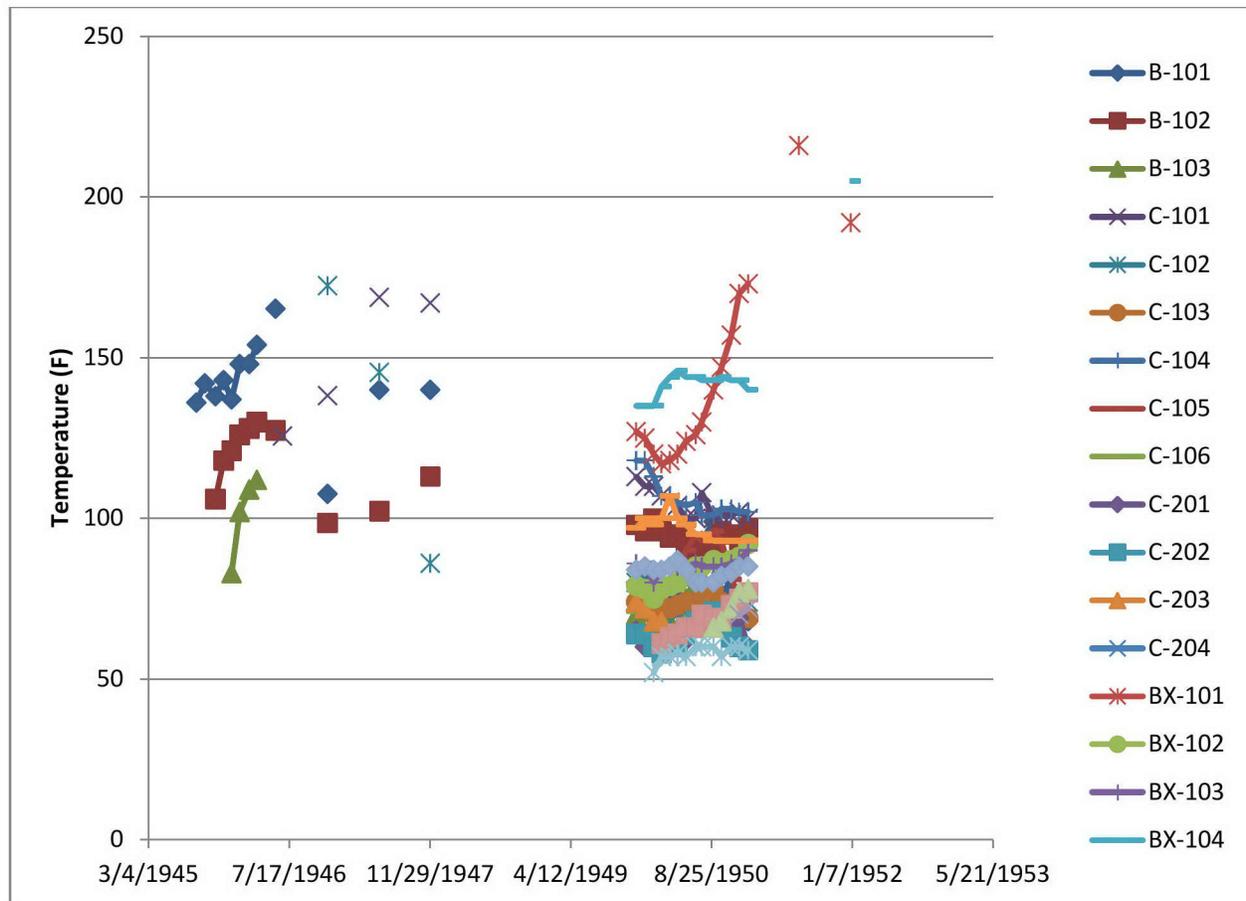
Figure 5-25. 200 East Area Metal Waste Tank Temperatures, 1945-1952

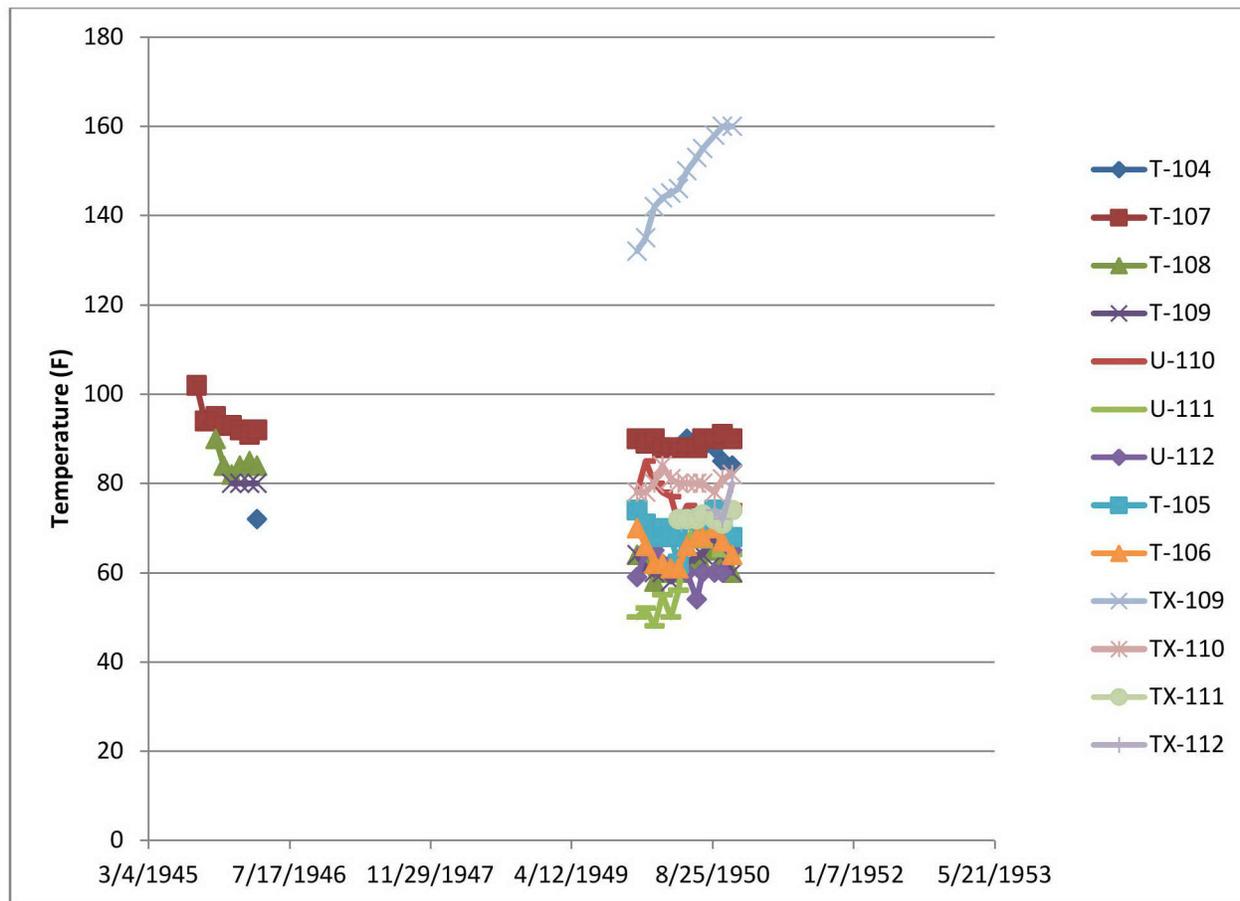
conductive rather than convective and evaporative heat transfer. Available temperature data for the tanks containing CW and 1C waste have been collected in two graphs (HW-3-3369, HW-7-450, HW-8697, HW-17906 DEL, HW-18812 DEL, HW-19432 DEL, and HW-20201 DEL). Records do not indicate the depth in the tank at which the temperature readings were taken. The first graph, Figure 5-26, lists those tanks used for storage of CW and 1C waste in the 200 West Area in support of T Plant operations. The second graph, Figure 5-27, lists those tanks used for storage of CW and 1C waste in the 200 East Area in support of B Plant operations.

Figure 5-26. 200 West Area Coating Removal and First Cycle Decontamination Waste Tank Temperatures, 1945-1952

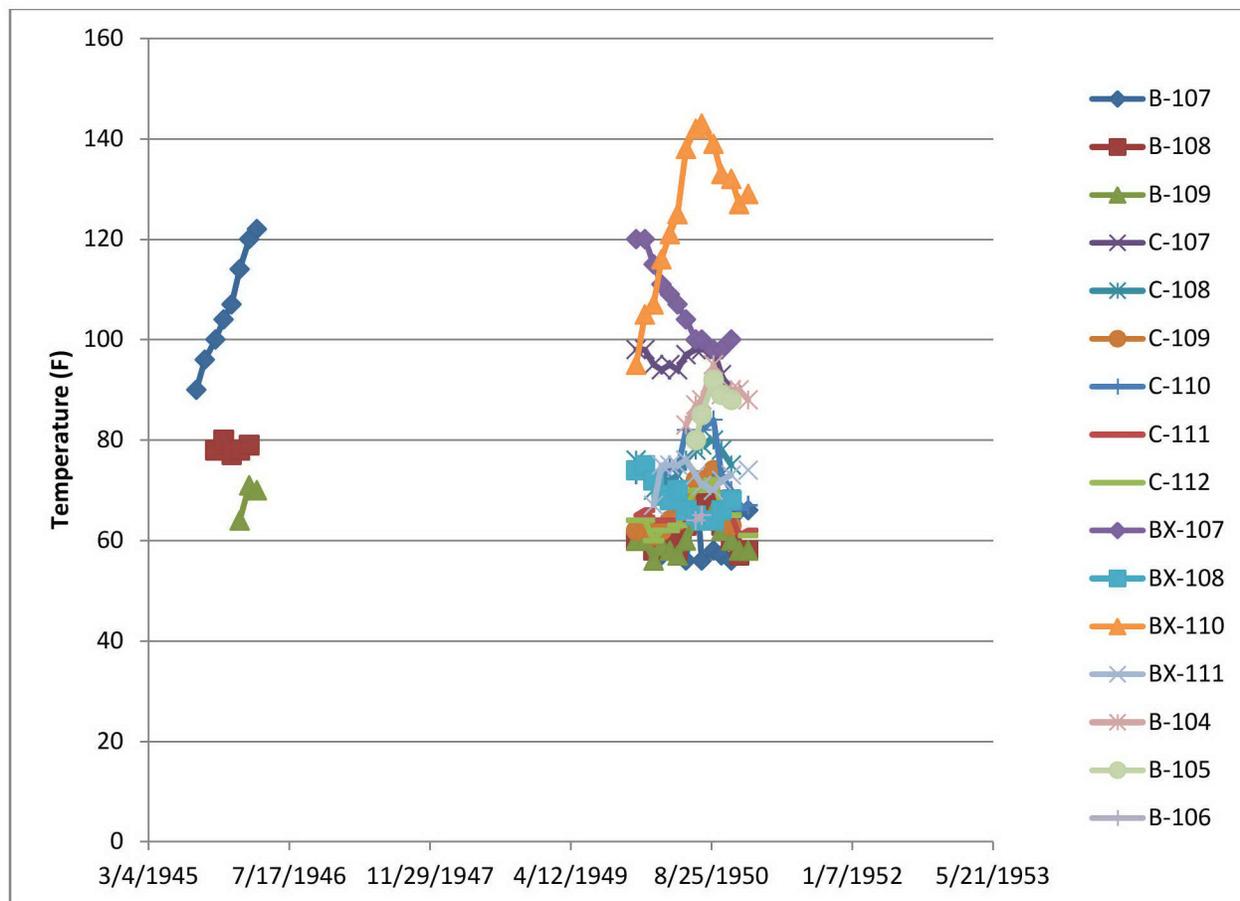
Figure 5-27. 200 East Area Coating Removal and First Cycle Decontamination Waste Tank Temperatures, 1945-1952

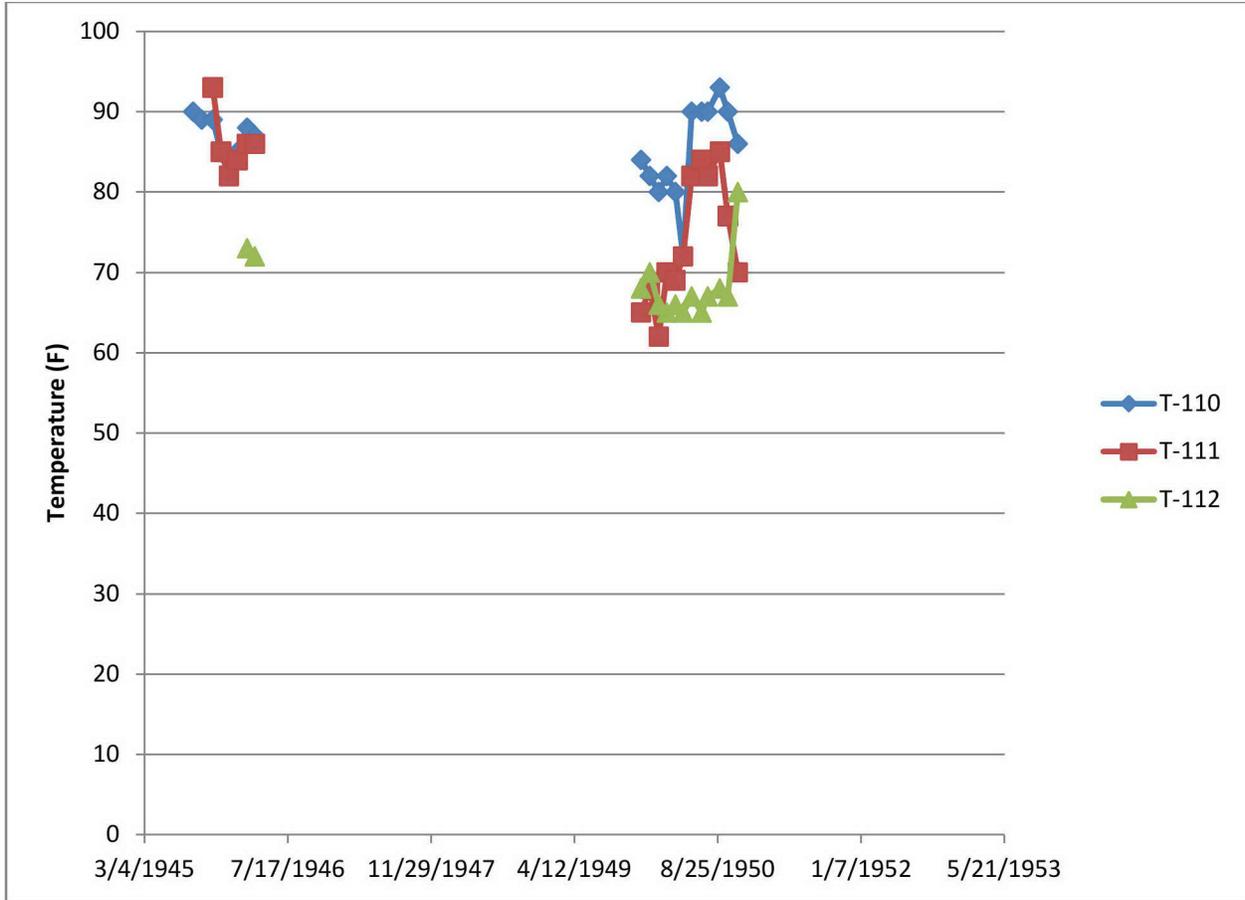
Figure 5-28. 200 West Area Second Decontamination Cycle Waste Tank Temperatures, 1945-1952

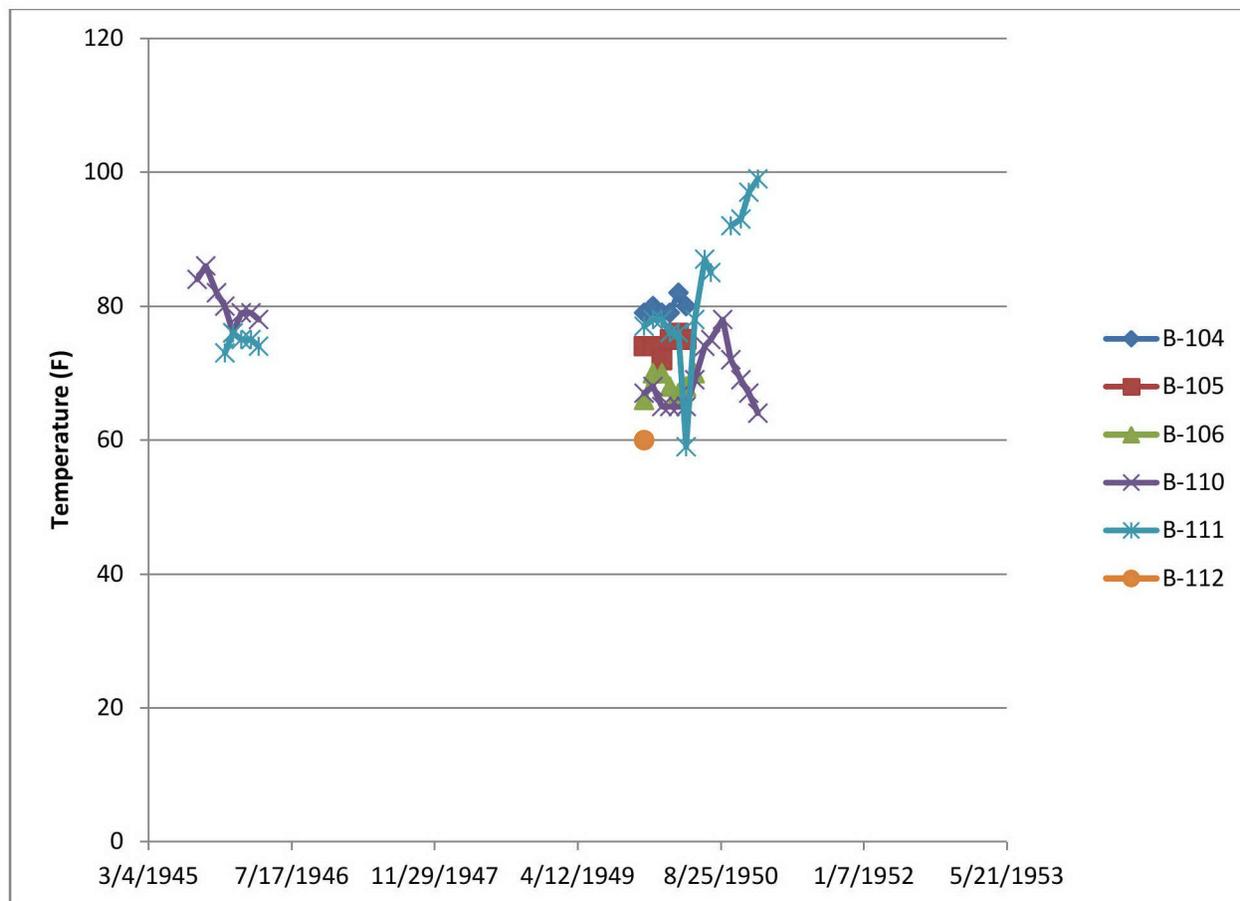
Figure 5-29. 200 East Area Second Decontamination Cycle Waste Tank Temperatures, 1945-1952

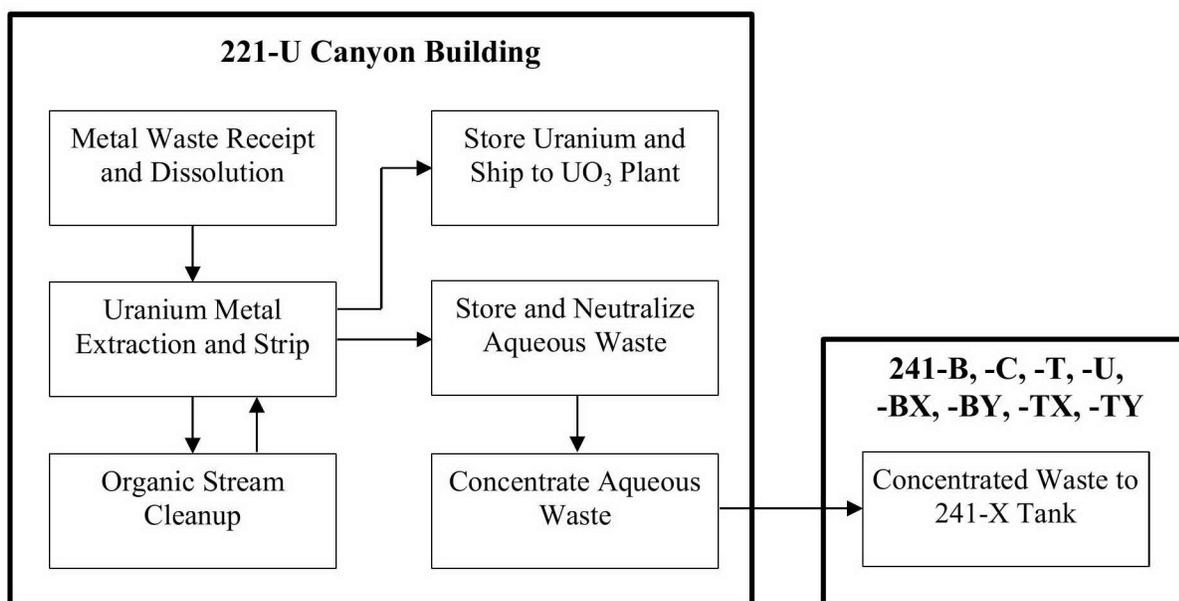
Figure 5-30. Metal Recovery or Tributyl Phosphate Process Simplified Schematic Showing Major Waste Stream Sent to Single-Shell Tanks

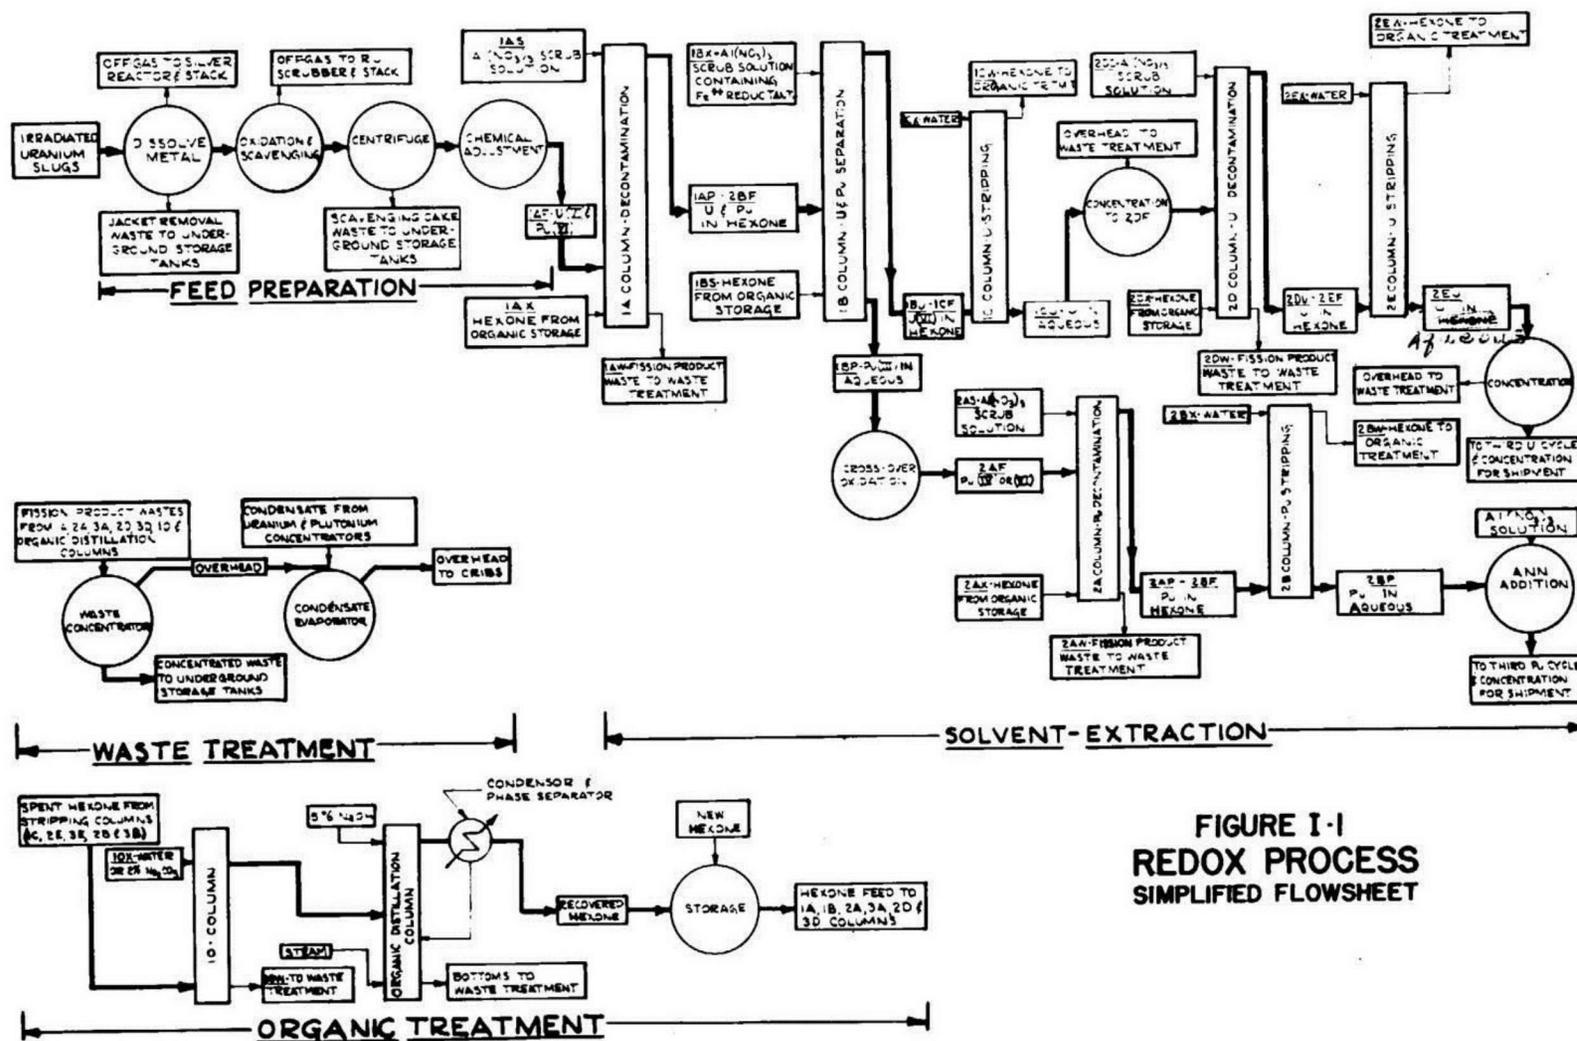
Figure 5-31. REDOX Process Simplified Flowsheet, Circa 1951

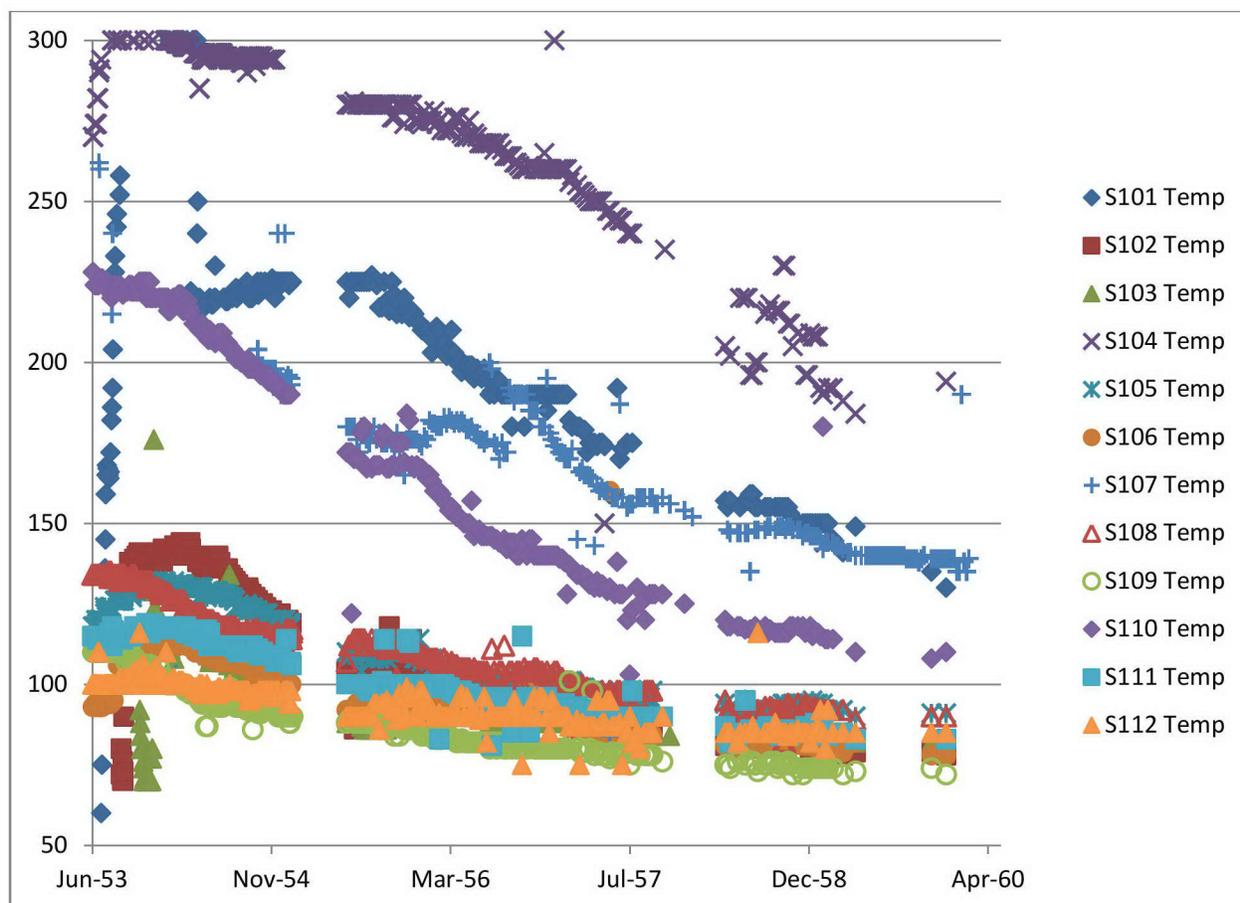
Figure 5-32. 241-S Farm Tank Content Maximum Temperatures When Filled with REDOX Waste, 1953-1960

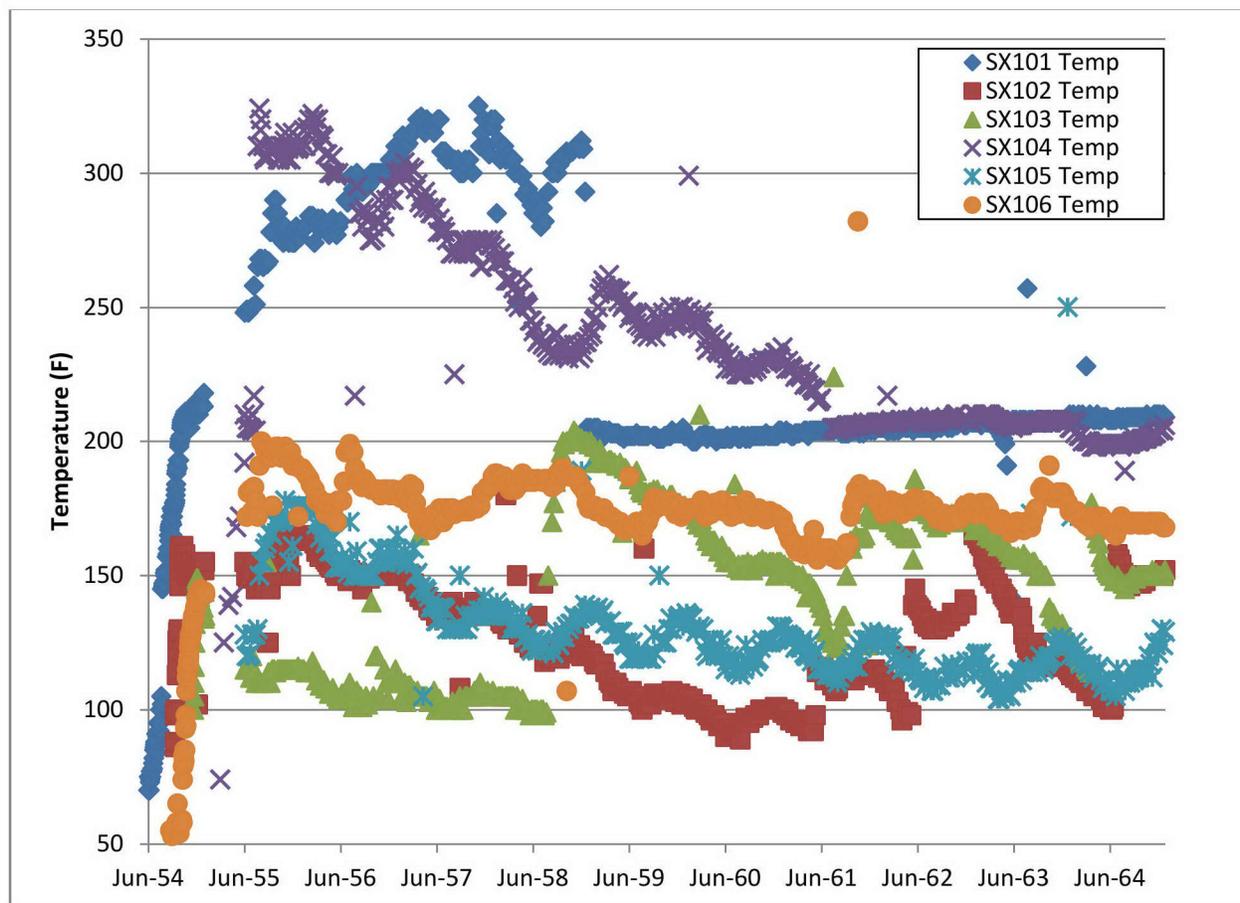
A temperature chart from 1954-1955 (RPP-RPT-58371) shows that the thermocouples in tanks SX-101 and SX-104 were lowered on July 13, 1955 with significant step changes in temperatures, 15°F in tank SX-101 and 106°F in tank SX-104. Available temperature data after the step change in July 1954 in tank SX-101 shows a gradual increase in the maximum temperature typically less than 3°F per day and a steadying out of temperature in SX-104.

Figure 5-33. 241-SX-101 to 241-SX-106 Tank Content Maximum Temperatures at the Time of Filling with REDOX Waste, 1954-1964

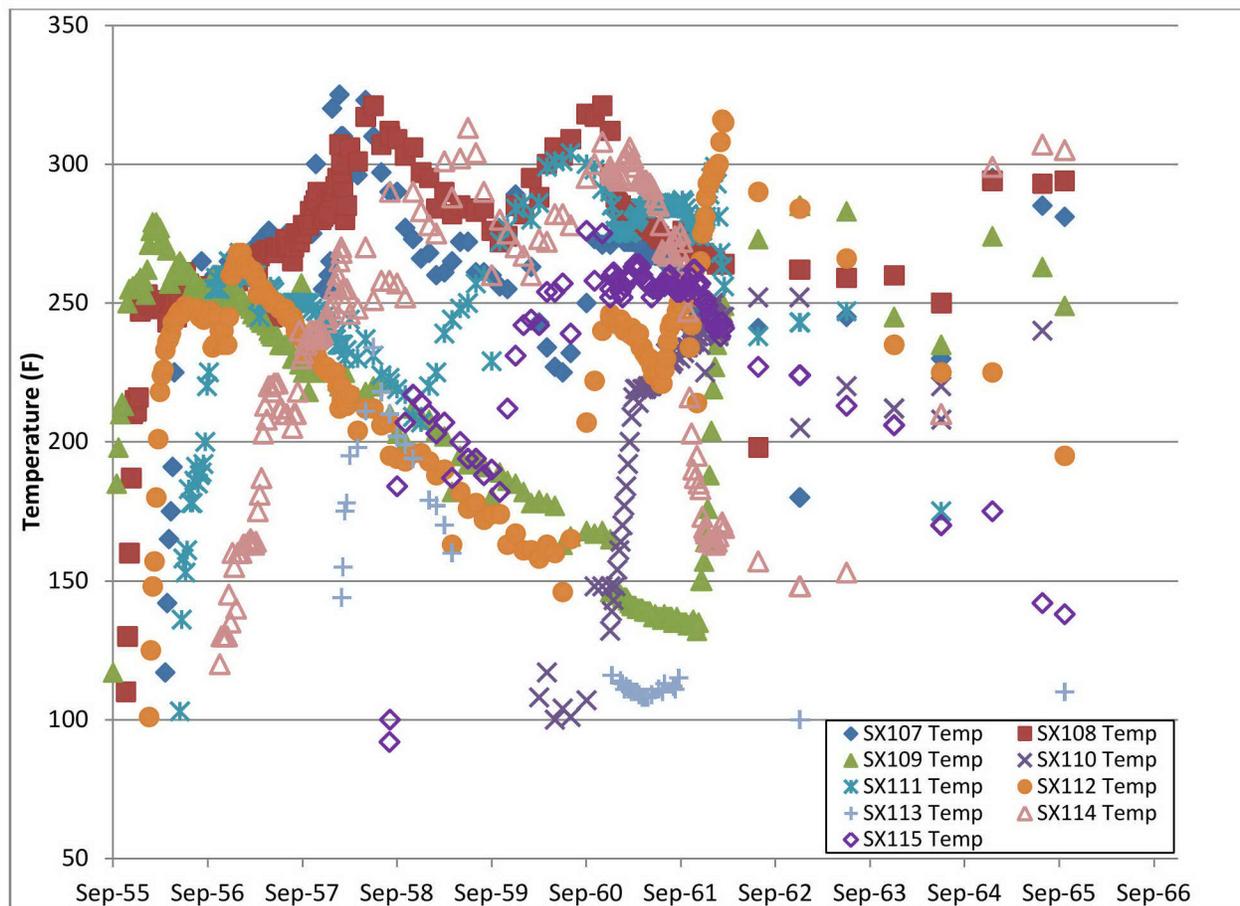
In the last nine tanks of SX Farm, the waste was not cascaded so all tanks were exposed to higher temperatures. Temperature profiles for tanks SX-107 through SX-115 during the time of REDOX operation are shown in Figure 5-34. These temperatures were generally measured 2 to 3 in. from the tank bottom. The maximum temperature for each tank ranged from 234°F in tank SX-113 to 390°F (not shown on plot) in tank SX-107⁵. Tank SX-113 failed within five months of the first addition of waste and had not been completely filled.

Figure 5-34. 241-SX-107 to 241-SX-115 Tank Content Maximum Temperatures at the Time of Filling with REDOX Waste, 1955-1965

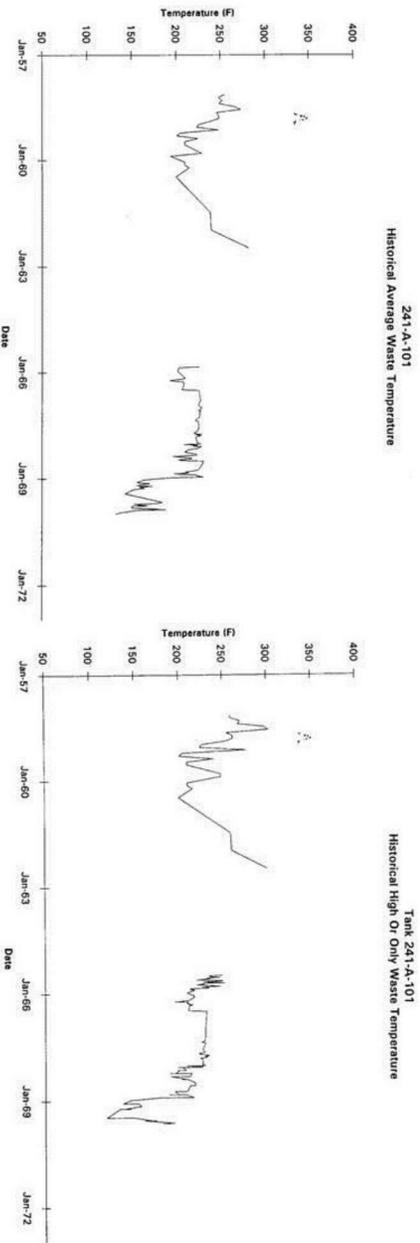
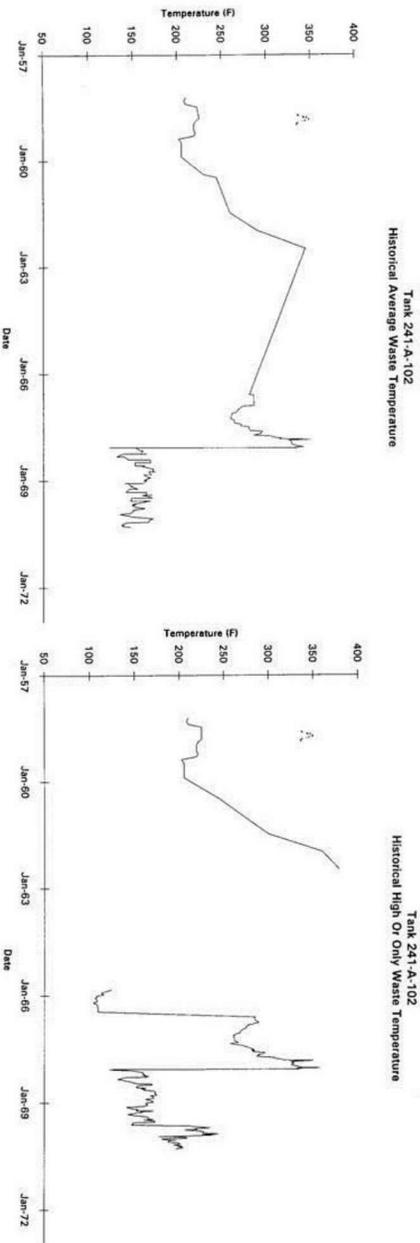
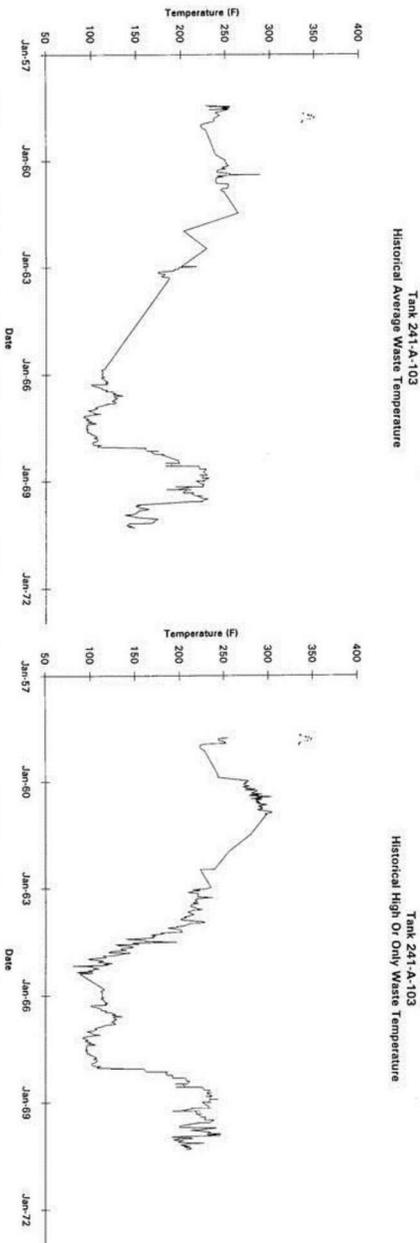
Figure 5-36. 241-A Tank Farm Waste Average and Maximum Temperatures, 1957 to 1972

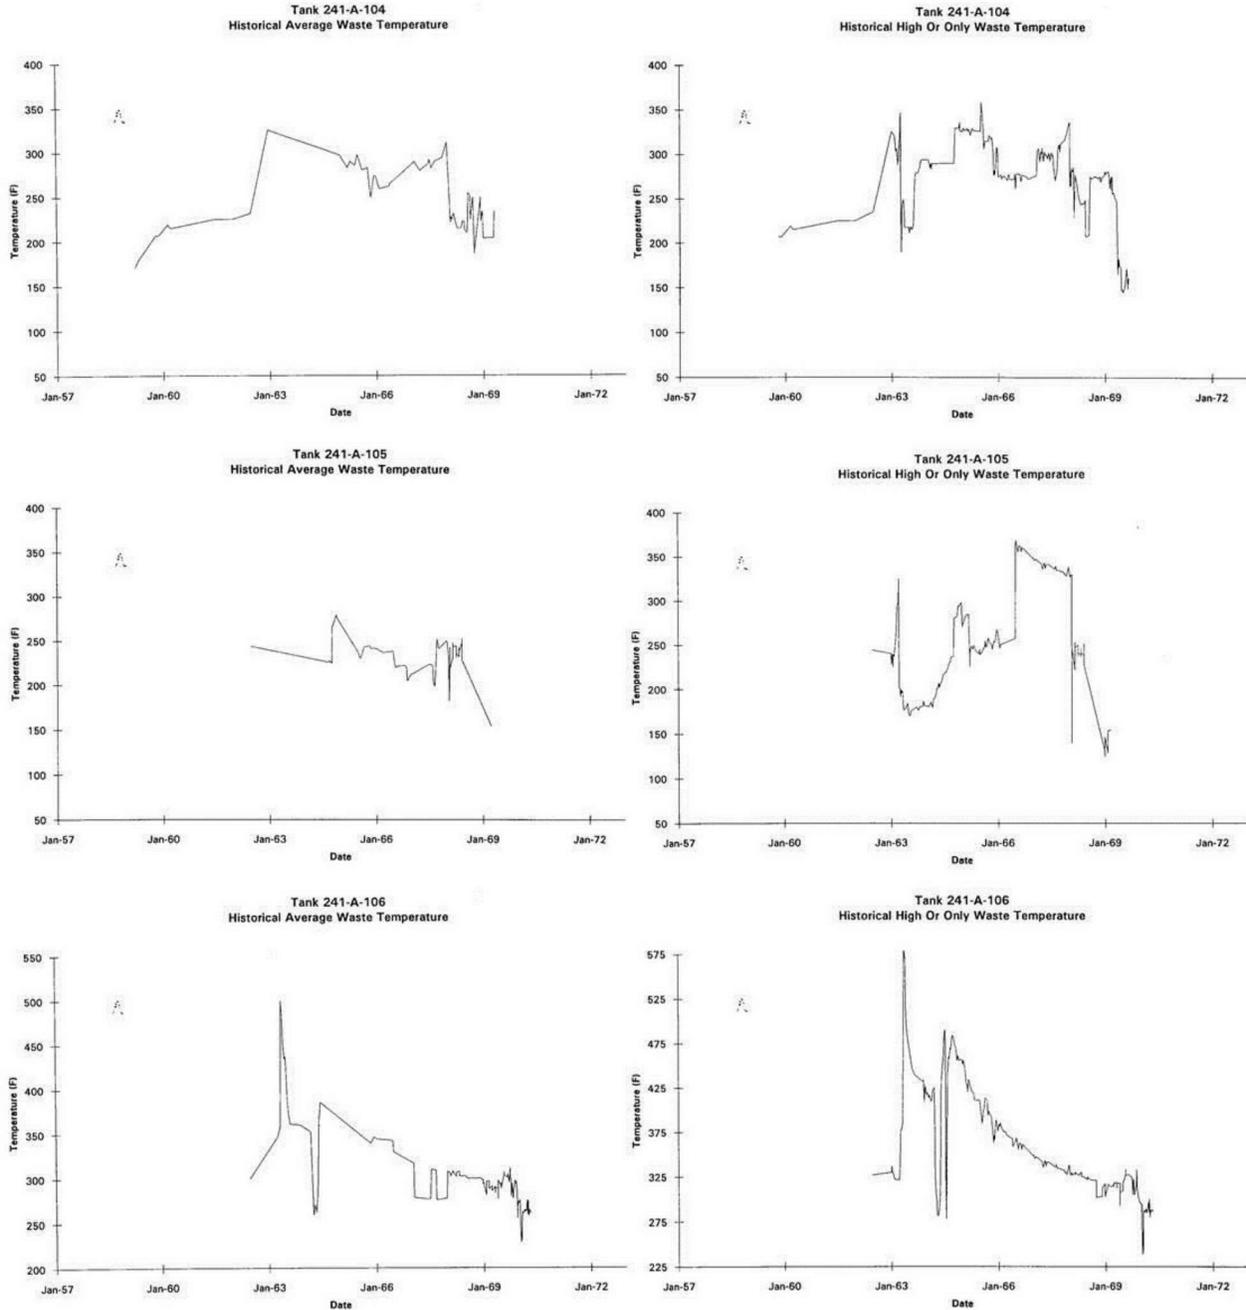
Figure 5-37. 241-A Tank Farm Waste Average and Maximum Temperatures, 1957 to 1972
