2. Document Title			
Common Factors Relating to Liner Failures in Single-Shell Tanks			
3. Design Verification Required			
<input type="checkbox"/> Yes <input type="checkbox"/> No

Common Factors Relating to Liner Failures in Single-Shell Tanks

Abstract: This report fulfills the requirement for target T04 for Hanford Federal Facility Agreement and Consent Order milestone M-045-91F. The goal of this report is to identify the common factors that may have contributed to liner failures in single-shell tanks. The tanks with probable liner failures are identified through the process identified in RPP-32681, Rev. 0, "Process to Assess Tank Farm Leaks in Support of Retrieval and Closure Planning."

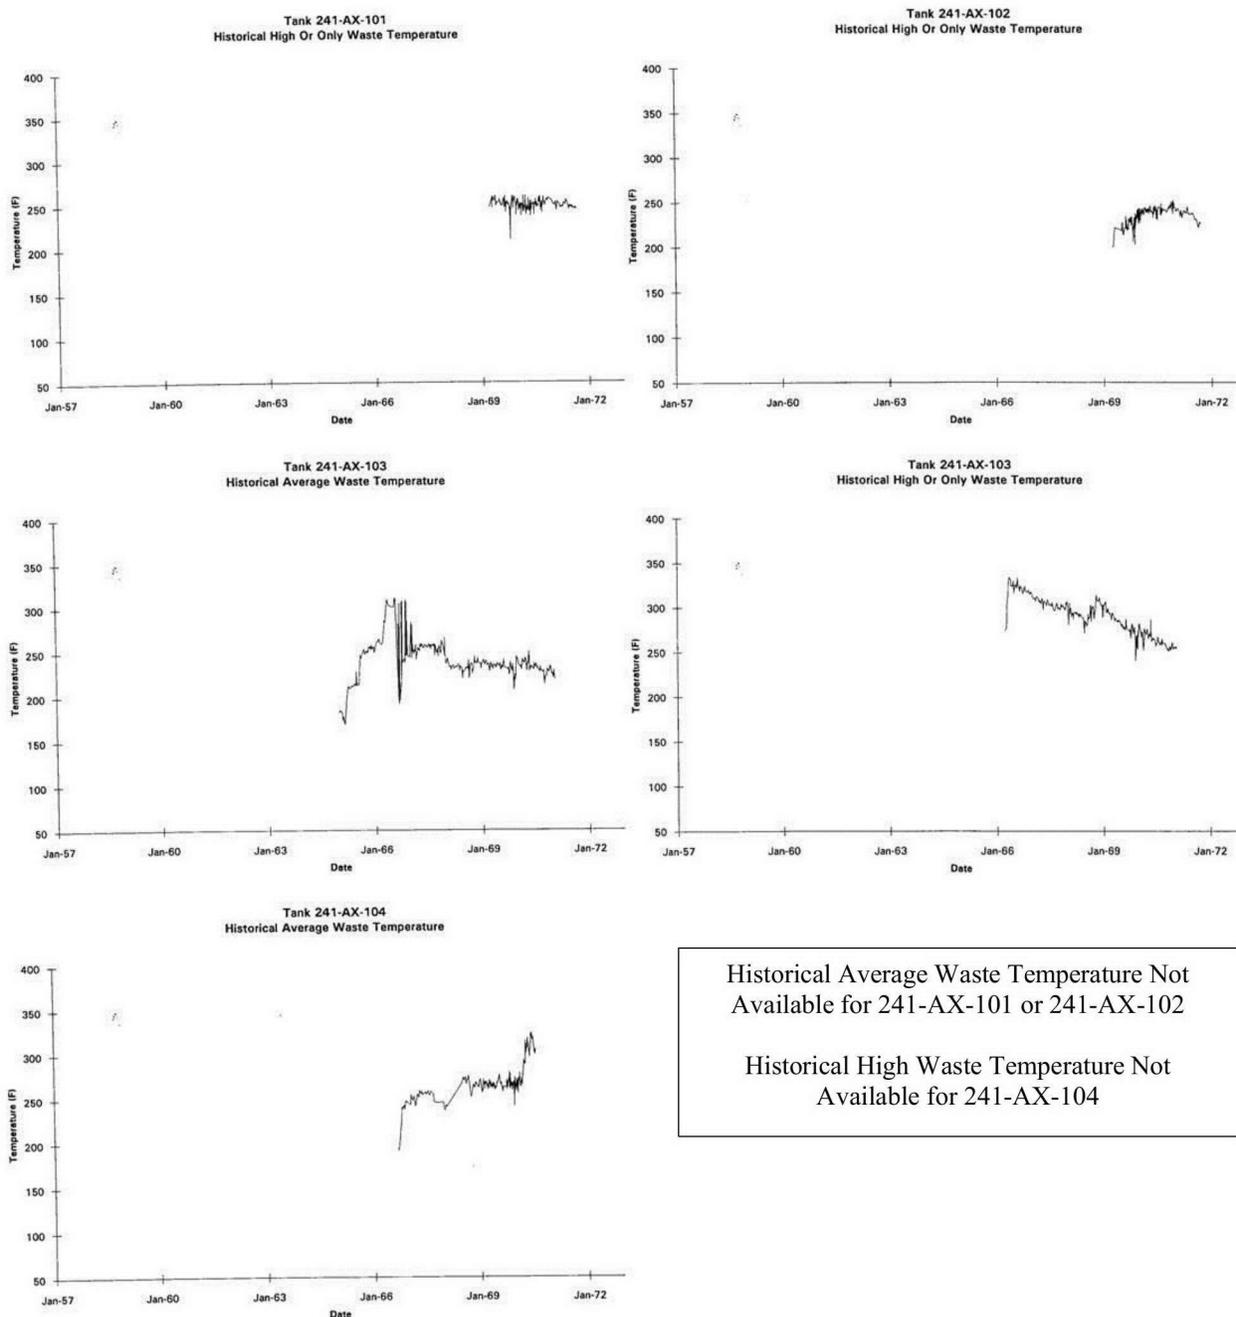
Figure 5-38. 241-AX Tank Farm Waste Average and Maximum Temperatures, 1957 to 1972

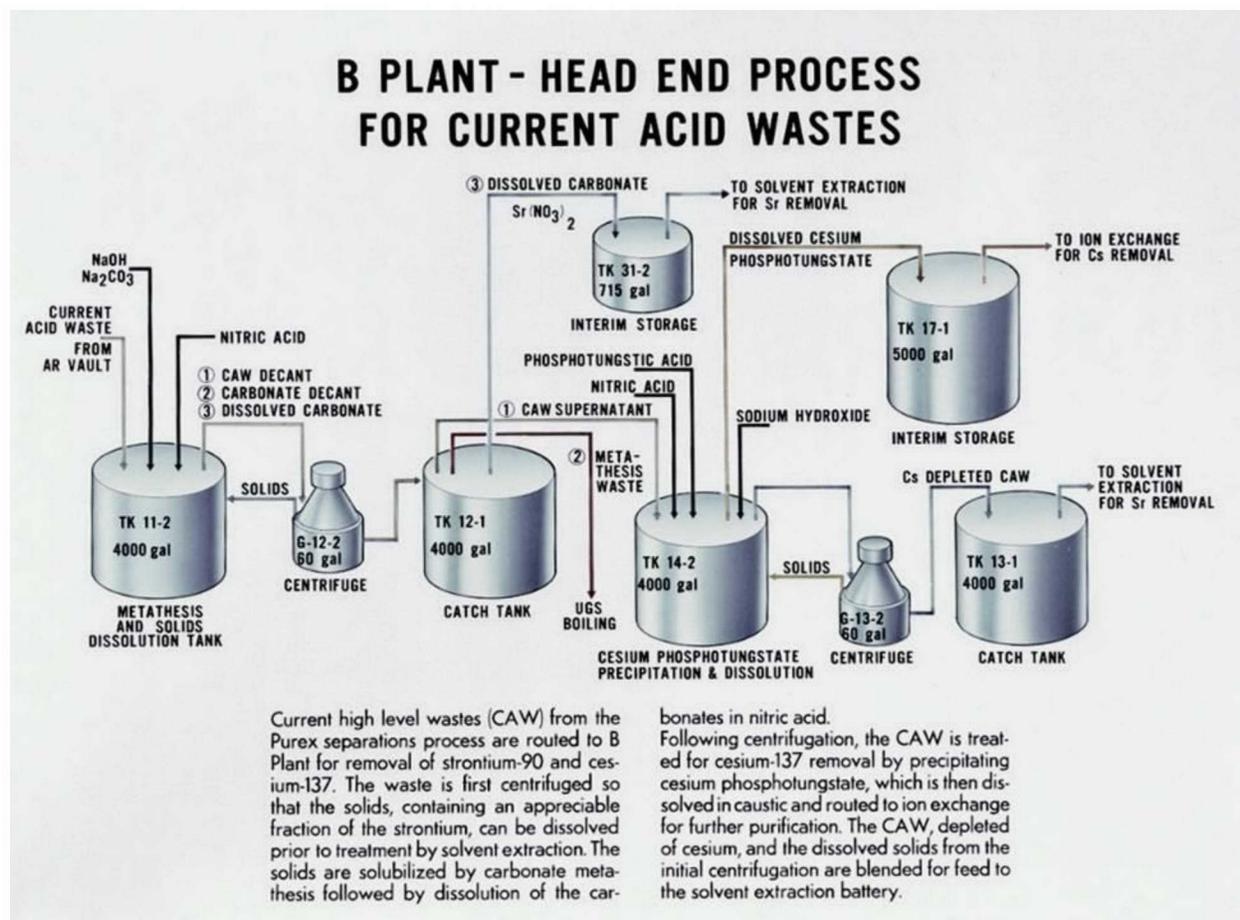
products from sulfates to carbonates, the waste metathesis solution was decanted and collected in waste tank TK-25-2 to be sent to underground storage in boiling waste tanks. The remaining solids were washed with 0.1 M sodium carbonate, settled, and then this wash solution was transferred to waste tank TK-25-2. The solids were then dissolved in nitric acid solution. Any residual solids (primarily siliceous solids) remaining after dissolution were slurried and ultimately sent to waste tank TK-25-2 for disposal. This B Plant head-end process for CAW is depicted in Figure 5-40. The figure also shows additional head-end processing prior to cesium recovery that is described in the following paragraph.

Figure 5-40. B Plant Head End Process for Current Acid Waste, Circa 1967

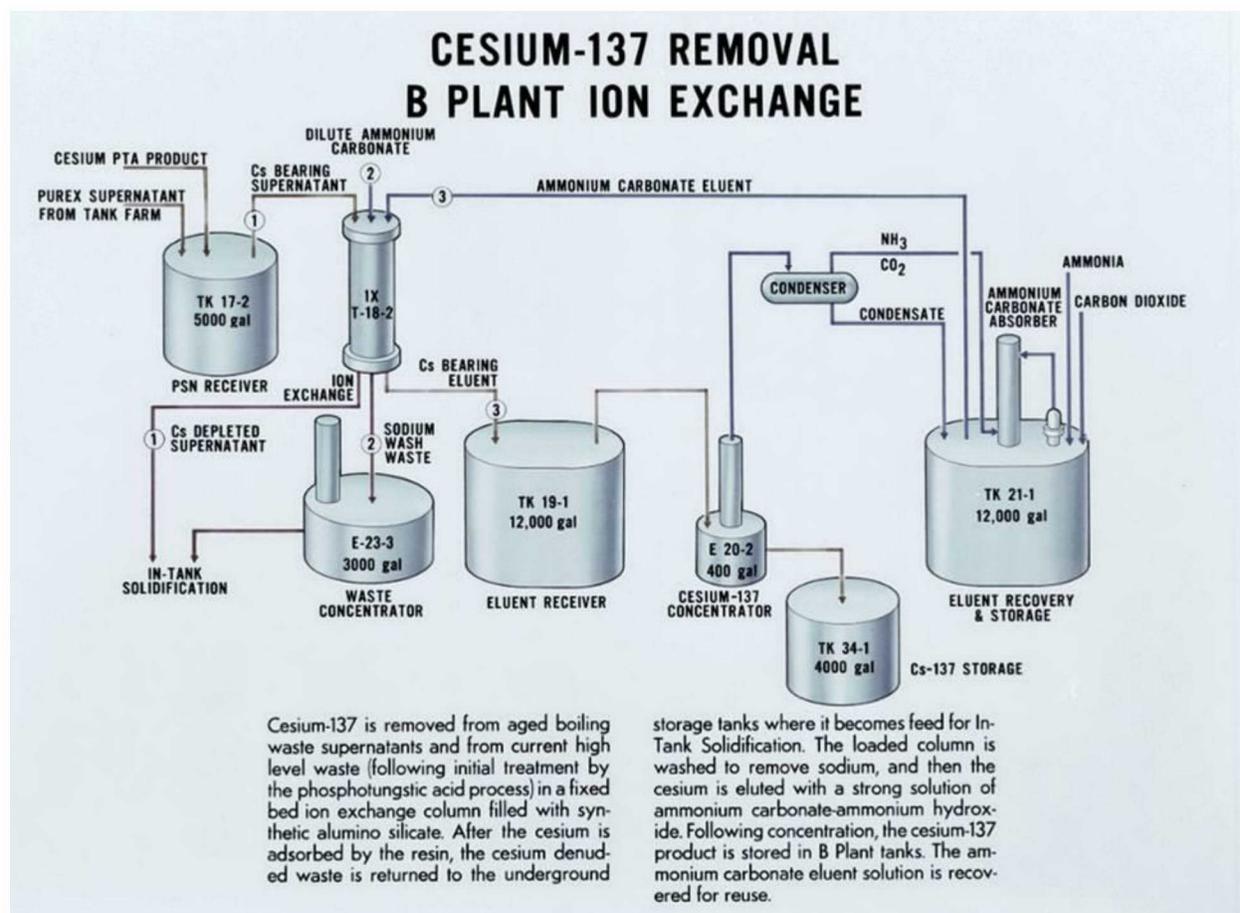
ion exchange cycle using feed from the cesium recovery process described in the above paragraph. After feeding the column to load it with cesium, the column was scrubbed to remove sodium, potassium and rubidium with dilute ammonium carbonate and ammonium hydroxide. The cesium was then eluted with concentrated ammonium carbonate – ammonium hydroxide flush solution. The solution with eluted cesium was concentrated, recovering the ammonium carbonate from the overheads. The waste stream from loading and the scrub solution were sent back to cesium recovery for recycle through the recovery process. If the streams contained low enough concentration of cesium they could alternately be processed as low level waste through the concentrator.

Figure 5-41. B Plant Cesium Recovery Ion Exchange Process, Circa 1967

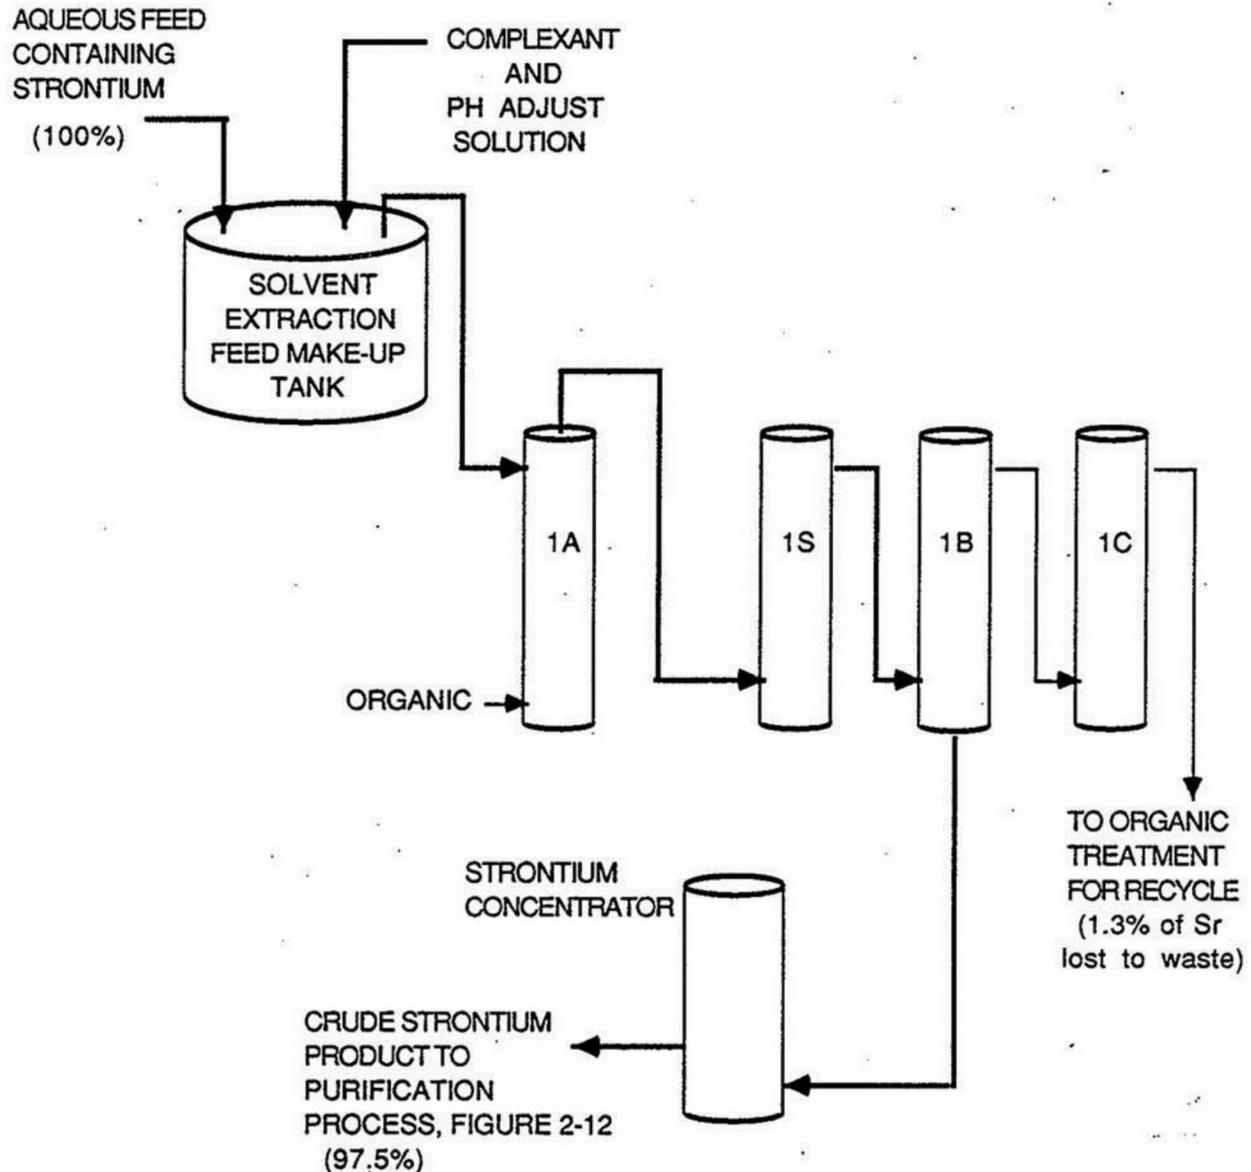
Figure 5-42. B Plant Strontium Recovery Solvent Extraction Process Simplified Flow Diagram

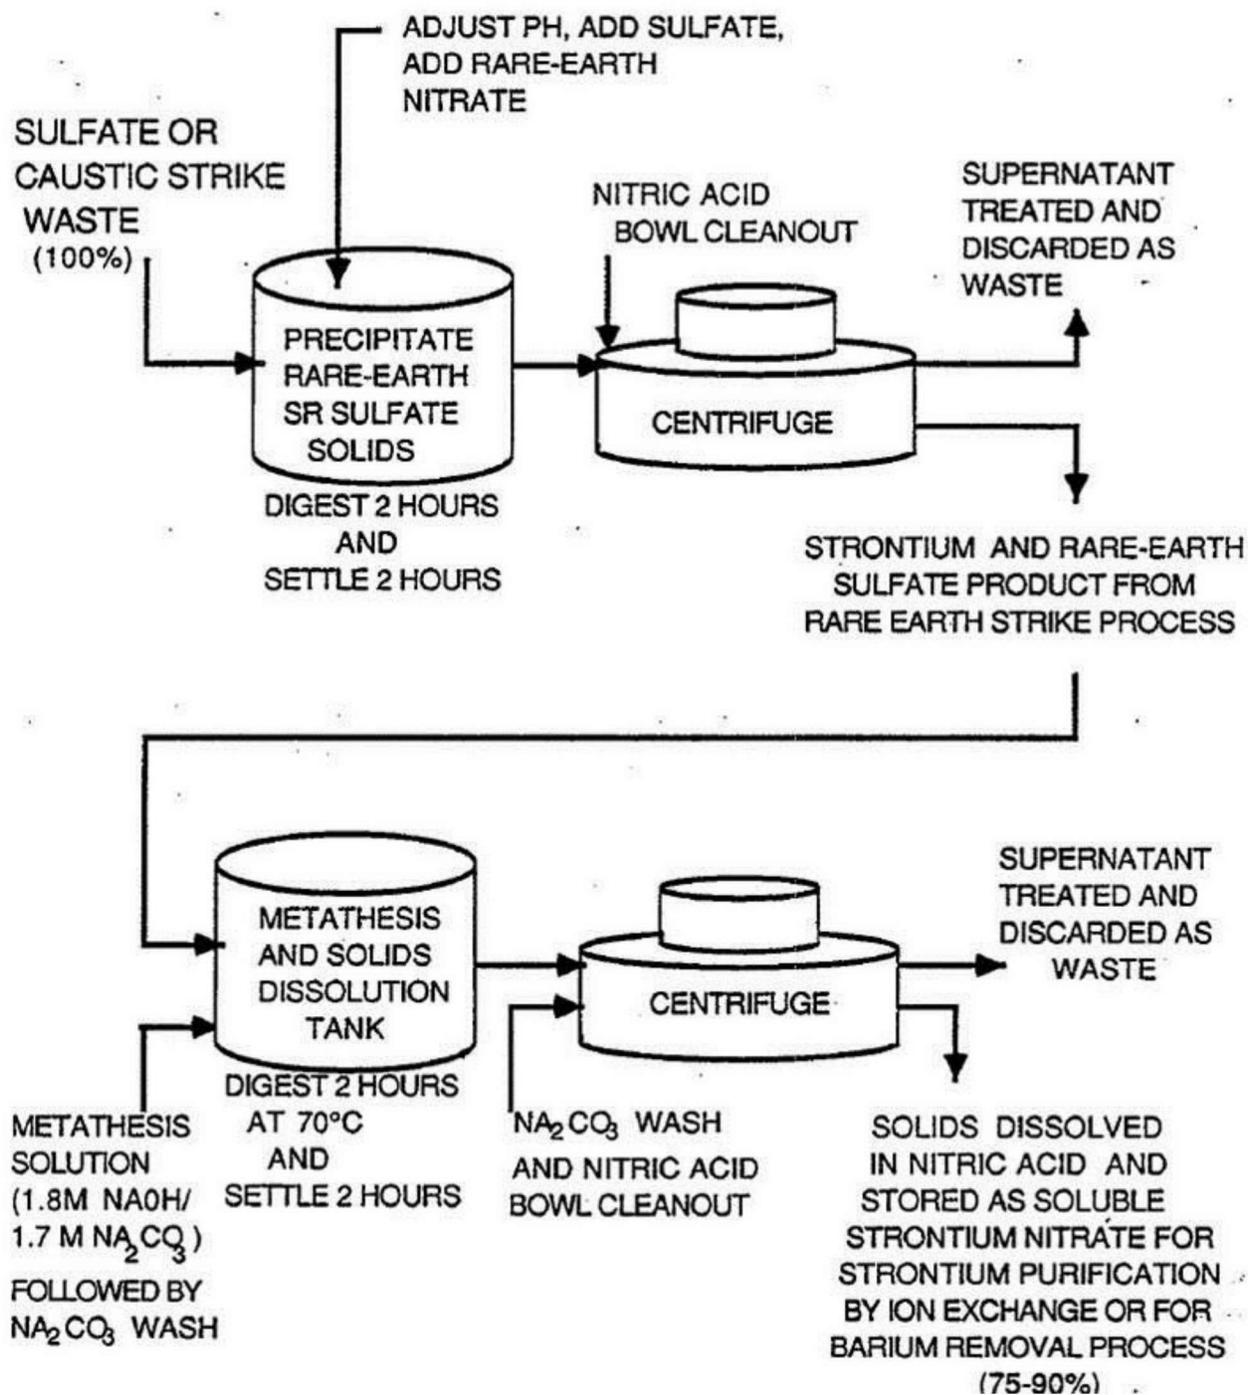
Figure 5-43. B Plant Strontium Purification Rare-Earth Sulfate Strike Process Simplified Flow Diagram

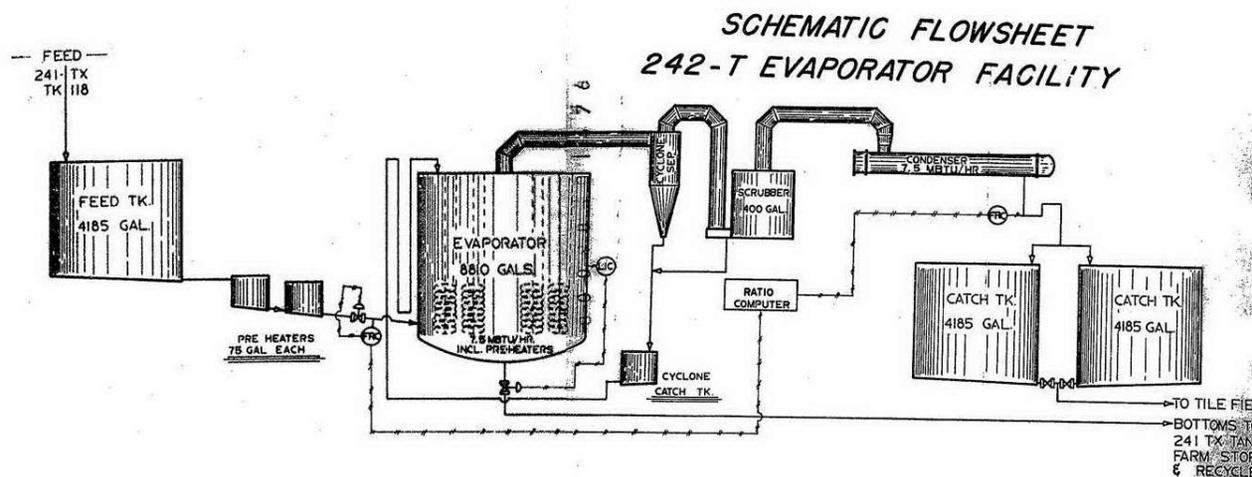
Figure 5-44. 242-T Evaporator Schematic Flow Diagram, Circa 1955

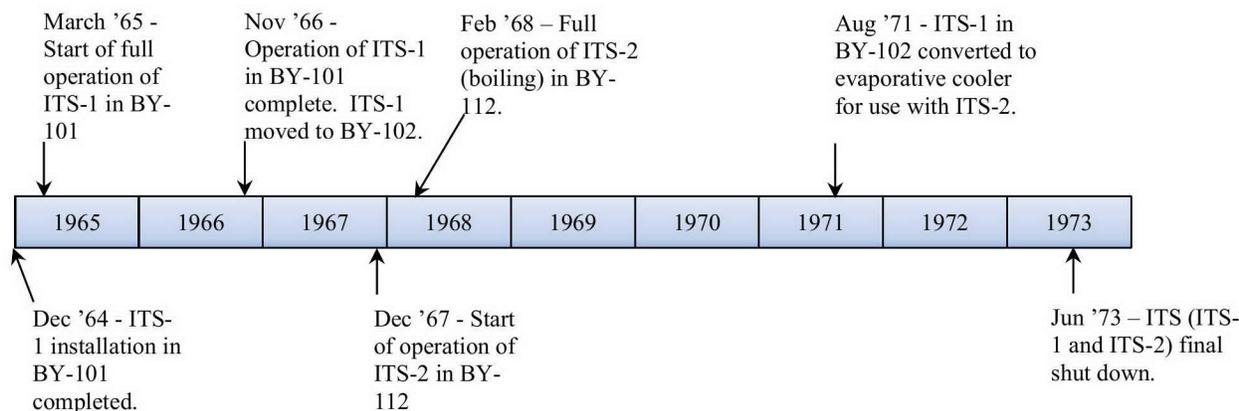
Figure 5-45. In-Tank Solidification Summary Operational Timeline

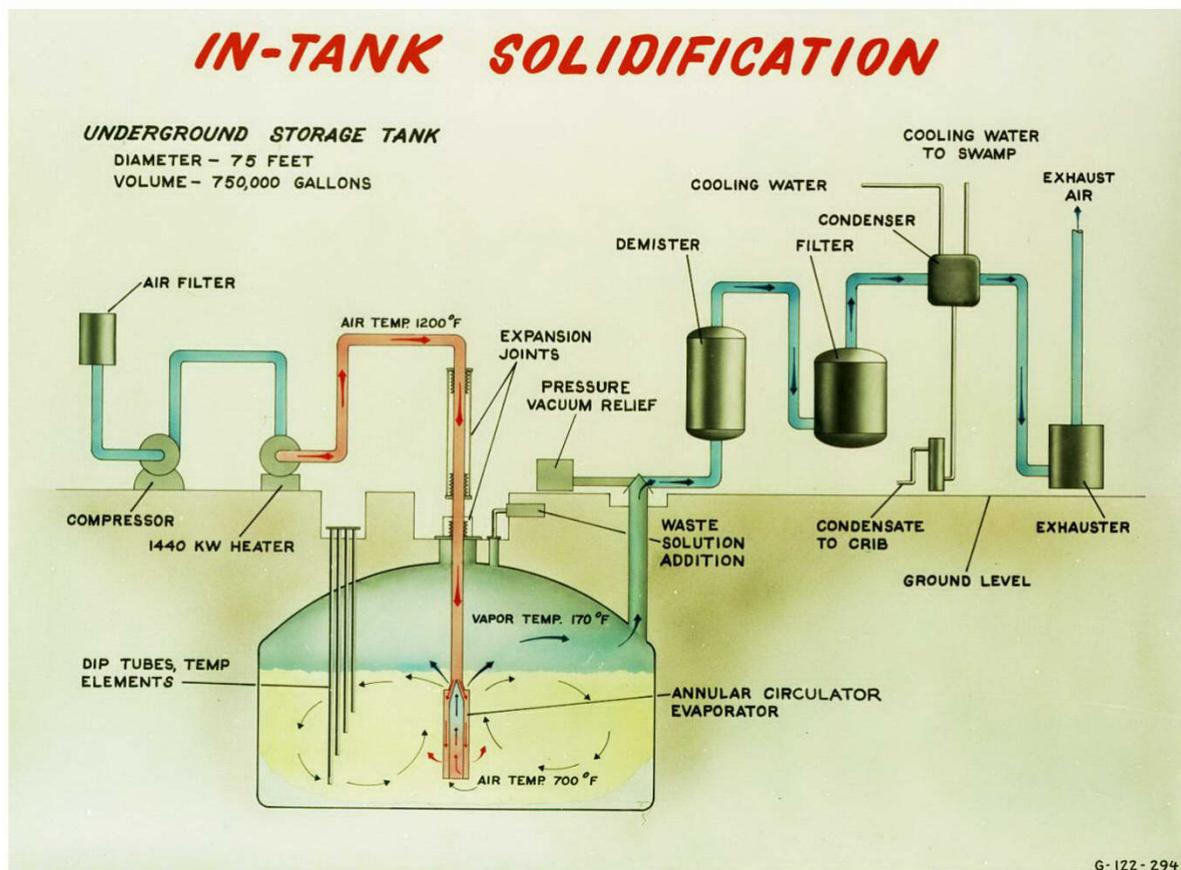
Figure 5-46. In-Tank Solidification Prototype Unit Flow Diagram

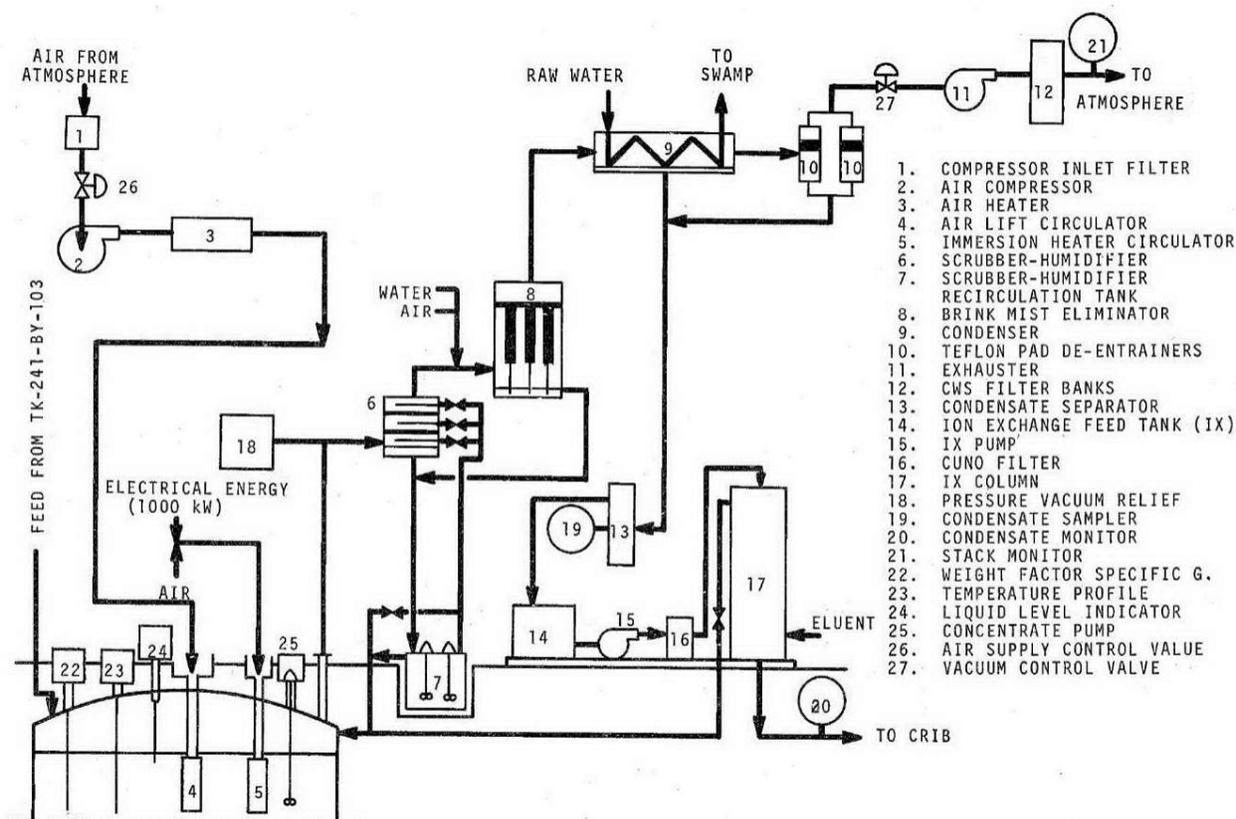
Figure 5-47. In-Tank Solidification Unit 1 (ITS-1) Flow Diagram During Operation in 241-BY-102

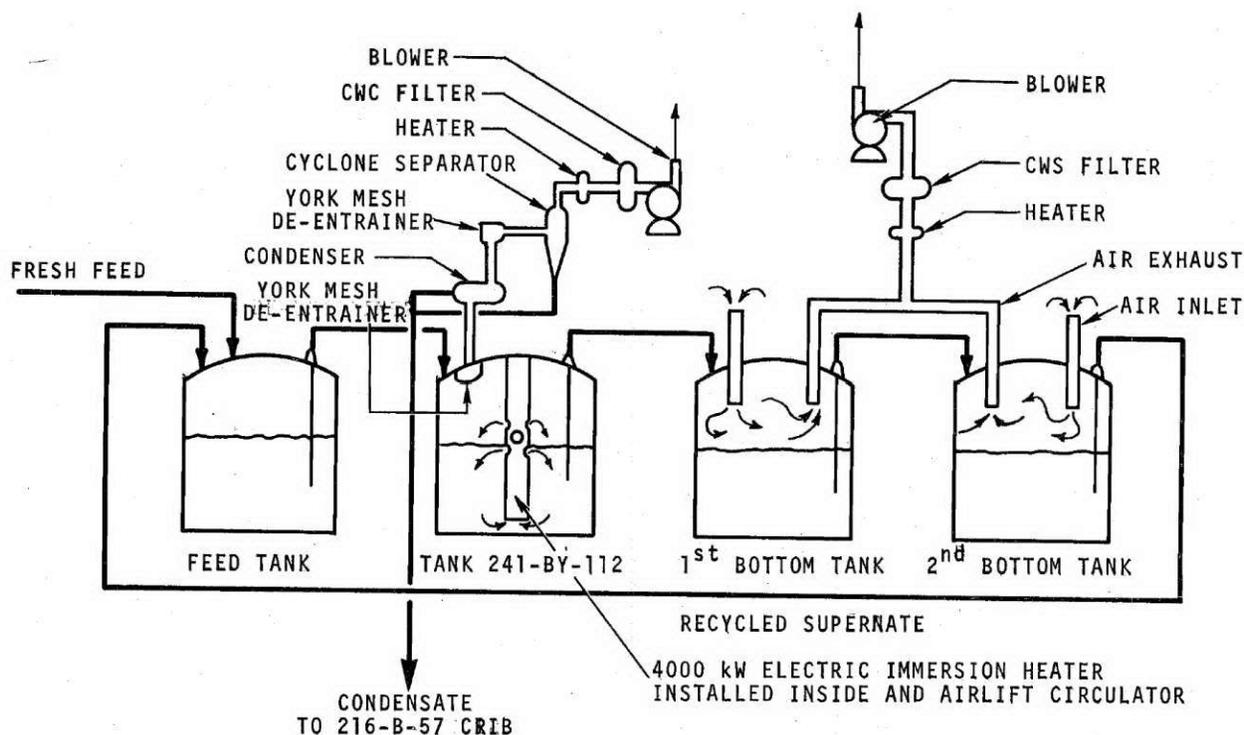
Figure 5-48. In-Tank Solidification Unit 2 (ITS-2) Simplified Flow Diagram

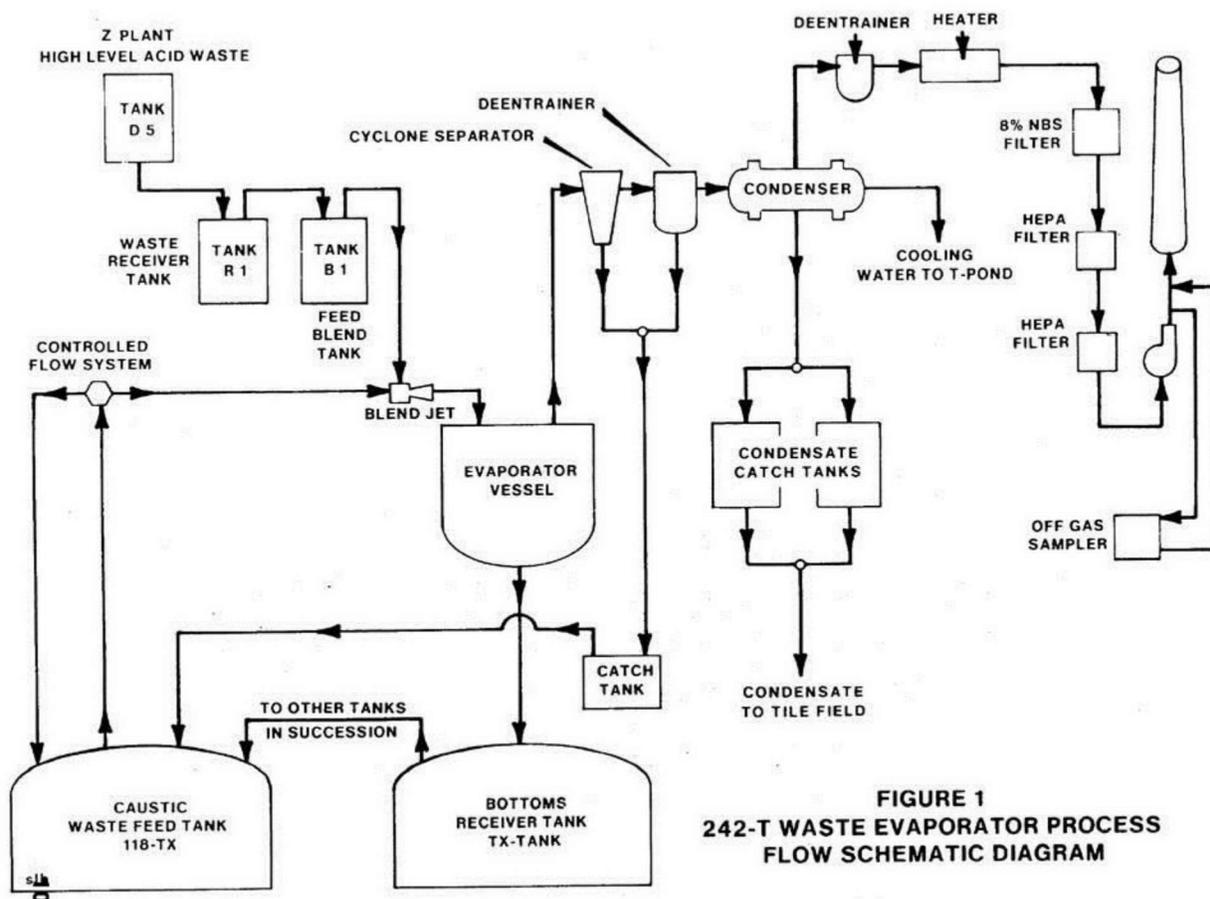
FIGURE 1
242-T WASTE EVAPORATOR PROCESS
FLOW SCHEMATIC DIAGRAM

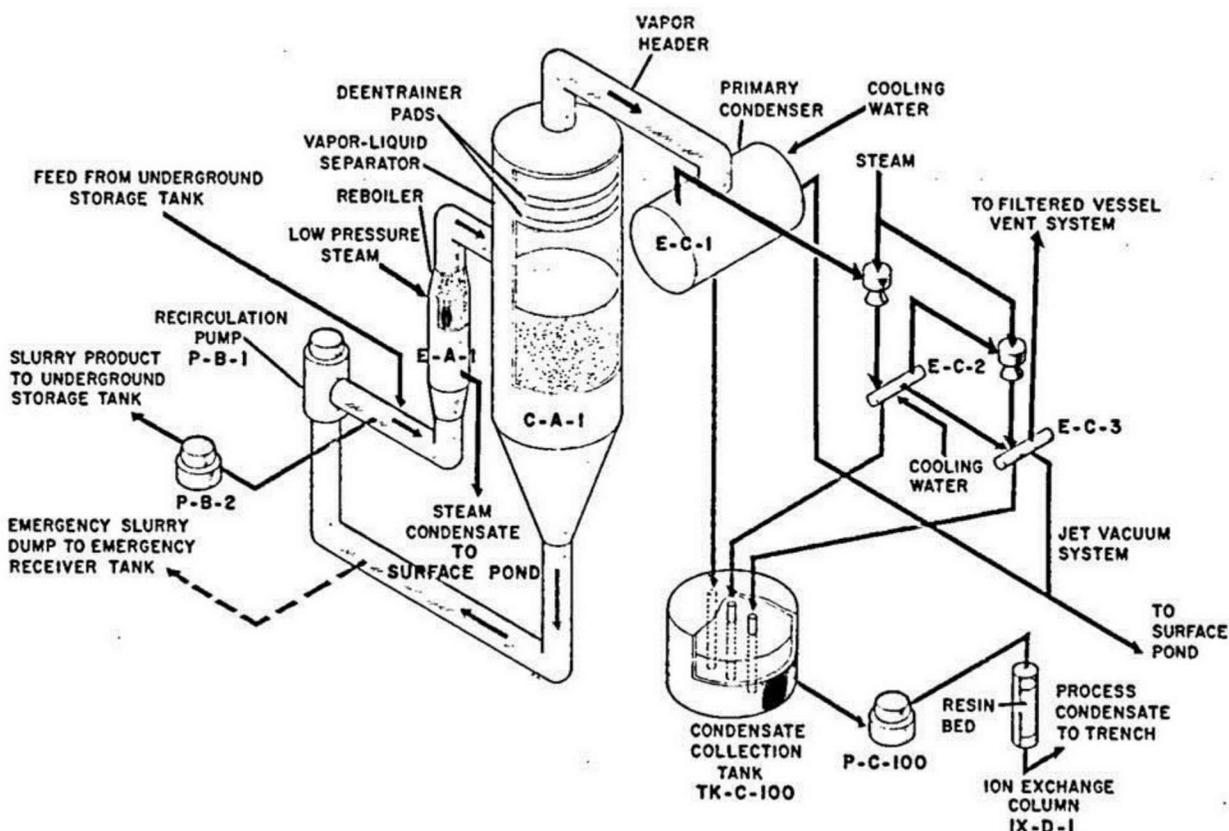
Figure 5-50. 242-S Evaporator Isometric Flow Diagram, Circa 1973

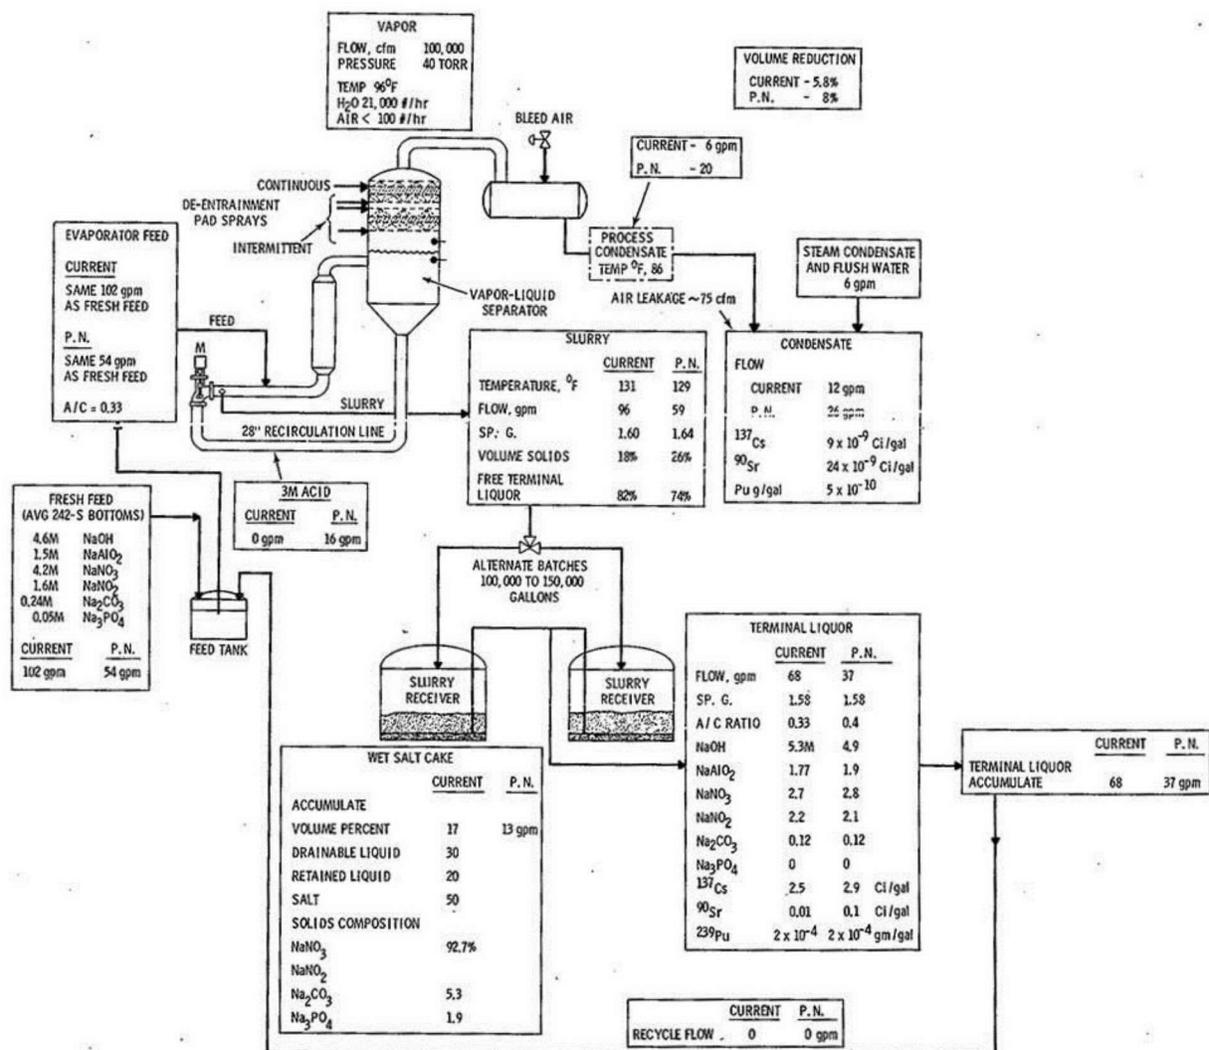
Figure 5-51. 242-S Evaporator Partial Neutralization Flow Diagram

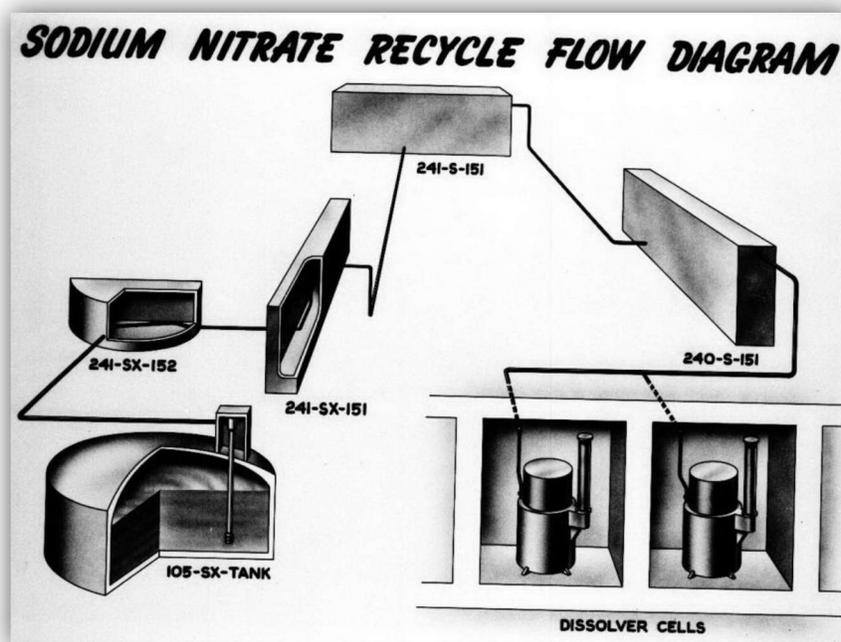
Figure 5-52. Sodium Nitrate Recycle Flow Diagram (IDMS document number 34213-1)

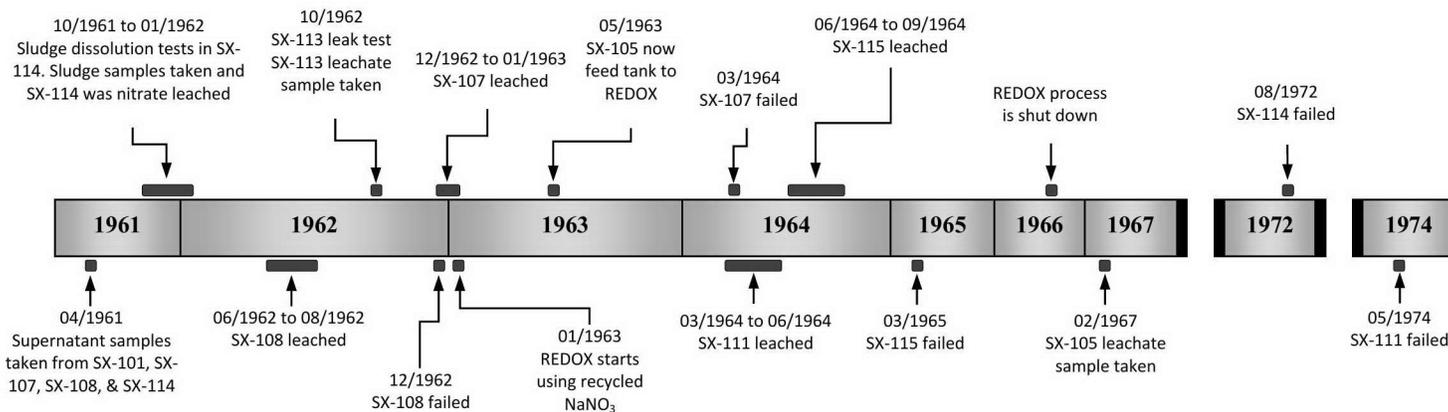
Figure 5-53. Timeline of Nitrate Recycle Operations

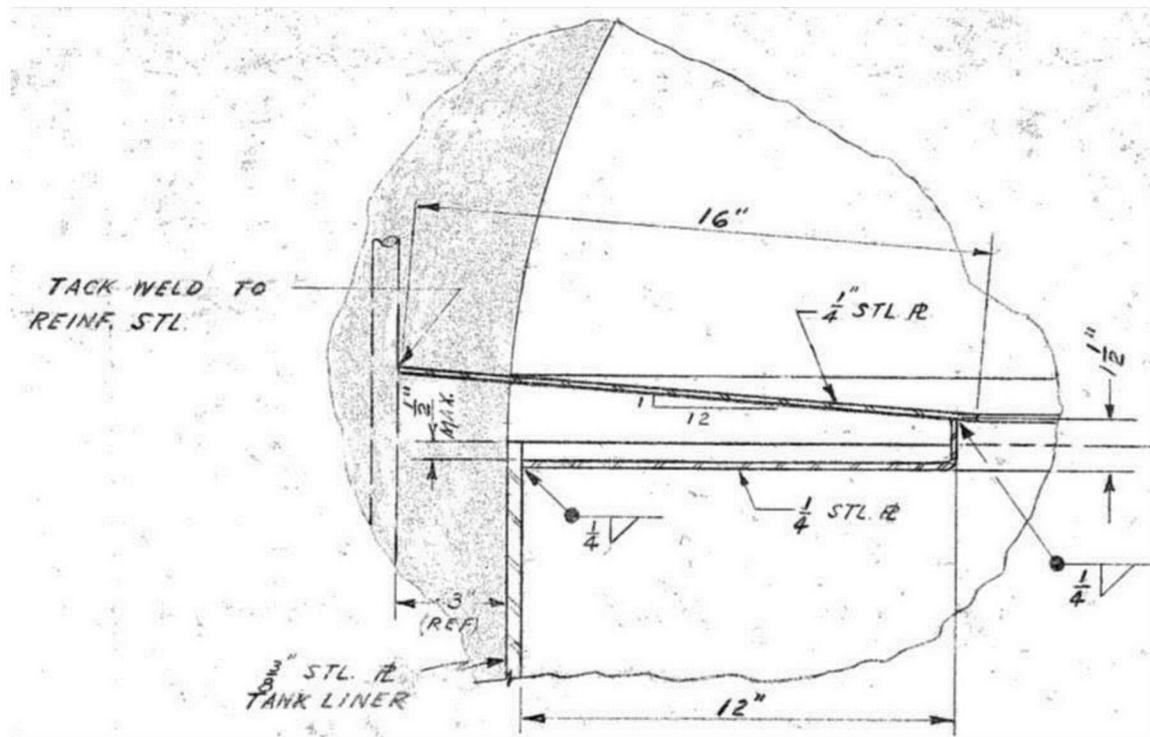
Figure 5-54. 241-SX Tank Liner Top Design

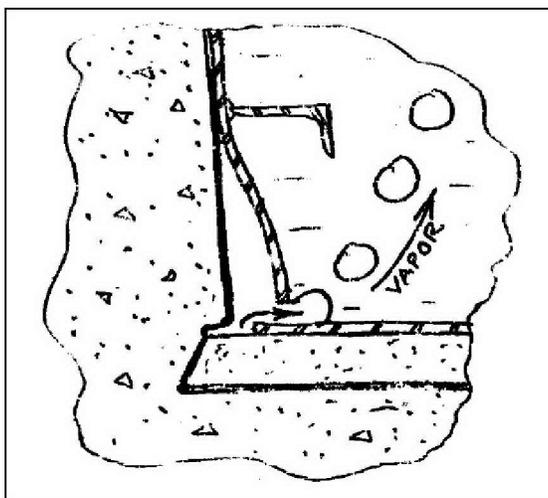
**Figure 5-56. Vapor Escape through Rupture of a Joint
(HW-57274 Fig. 8)**

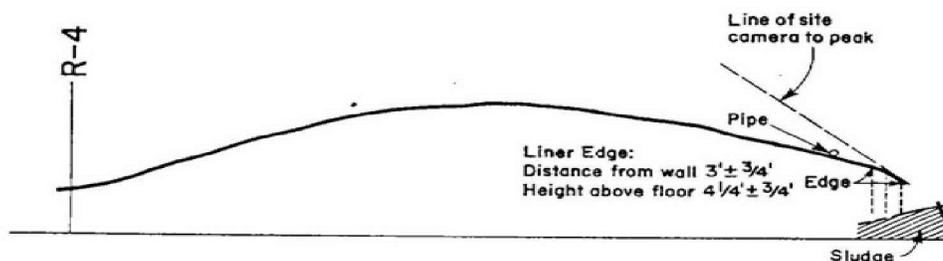
Figure 5-57. Rupture of Liner in Tank A-105 (TRAC-0022)

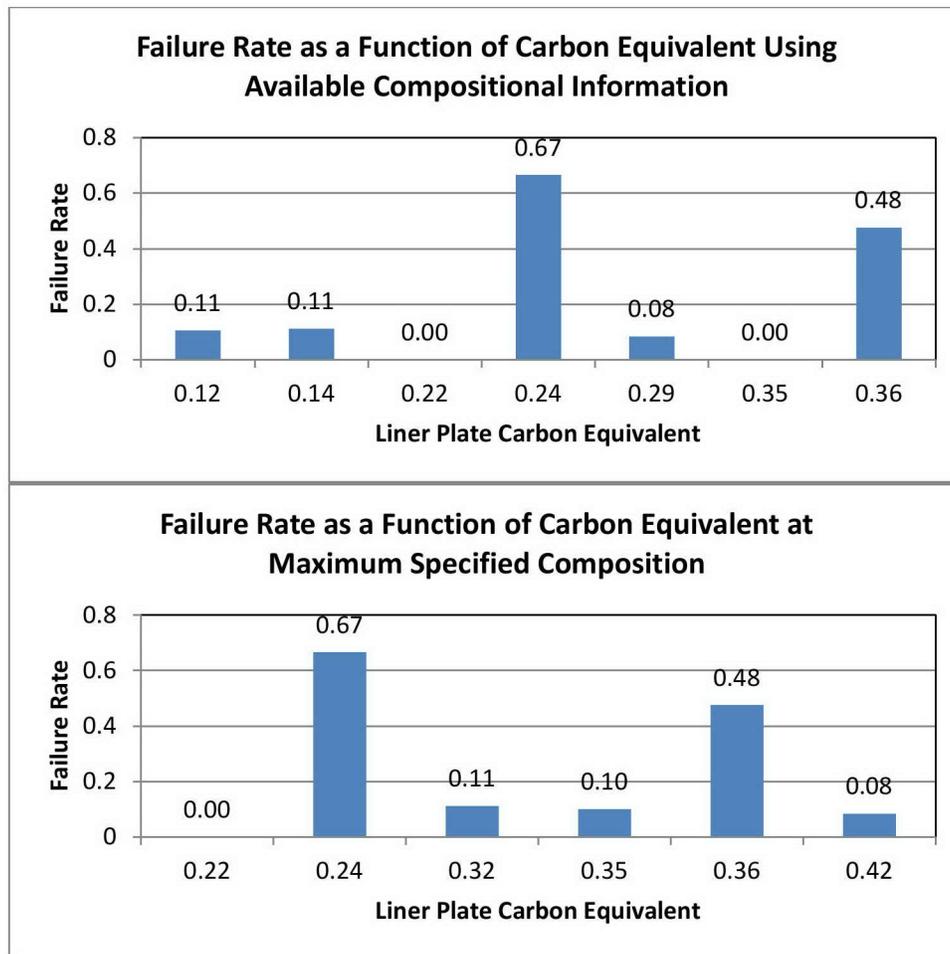
Figure 6-1. Tank Liner Failure Rate as a Function of Liner Plate Carbon Equivalent, with and without Compositional Information

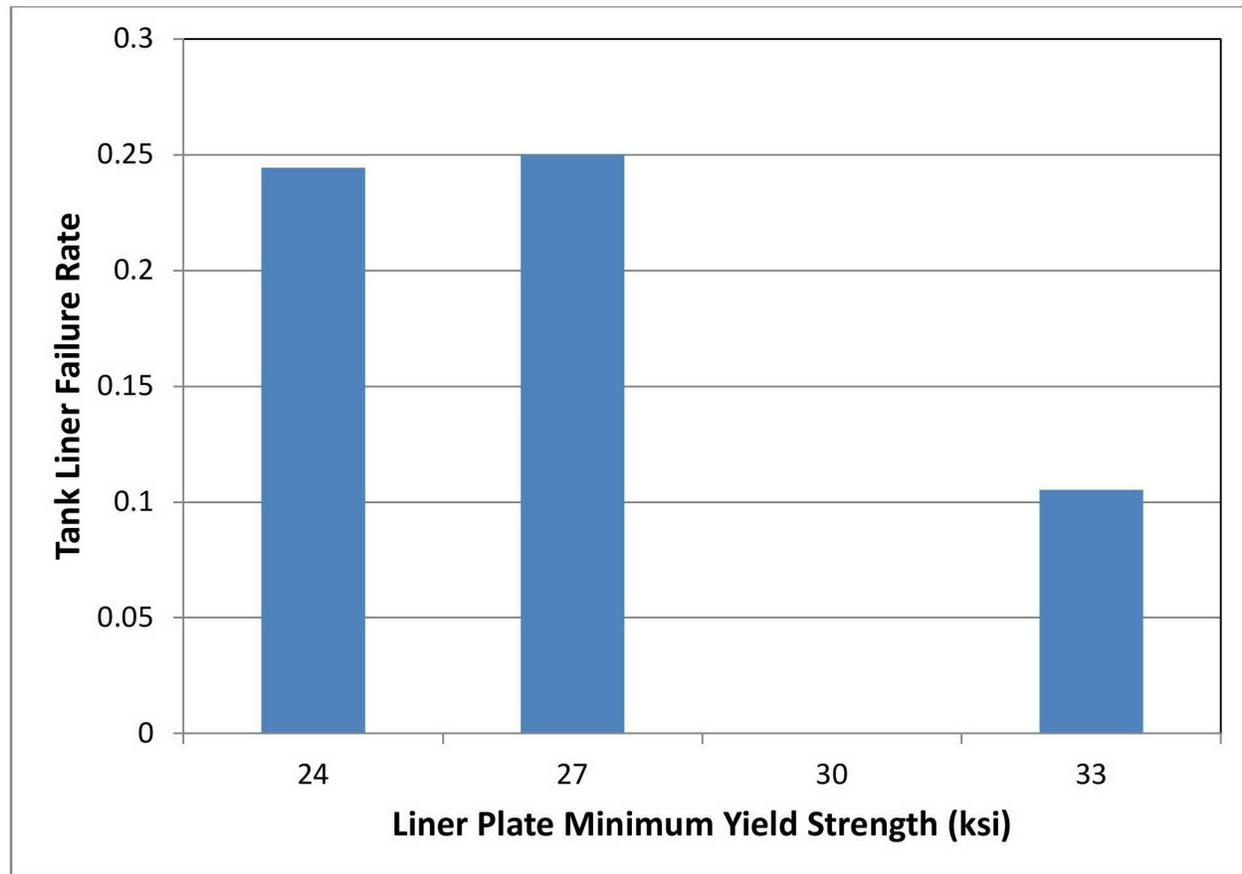
Figure 6-2. Tank Liner Failure Rate as a Function of Liner Plate Minimum Yield Strength

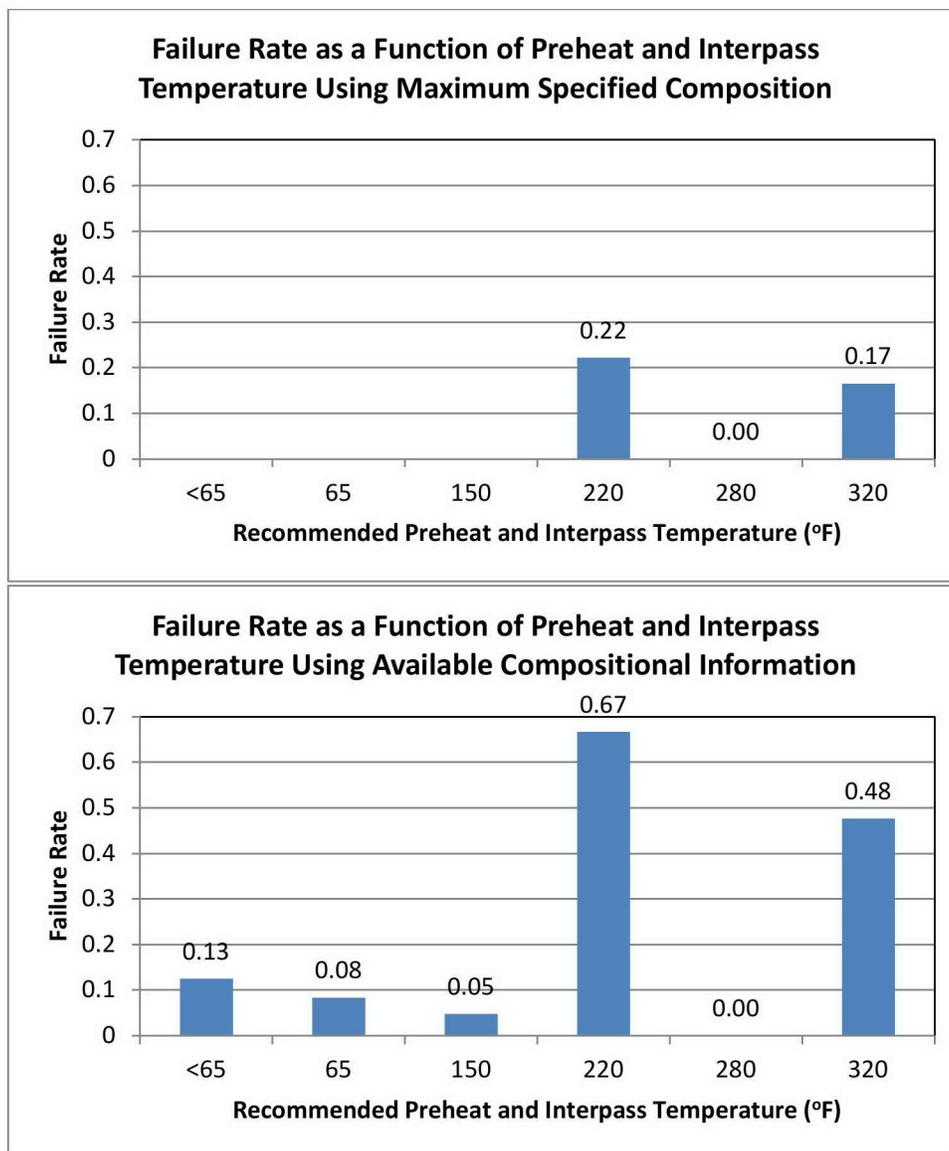
Figure 6-3. Tank Liner Failure Rate as a Function of Preheat and Interpass Temperature, with and without Available Compositional Information

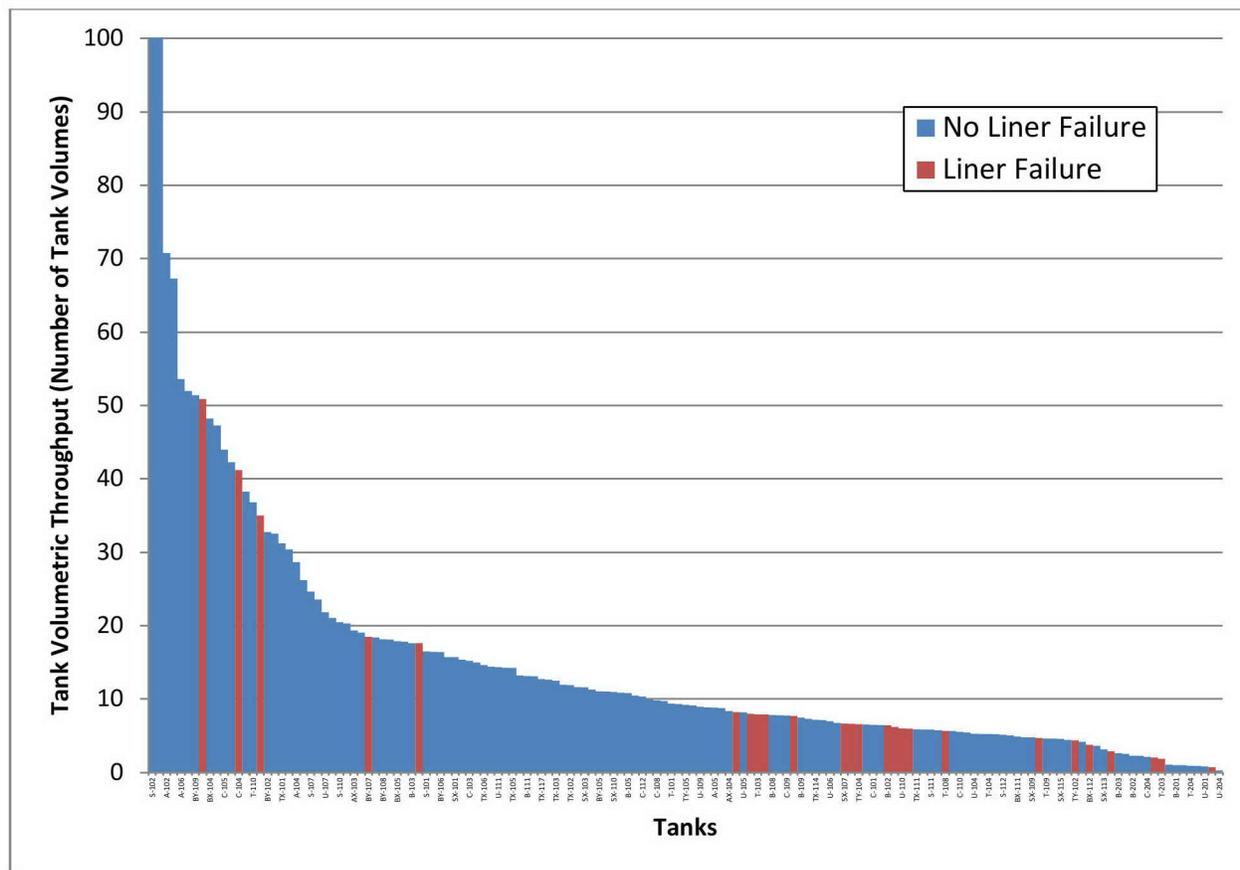
Figure 6-4. Tank Volumetric Throughput in Number of Tank Volumes for Single-Shell Tanks
