WASTE SITE RECLASSIFICATION FORM

Operable Unit: 300-FF-2

Control No.: 2014-106

**SUPPORTING INFORMATION FOR RECLASSIFICATION OF THE
300-291, GARNET SAND WEST OF 350-A PAINT SHOP
WASTE SITE**

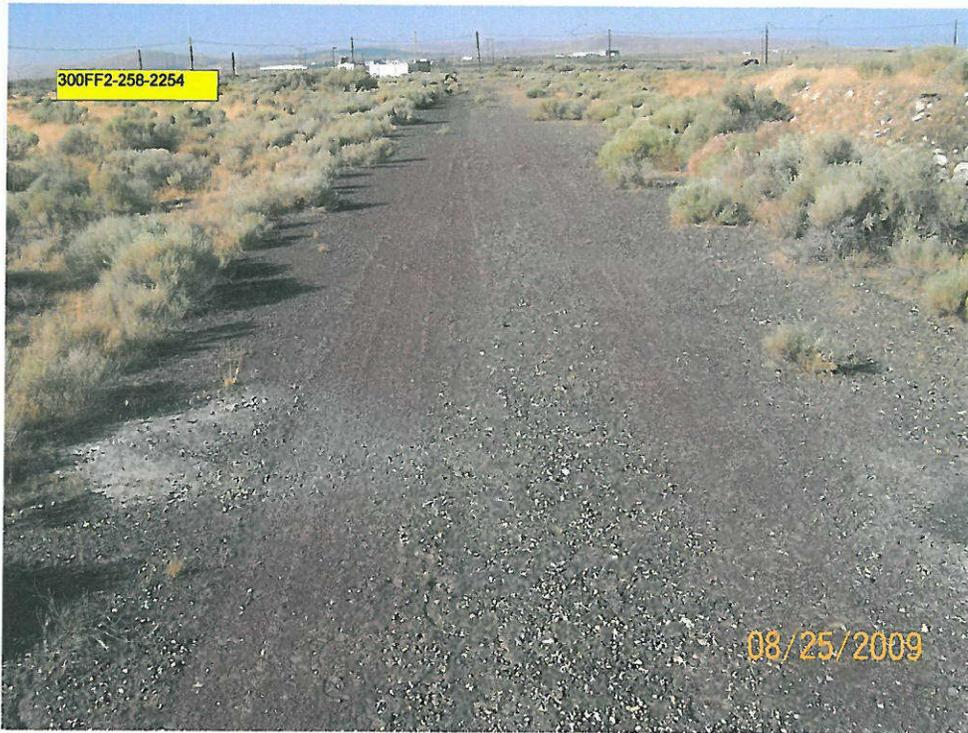
The 300-291 waste site consists of garnet sand on a gravel roadbed (Figure 1) and is located approximately 60 m (197 ft) west of the former location of the 350A Paint Shop. Garnet sand was commonly used in grit-blasting operations to clean rust, paint, or contamination from the surface of metal components. The garnet sand material is not a hazardous substance, but there is potential for contamination from the surface material that was removed by grit blasting. Based on the location of the garnet sand being in close proximity to the 350A Paint Shop, it is likely the garnet sand was used to sandblast painted surfaces.

Figure 1. Photograph of the 300-291 Waste Site in August 2009.

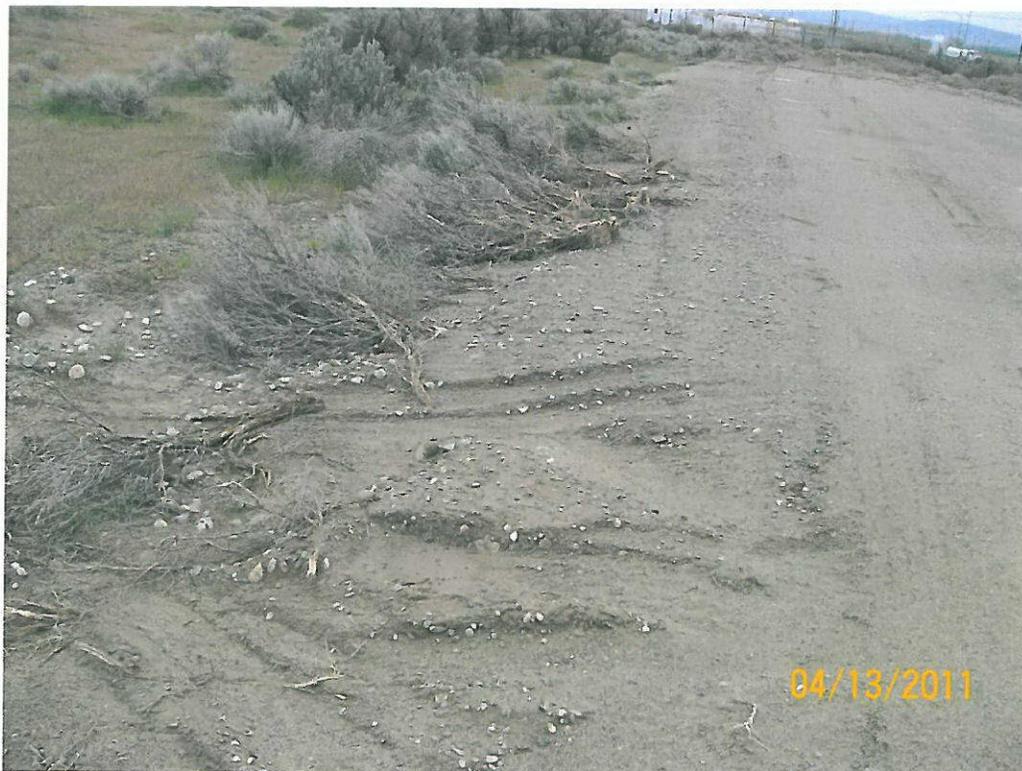
The gravel roadbed was excavated in February 2011 to install a water main to the 385 Pump Station. Following the installation of the 41-cm (16-in.)-diameter water main pipeline, the site was backfilled and covered with approximately 0.6 to 1.0 m (2 to 3 ft) of clean soil (Figure 2). The 300-291 site location map is provided in Figure 3.

Figure 2. Photograph of the 300-291 Waste Site (April 13, 2011).

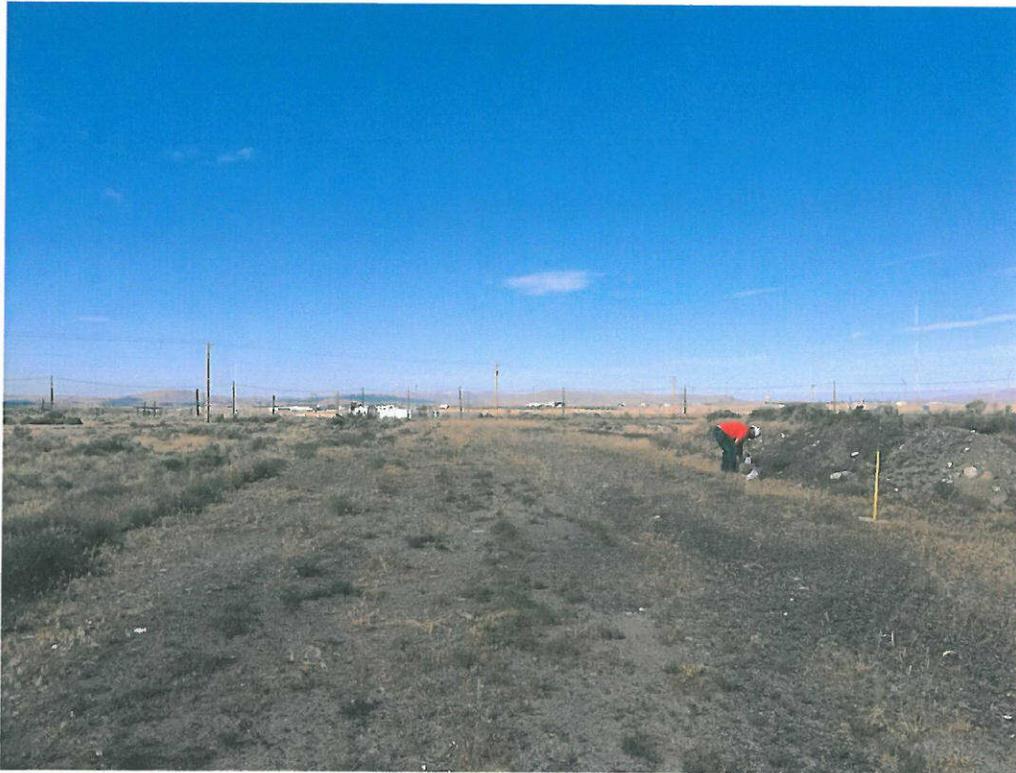
The garnet sand is no longer visible along the gravel/dirt roadway due to the installation of the pipeline; however, a small amount is present on a berm located on the north side of the roadway (Figure 4). A discrete grab in-process sample (J1TWJ8) consisting of garnet sand material and soil was collected from the berm area on June 24, 2014 (Figure 5). The sample was collected to support a determination that residual contaminant concentrations at this site meet the cleanup levels specified in the 300 Area Final ROD (EPA 2013). A summary of the sample collected is provided in Table 1. The sample was submitted for full protocol laboratory analysis and was analyzed using U.S. Environmental Protection Agency (EPA)-approved analytical methods as shown in Table 2.

Figure 4. Photograph of the 300-291 Sample Location.

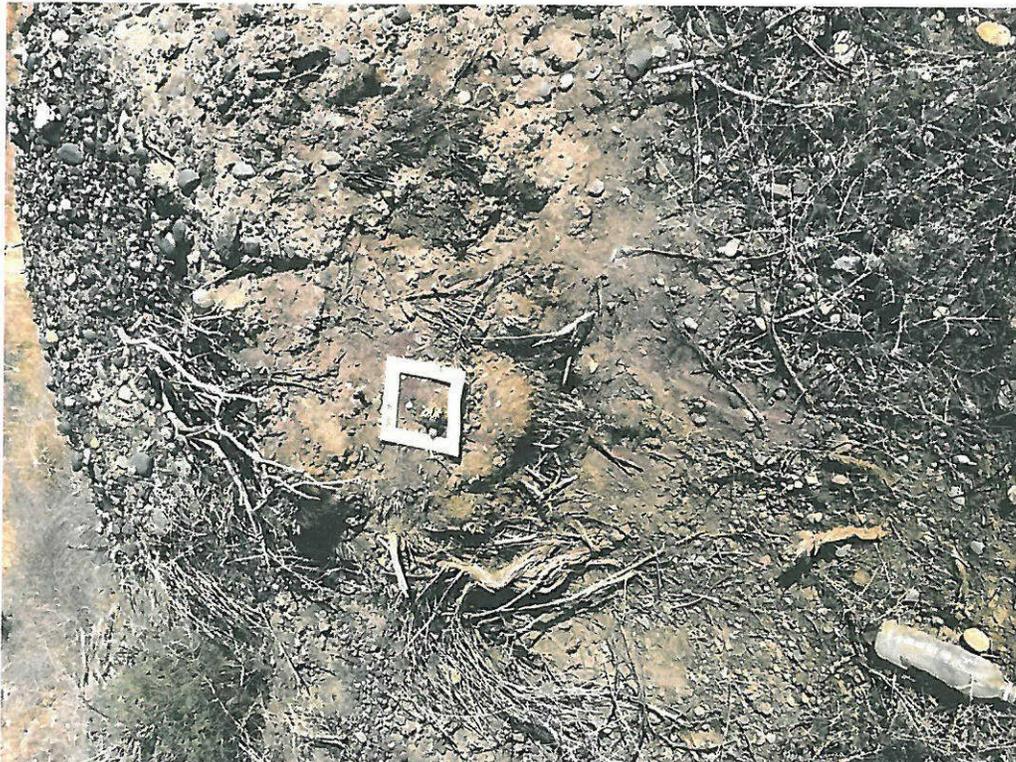
Figure 5. Photograph of the 300-291 Sample Location.
