SUBMITTAL OF ADDITIONAL CLOSURE PLANS FOR CLOSING DANGEROUS WASTE MANAGEMENT UNITS (DWMUs) AT THE T-PLANT COMPLEX

Figure F-1. T-Plant Complex 221-T Tank System

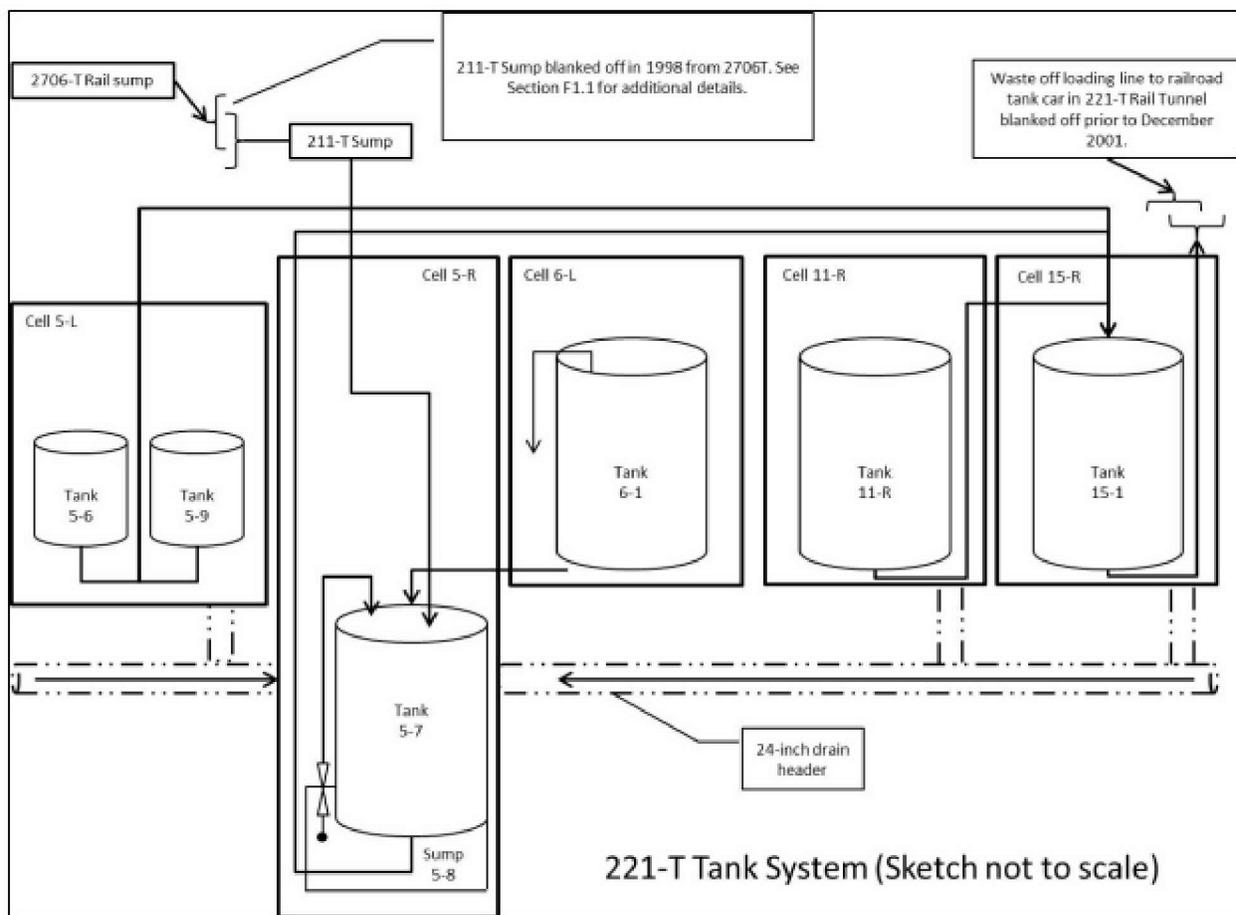
The 221-T Tank System consists of six tanks (Tank 5-6, Tank 5-7, Tank 5-9, Tank 6-1, Tank 11-R, and Tank 15-1), the 211-T Sump, the 5-8 sump, associated piping, and ancillary equipment. The six tanks are stainless steel, closed bottom tanks of varying size that have been isolated from further waste addition and are, therefore, considered non-operational (Figure F-1). The 5-8 sump is located in 221-T Cell 5R below Tank 5-7. The 211-T Sump is located between the 2706-T Building and the 221-T Building and has been isolated and is awaiting closure. The six tanks, 211-T Sump, 5-8 sump, and waste transfer piping and ancillary equipment leading from the tanks to the first isolation point will be closed under this plan.

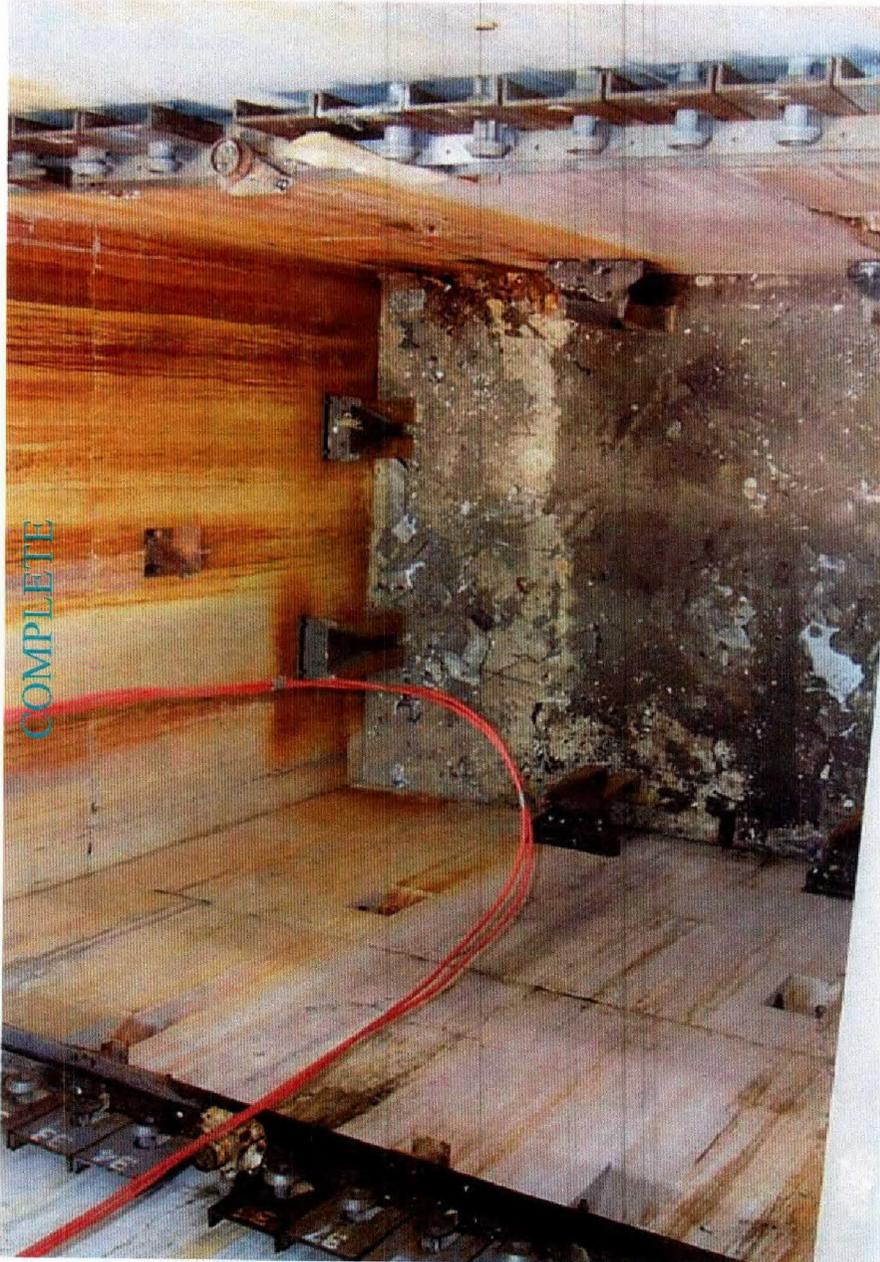
Cell 3L 2001

<i>New Cell No</i>	3L
<i>Old Cell No</i>	5
<i>HNF-1982 Info</i>	Coating removal, metal dissolving, and reduction.
<i>MR-0452 Info</i>	Coating removal, metal dissolving, and reduction.
<i>HNF-1982 Recent</i>	Essentially empty except for a few pieces of junk at the bottom. Exceptionally clean compared with the other cells.
<i>ISB and LTDES</i>	Misc. Equipment
<i>Video Info</i>	1986 - relatively empty. Small debris, hose, step off pad, tubing, misc. junk. [1:05:47 - 1:06:53] 4/23/01 - As above. Dry. Orange-stained, unchipped walls. No large items. Wrapped items, concrete chunks, tools/other metal items, many chokers, plastic.
<i>Chemical Info</i>	
<i>Plant Interface</i>	
<i>Radiological Info</i>	100-200 mR/hr shallow dose, 0 deep dose, cell bottom prior to cell cleanout (T Plant handout)
<i>Interview1</i>	
<i>Interview2</i>	
<i>Current Contents</i>	Sludge storage rack - cell ready to receive KE Basin sludge containers

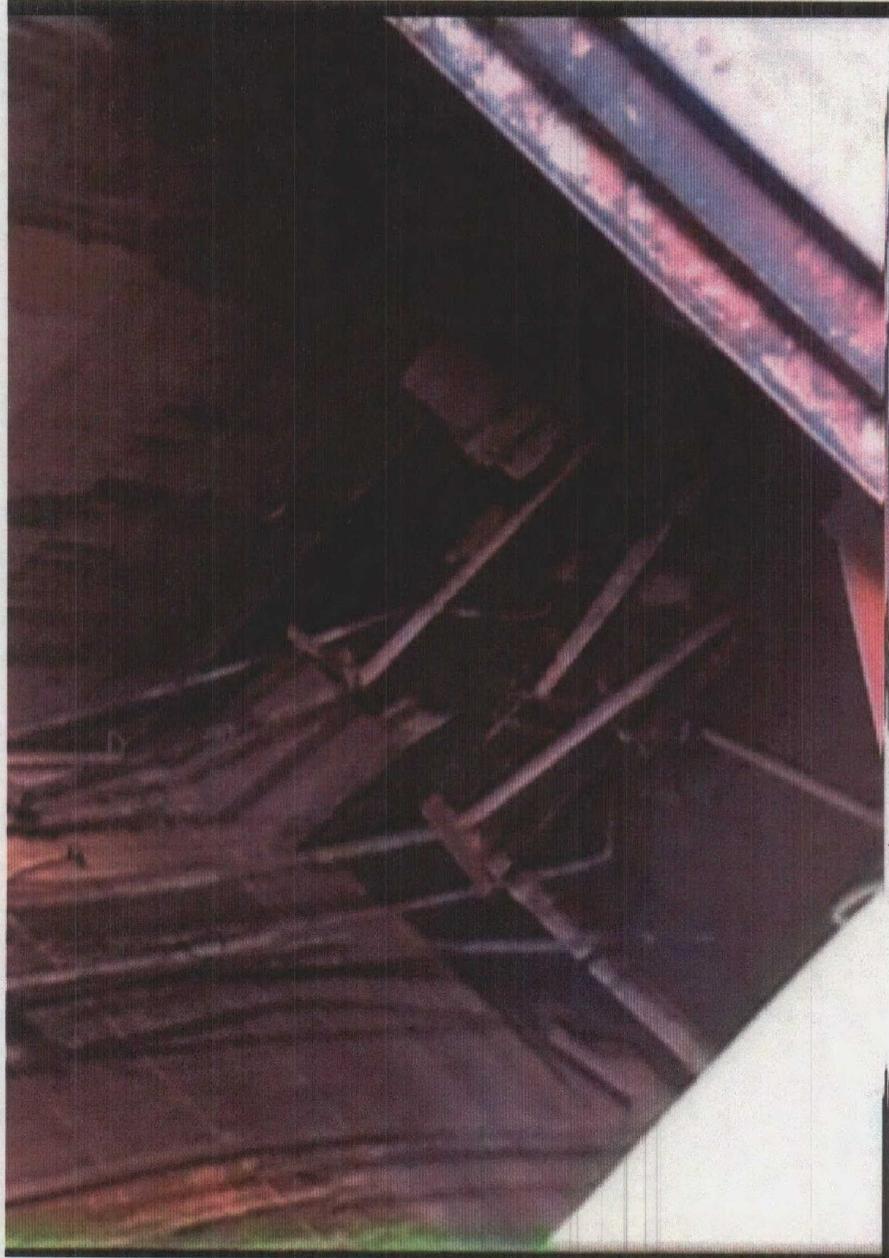
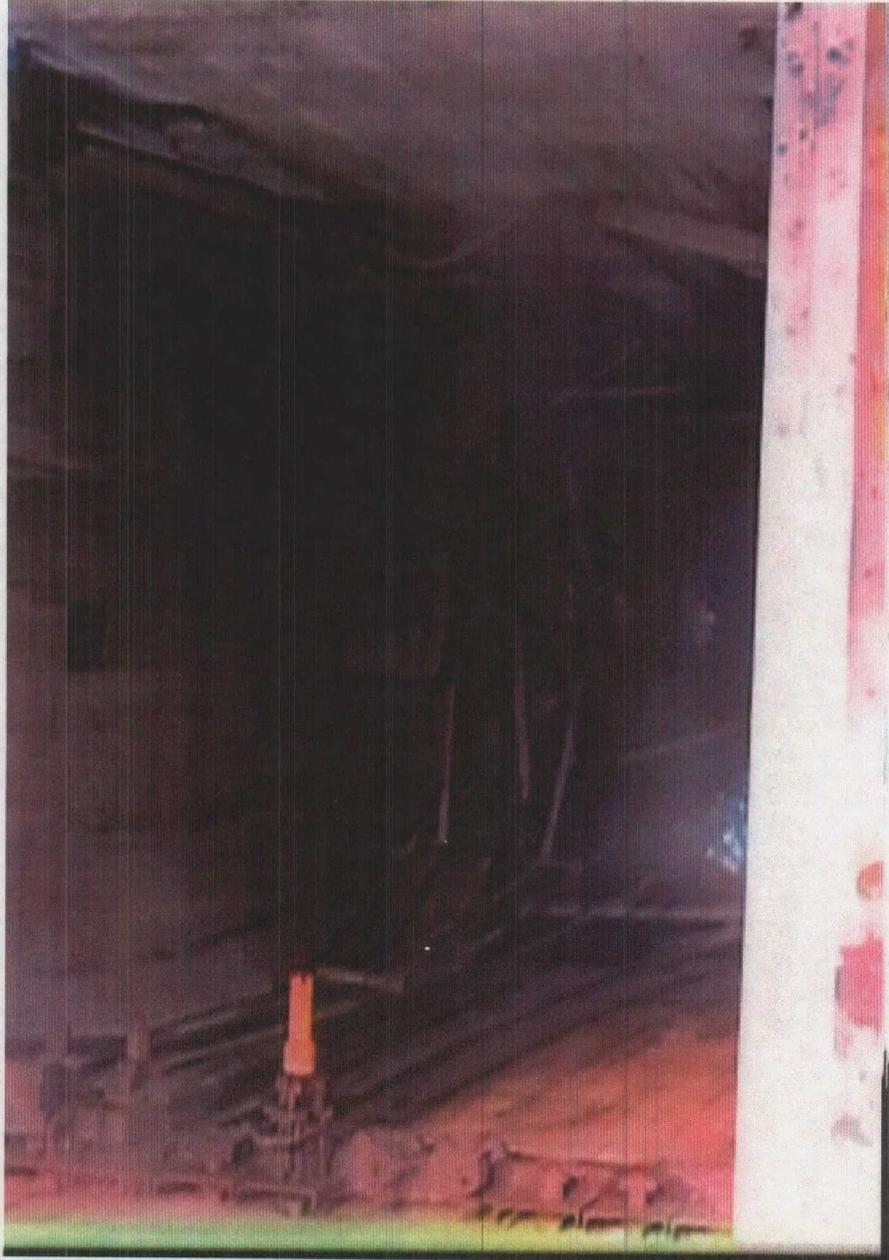
Cell 5R 1986

New Cell No	5R
Old Cell No	10
HNF-1982 Info	Sewage disposal, sewer cell.
MR-0452 Info	Sewage disposal, sewer cell. [Note that this does not mean sanitary sewage, but process sewage].
HNF-1982 Recent	Deepest cell in the plant. Full cell rectangular open-top tank (5-7 tank). The cell is called the 5-8 tank, no longer in use as a tank. It is possible to jet the contents of tank 5-7 to tank 5-9, also 5-7 to 5-6. Jumpers on the wall (~6), and a number of junk jumpers (~4) in the bottom of the cell. One 40' jumper, high (?) side, not connected. Back wall five 40' jumpers to 5-7, one loose. Low side eight 4'- jumpers. 24" drain - front corners. Flooded, much sludge.
ISB and LTDES	Original Equipment Tank 5-7 (38,000 L [10,000 gal]) LTDES Decon Function: Radioactive liquid waste storage. Open tank 5-7 (SS, 14,000 gal) and sumps 508 (14' X 16' X 22') The radioactive drain lines from all other cell floors drains in tank 5-7

Video Info	1986 - Almost full-size tank in cell with liquid. Liquid was over the level of the top of the tank at this time (tank not visible). Pipes, jumpers. Tank appears to be constructed with a "flared out bottom" (cell widens out in deeper areas). 2001 - Liquid within tank. Cracked sludge on side walls. No jumpers, 45' deep receiver tank, two 24" headers terminate above tank, active bubbling (probably from "nozzle 47 - liquid level and pressure"), rack and pump above water, >2" cracked overflow sludge adjacent to tank, rad sign, plastic bottle, orange stain on walls. (Video footage 19:19-26:23 and 29:46-33:47)
Chemical Info	F001-F005 from tank 5-7 contents; PCBs >500 ppm in waste
Plant Interface	
Radiological Info	
Interview1	
Interview2	
Current Contents	Tank 5-7 (contains liquid and sludge) and installed jumpers.
Property List	Tank (Struthers Wells).
Investigation Status	Complete - opened 2001

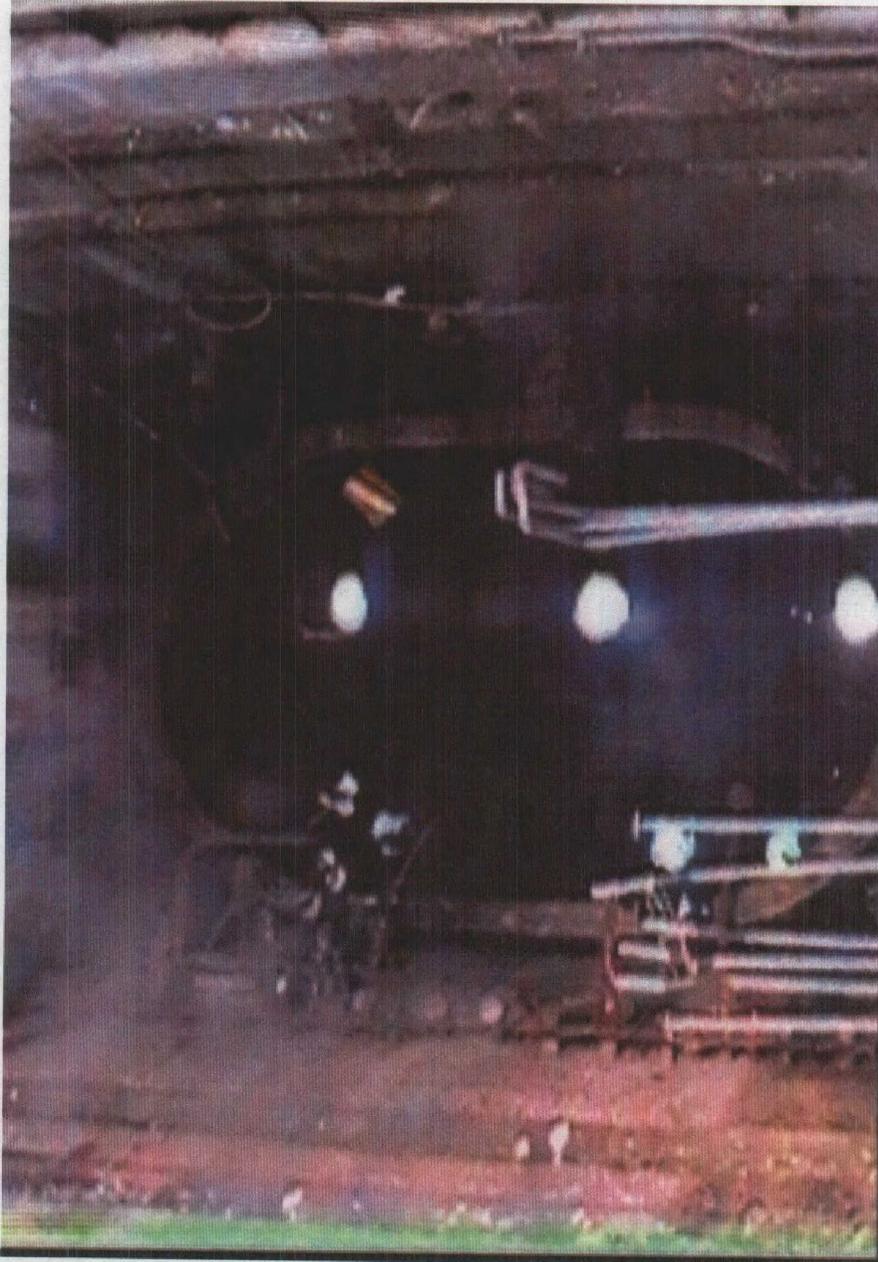
Cell 15R 1986

New Cell No	15R
Old Cell No	30
HNF-1982 Info	Treatment of decontamination wastes.
MR-0452 Info	Treatment of decontamination wastes. Section 15 contained a standard grouping of process equipment that consisted of four pieces: a precipitator, a catch tank, a centrifuge, and a solution tank.
HNF-1982 Recent	Cover block steel and concrete (all other cells not noted are concrete). Contains large oval open-top tank in bottom of cell, not believed to be original. Installed in 1960 from U or B Plant (?), receives waste from tank 5-7. Some jumpers appear to be connected (~5). 4 jumper heads (no good). Drain not plugged. Flow to drain good. Bottom of cell has little bit of trash.
ISB and LTDES	<p>Waste Tank 15-1 (53,000 L [14,000 gal])</p> <p>LTDES Decon. Equip.: Decon Thimbles. Immersion tank for chemical decon purposes. Piping includes air, steam, caustic, acid, and water. 48" deep by 30" diameter, SS, 350 gal. Capacity. 48" deep by 36" diameter, SS, 332 gal. Capacity.</p> <p>4 to 1 and 5 to 1 Portable Chemical Spray Pumps. Location Where Needed (i.e., 11R, 13R, 15R). Beta-gamma decon using chemicals or water. Pressure at nozzle four times greater than air pressure applied. SS pump section. Outlet discharge pressure is four or five times greater than inlet pressure.</p> <p>LTDES Decon Function: Radioactive liquid waste storage. Open tank 15-1 (SS, 14,000 gal. Capacity)</p>

Video Info	1986 - Oval tank without lid full of liquid (same design as tank in 11L and 11R). [1:06:54 - 1:08:35]
Chemical Info	Assume F001-F005 from tank 15-1 contents. PCBs found in tank sludge (T Plant sample 221T-99-023)
Plant Interface	
Radiological Info	
Interview1	
Interview2	
Current Contents	Tank 15-1 (large open-top tank)
Property List	Tank (Hanford)
Investigation Status	Cell is visible.

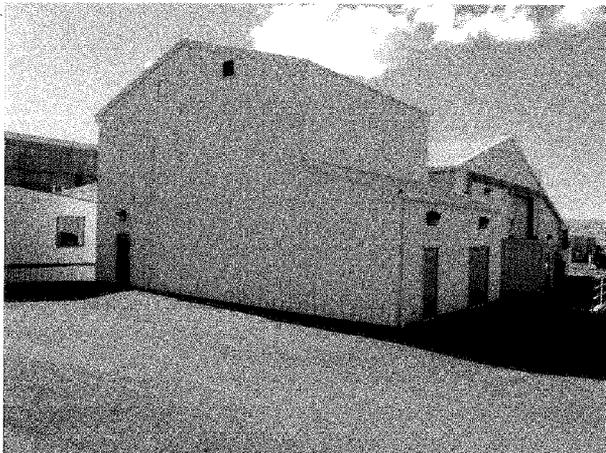
T Plant Complex 2706-TB Building Storage Area

No waste is being stored in this area. The 2706-TB building tanks have been emptied and deactivated (Tank T-XX-2706-220 and T-XX-2706-221). The 2706-TB Building houses a functioning air compressor which is still required for operation of the Drum Venting Assemblies in 2706-T and 2706-TA. This compressors' Automatic 'Blow Down' drain has cause a visible spot in the 2706-TB sump (see photographs). No other spill evidence was noted.

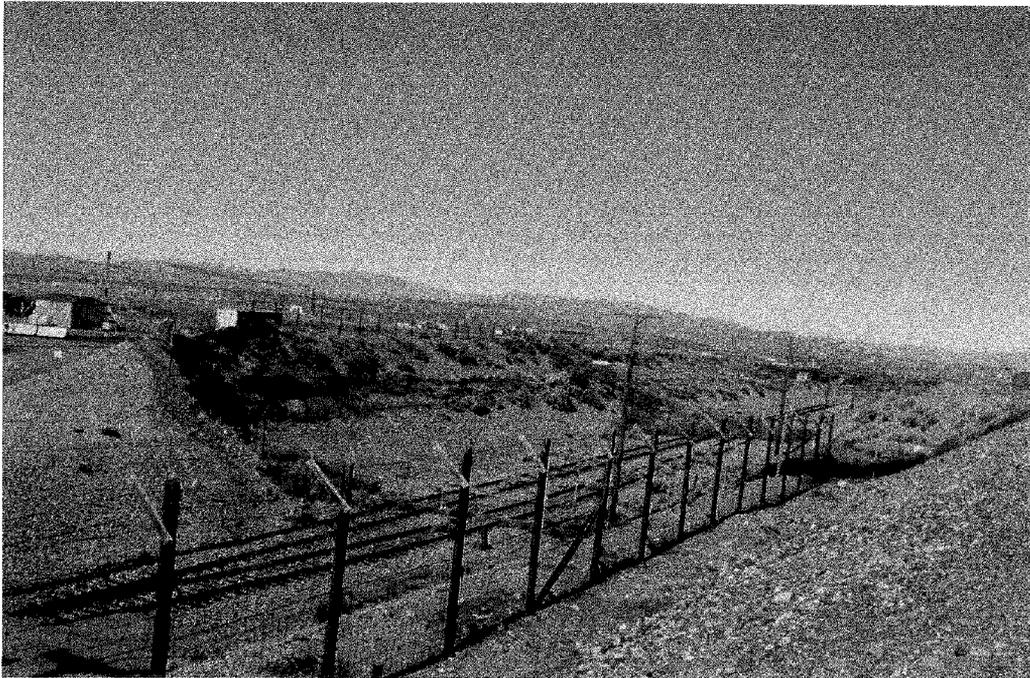
T Plant Complex 221-T Railroad Cut Storage Area

No waste is being stored in this area. Area consists of abandoned rail road tracks, gravel, tumbleweeds, and an inner and outer chain link fence and gates. Some debris was noted at the Western end of the Cut. Debris consists of steel plate, steel pipe, railroad ties, and a metal storage box (see photographs).

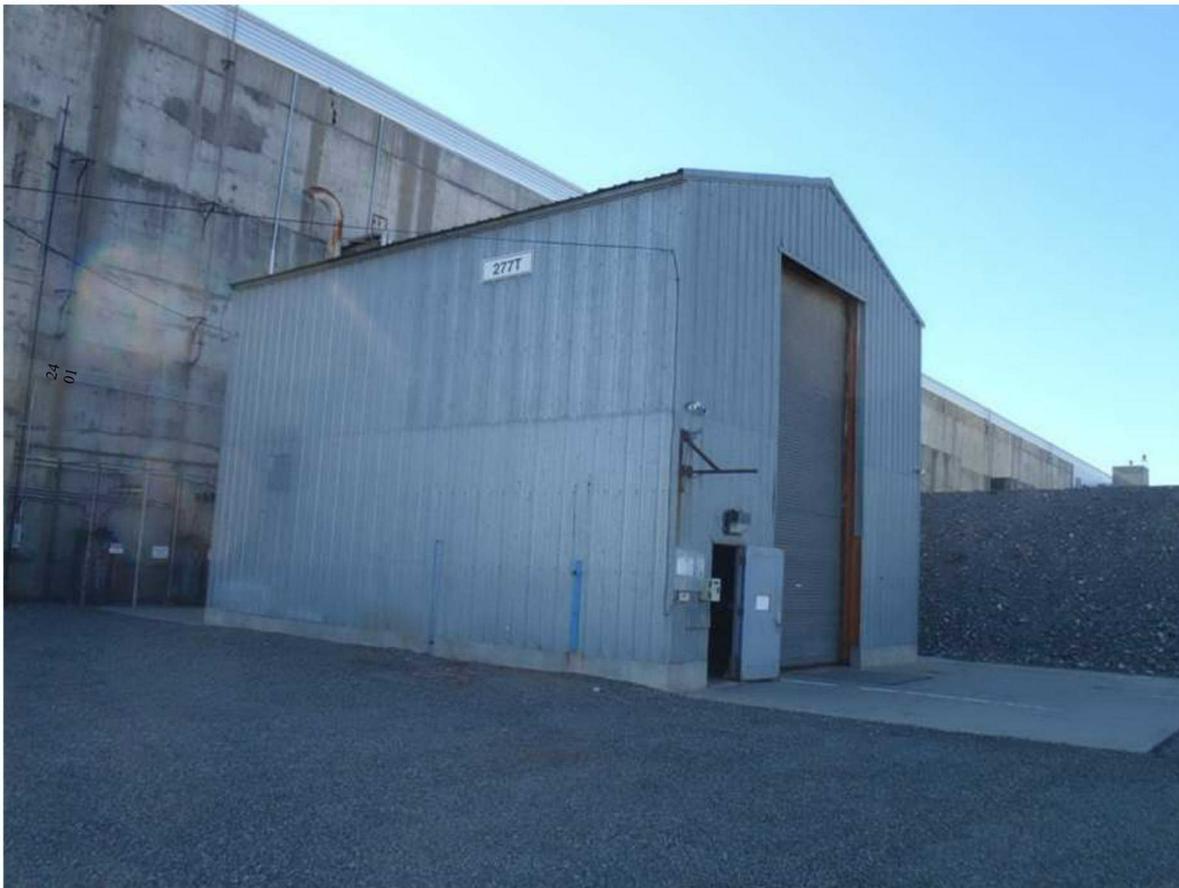
11
12 **Figure I-1. T-Plant 277-T Building**

38 The maximum inventory of dangerous, mixed, or TSCA-PCB waste stored in the 277-T Building over its
39 lifetime included one container of mixed, TSCA-PCB waste with a total volume of 27 m³ (36 yd³).
40 The waste was introduced into the 277-T Building in December 2002 where it was overpacked and stored
41 until September 2003. Details on the dangerous, mixed, and TSCA-PCB waste container are presented in
42 Section I3.3 of this closure plan.

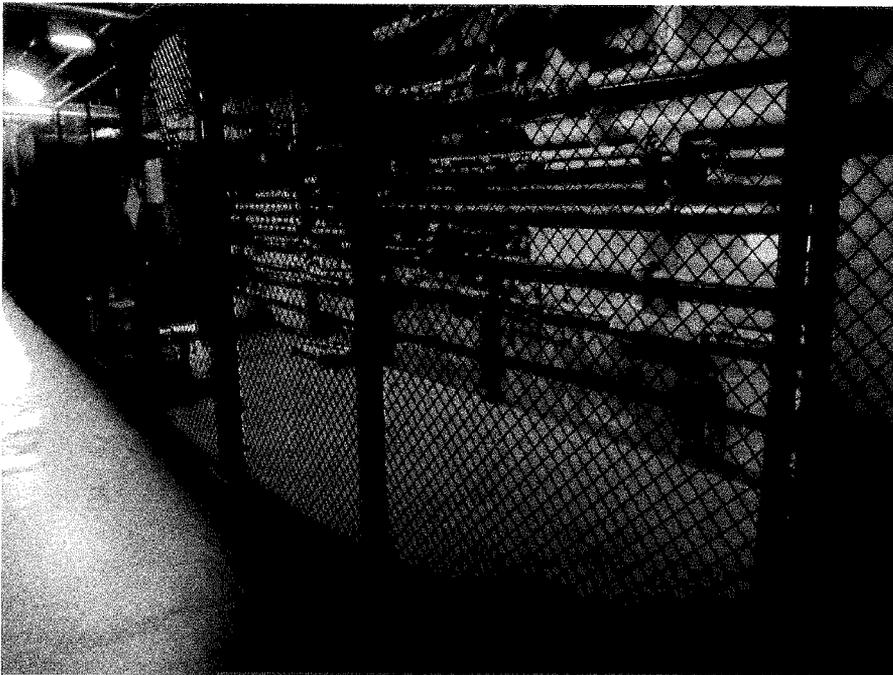
T Plant Complex 221-T Pipe Gallery Storage Area

Concrete floor is sealed with paint no evidence of cracking or peeling. Painted floor surface shows no evidence of staining or waste spills. Area contains old process piping along the East wall. Markings on these pipes indicated they are abandoned, no evidence of leakage. No waste is being stored in this area. Area is currently storing spill cleanup material/product; kitty litter and soil cement.
