## WASTE SITE RECLASSIFICATION FORM

Operable Unit: 100-NR-1

Waste Site Code(s)/Subsite Code(s): 1908-N, 1908-N Outfall

**1908-N, 1908-N REACTOR OUTFALL FACILITY  
STATUS CHANGE FORM**

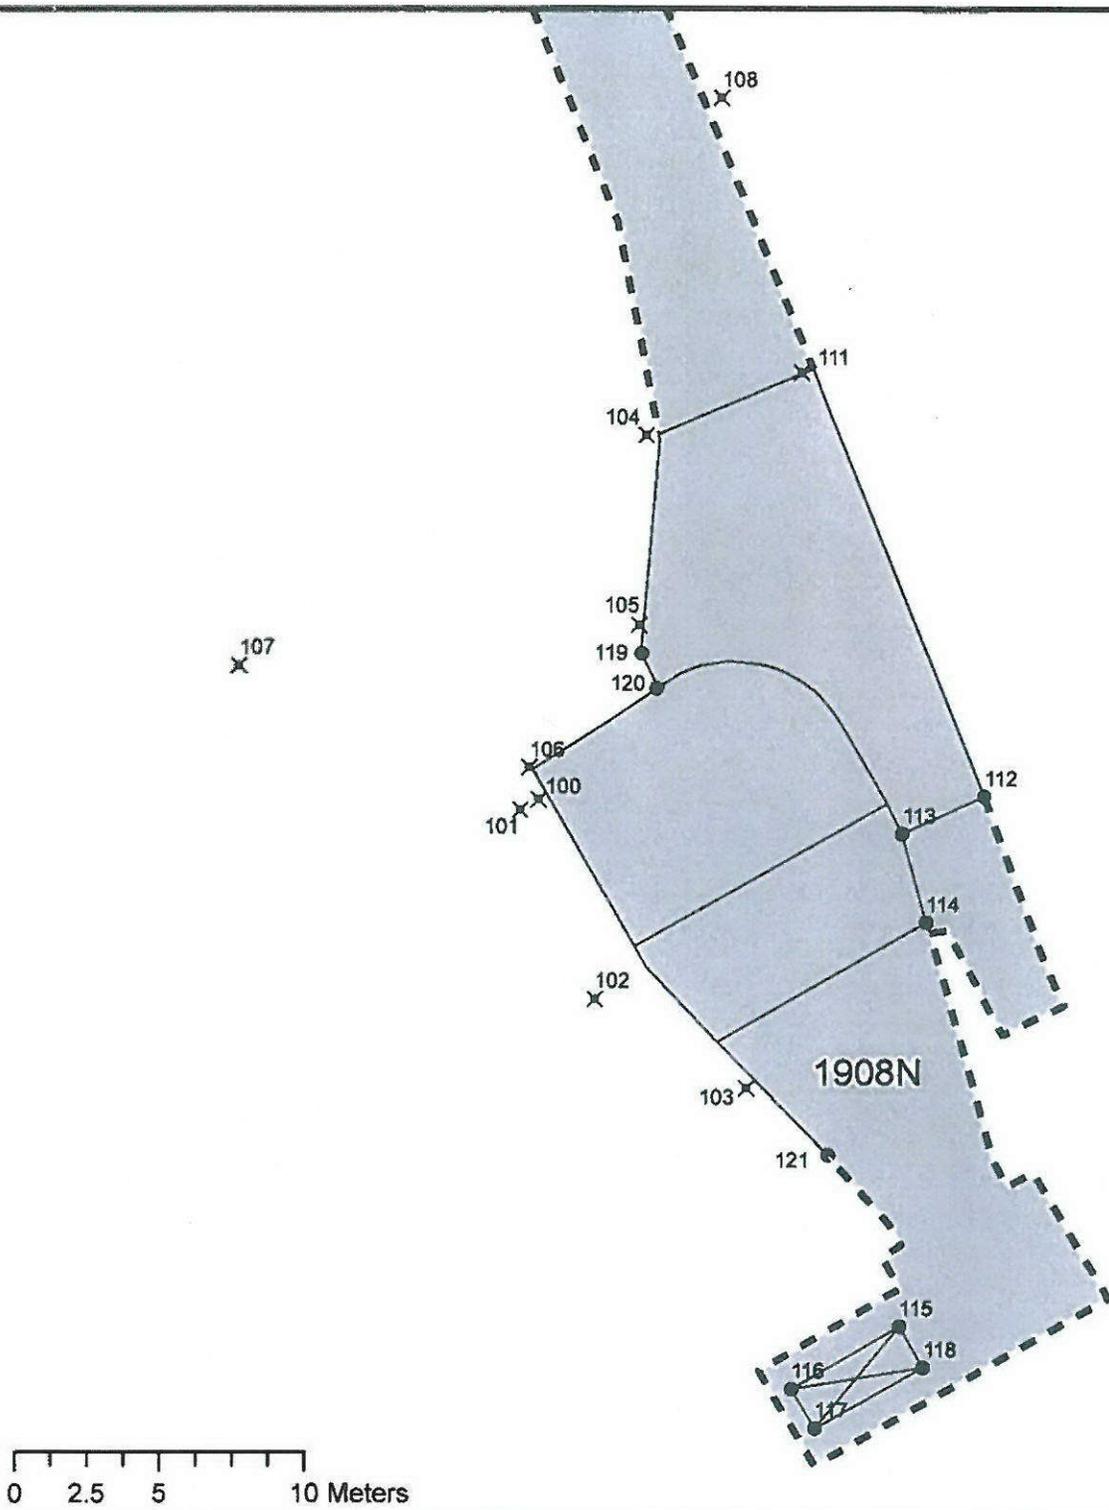
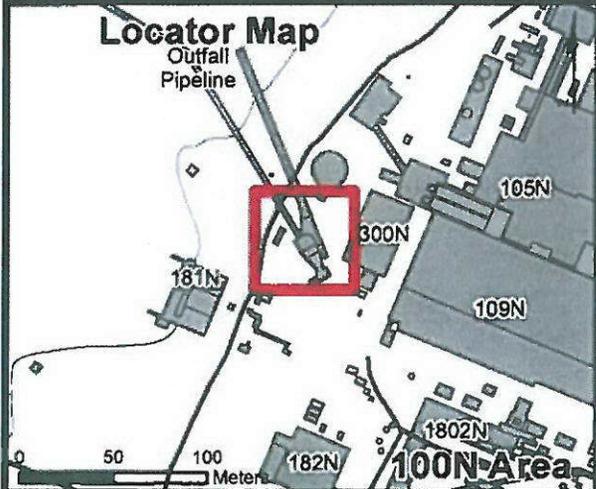
## GPS Pre Demo Report For 1908N

Survey Project Name: Pre Demo Survey for 1908N  
 Date: 6/11/2012  
 Equipment: 5800  
 Survey Purpose: Pre Demo Survey for 1908N  
 Requested By: Thomas Yamamoto  
 Location: 100N  
 Charge Code:  
 Field Surveyor: Margo Aye  
 Survey Software Used: Trimble Survey Controller, and Geomatics Office V.11  
 Survey Equipment Used: 5800  
 Control Monuments Used: N-2  
 Survey Method: RTK  
 Horizontal Precision: .020m  
 Vertical Precision: .050m  
 Fieldwork Start Date: 01/16/12  
 Fieldwork Completion Date: 01/16/12  
 Notes: Not all areas of the building were accessible so they were derived via GIS.

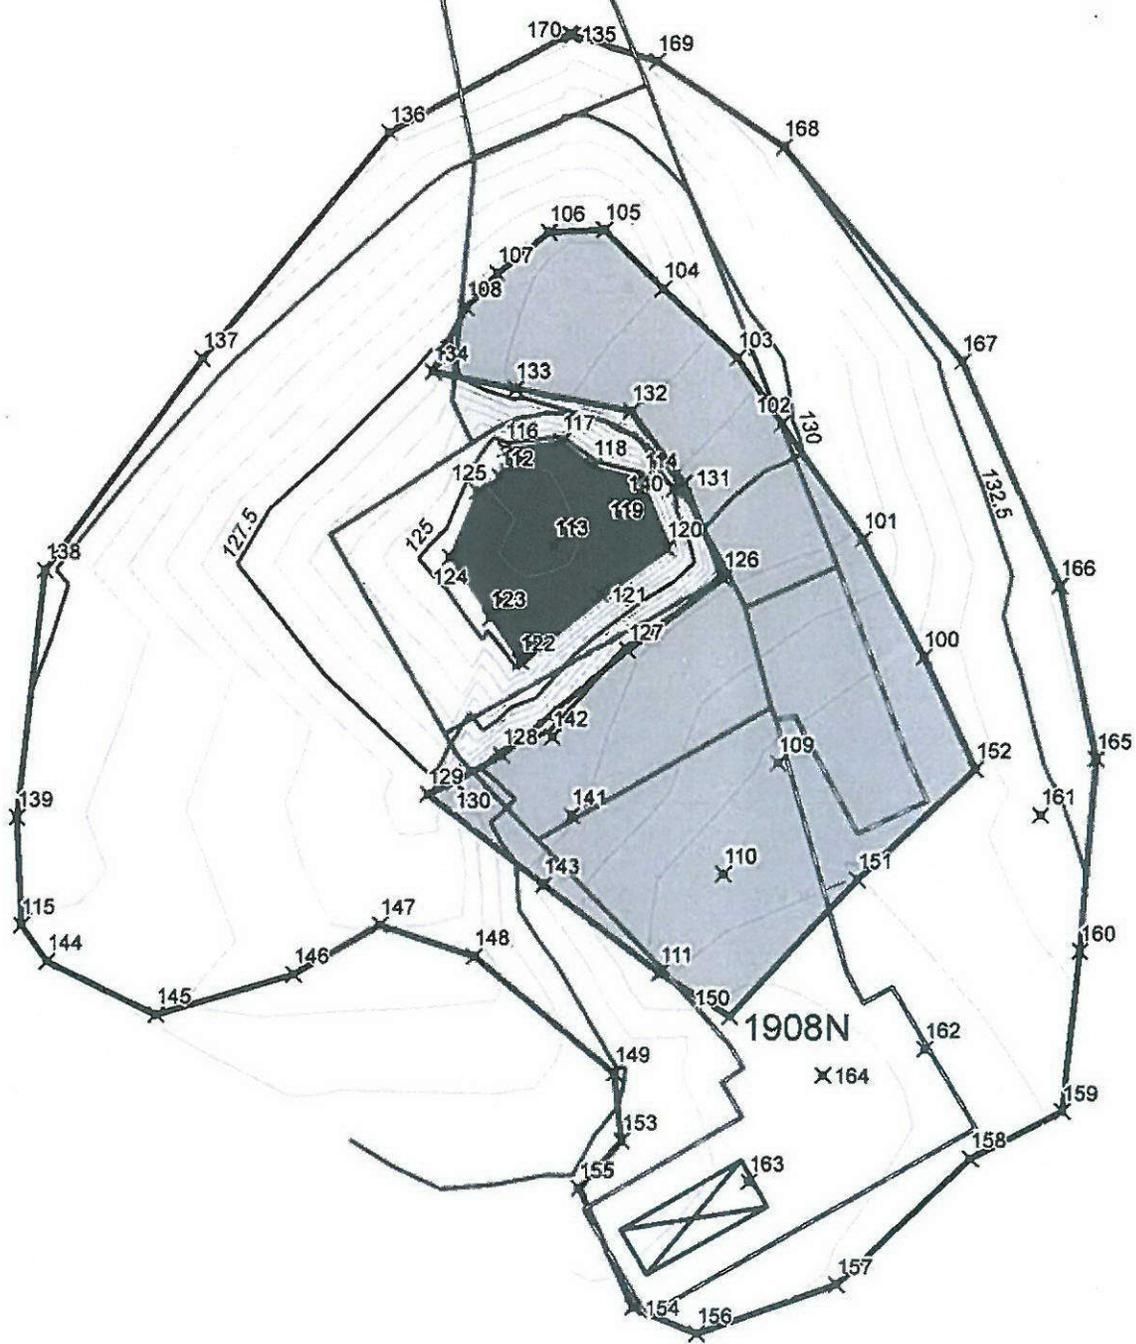
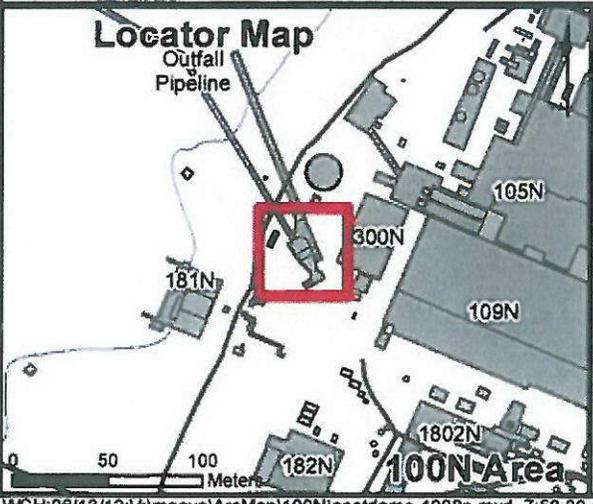
### GPS Post Demo Report For 1908N

- x GPS Points (See Survey Report for Point Details)
- Major Contour 2.5m
- Minor Contour .5m
- █ Excavation Toe
- ▒ Excavation Daylight
- ▒ Monolith
- - - 1908N Below Grade (Pre Demolition)
- ▭ Building Location (Pre Demolition)

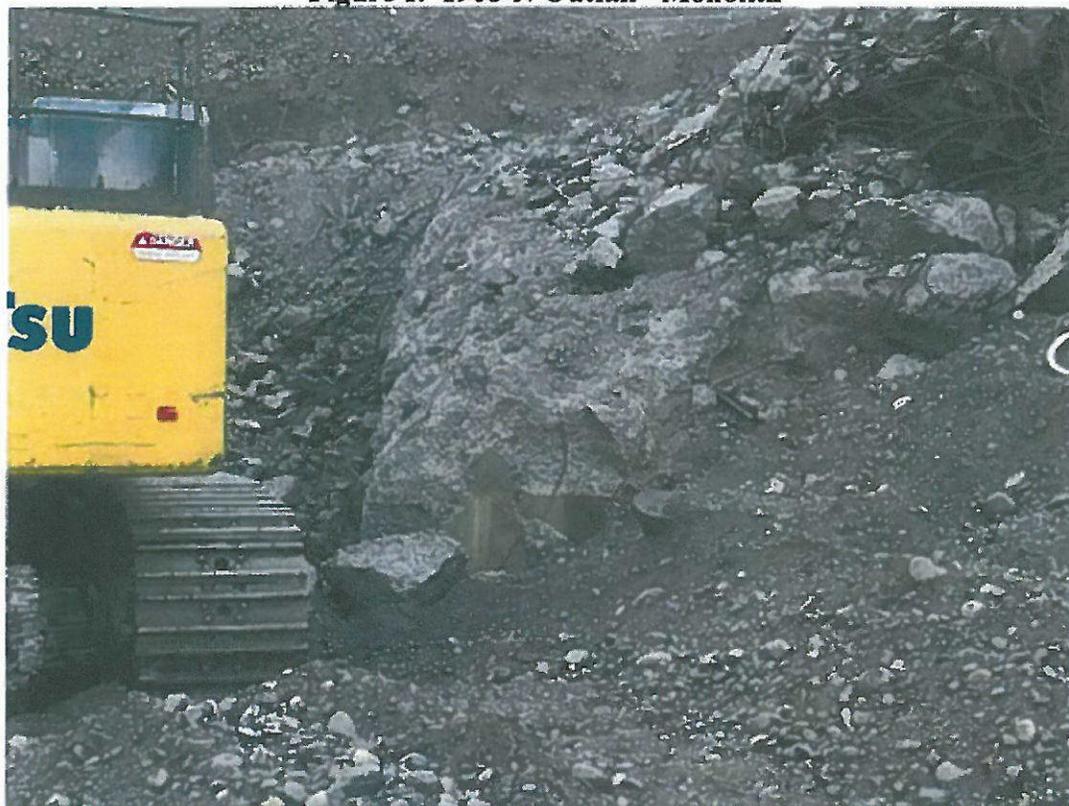
Figure I. 1908-N Outfall - Monolith

On April 26, 2002, a sample of concrete was collected from the 1908-N concrete monolith that remains after demolition of the 1908-N Outfall structure (Figure 1). The sample was chipped from the monolith and submitted for laboratory analysis to evaluate potential contaminant concentrations and make a decision concerning whether or not this material may remain in place or requires removal as provided in the *Removal Action Work Plan for 100-N Area Ancillary Facilities* (DOE-RL 2012). The concrete sample was collected in accordance with ENV-1, *Environmental Monitoring & Management*, to fulfill the requirements of the *100-N Area Remedial Action Sampling and Analysis Plan for CERCLA Waste Sites* (SAP) (DOE-RL 2006a).

Evaluation of the results provided in Table 3 indicate that all COPCs were either undetected or were quantified below remedial action goals (RAGs) and soil lookup values with the exception of copper and zinc which were detected above the soil RAGs for protection of the Columbia River. However, based on RESRAD modeling discussed in Appendix C of the 100-N Area RDR/RAWP (DOE-RL 2006b), residual concentrations of copper and zinc are not predicted to migrate more than 3 m (9.8 ft) in 1,000 years, based on copper, having the lowest partitioning coefficient, 22 mL/g. The vadose zone underlying the concrete monolith at the 1908-N outfall is approximately 4.4 m (14.5 ft) thick. Therefore, residual concentrations of copper and zinc are predicted to be protective of groundwater, and thus, the Columbia River.

**We reviewed the data and approve of leaving the monolith in place. Can you make sure that the attachment can be referenced at a later date?**  
**Thanks,**

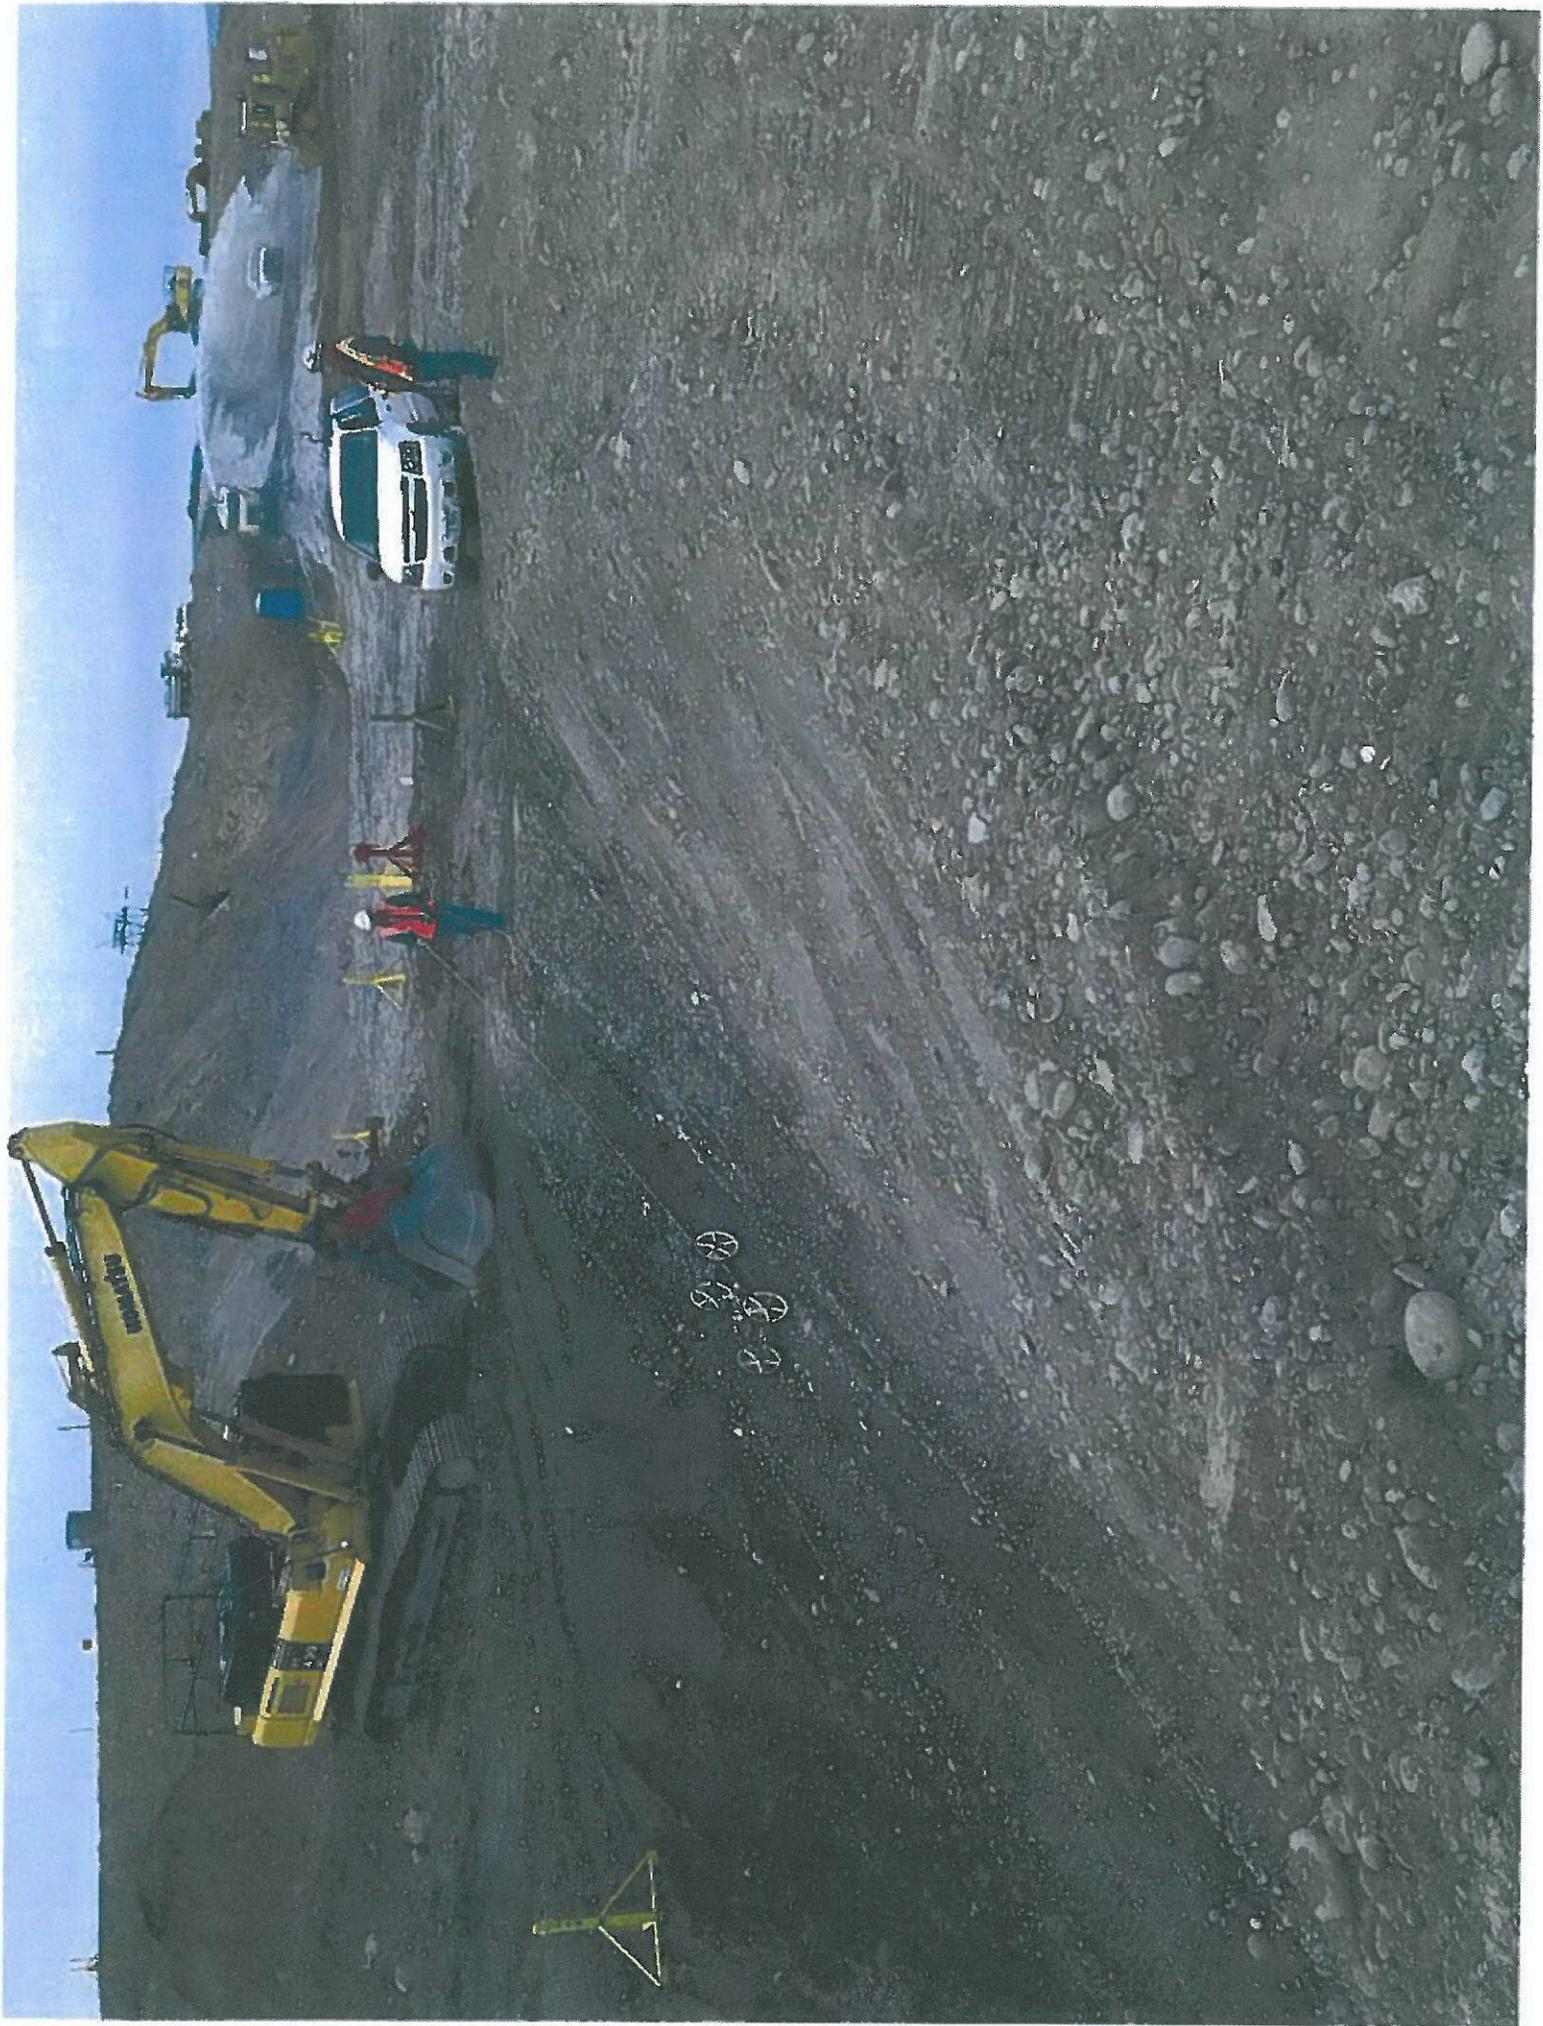
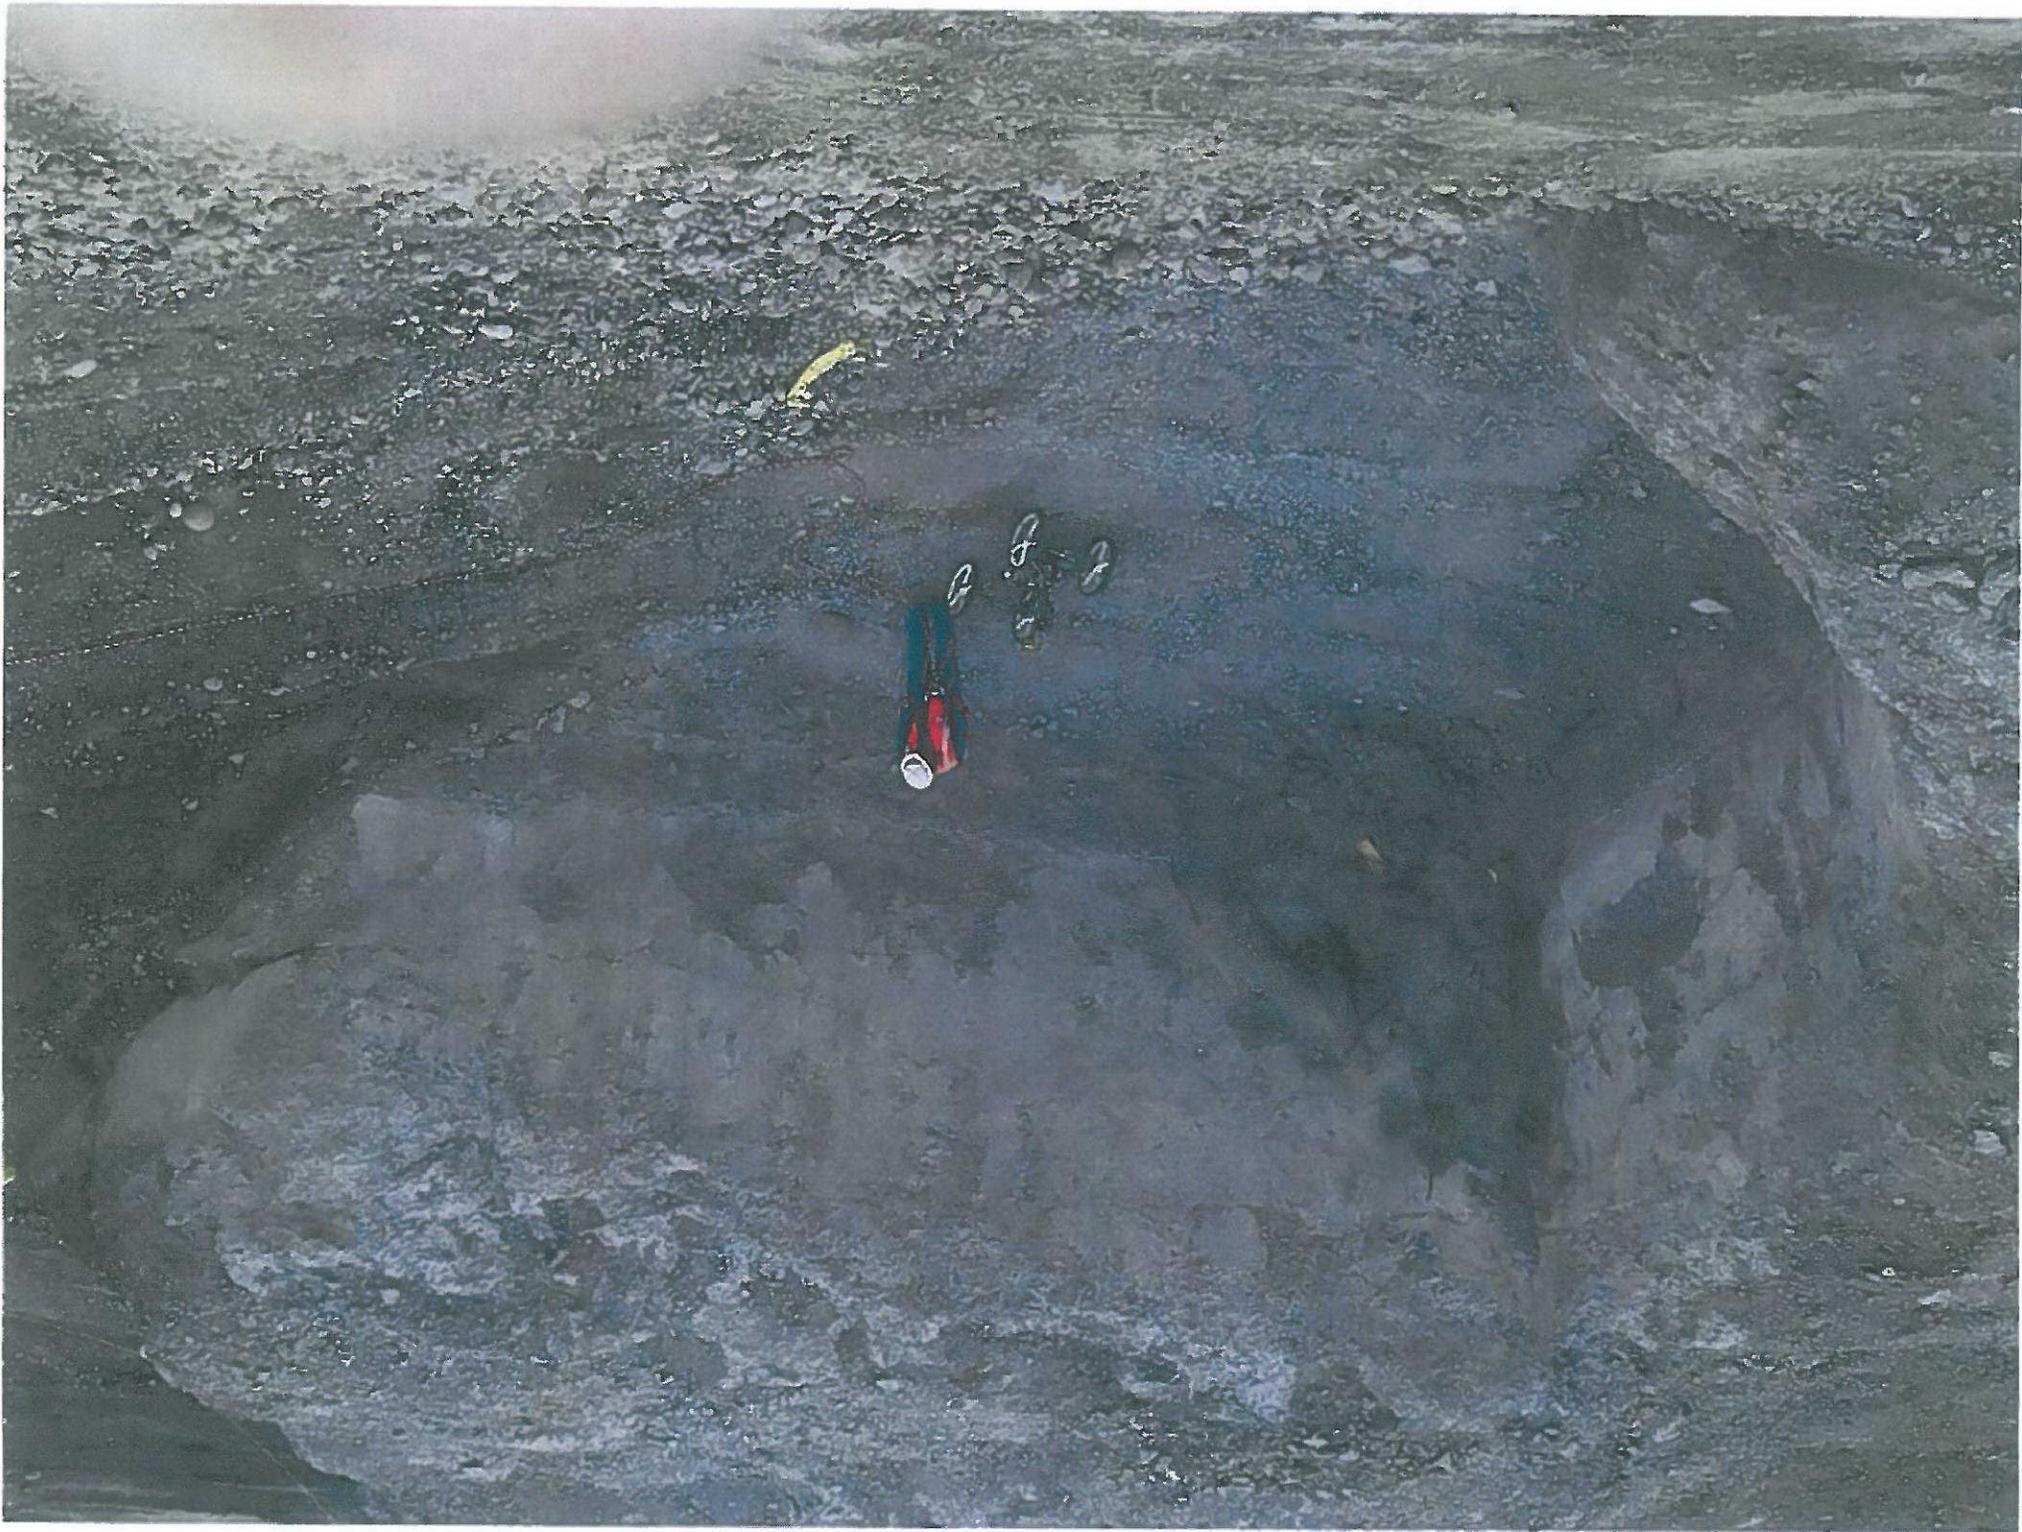
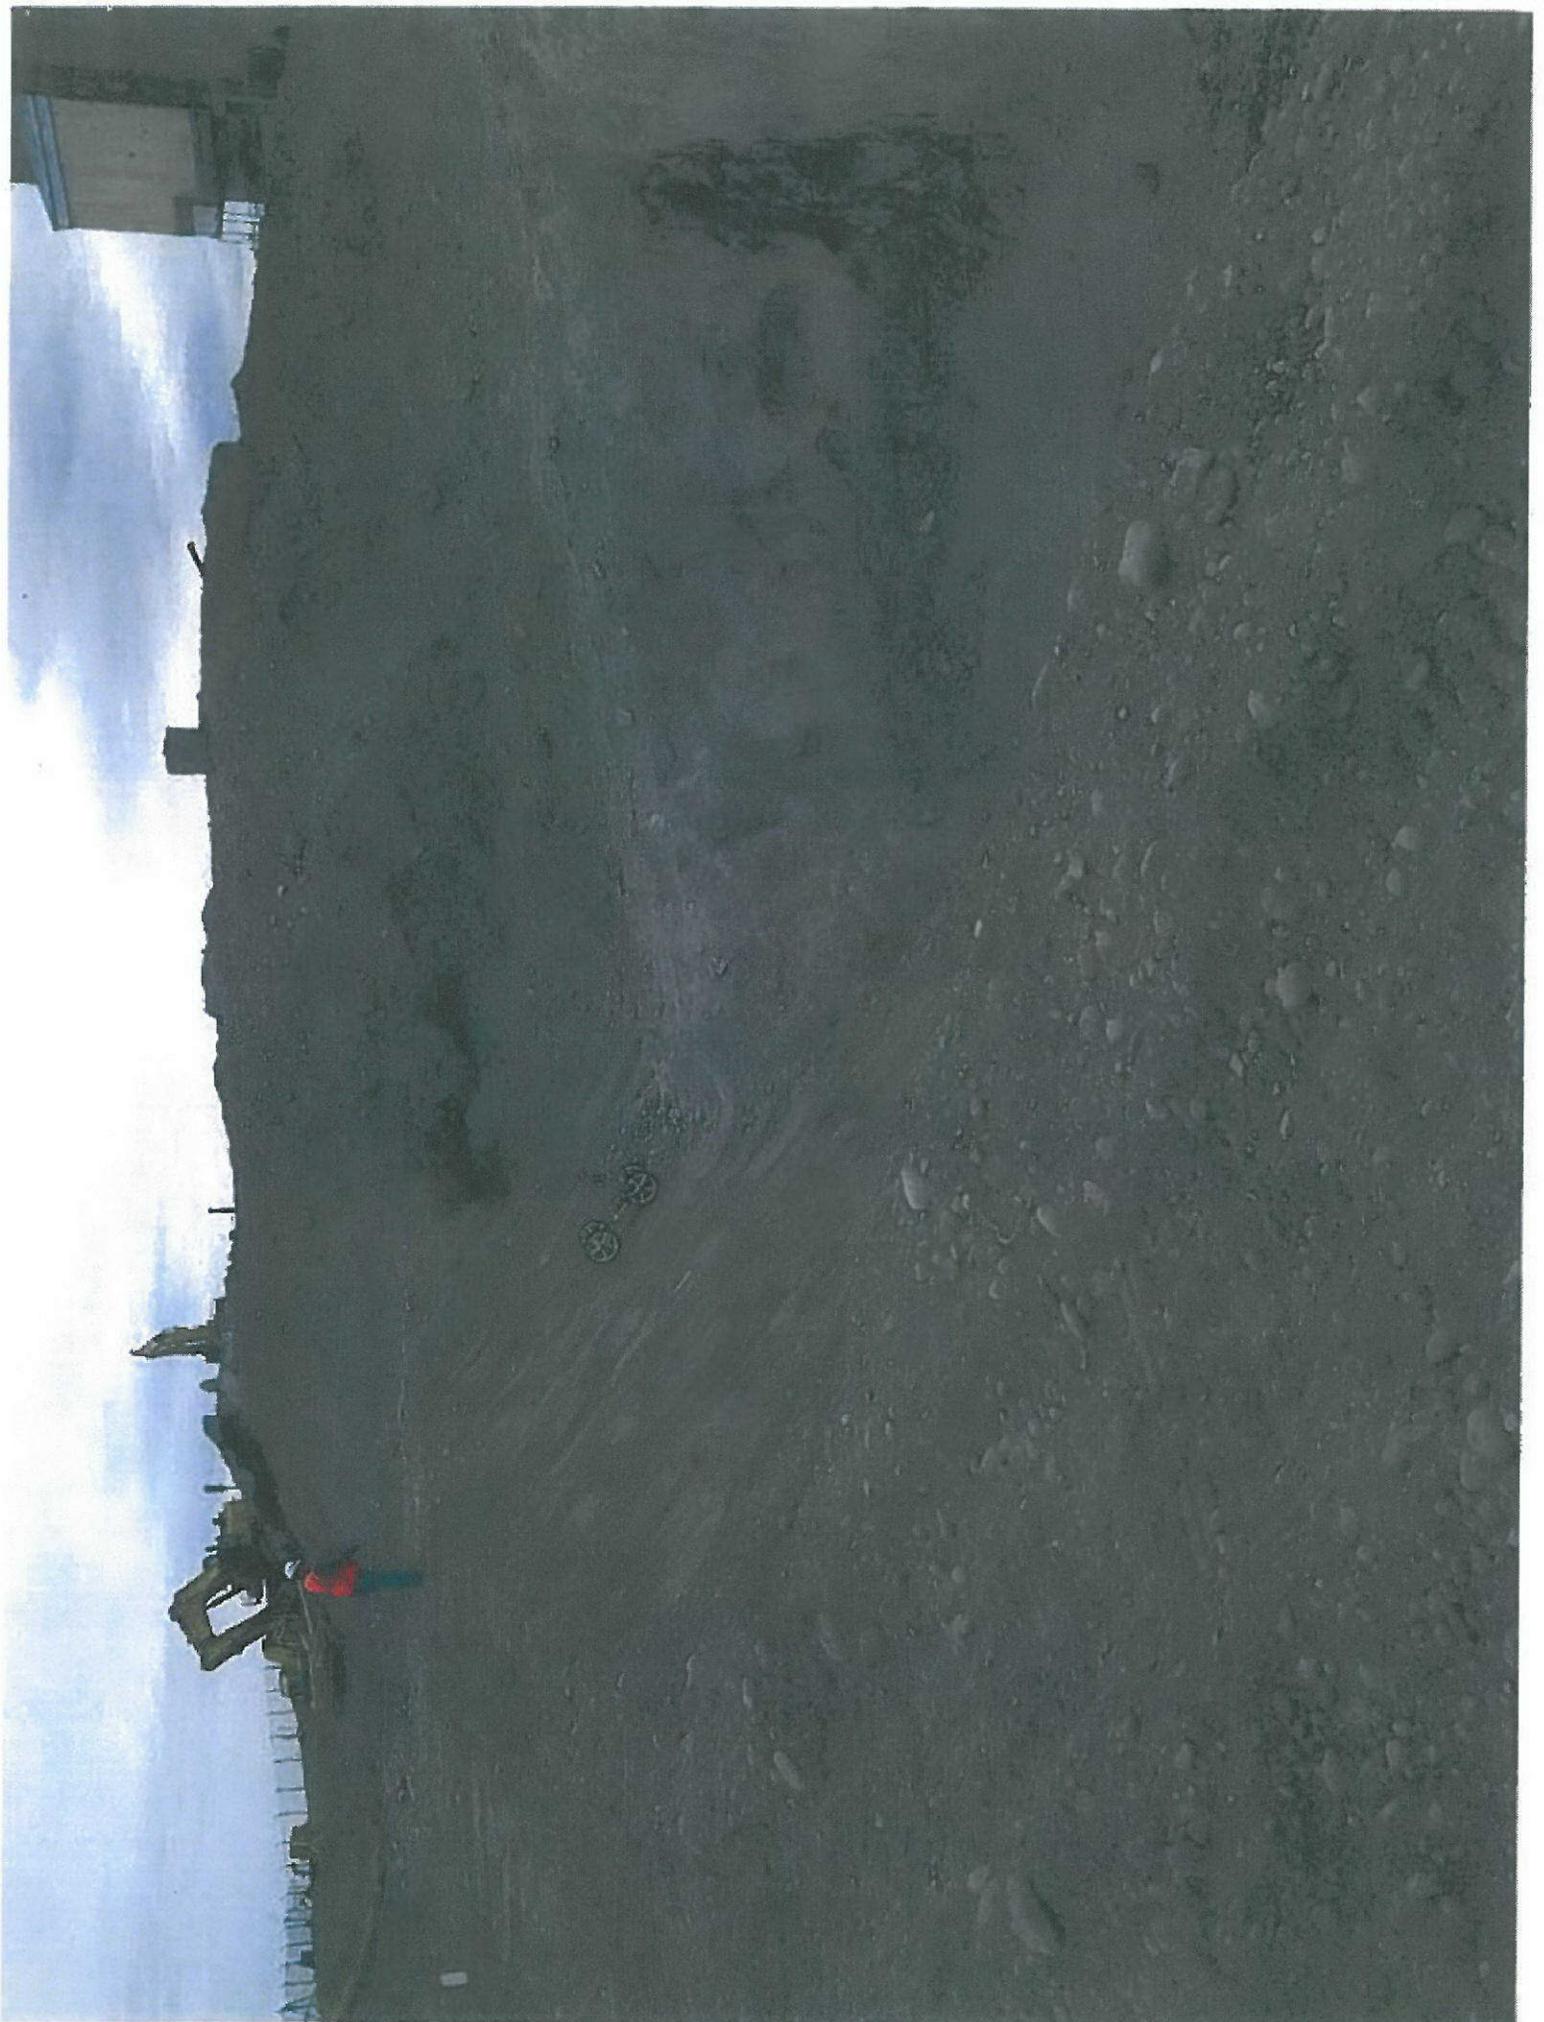
Survey Map Prepared By Bruce Coomer, ESI

Wanda. Successfully got GPERS performed on the 1908-N this morning. They used their cart and were able to safely cover much more of the structure than I had anticipated. Attached is the report. Nothing exceeded 1.5 times background. I've also attached some action photos of the survey. While I was there this morning, I did not observe any stains or anomalies on or around the monolith. Looks pretty clean to me. We're still requesting Ecology concurrence with leaving the stubborn concrete stuck in the corner of the below grade monolith. Let me know what you think.

A final GPERS survey over the interior footprint of the 1908-N basement was conducted in May 2012. 1373 data points were measured and no data point was greater than 1.5 times the average background of 1,204 counts per minute. A copy of the survey map is included in Attachment 6.

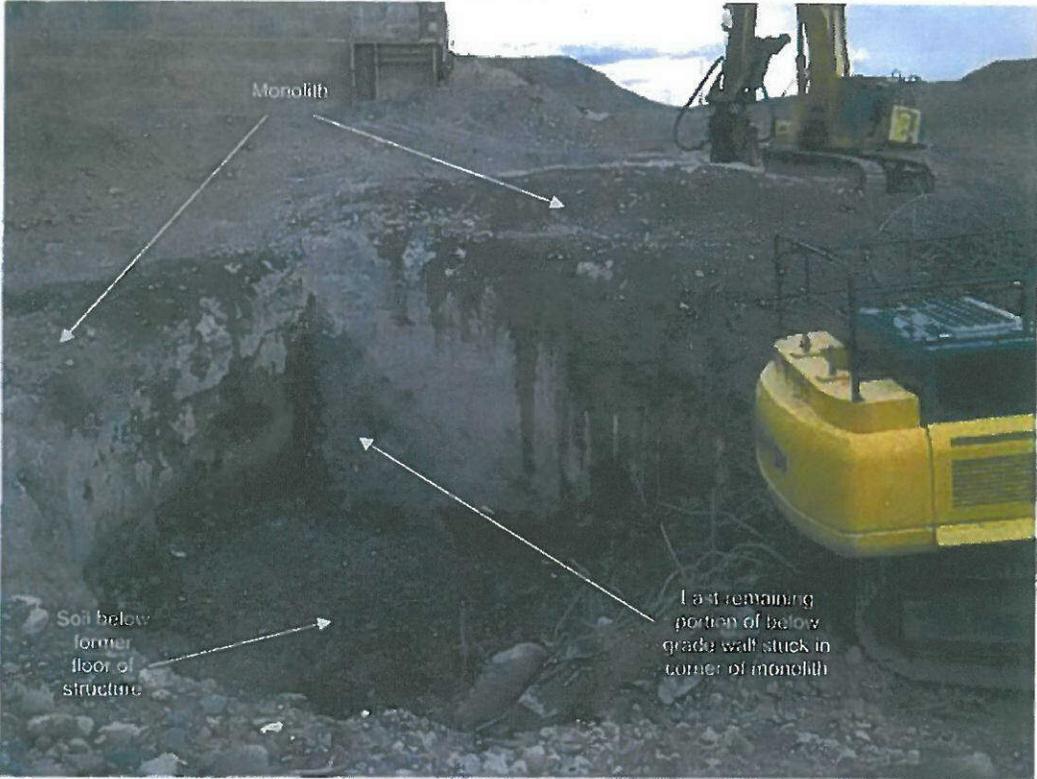
View of monolith below grade (facing east).

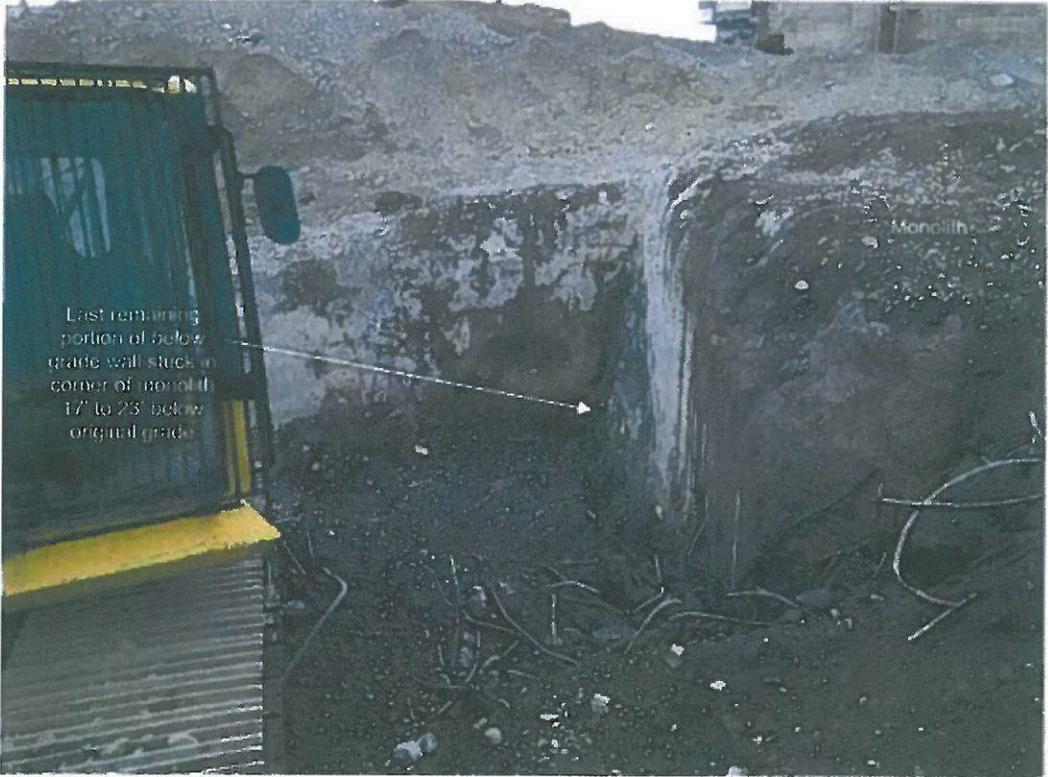
View of monolith below grade (facing north).
