FACILITY STATUS CHANGE FORM

Date Submitted: Mar 10, 2009	Area: 100-N	Control #: D4-100N-0013
Originator: Bob Cathel	Facility ID: 1705-N, 1705-NA and 1706-N	
Phone: (509) 845-6146	Action Memorandum: 100-N Ancillary Facilities

100-N D4 Project Facility Completion Form

Attachment 1: Facility Information (6 pages)

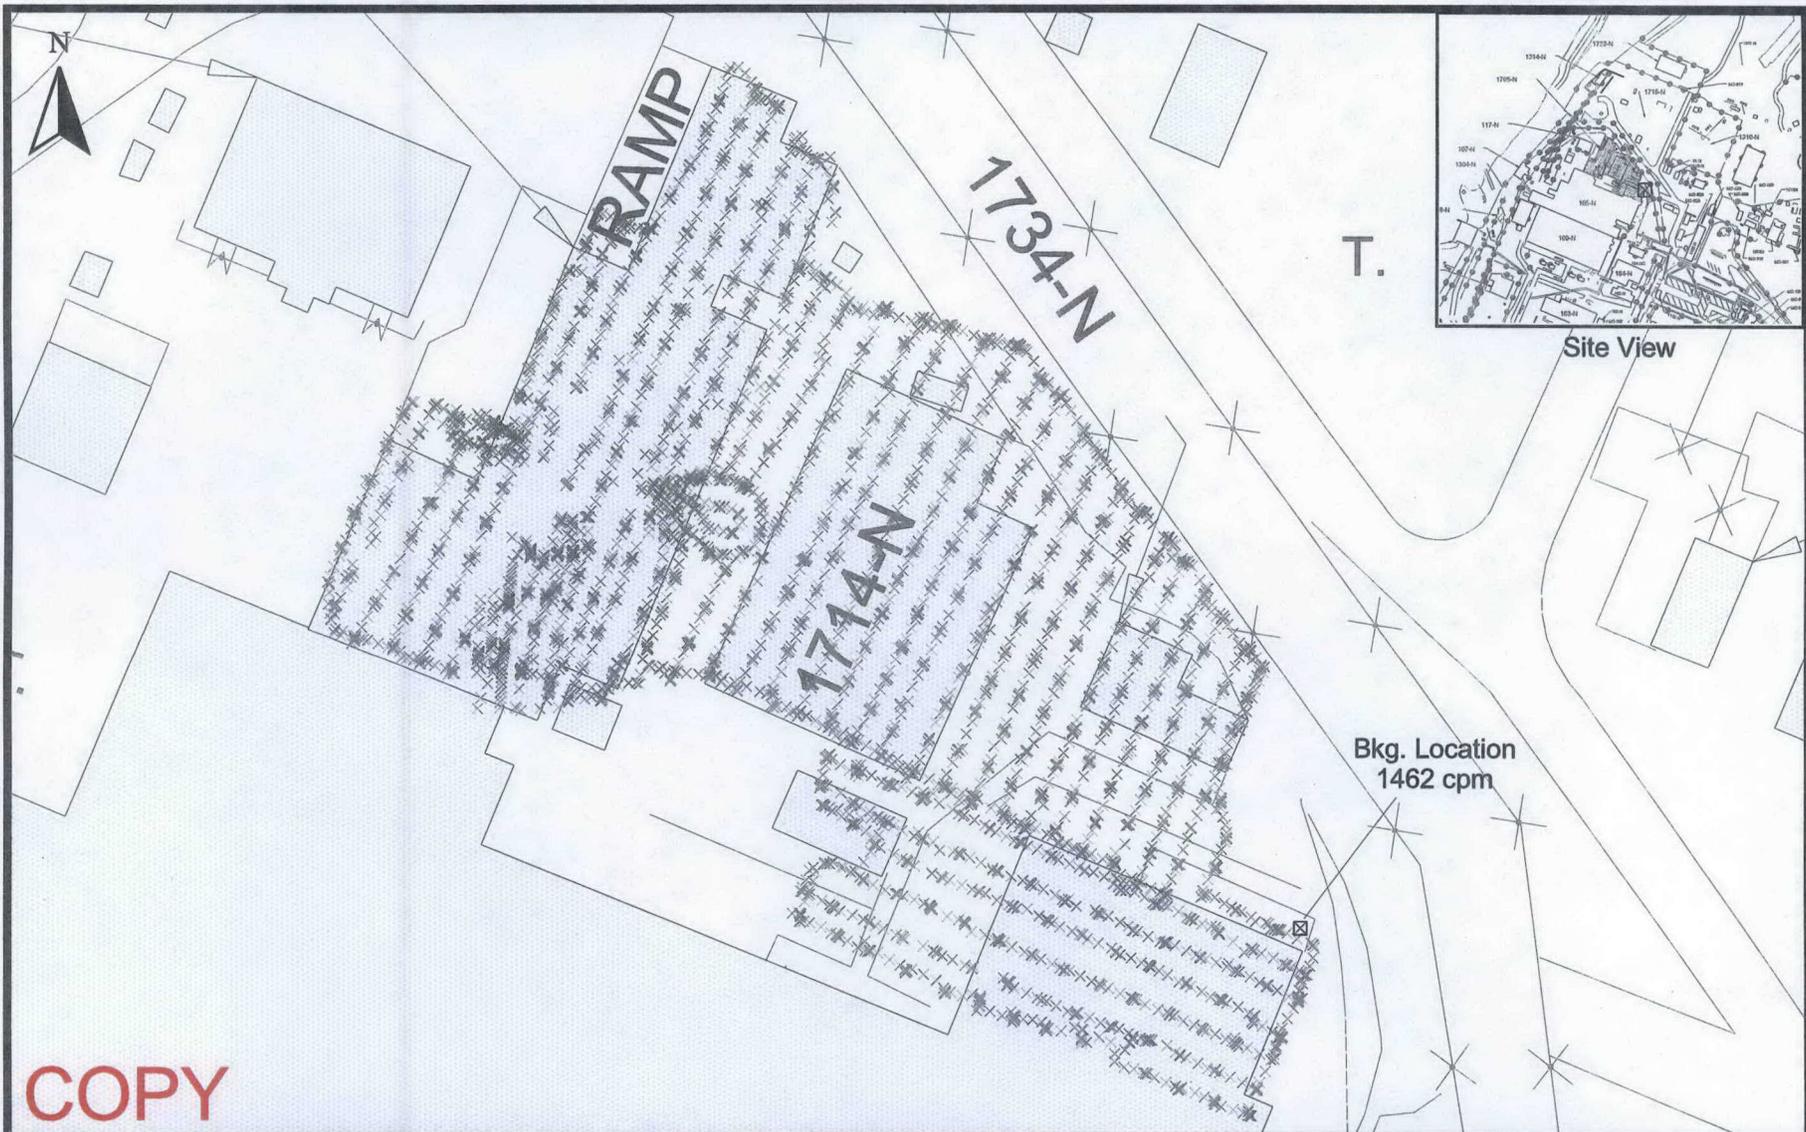
**100N D4 Project
 1705N Slab Village
 GPERs Radiological Survey
 Gamma Track Map**

The clearance radiological surveys were performed on June 14, 2008 and June 25, 2008 and documented in RSR-100N-08-1065 and RSR-100N-08-1130. A post-demolition Global Positioning Environmental Radiological Survey (GPERS) was conducted on the 1705-N complex as a final survey of this site on July 8, 2008. During the survey, 10858 data points were collected and no data point was greater than 2 times the average background of 1462 counts per minute. A copy of the survey map is provided in Attachment 2.

Coverage File: N190,A
 Number of Data Pnts: 10858
 Type of Survey: 'Gamma'
 Max GCPM: 2346
 Avg Bkg CPM: 1462
 Survey Date: 07/08/2008
 Area Surveyed: 5052 m2
 Project File: N190
 Pdf File: ESRFRM080109C

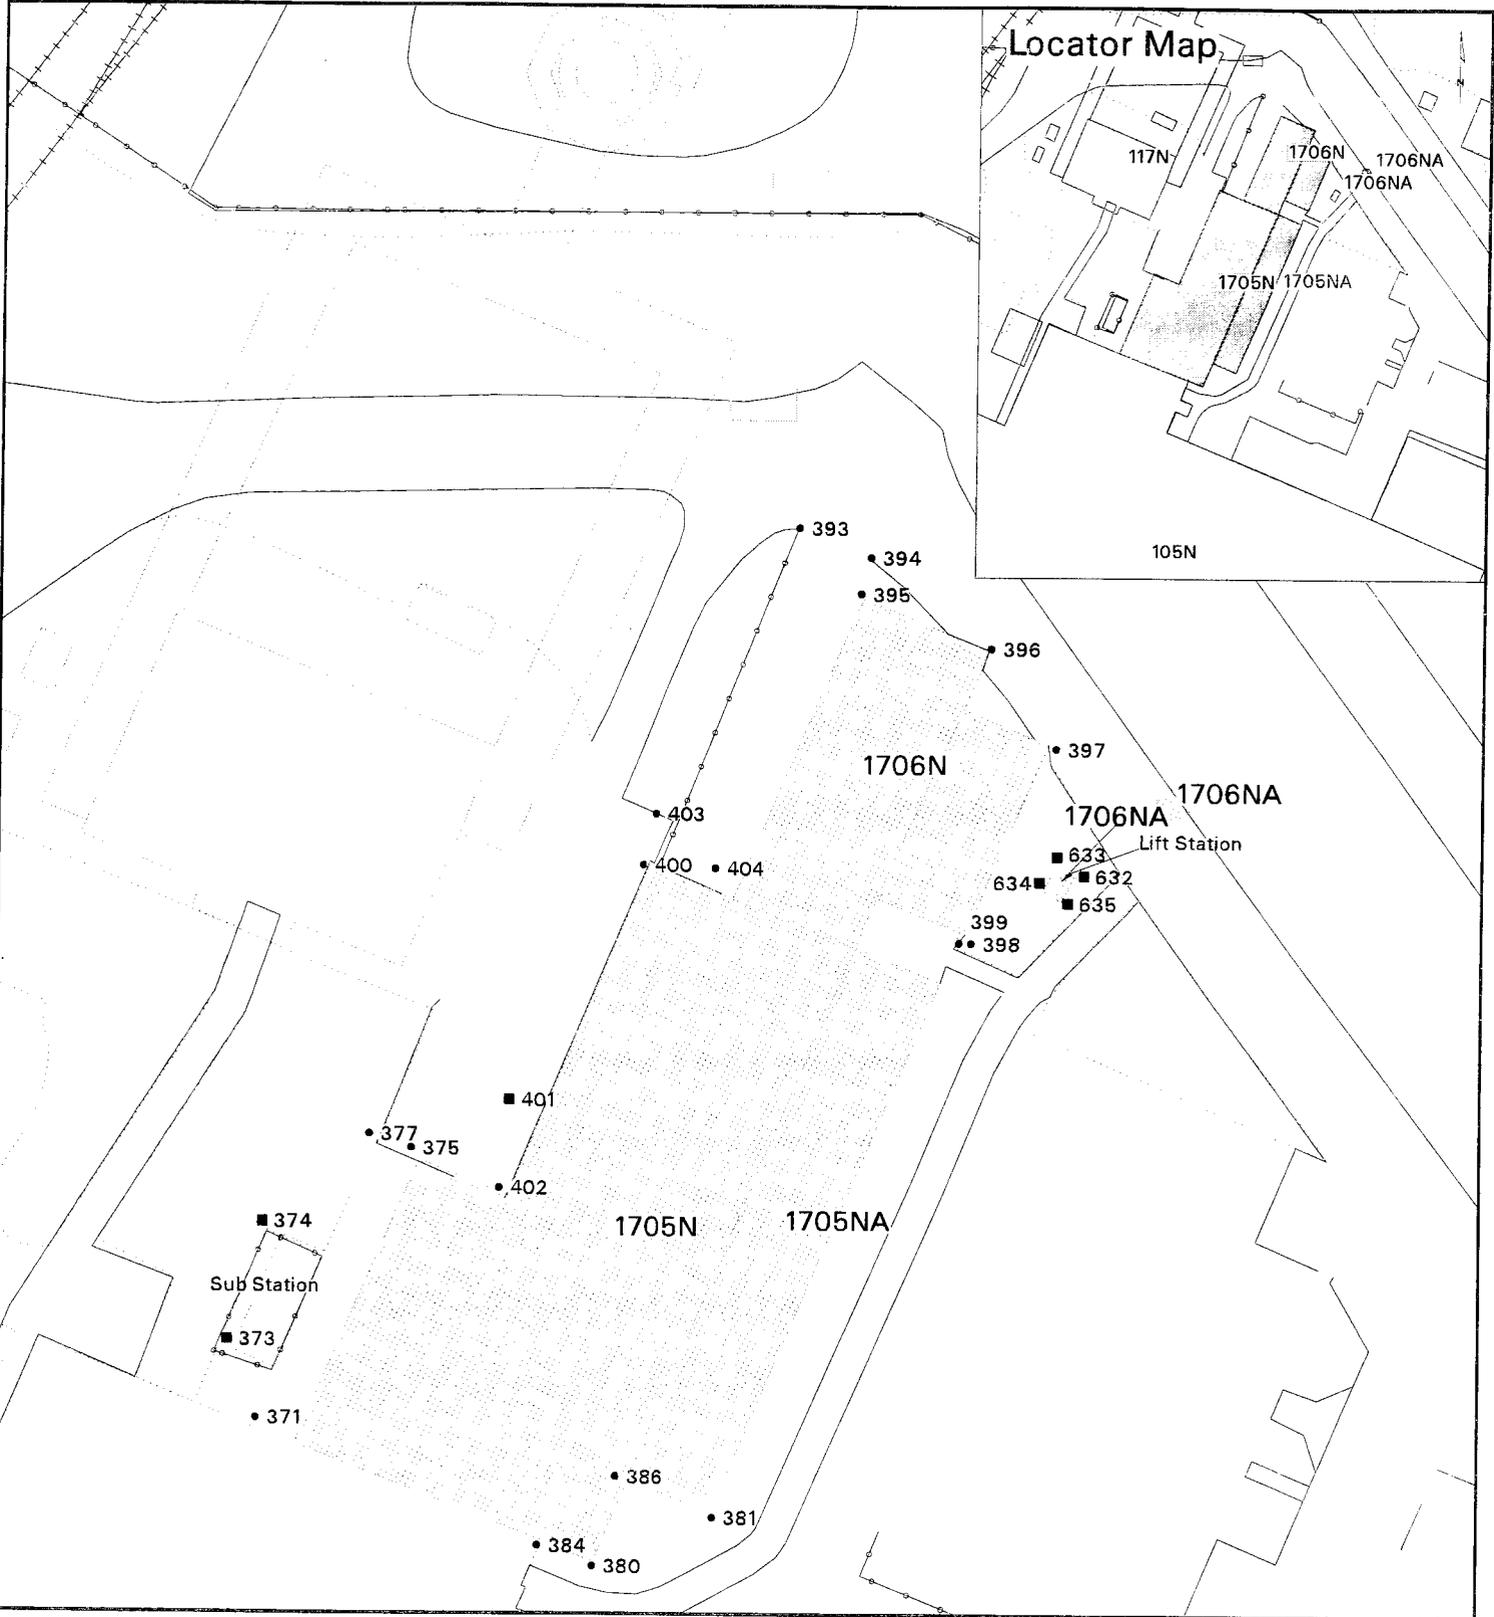
**Pre- Demolition Survey
of The 1705N-NA,
1706N-NA Buildings**

Location of the 1705N-NA and 1706N-NA Buildings Prior to Demolition
-

GPS Locations for Building Corners, Prior to Demolition
-

GPS Locations for Surrounding Features

A pre-demolition Global Positioning System (GPS) survey was performed on June 6, 2006 and a post-demolition GPS survey was performed on October 7, 2008. Both surveys are included in Attachment 3.

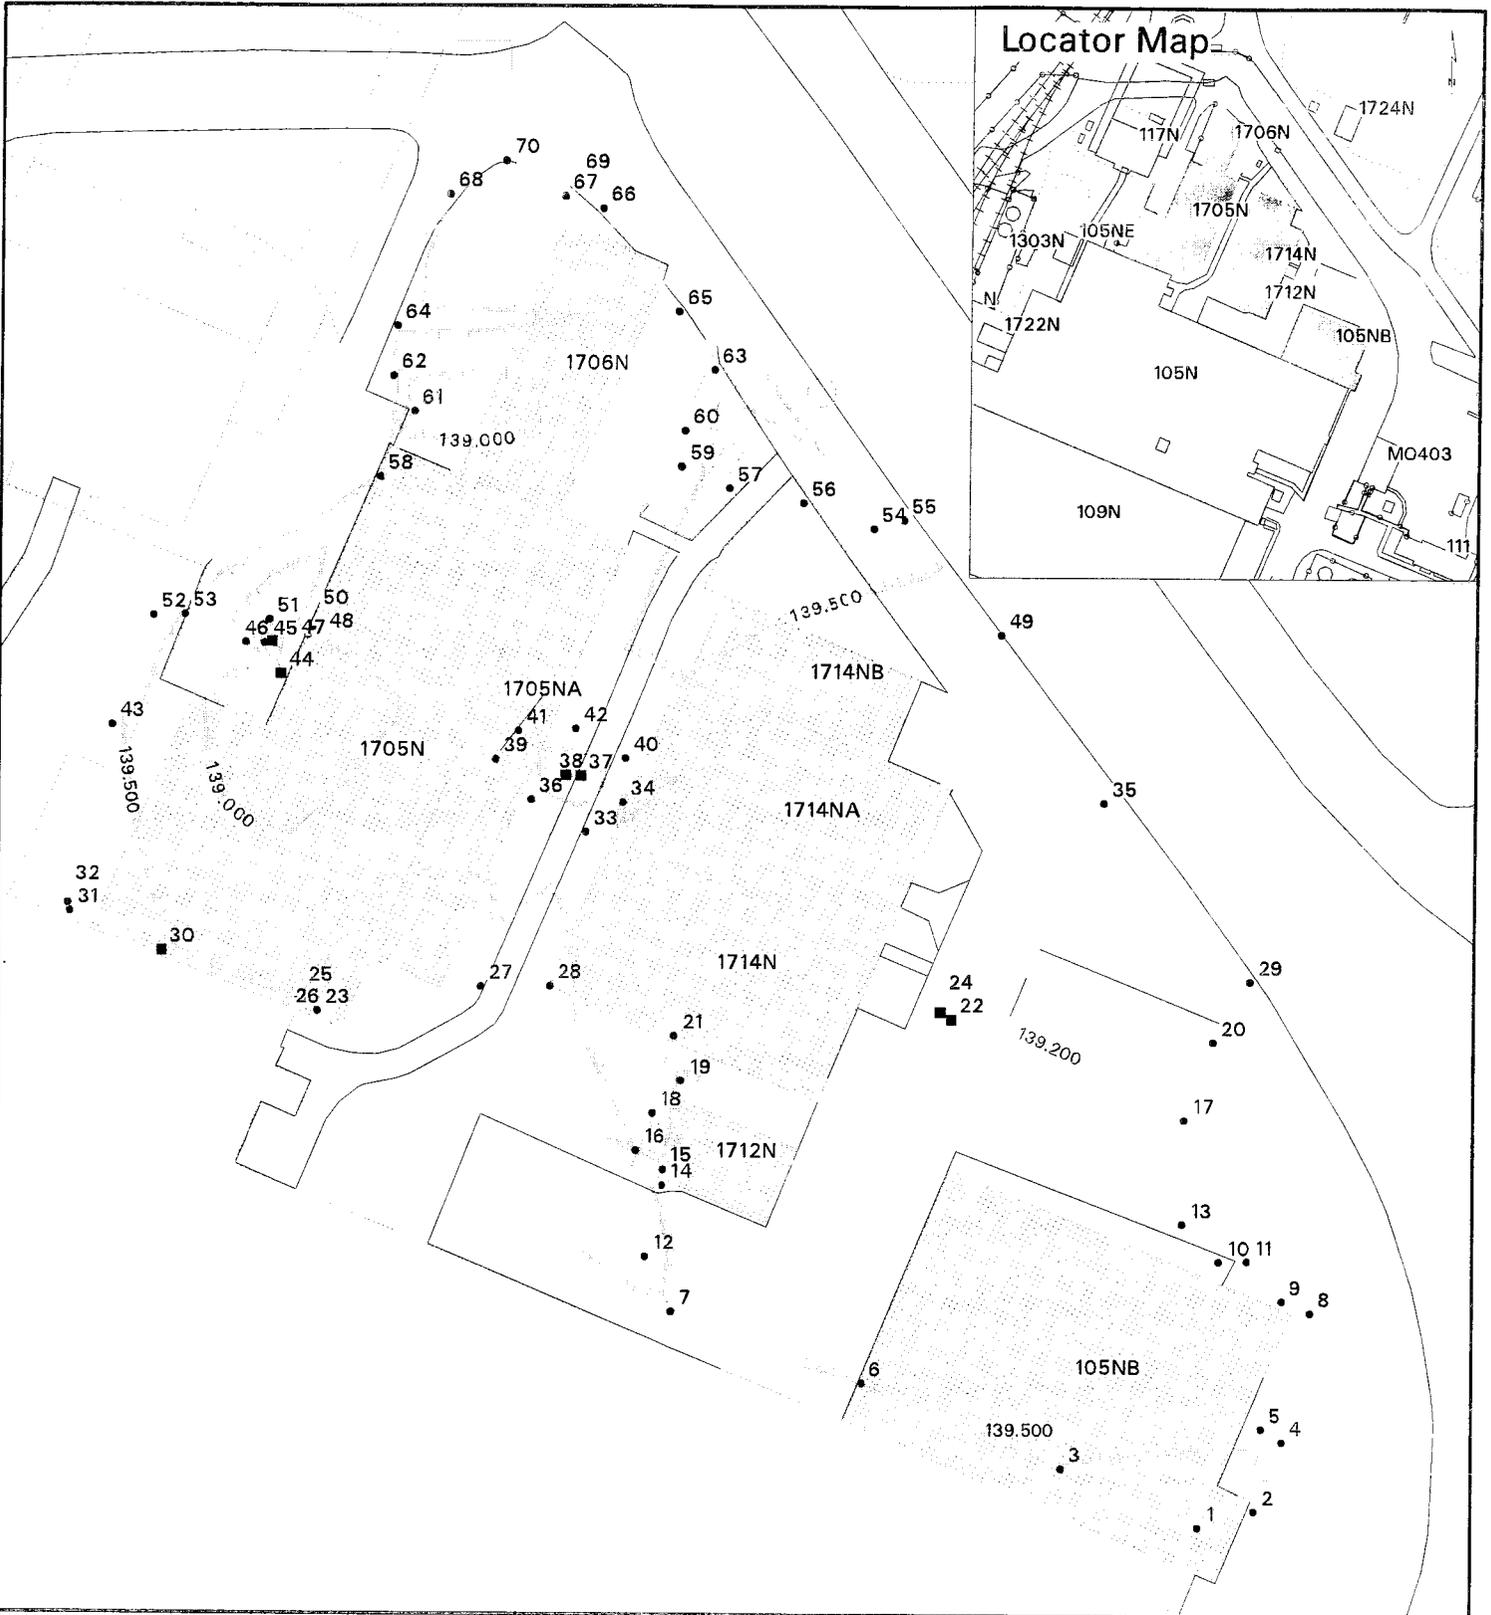
**Post Demolition Survey of
1712N, 1714N, 1714NA, 1714NB,
1705N, 1705NA, 1706N,
& 105NB Foundations**

- Foundation Locations Prior to Demolition
- GPS Post Demolition Locations
- GPS Locations for Additional Features (See attached survey report for details)

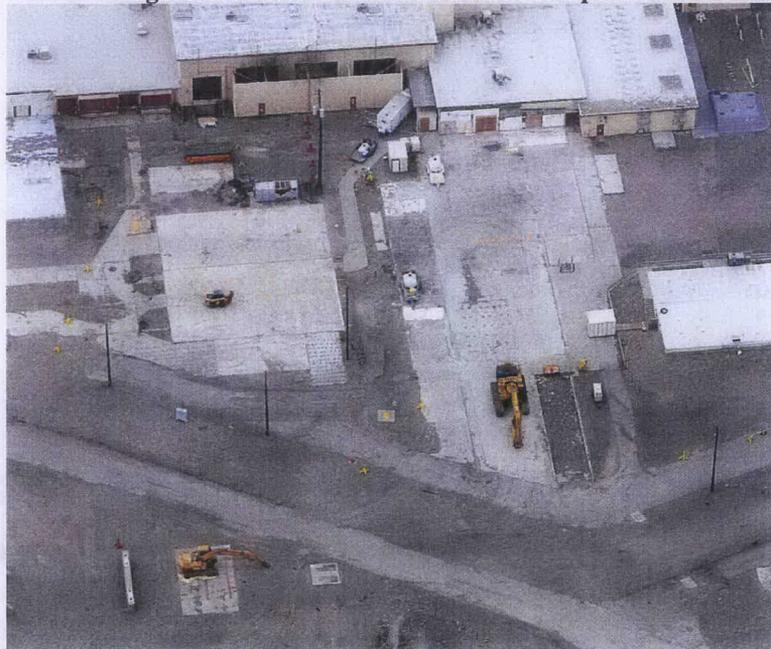
Figure 2. Debris removed and slabs still present

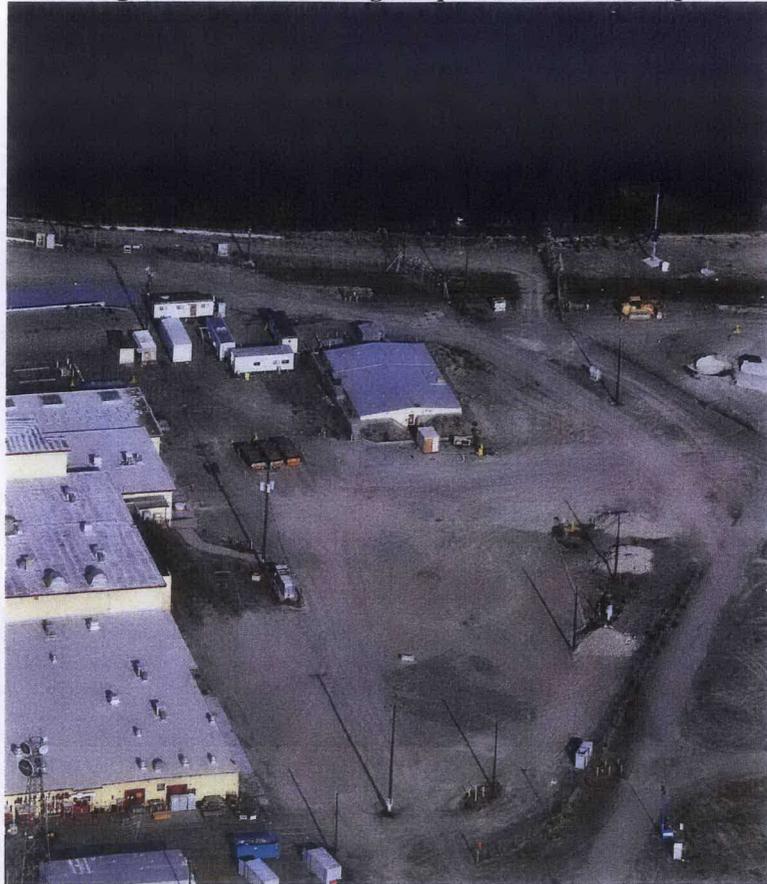
The RCC contractor has demolished and removed all traces of the 1705-N complex facilities and concrete pads. A minimal amount of soil was removed along with the concrete pad. Contaminants of concern a determination of no impact to the soil is provided in Table 4. Backfill material from 100-N Borrow Pit was brought in to regrade the site.

Figure 3. 1705-N building complex at end of cleanup
