FACILITY STATUS CHANGE FORM

SUBJECT: **POST-DEMOLITION SUMMARY REPORT FOR THE 1707N RIVER PATROL
BOAT HOUSE**

Post Demolition Summary Report for the 1707N River Patrol Boat House

WASHINGTON CLOSURE HANFORD D4 FACILITY CHARACTERIZATION HISTORICAL SITE ASSESSMENT FOR THE 1707-N BOAT HOUSE

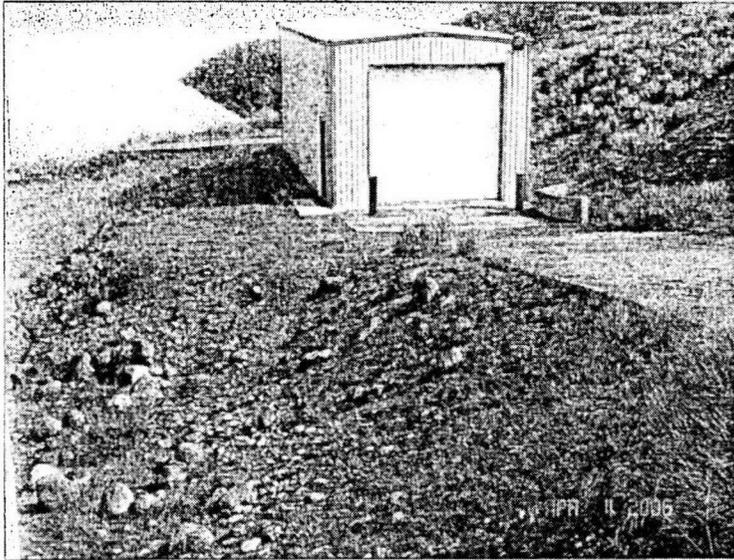
Figure 1 – 1707N Patrol River Boat House Before Demolition (Facing North)

The 1707N Boathouse was a 500 ft² (46.5 m²), pre-engineered, metal building supported on a reinforced concrete slab foundation. The structure had a roll-up door at each end, one door was non-functional. A concrete boat ramp led from the boat house to the river water line.

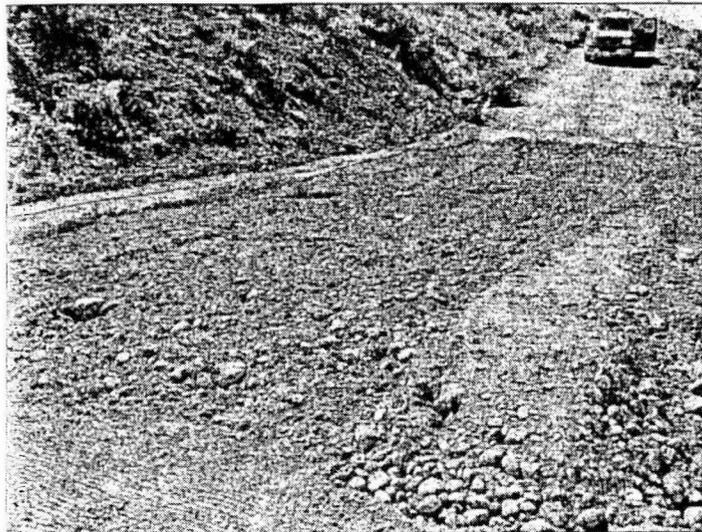
Figure 2 – 1707N Patrol River Boat House After Demolition (Facing South)

The 1707N building and the concrete pad it was directly over were demolished and removed. The concrete boat ramp leading from the roll up doors of the boat house to the river was left in place. The excavation was back-filled to minimize tripping hazards (see Excavation Permit DAN-2592-1).

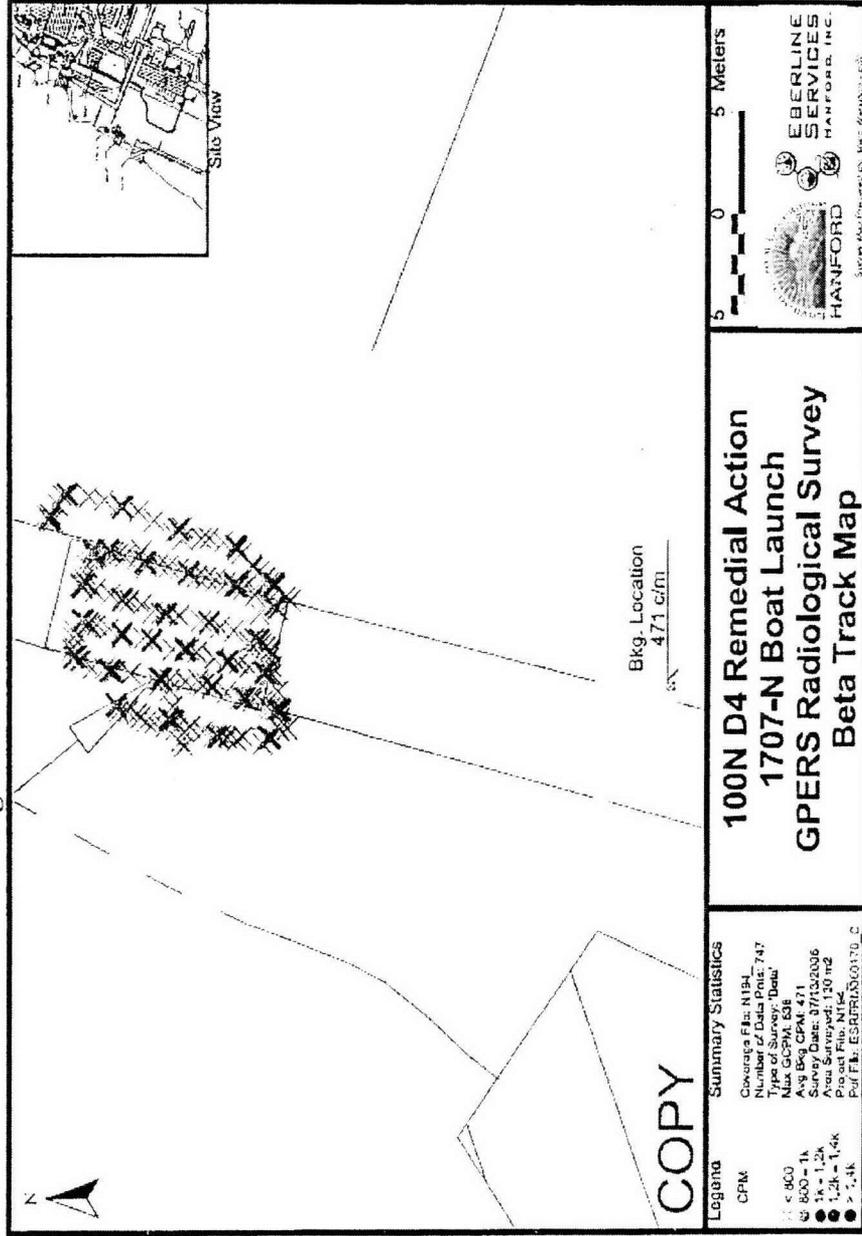
GPERS surveys were completed after building demolition and before soil re-grading. Both beta and gamma track GPERS surveys found no radiological contamination. The GPERS surveys are included as Figures 3 and 4.

Figure 3 – GPERS Beta

A GPERS survey was performed at this structure. See GPERS surveys in Figures 3 and 4.

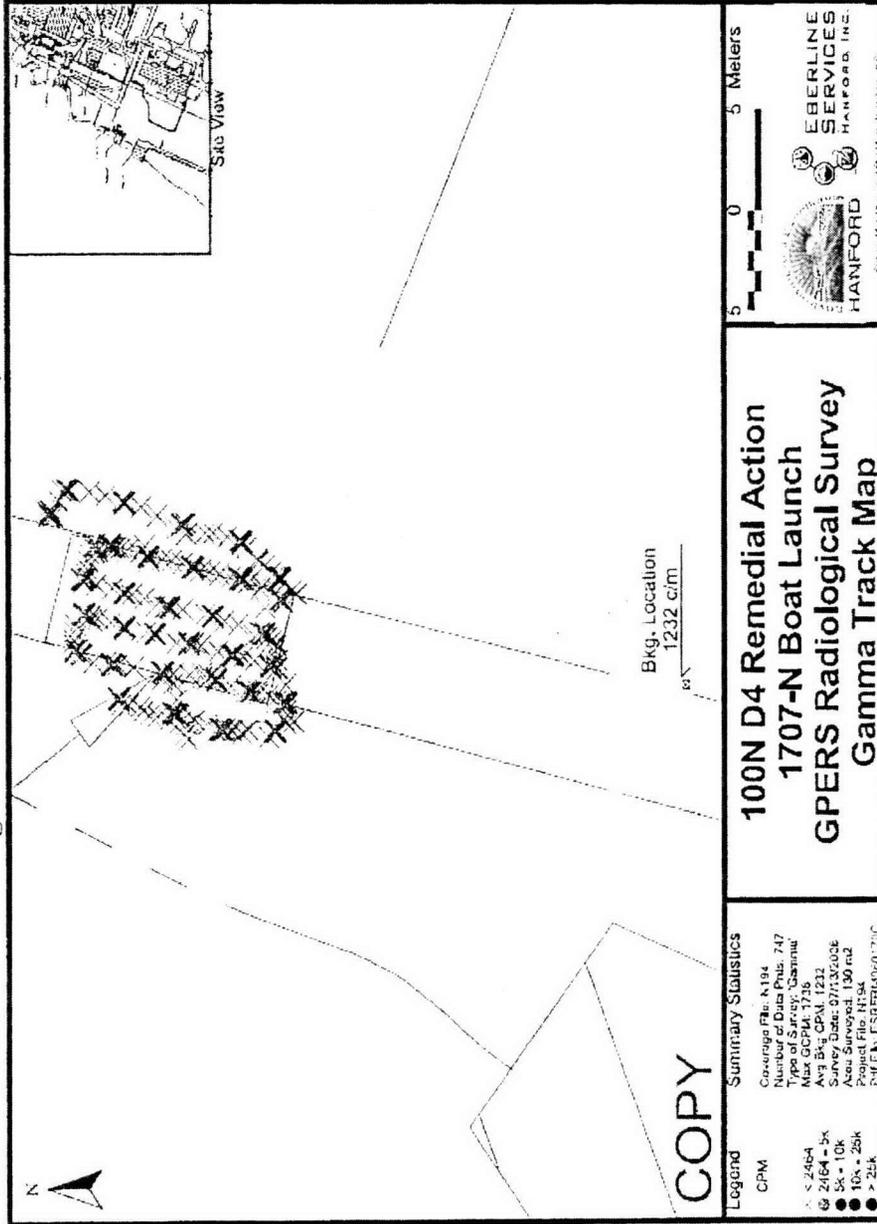
Figure 4 – GPERS Gamma Survey

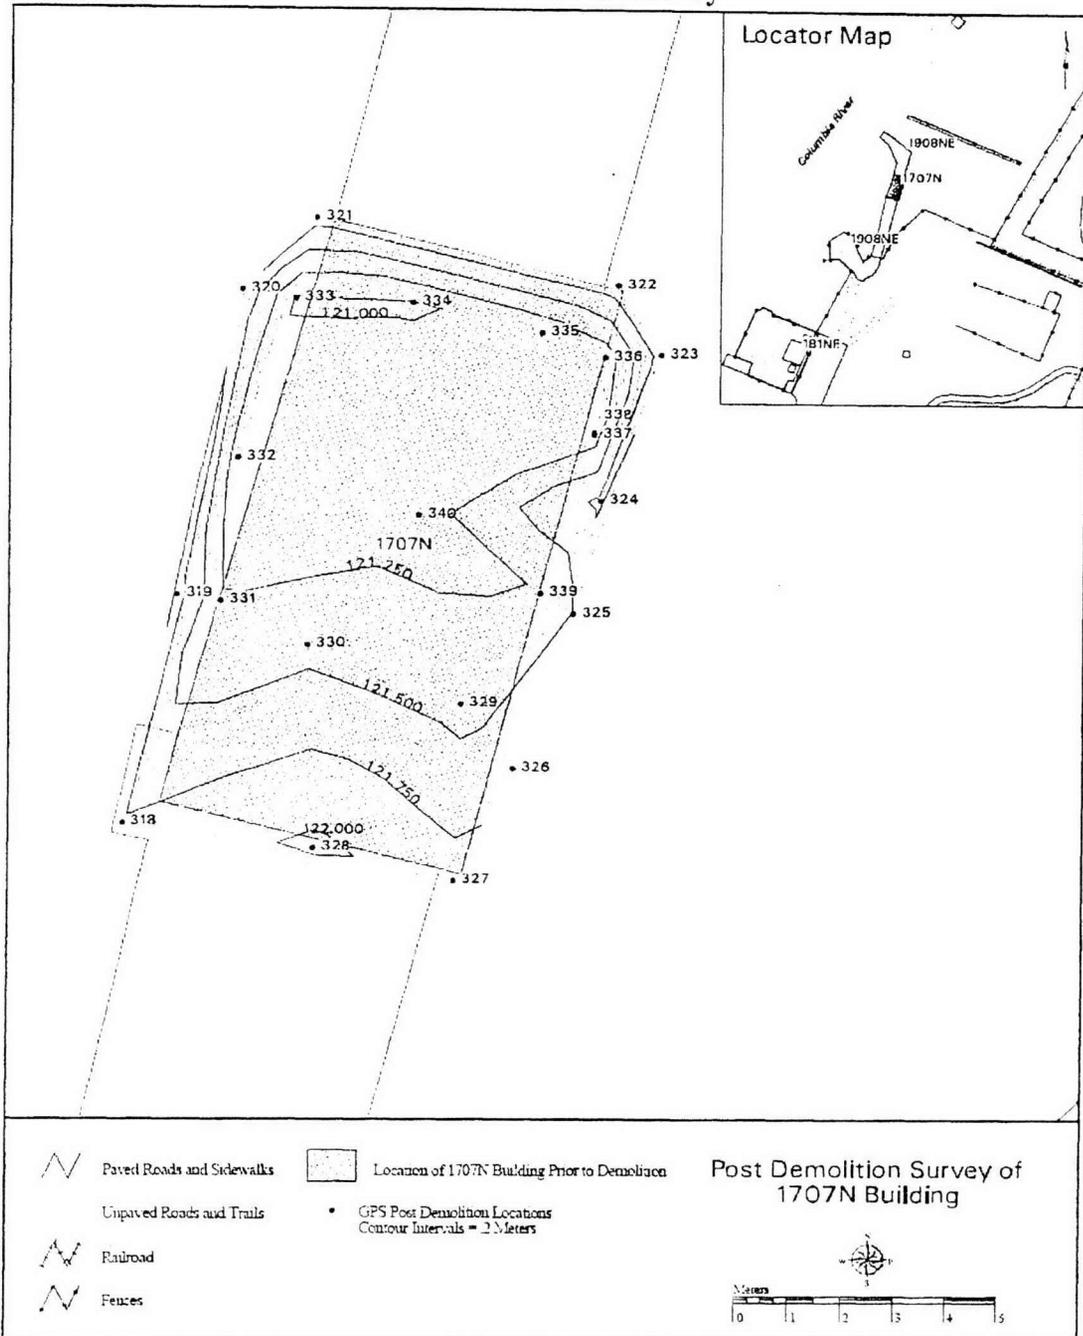
Attachment 1 – Civil Survey

GPS civil surveys were performed at 1707N. Copies of these surveys are provided as attachments at the end of this report.

Survey Project Name/Title: 1707N Excavation
 Survey Purpose: Survey the post demolition of 1707N
 Requested By: Amy Hood
 General Site Location: 100N
 Charge Code:
 Field Surveyor: Margo Aye
 Computer Software Used: Trimble Survey Controller, and Geomatics
 Office V.11
 Survey Equipment Used: 5800
 Control Monuments Used: 100N-4
 Survey Method: RTK
 Estimated Horizontal Precision: .020m
 Estimated Vertical Precision: .050m
 Fieldwork Start Date: 7/24/06
 Fieldwork Completion Date: 7/24/06
 Notes:

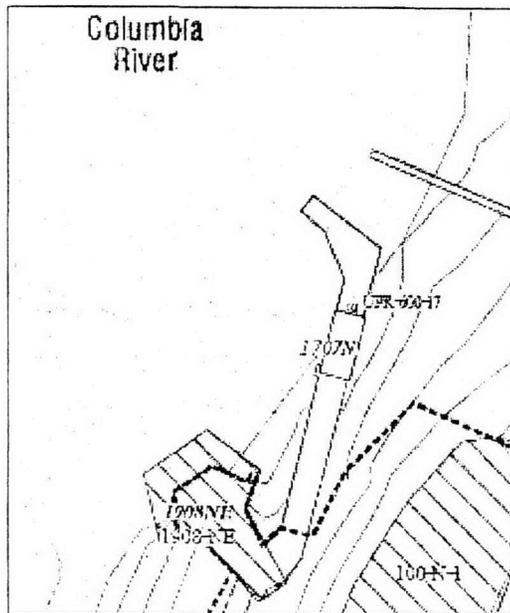
WIDS Sites Near 1707-N

- 6.1. UPR-600-17, 600 AREA PATROL BOAT SPILL (inactive): On August 17, 1986, gasoline was spilled inside a patrol boat during refueling operations, and gasoline was discharged from the boat to the shoreline. The area is periodically flooded as the river level changes daily and seasonally. Because the site is periodically flooded by the Columbia River, and since the spill occurred in 1986 and has dissipated over that time, no trace of the gasoline spill is expected to remain.

- 6.2. 1908-NE, 1908-N OUTFALL (active): The 1908-N Sealwell (outfall) served as a sump for several discharge lines, and to drop the liquid discharge level for overflow to the river. The outfall also discharged to a flume which was used as an alternative to the river pipelines. An unknown level of radioactive contamination exists within the structure because the discharge lines were associated with the reactor secondary steam system. 1908-NE is located on the Columbia River shoreline, near the 1707-N Boathouse.

- 6.3. 100-N-1, HGP SWMU #6, HGP SETTLING POND (inactive): The Hanford Generating Plant (HGP) Settling Pond was constructed to control the HGP waste stream effluents. This unit was located between the HGP Seal Well (1908-E) and the 185-N Building. The site has been remediated and interim closed out.

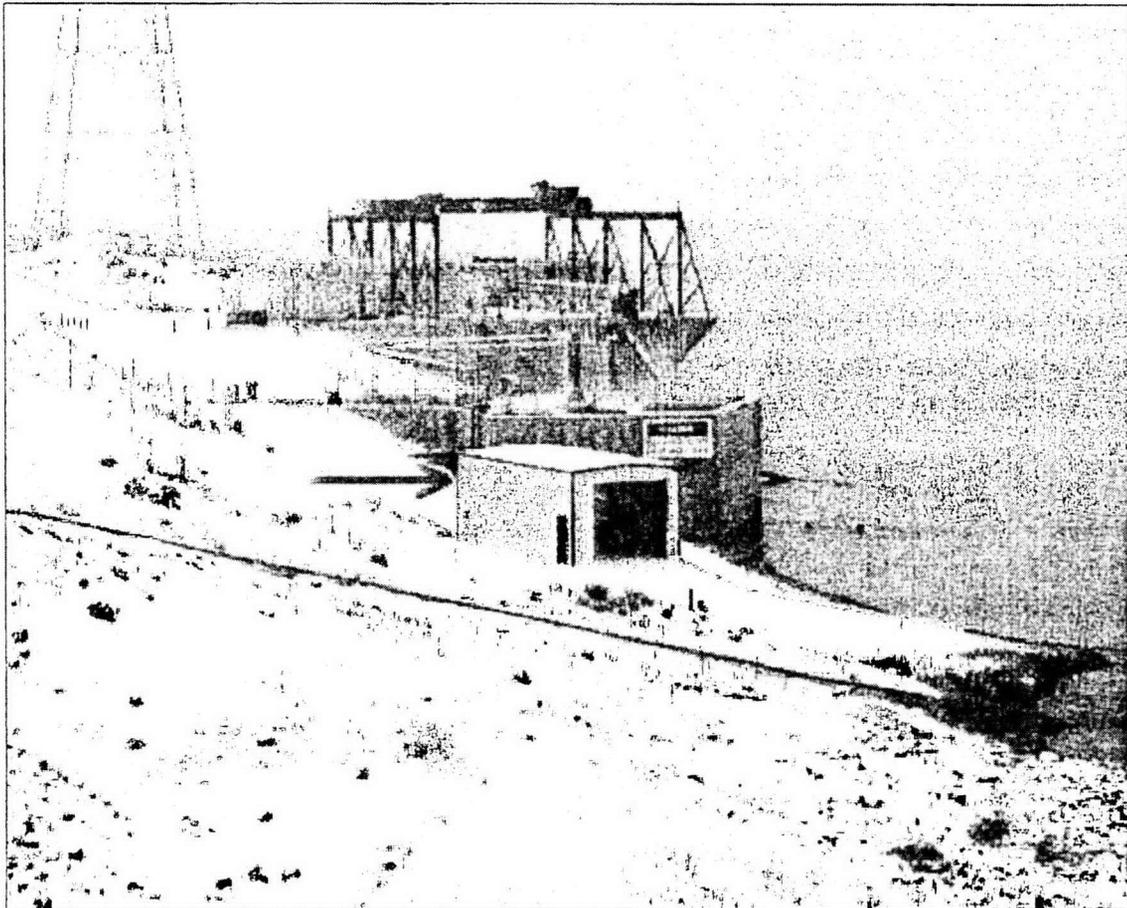
The 1707-N Boathouse is a 500 ft² (46.5 m²), pre-engineered, metal building supported on a reinforced concrete slab foundation. The structure has a roll-up door at each end, one door is non-functional. A concrete boat ramp leads from the boathouse to the river water line.

Figure 9.1 – 1707-N Boathouse
