# FACILITY STATUS CHANGE FORM

<b>Date Submitted:</b> 6-7-2012 <b>Originator:</b> David Warren <b>Phone:</b> (509) 539-6040	<b>Area:</b> 100-N <b>Facility ID:</b> 1322-N, -NA, -NB, and -NC <b>Action Memorandum:</b> 100-N Ancillary Facilities	<b>Control #:</b> D4-100N-0034
-------------------------------------------------------------------------------------------------------------	--------------------------------------------------------------------------------------------------------------------------------------	-----------------------------------

**Attachment 1: Facility Information (8 pages)**

This document provides information regarding the history and characterization of the 1322-N, 1322-NA, 1322-NB, and 1322-NC facilities and final status at the completion of deactivation, decontamination, decommissioning, and demolition (D4) activities.

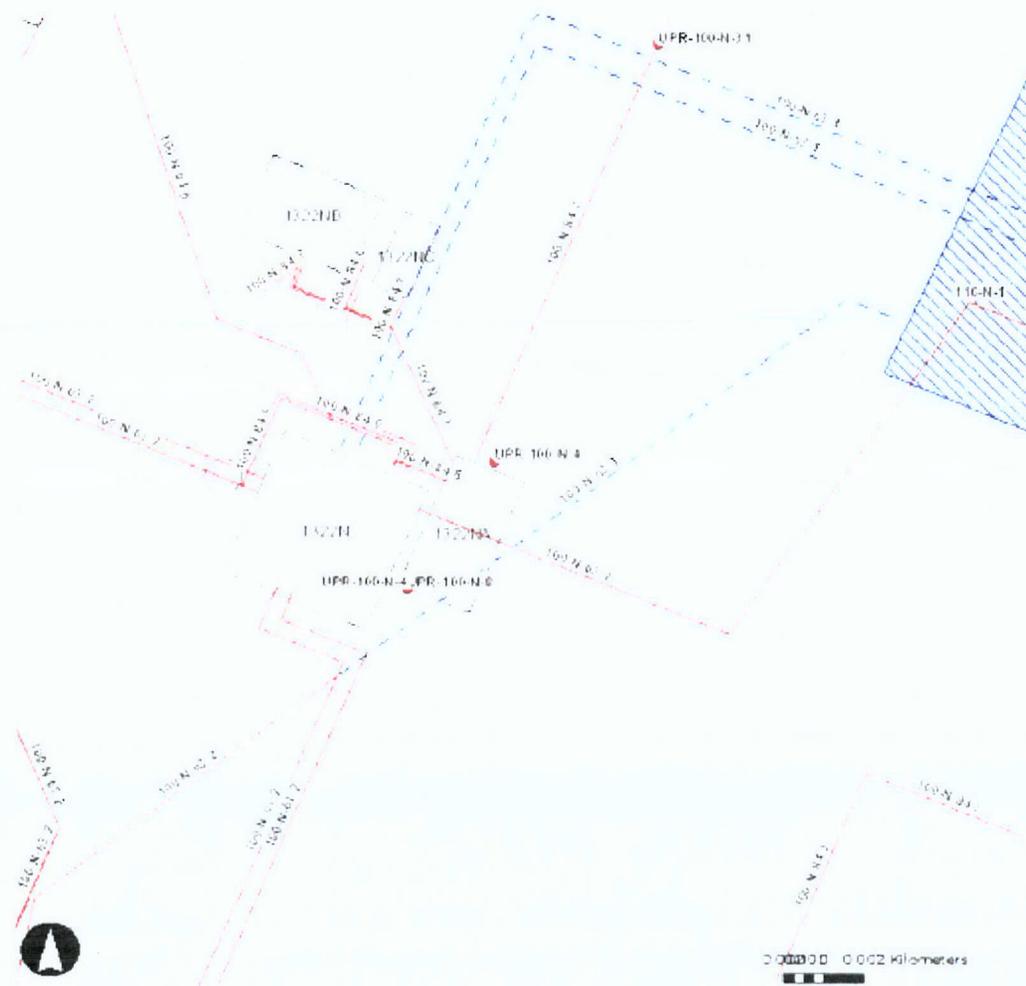
**Figure 1. Map of 1322-N Facilities**

Table-4 below lists each waste site, an abbreviated description, and whether or not the site was affected by D4 activities. Figure-1 (below) shows the excavation layback in light blue and the excavation toe in tan. The wastes sites can be seen in red with black type.

Figure 1 of this Attachment illustrates the basic underground piping associated with the facility.

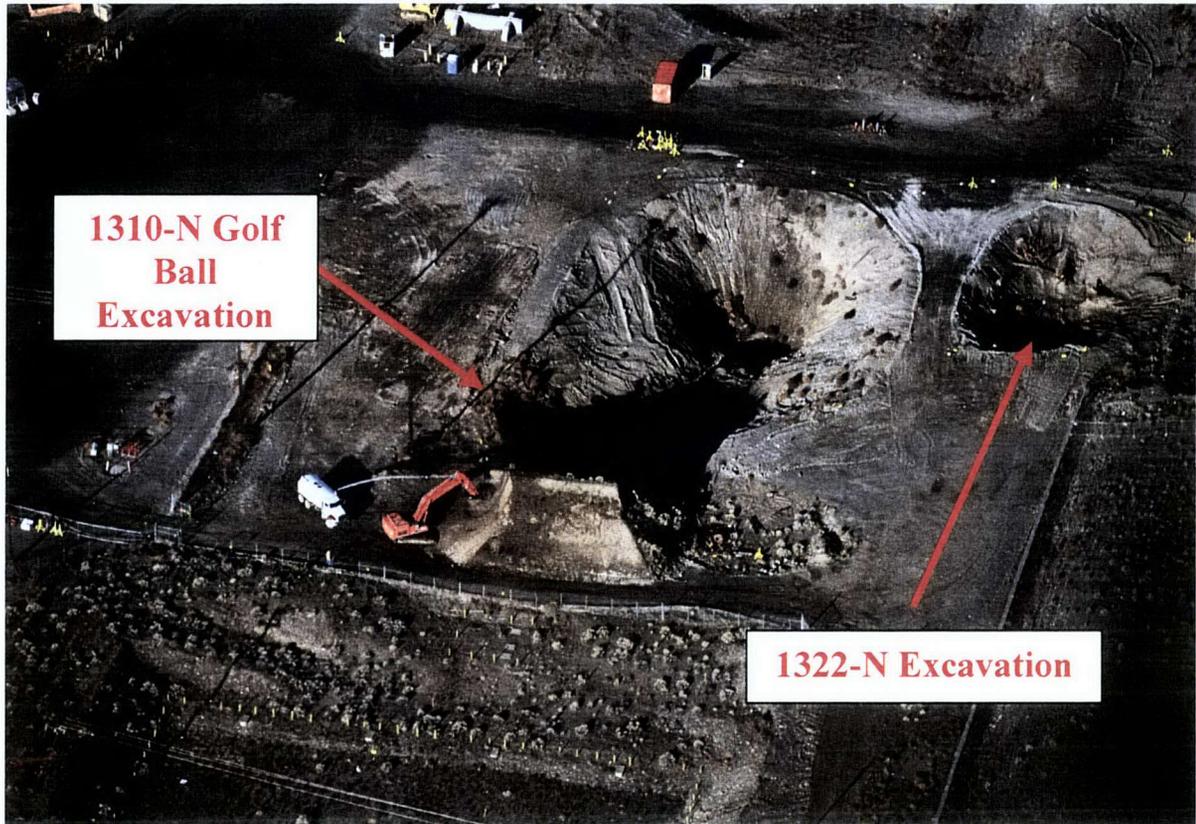
Photo 3. Aerial Photo of 1322-N Facilities following demolition

The above and below grade structures of the 1322-N Facilities were completely demolished. All that remained at the completion of D4 activities was an excavation approximately 108-feet by 87-feet, with piping was exposed in the side slopes. The Field Remediation organization has since performed further remediation in that area to include removal of remaining WIDS sites and radiological contamination. The post demolition photographs and December 2, 2010 Civil GPS Survey depict the condition of the area at the conclusion of D4 activities.

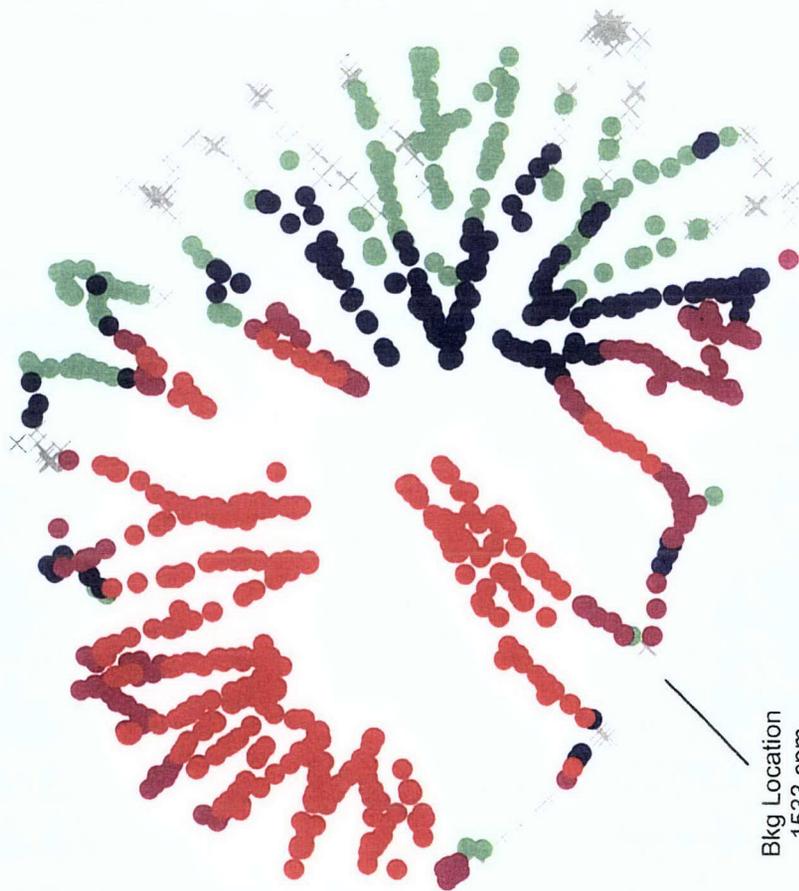
# 100N D4 1322-Ns GPERs Radiological Survey Gamma Track Map

Type	Quantity	Method Detection Limits	Results
Post Demolition GPERS Surveys	Multiple. Each survey included multiple sample locations.	N/A	Surveys reveal that considerable contamination existed in the excavation area and slopes. It should be noted that readings that are under two times the background count are considered insignificant. (See Attachment 3)

Coverage File: N322B  
Number of Data Pnts: 2164  
Type of Survey: Gamma  
Max GCPM: 949164  
Avg Bkg CPM: 1533  
Survey Date: 1/18/2010  
Area Surveyed: 709 m<sup>2</sup>  
Project File: N322B  
Pdf File: ESRFRM100146GC

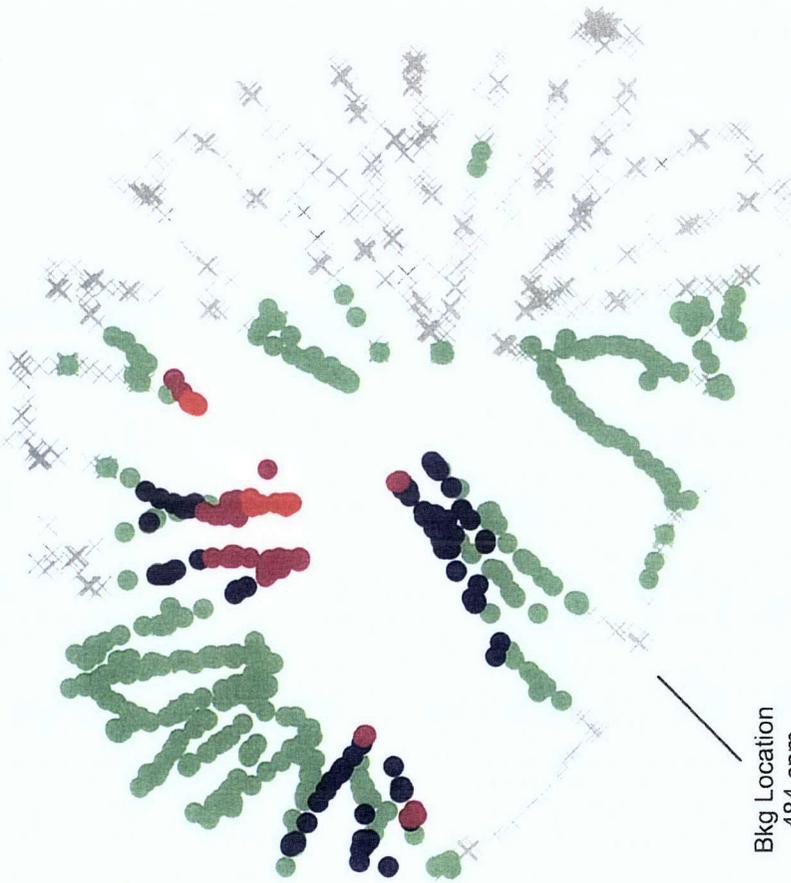
# GPERs Radiological Survey BetaTrack Map

<b>Legend</b>	<b>Summary Statistics</b>
NET CPM	Coverage File: N322B
X < 968	Number of Data Pnts: 2164
● 968 - 5000	Type of Survey: 'Beta'
● 5000 - 10000	Max GCPM: 95987
● 10000 - 25000	Avg Bkg CPM: 484
● > 25000	Survey Date: 1/18/2010
	Area Surveyed: 709 m <sup>2</sup>
	Project File: N322B
	Pdf File: ESRFRM100146BC

GPERS surveys conducted at the facility indicate the presence of elevated radiological levels (ESR-FRM-05-0265 & ESR-FRM-10-0146). Both the beta and gamma radiological levels exceeded twice their corresponding background radiological levels at the time of the survey (ESR-FRM-10-0146).

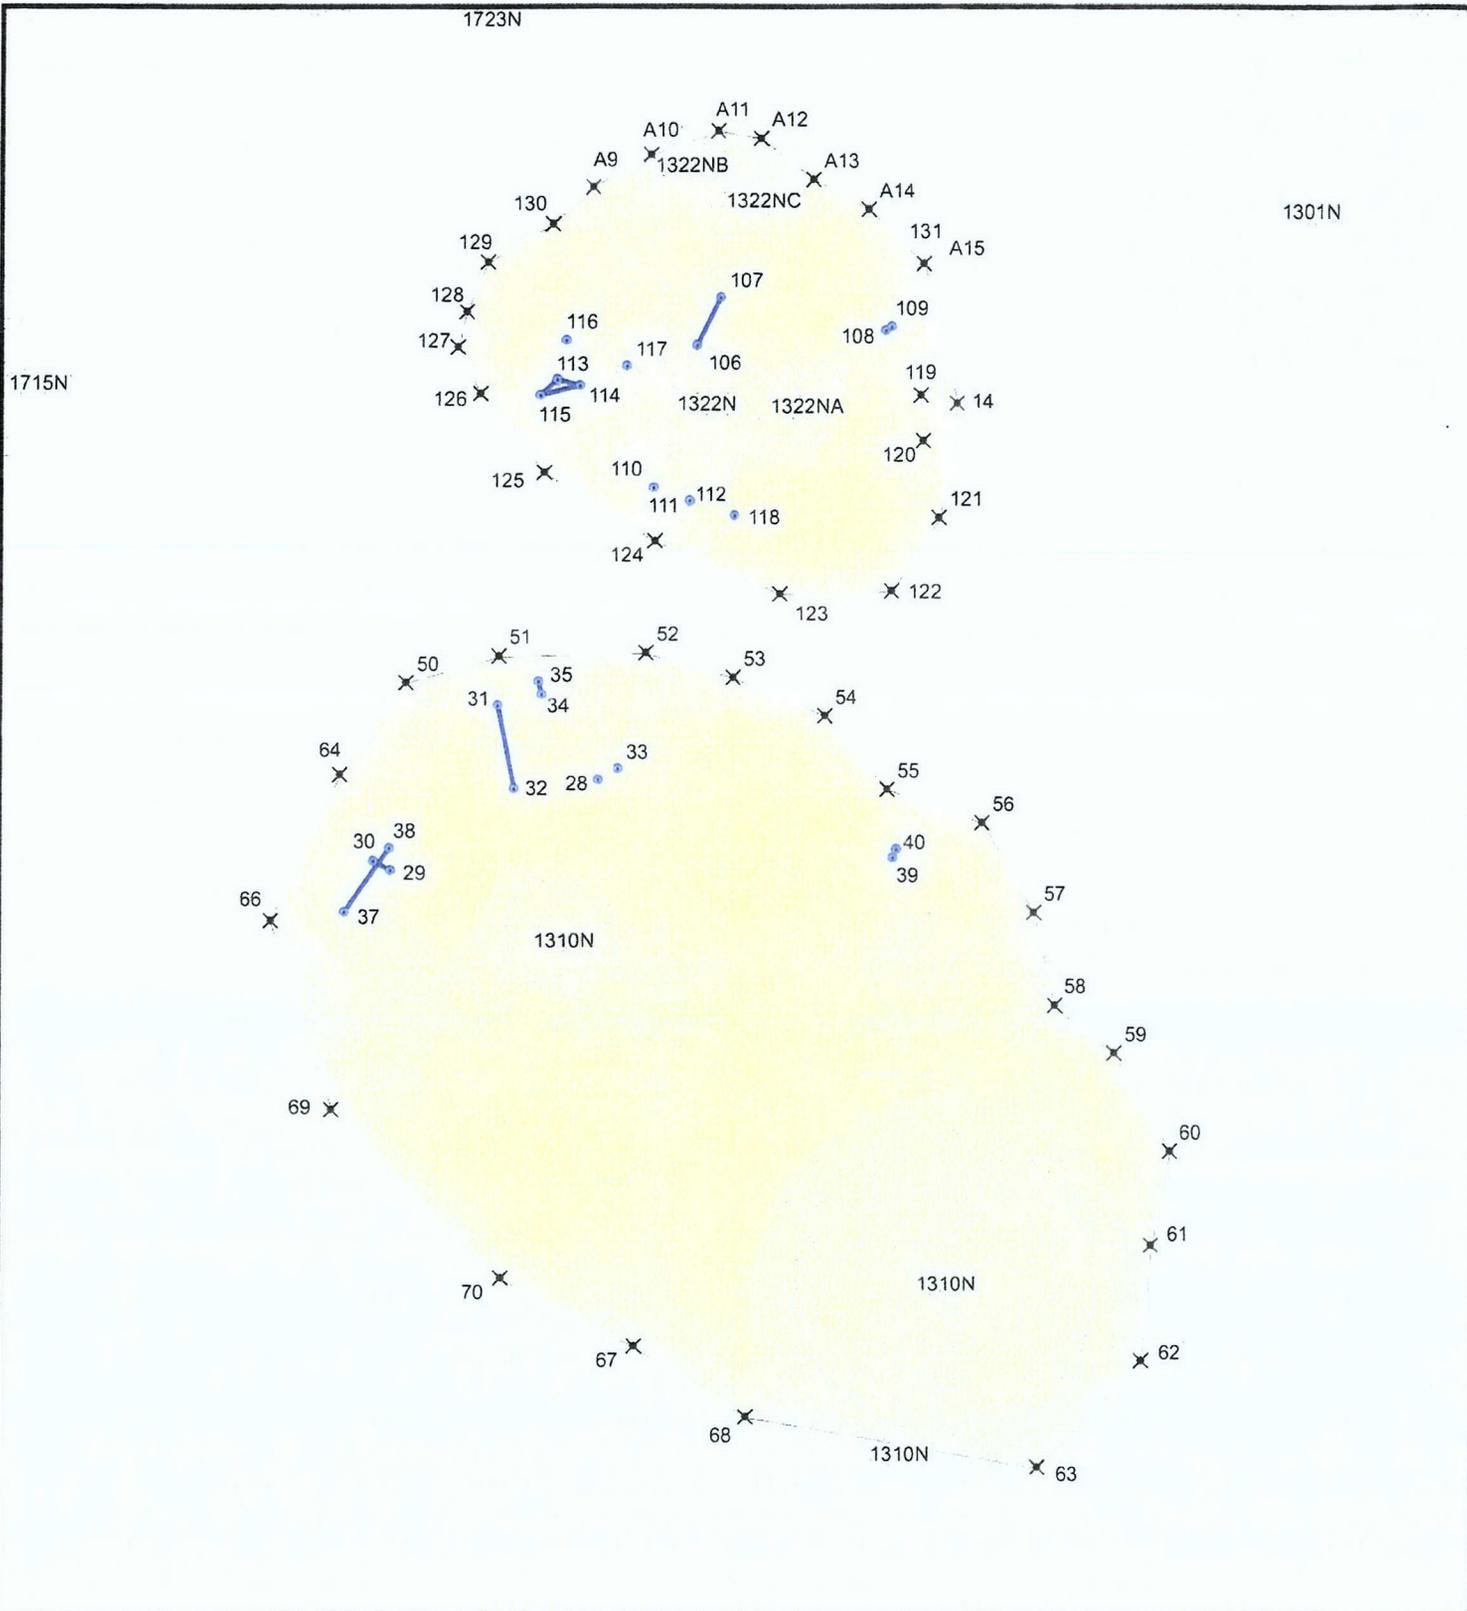
1310N, 1322N, 1322NA, -  
1322NB, & 1322NC  
Post Demolition GPS Survey

Survey Project Name:	1310N Post Demo Survey
Date:	12/2/2010
Equipment:	5800, Laser Impulse
Survey Purpose:	Map the excavation footprint for 1310N Area
Requested By:	John Harrie, Clay McCurley
Location:	100N
Charge Code:	R1322NJ451
Field Surveyor:	Margo Aye
Survey Software Used:	Trimble Survey Controller, and Geomatics Office V.11.4
Survey Equipment Used:	5800
Control Monuments Used:	N-2
Survey Method:	RTK
Horizontal Precision:	.20m
Vertical Precision:	.30m
Fieldwork Start Date:	10/28/10
Fieldwork Completion Date:	11/3/10
Notes:	Points A9-A14 were mapped using a GeoXH accuracy ~ .50 m.

All other points were mapped using a laser.  
Pipe Diameters are estimates.

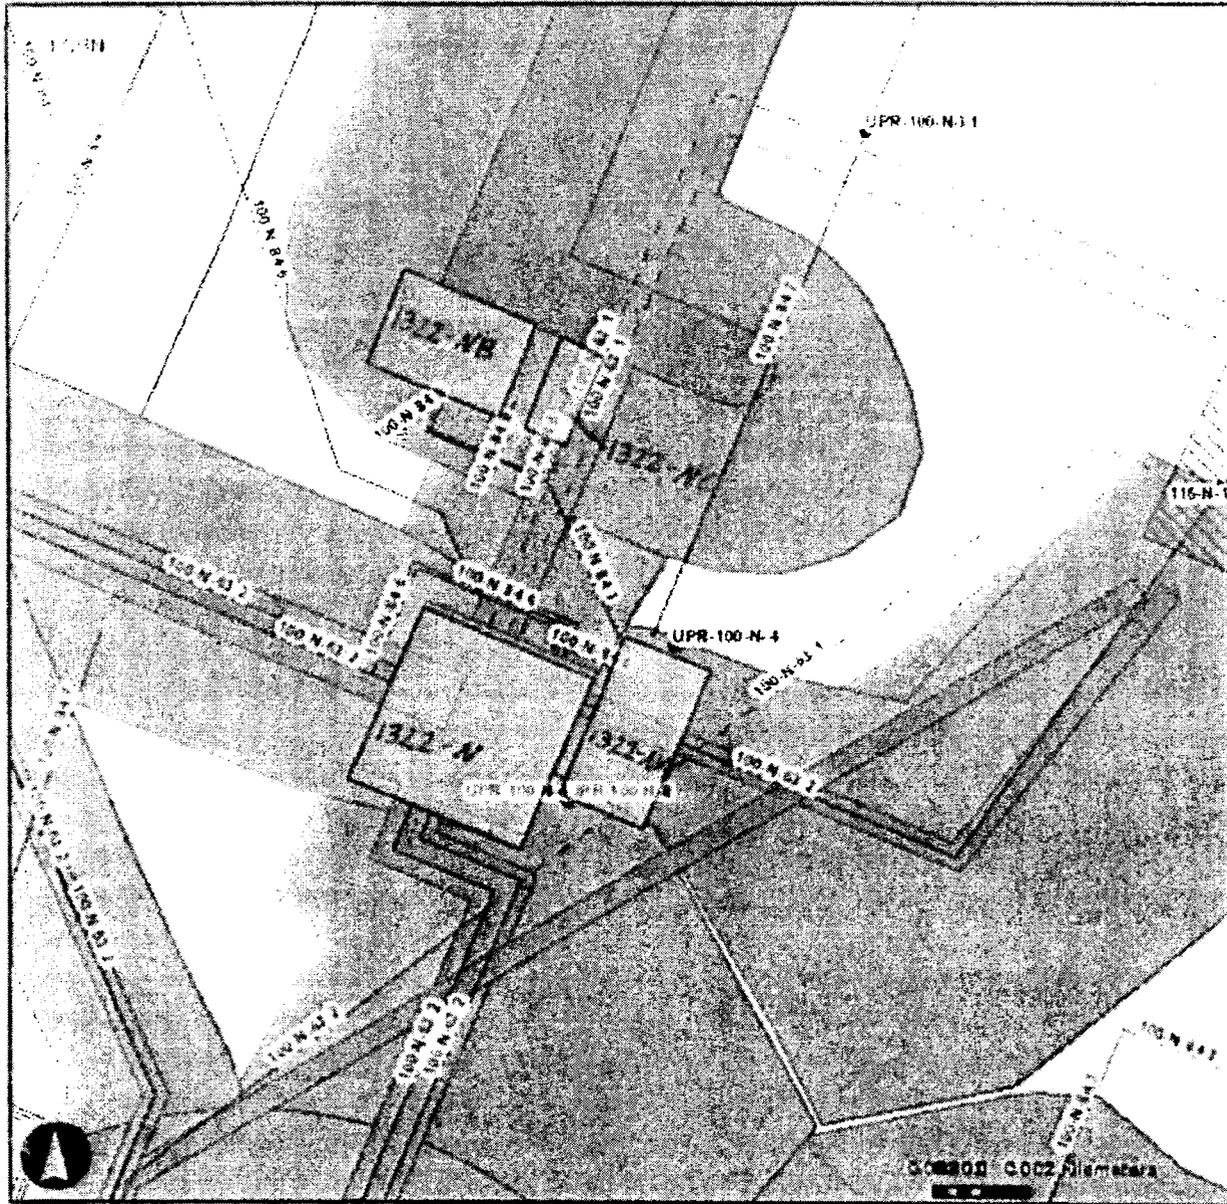
# Map

Each of these facilities has been demolished, including their respective foundations (WCH-473 pgs. 5-8 & pg. 15). The location where these facilities used to exist has been transferred to the Field Remediation organization (WCH-473 pgs. 5-8 & CCN 157108 pg. 7). Verifying the attainment of cleanup standards at this location will be determined as part of a remedial action (WCH-473 pg. 16 & CCN 157108 pg. 7). All waste sites associated with these facilities will be closed out by the Field Remediation organization (CCN 157108 pg. 4). The planned excavation boundaries for the associated waste sites cover the historical footprints of these facilities in entirety (GIS Field Remediation Overlay Map--attached to this form).
