Control #: D4-300-063**FACILITY STATUS CHANGE FORM**

<b>Date Submitted:</b> Jul 11, 2012	<b>Area:</b> 300 Area	<b>Control #:</b> D4-300-063
<b>Originator:</b> John Harrie	<b>Facility ID:</b> 3719	
<b>Phone:</b> 509.308.9935	<b>Action Memorandum:</b> Action Memorandum #1

# FACILITY STATUS CHANGE FORM

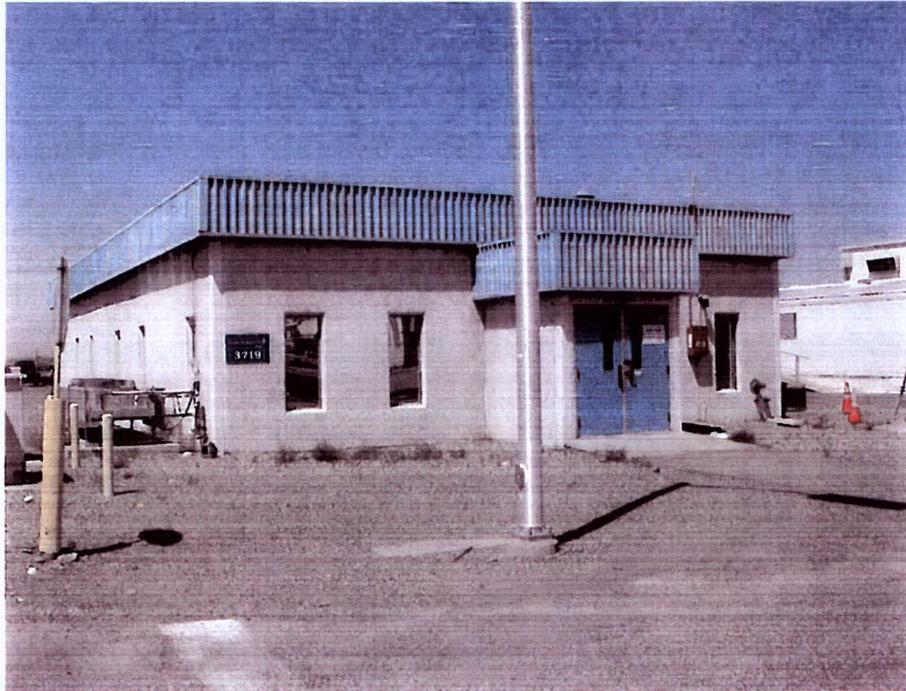
**Figure 1: Looking north at the 3719 Building in July of 2004.**

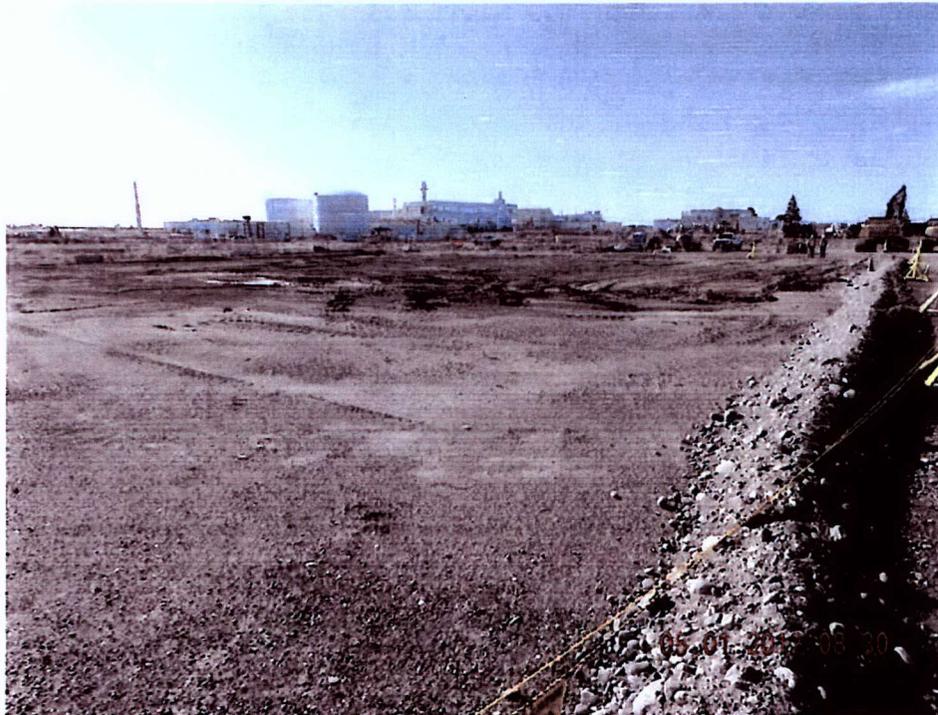
No anomalies were observed during the demolition of the 3719 Building. Soil beneath the slab displayed no visual evidence of staining or discoloration.

**Figure 2. Looking southeast at 3719 following slab removal on May 1, 2012.**

**Demolition:** Above-grade demolition of the 3719 facility was completed in June of 2007. Below-grade demolition of the 3719 foundation slab was completed in April of 2012. Approximately 2-feet of soil was removed during slab demolition and the excavation backfilled with clean fill. The building debris were removed and disposed of at ERDF. The demolition was performed with Radiological and Industrial Hygiene controls.

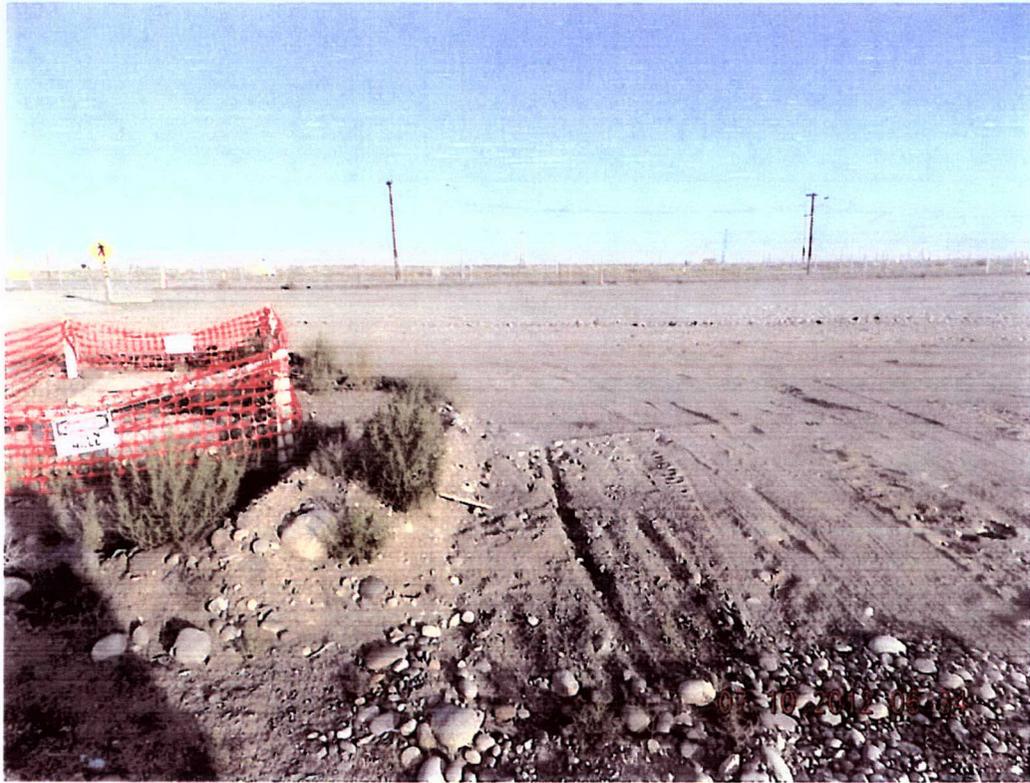
The building debris and slab foundation was removed and disposed of at EDRF. A GPERS survey is included as Attachment 3. Excavation was backfilled to grade with clean fill.

**Figure 4. Looking west at 3719 following backfill in July of 2012.**

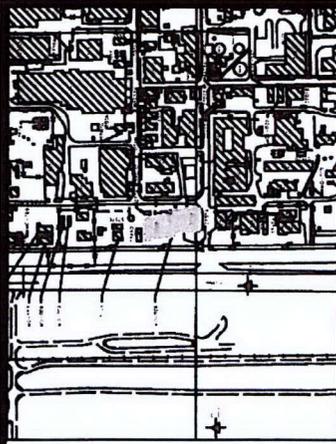
**300 D4  
 3705, 3705BA, 3719  
 GPERs Radiological Survey  
 Gamma Track Map**

Bkg Location  
394 meters NE  
1217 cpm

Coverage File: D4\_93  
 Number of Data Pnts: 1733  
 Type of Survey: gamma  
 Max GCPM: 1747  
 Avg Bkg CPM: 1217  
 Survey Date: 4/2/2012  
 Area Surveyed: 2411 m<sup>2</sup>  
 Project File: ESRFRM120043  
 Pdf File: ESRFRM120043C
