**FACILITY STATUS CHANGE FORM**

<b>Date Submitted:</b> Aug 7, 2012	<b>Area:</b> 100-N	<b>Control #:</b> D4-100N-0040
<b>Originator:</b> David Warren	<b>Facility ID:</b> 105-ND Remote and Local Air Intakes	
<b>Phone:</b> 539-6040	<b>Action Memorandum:</b> General Hanford Decommissioning Activities

**Attachment 1: Facility Information (3 pages)**

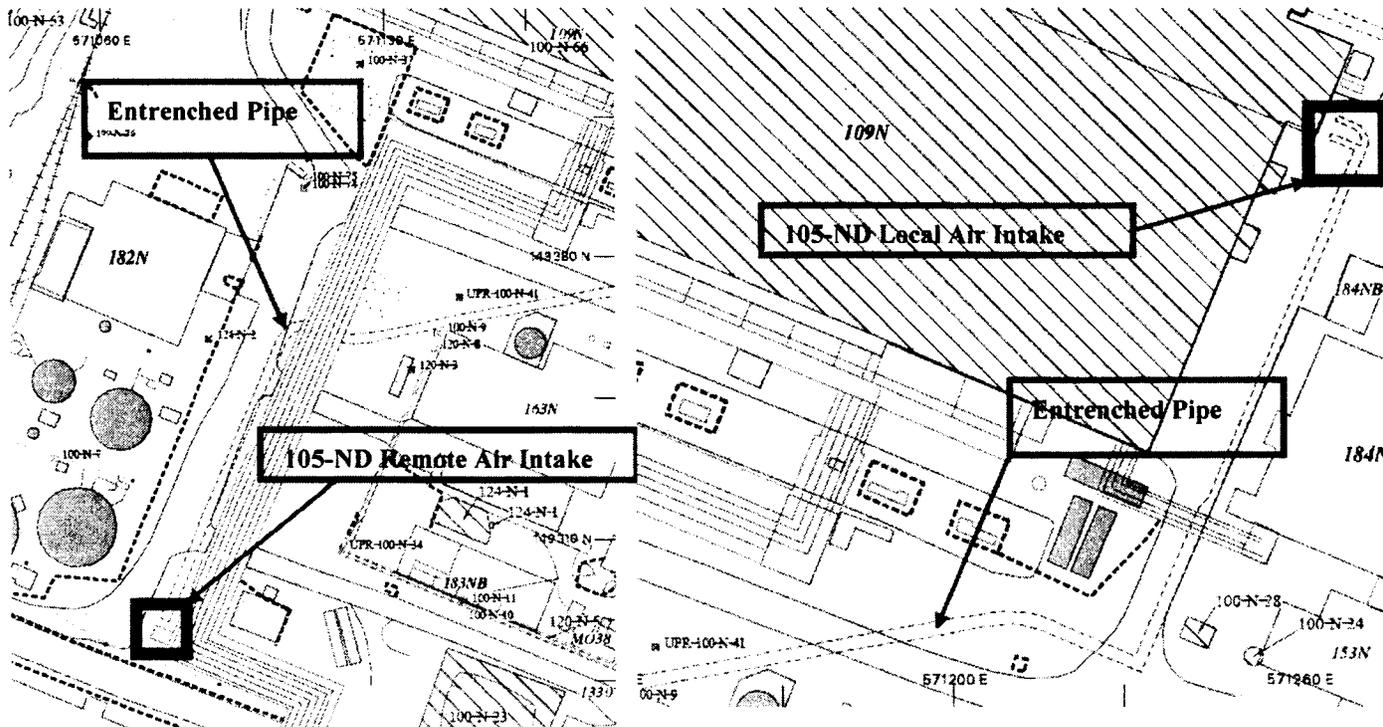
**Figure 1. Location of the 105-ND Facility**

The 105-ND facility consisted of two above-grade structures and a connecting entrenched pipeline. The facility was used to provide emergency air for the personnel in the 105-N Control Room and the 182-N High Lift Pump House. The 105-ND Remote Air Intake was an above-grade concrete block approximately 6' by 8' wide and 12' tall, with an internal screen and a manhole cover on top. It was located adjacent to the 1802-N Pipe Trestle on the south side of the 109-N Heat Exchanger Building. The 105-ND Local Air Intake was an above-grade, cylindrical, mushroom-shaped structure located east of the 105-N Reactor Building. The two intakes were connected by a 14" diameter pipe packed in an underground concrete trench, approximately 5' 9" wide by 3' 6" tall. The pipe was connected to the 105-N Control Room Vestibule inside the 105-N Reactor Building and the 182-N High Lift Pump House. A map of the 105-ND facility is included in Figure 1. Photographs of the 105-ND facility are included in Attachment 2.

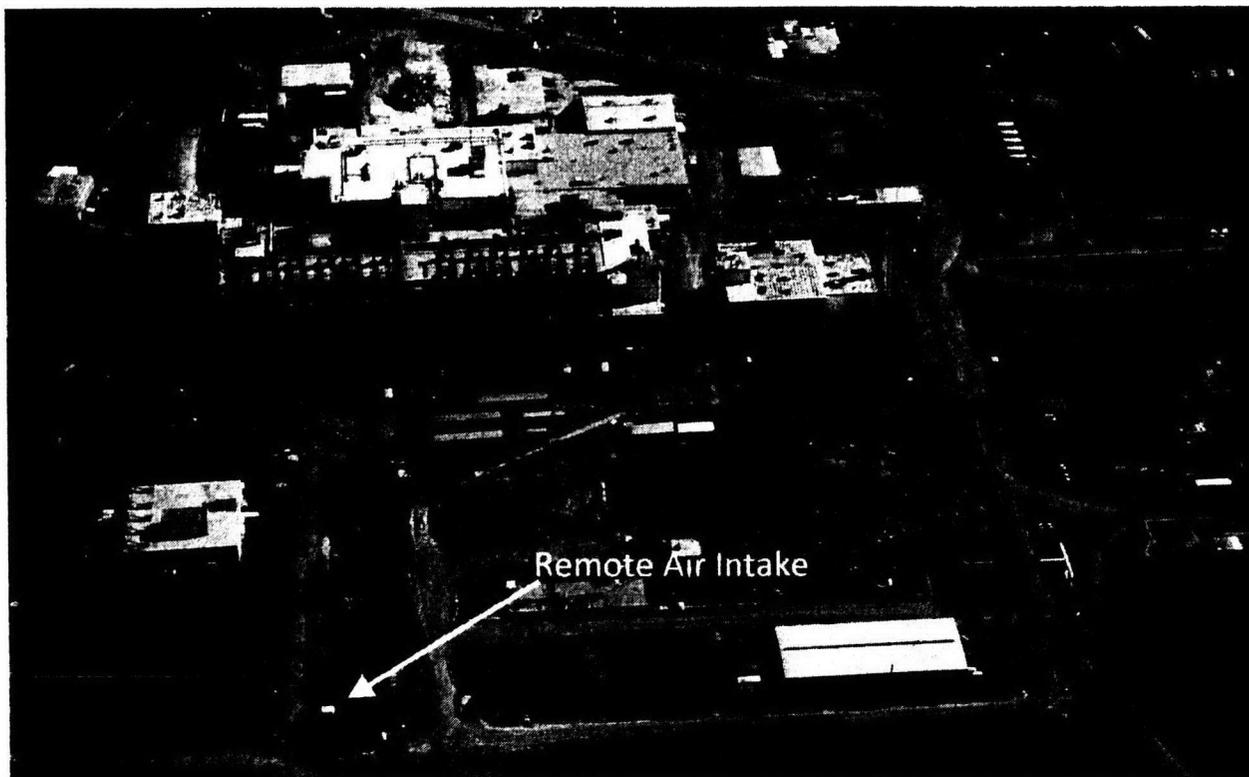
105-ND Remote Air Intake Pre-Demolition

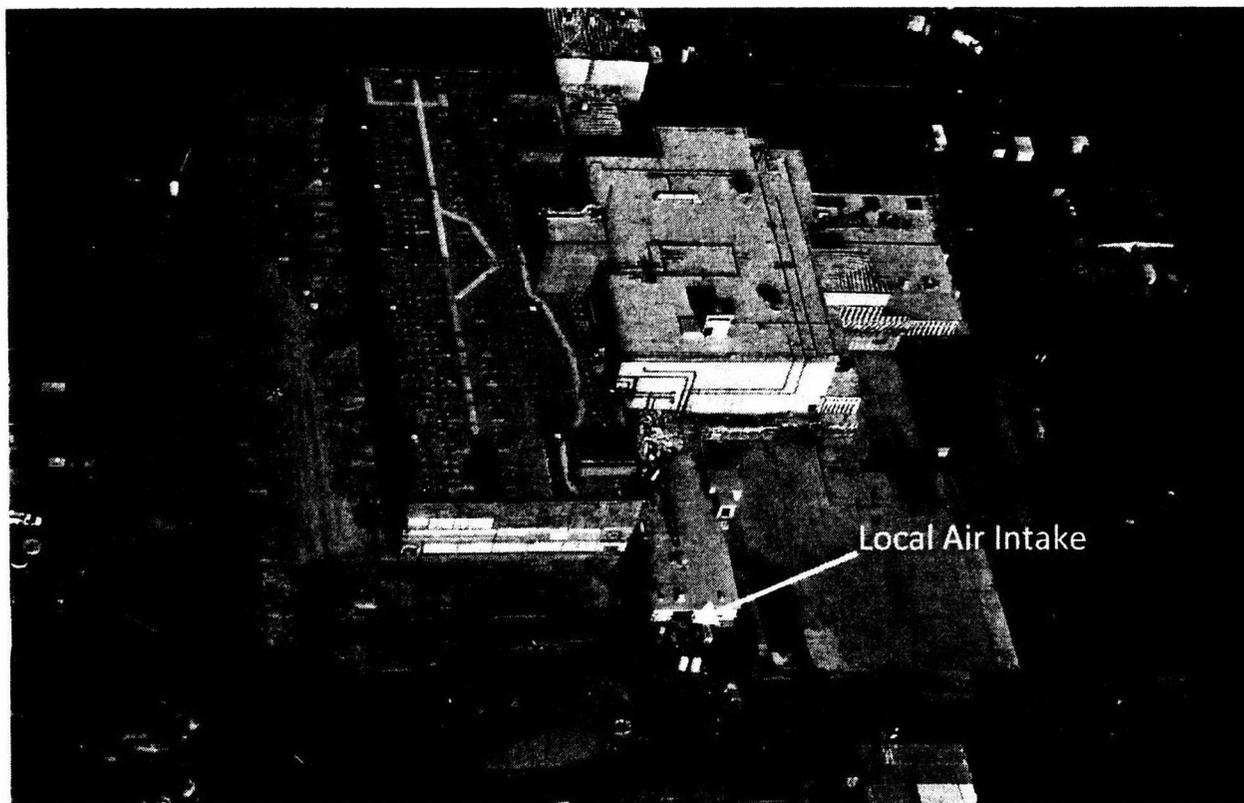
105-ND Local Air Intake Pre-Demolition

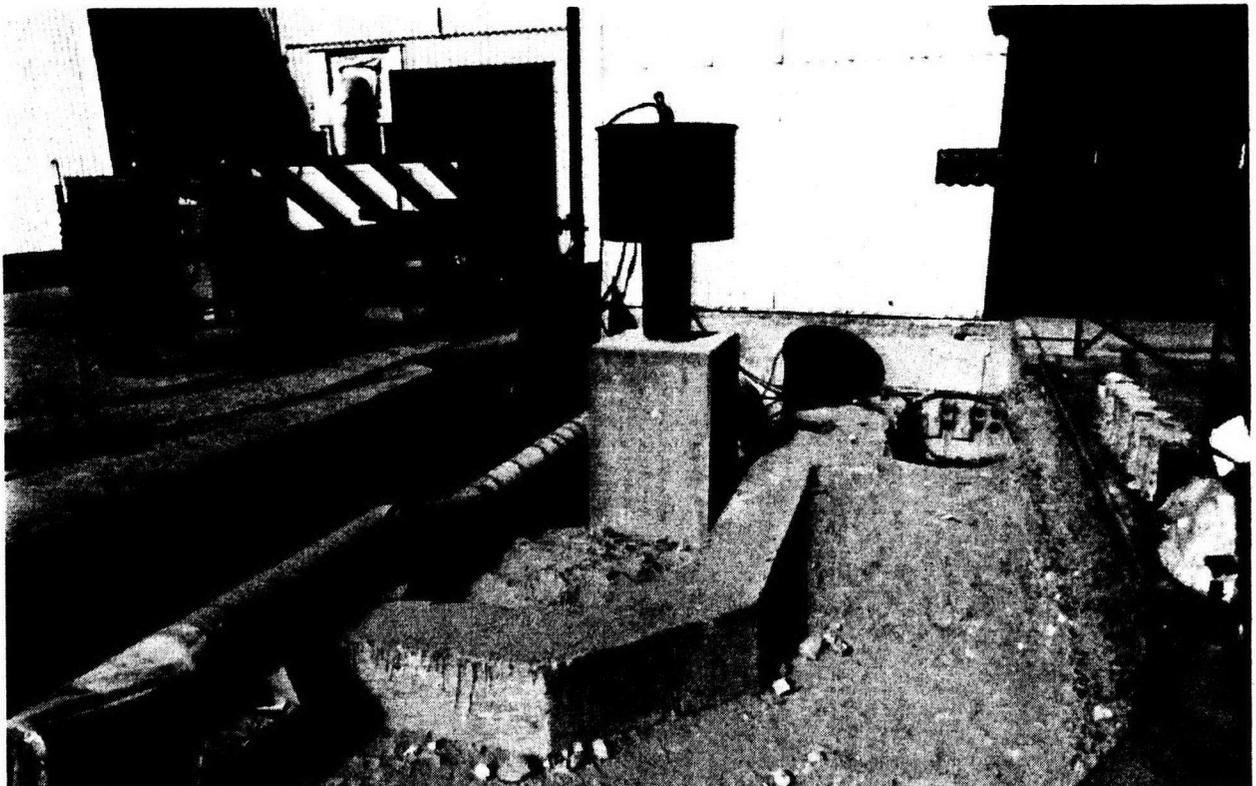
105-ND Local Air Intake Pre-Demolition

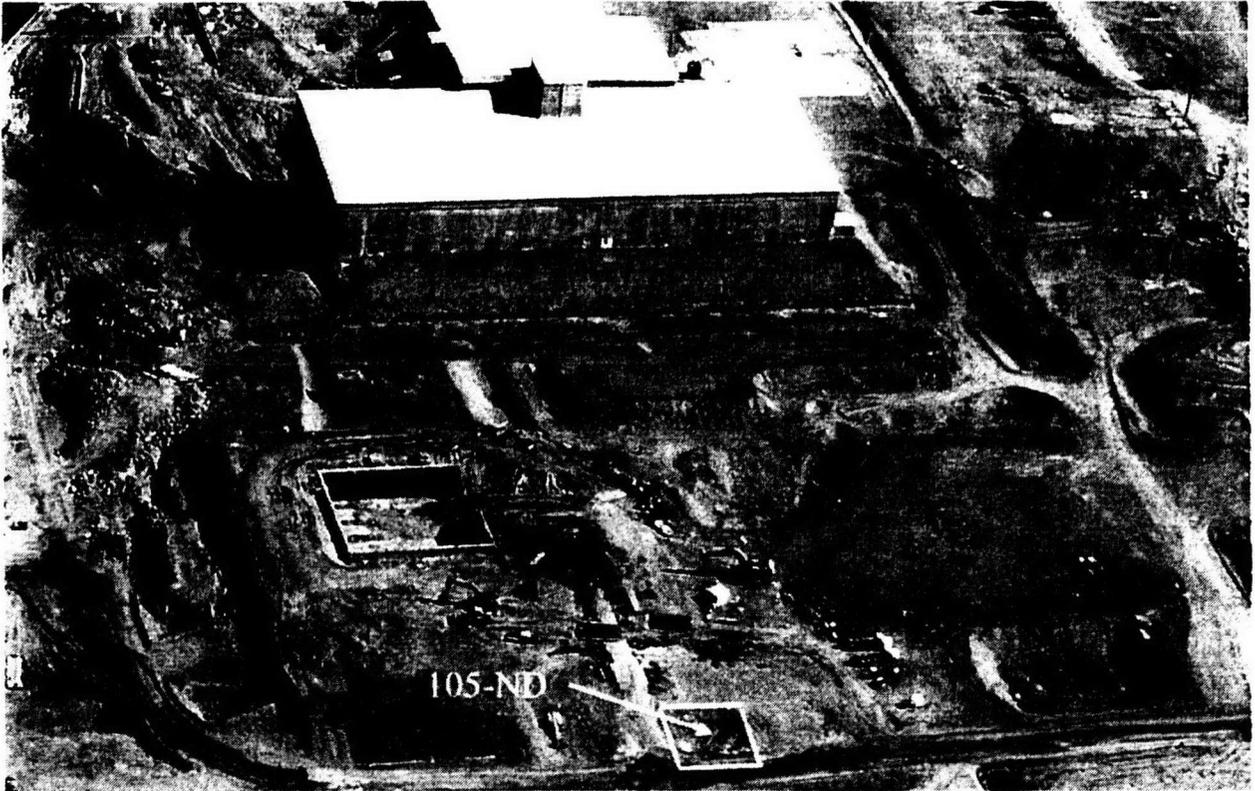
Demolition and load out of the 105-ND Remote Air Intake was completed on April 5, 2012. Six containers of debris were shipped to the Environmental Restoration Disposal Facility (ERDF) for disposal. The 105-ND Local Air Intake was demolished in October 2009 with the 109-N/105-N structures down to the exterior walls of what later became the Interim Safe Storage Enclosure. The entrenched pipe that connected the two intakes remains in place with the exception of portions that were removed during 182-N demolition and remediation of waste site 100-N-61 by the Field Remediation (FR) organization. It is estimated that the original length of the entrenched pipe was 1,140 linear feet and that FR removed 600 linear feet. Post-demolition photographs are included in Attachment 2. A visual inspection and GPERS surveys were conducted of the excavated areas. No soil staining or radiological contamination was identified.

105-ND Remote Air Intake Post-Demolition

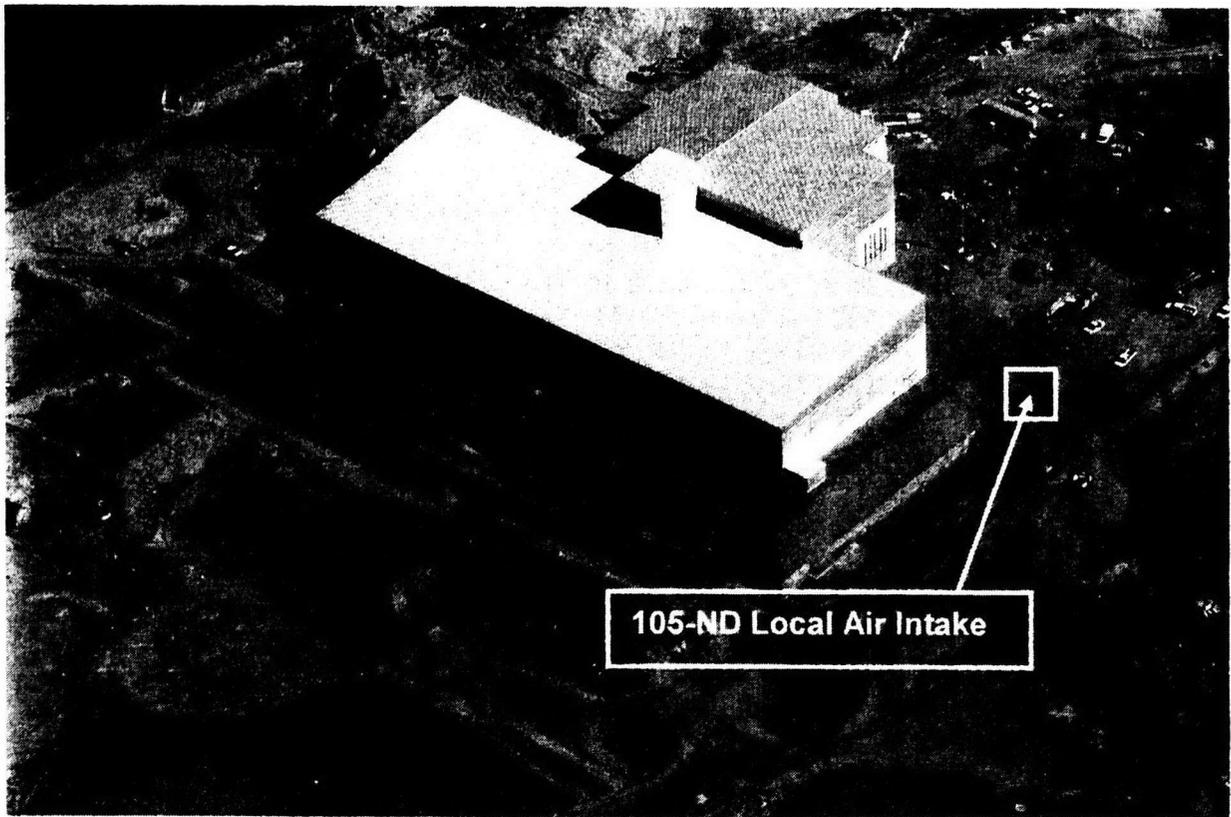
105-ND Local Air Intake Post-Demolition

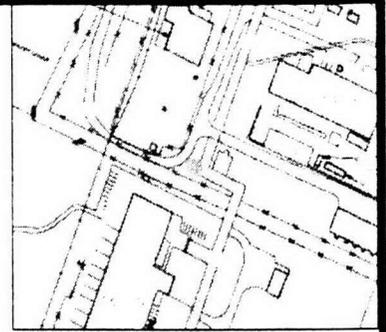
**100N D4  
105-ND Intake  
GPERS Radiological Survey  
Gamma Track Map**

Coverage File: N109  
Number of Data Pnts: 244  
Type of Survey: gamma  
Max GCPM: 2012  
Avg Bkg CPM: 1627  
Survey Date: 4/18/2012  
Area Surveyed: 45 m<sup>2</sup>  
Project File: ESRFRM120053G  
Pdf File: ESRFRM120053GC

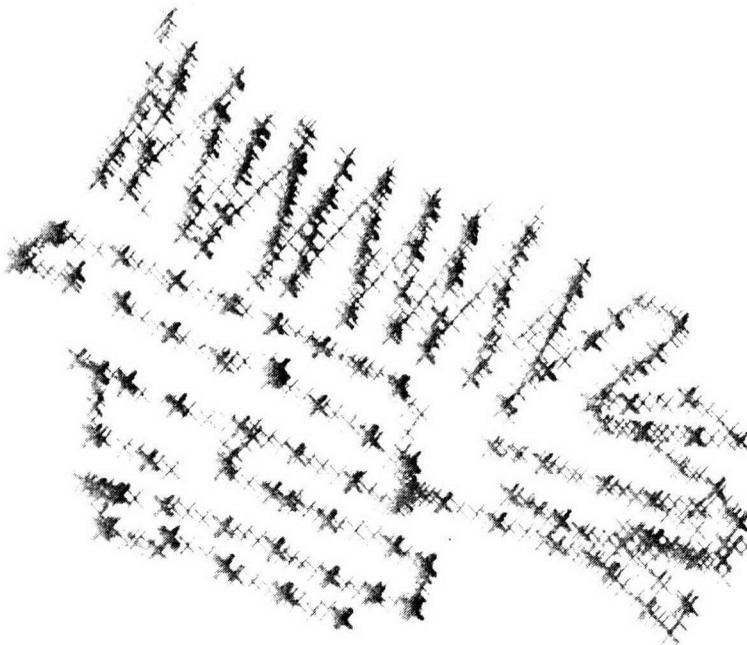
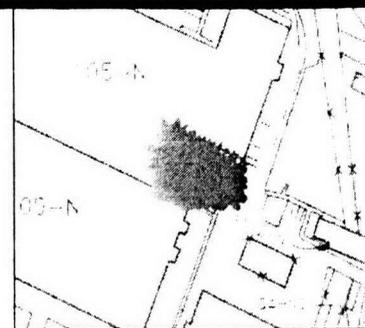
**100N Field Remediation  
105-N Control Room  
GPERS Radiological Survey  
Gamma Track Map**

Coverage File: N322A  
Number of Data Pnts: 2139  
Type of Survey: 'Gamma'  
Max GCPM: 2289  
Avg Bkg CPM: 1236  
Survey Date: 11/18/2009  
Area Surveyed: 134 m<sup>2</sup>  
Project File: N322A  
Pdf File: ESRFRM090173GC

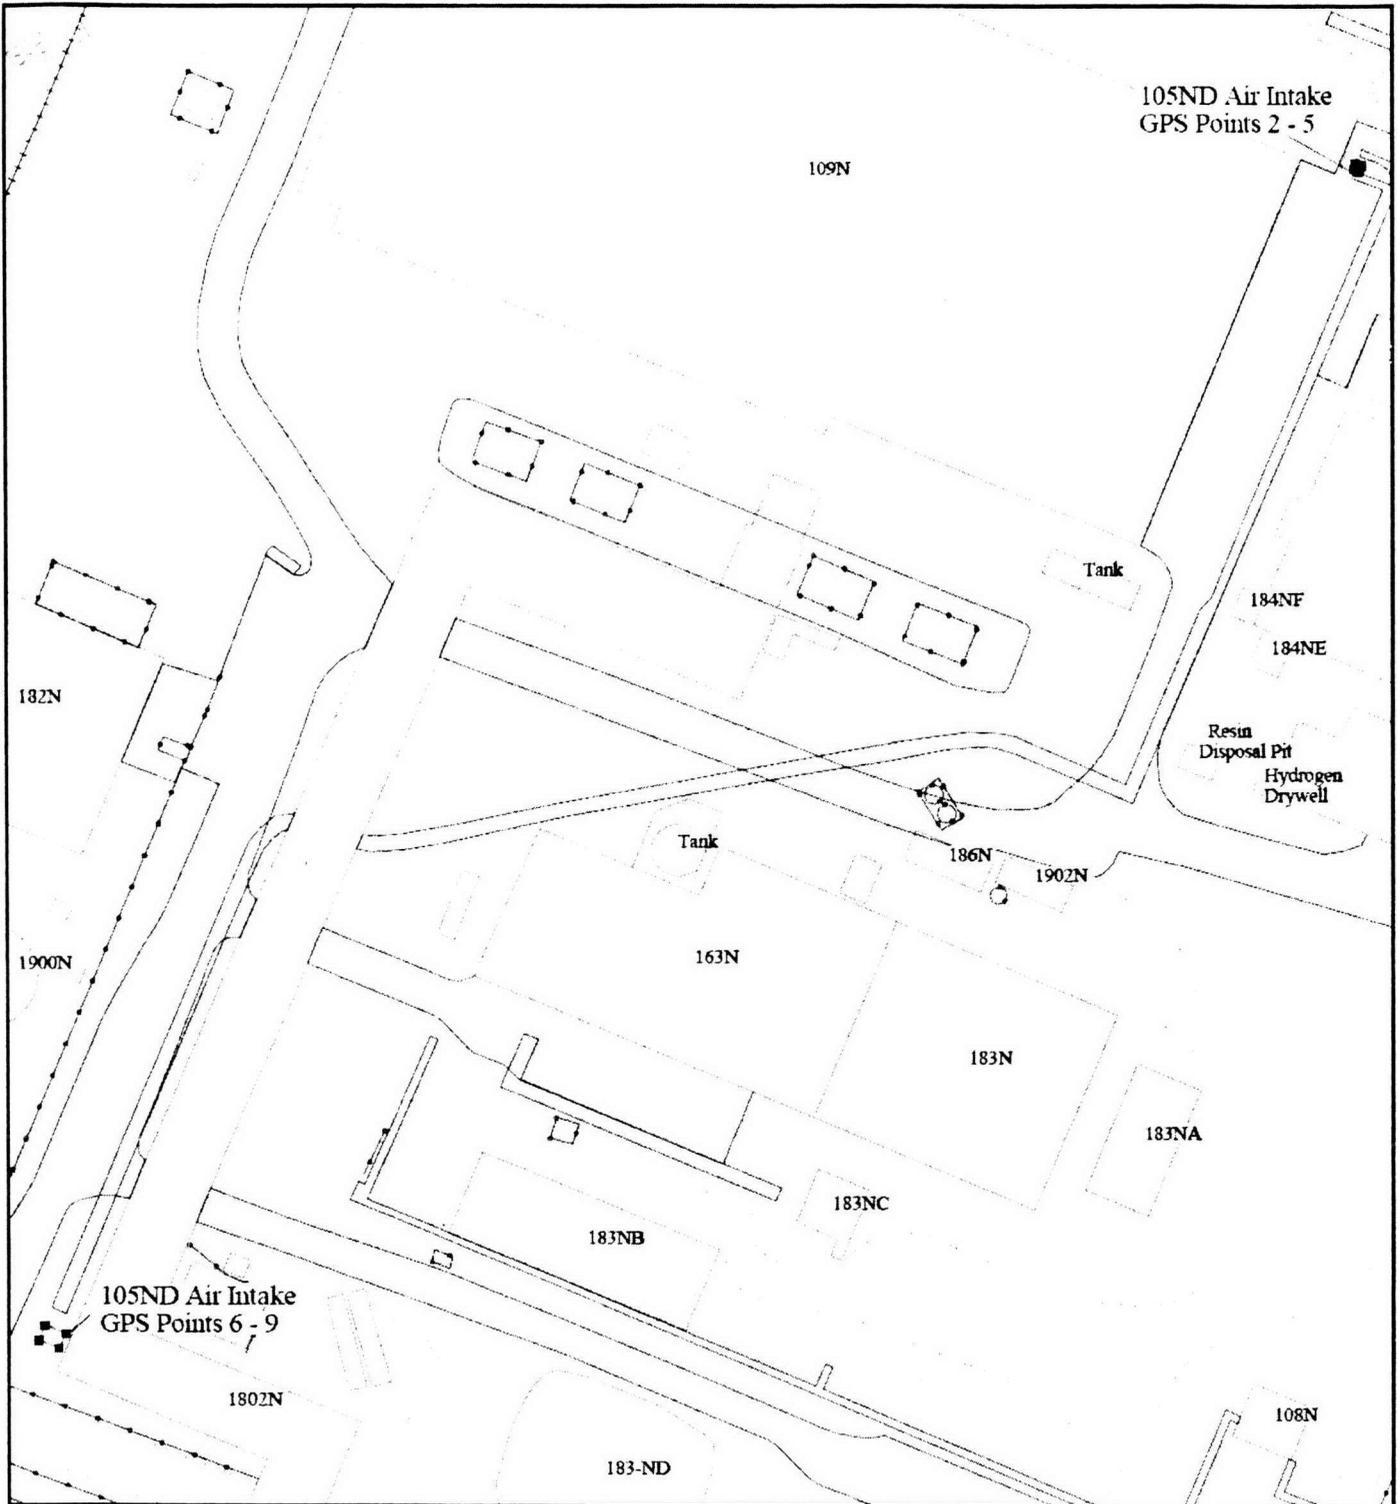
**Pre- Demolition Survey of  
The 105ND Air Intake**

Paved Roads and Sidewalks		Location of the 105ND Air Intake
	Unpaved Roads and Trails		GPS Locations for 105ND
	Railroad	See GPS Survey Report for Coordinate Information	
	Fences

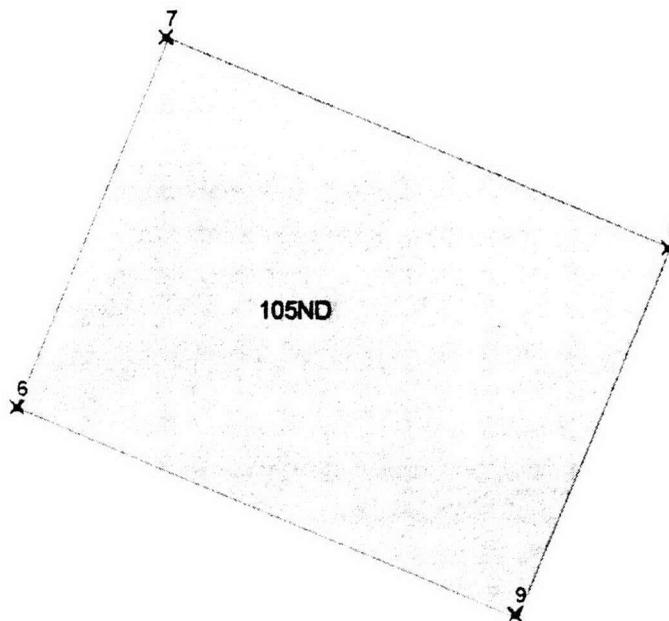
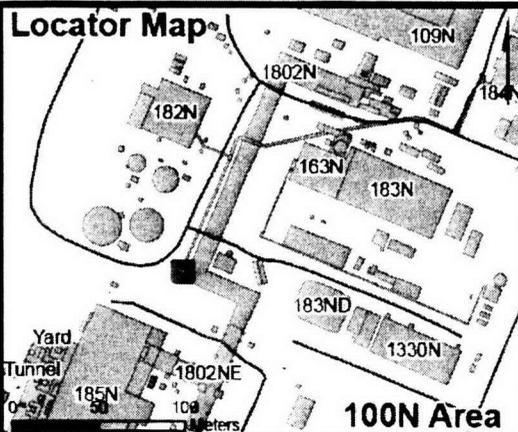
### GPS Pre Demo Survey Report For 105ND Building

GPS Survey Date 1/24/08  
 US State Plane 1983  
 Zone: Washington South 4602;  
 NAD83, NAVD88; Units are in Meters

Name	Feat_Code	Northing	Easting	Elevation
6	corner	149285.689	571072.438	139.166
7	corner	149287.924	571073.344	139.075
8	corner	149286.657	571076.347	139.165
9	corner	149284.44	571075.416	139.129

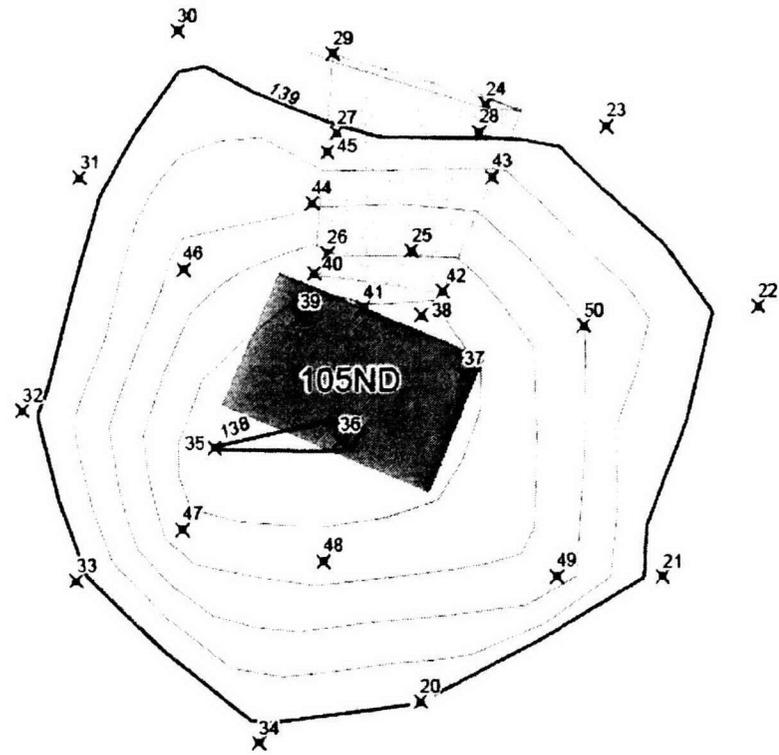
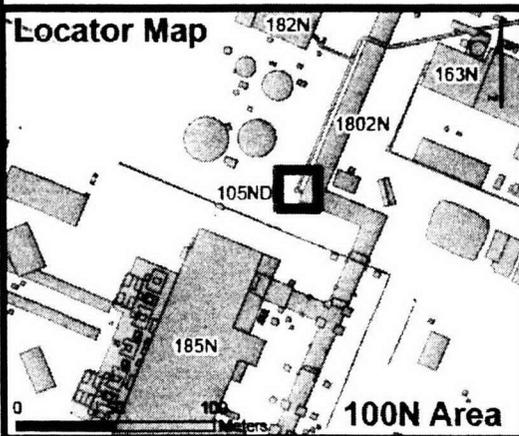
### GPS Post Demo Survey Report For 105ND

Survey Project Name: 105ND Post Demo  
 Date: 4/19/2012  
 Equipment: 5800  
 Survey Purpose: Post Demo Survey for 105ND Excavation  
 Requested By: Clay McCurley  
 Location: 100N  
 Charge Code:  
 Field Surveyor: Margo Aye  
 Survey Software Used: Trimble Survey Controller, and Geomatics Office V.11  
 Survey Equipment Used: 5800  
 Control Monuments Used: N-2  
 Survey Method: RTK  
 Horizontal Precision: .020m  
 Vertical Precision: .050m  
 Fieldwork Start Date: 4/19/12  
 Fieldwork Completion Date: 4/19/12  
 Notes: This excavation had a large concrete footing with in it.

- GPS Post Demolition Survey Points:
- x See Survey Report for Point Details
  - Major Contour 1 Meter Interval
  - - - Minor Contour .2 Meter Interval
  - Building Location
  - ▨ Concrete Structure
