WASTE SITE RECLASSIFICATION FORM

Control No.: 2012-088

Waste Site Code(s)/Subsite Code(s): 1908-NE, HGP Outfall, 1908-NE Building, HGP-SWMU # 7

**1908-NE, HGP OUTFALL, 1908-NE BUILDING, HGP-SWMU #7
FACILITY STATUS CHANGE FORM**

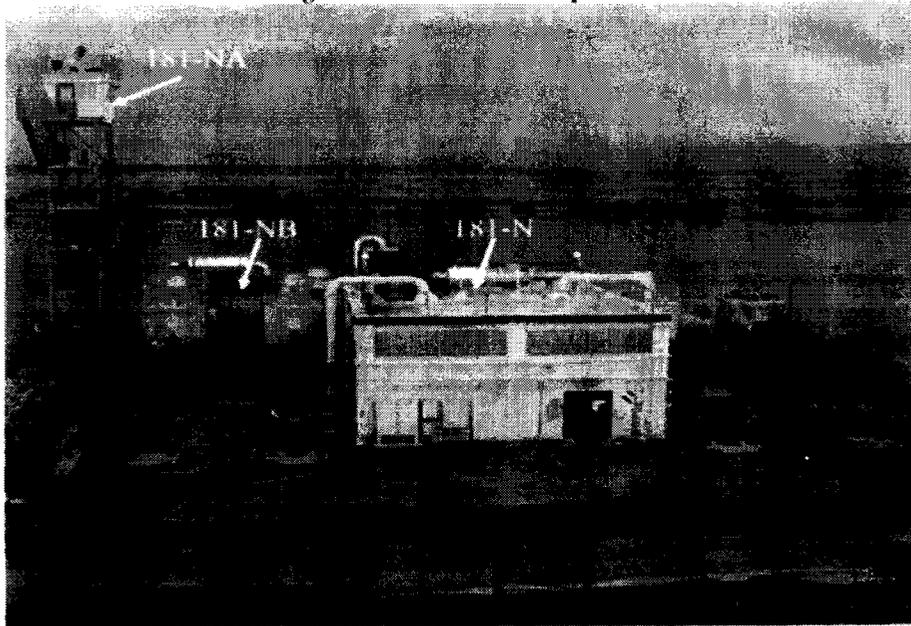
Figure 1. 181-N River Pumphouse

181-N River Pumphouse was a rectangular building partially situated in the Columbia River with a total outside foot print of 111-ft by 108-ft. The structure was constructed of reinforced concrete, masonry in fill walls, a flat concrete roof, and concrete wall foundation. The building contained two low-lift, diesel engine driven and four remotely operated, vertical, deep-well pumps with submerged bowls and impellers. 4 deep-well pumps with a design rating of 105,000 gpm each at 112-ft of head supplied the circulating raw water cooling system for the N-Reactor. Pumps 1 and 2 discharged into a 102-in distribution header, and pumps 3 and 4 discharged into a second distribution header of equal size. The facility had six traveling "trash" screens and supporting equipment.

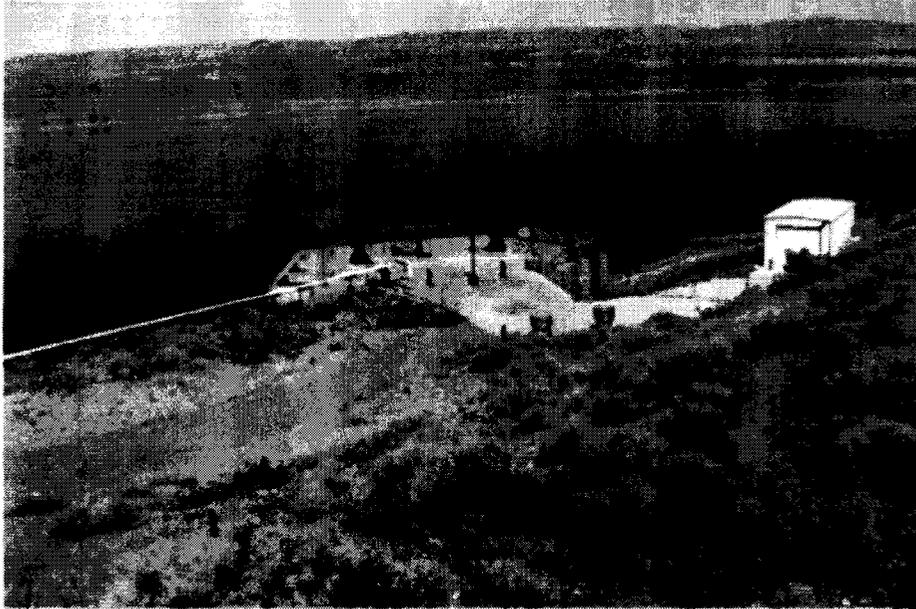
Figure 3. 1908-NE HGP Outfall

The 1908-NE, HGP Outfall, 1908-NE Building, HGP-SWMU #7 waste site was a hexagonal-shaped, open-topped, multi-compartmentalized, reinforced concrete outfall structure located in the 100-NR-1 Operable Unit. The structure measured 23 m (76 ft) wide by 31 m (102 ft) long by 15 m (49 ft) tall. Coolant water from the Hanford Generating Plant (HGP) entered the outfall structure and was discharged via a 3.4-m (11-ft)-diameter pipe for 319 m (1,050 ft) into the Columbia River's main channel. In addition, clarified wastewater overflow from the 100-N-1 HGP Settling Pond, which collected runoff from the HGP building roof, floor drains, and other exterior areas, was routed to the 1908-NE outfall.

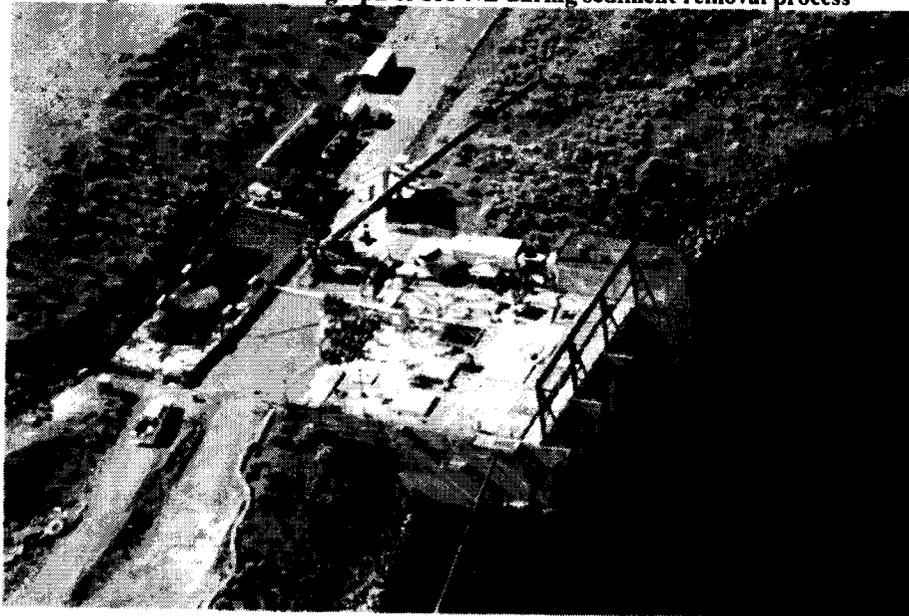
Figure 6. Aerial Photograph of 181-NE during sediment removal process

Sediment Removal: Utilizing a vacuum apparatus connected to a pump feeding a water filtration system, contaminated sediment within the structures was removed by divers from July through August of 2011. In consultation with the Department of Ecology, and as outlined in WCH-446, divers made two vacuuming passes through each of the structures with a minimum of 12 hours settling time between each pass. The filtration system, composed of various components including a Geotube[®] sediment bag, paper filter media, sand filters, and granular activated charcoal (GAC) filters, was designed to remove 95% or more of the sediment from the water. The sediment laden water from each facility was passed through the filtration system and fed back to the interior of the structures from which it came. In September 2011 (See Attachment 5, CCN 161465), Ecology concurred that, based on visual inspection of the interior of the structures by divers, the amount of sediment removed from each structure was acceptable and fill of the interior of the structures with sand to the level of the bench could commence. The sediment captured from the facilities and the filtration media from the filtration system were disposed of at the ERDF.

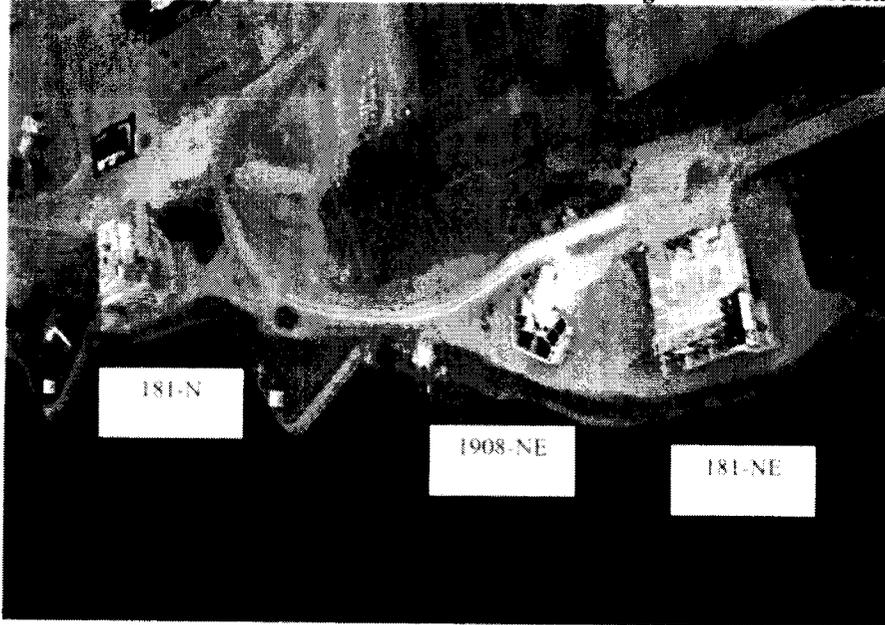
Figure 7. Aerial Photograph of 100-N River Structures following construction of benches

Bench Installation: Installation of the earthen benches to isolate the structures from the river started in August and was completed in September of 2011. The benches were composed primarily of fill material from the 100-N borrow pit and basalt rock rip-rap material from an off-site quarry. Turbidity monitoring was performed in accordance with an approved monitoring plan (See Attachment 9). Completion of the benches isolated 181-N, -NA, -NB, -NE, and 1908-NE facilities from the Columbia River and made it possible to use conventional demolition equipment to demolish the facilities outside of the specified in-water work windows.

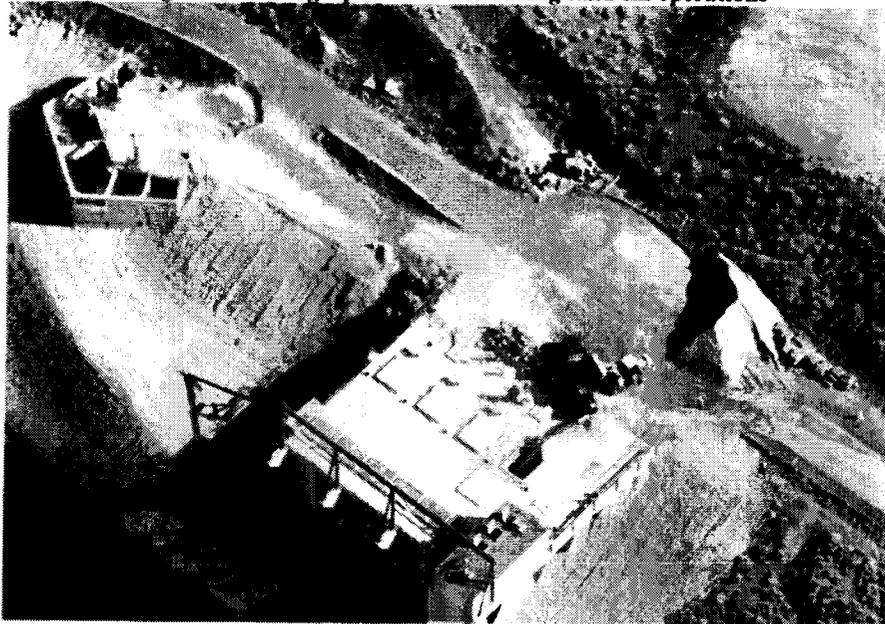
Figure 8. Photograph of 181-NE during sand fill operations

Sand fill of interior of structures: The interior of the structures were filled with borrow sand material from the ERDF. The sand displaced the water from the 181-N and 181-NE pumphouses through the stop logs and benches but the plug in the 1908-NE caused the facility to hold its water and approximately 260,000 gallons of water remained trapped inside the structure at the completion of backfill. The water did not evaporate readily and in March of 2012, with approval from DOE and Ecology, the structure was demolished in a controlled manner that allowed the water to soak into the surrounding soils/bench.

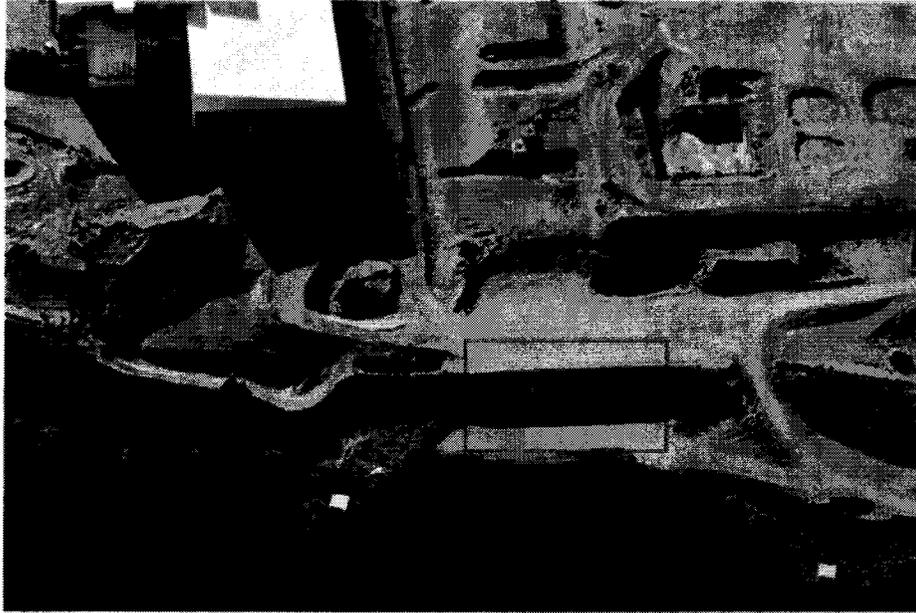
Figure 9. Photograph of 181-N post demolition

Demolition: The facilities were demolished using conventional heavy equipment. Demolition of the above-grade of the 181-NA guard tower began in January of 2012 when it was pulled over from the main 181-N structure. Demolition of the 181-NB began shortly thereafter and was followed by demolition of the 181-N main structure from February through April. Demolition of the above grade of the 181-NE and 1908-NE began in January and March of 2012, respectively. Removal of the below grade portions of the 181-N, 181-NE, and 1908-NE occurred in May through June of 2012, as allowed by unusually high river water flows/levels for that time of the year. Size reduction of demolition debris and loadout activities spanned the entire time period. Demolition debris was disposed of at the ERDF. There were no contaminants of concern for demolition as the facilities were not contaminated. There were no anomalies encountered during demolition of the 100-N River Structures.

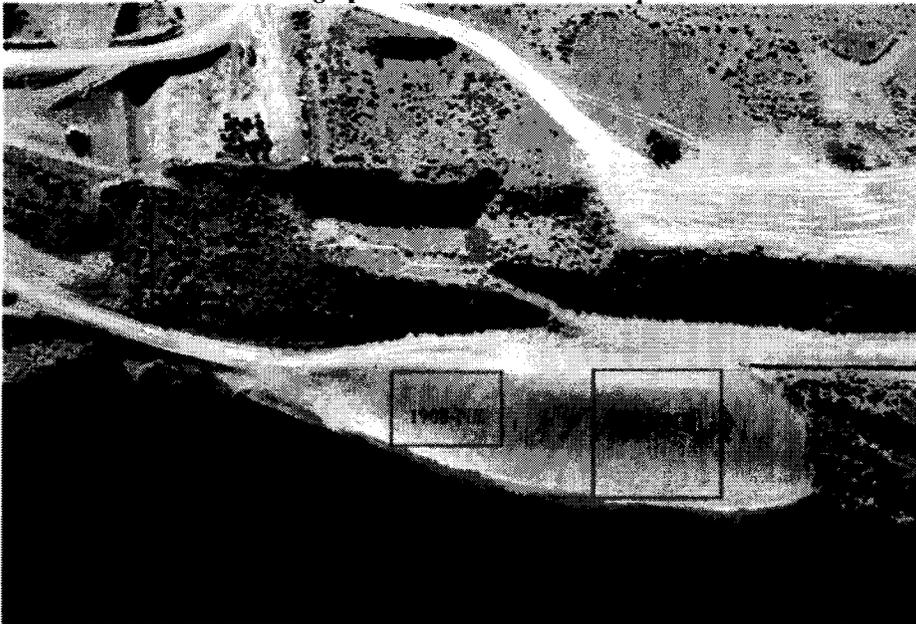
Figure 10. Photograph of 181-NE and 1908-NE post demolition

The 181-NA and -NB were completely demolished and removed as they were constructed on top of the 181-N. The 181-N, 181-NE, and 1908-NE, consistent with agreements and consultation with Ecology and ARARs agencies, were demolished to a level 3 feet below the grade of the existing riverbank and the benches installed to facilitate demolition of the structures. The remainder of the structures remain buried three feet below the grade of the riverbank and benches. The excavations that resulted from demolition operations were backfilled with fill material from the 100-N borrow pit.

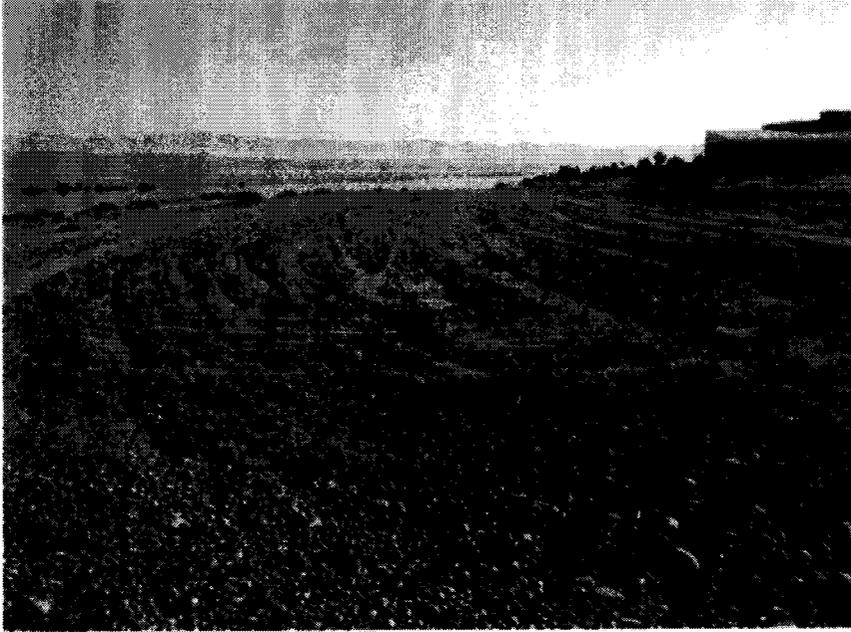
181-NE Staging Pile Area Looking North

At approximately 0800 hours on 7/10/12, the staging pile area above the 181-NE was visually inspected for signs of staining or anomalous items. The staging pile area was used for staging of non-hazardous/non-contaminated building demolition debris from demolition of the 181-N, 1908-N, 181-NE, and 1908-NE river structures. The area was observed to be free of any stained soils or anomalies that would be indicative of chemical or petroleum contamination. The GPERS surveys, both pre and post (Performed 7/12/11 and 7/26/12), didn't identify contamination, nor was any expected since the river structures were not radiologically contaminated. Please see the attached PDF file (CCN 164787) for Ecology approval of the use of the area for staging debris, as well as the word file for photographs that were taken during the visual inspection, and PDF files of the GPERS surveys. I'll CHRON this e-mail and attachments for future use as reference for closure documentation. Feel free to contact me if you have any questions. Thanks.

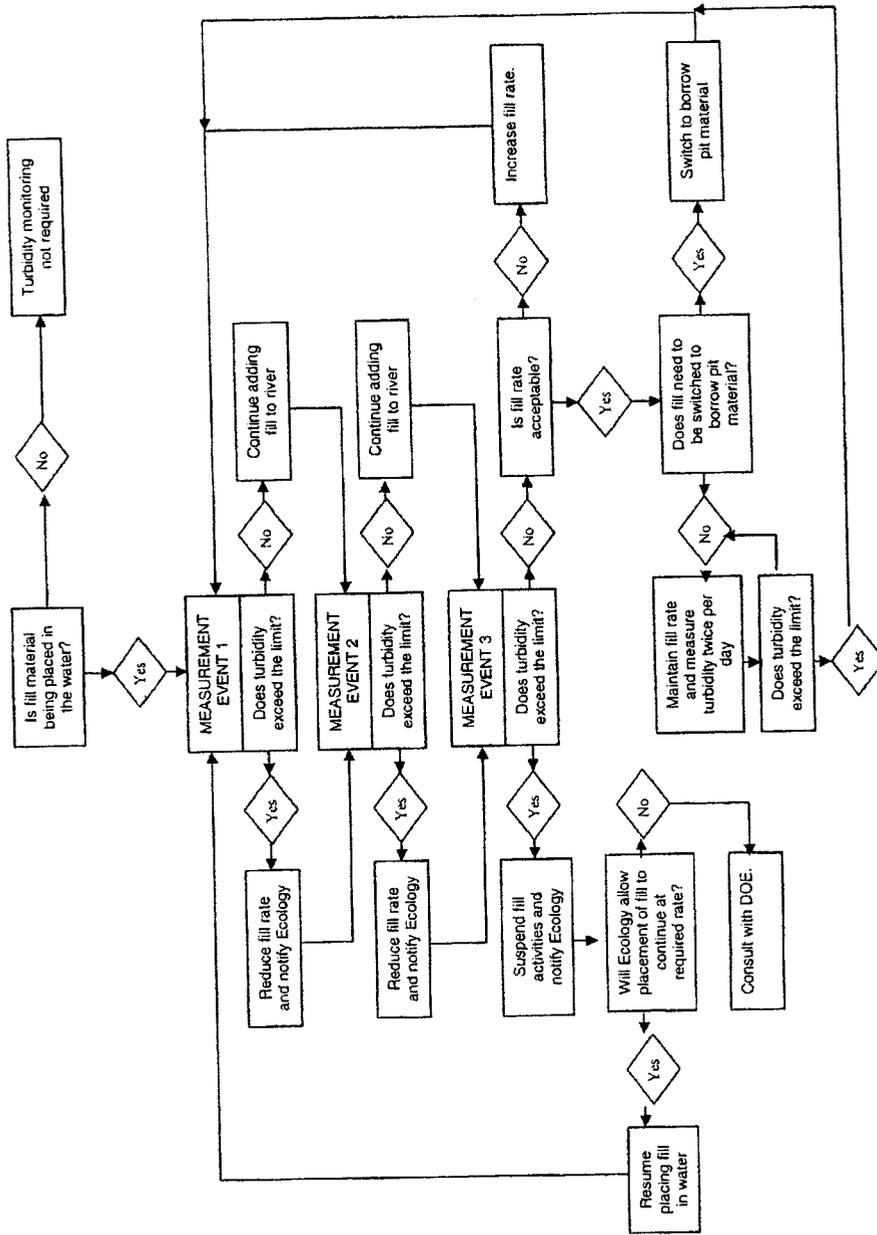
Figure 1 Turbidity Monitoring Flow Diagram

Turbidity monitoring will be conducted during bench installation to ensure activities are conducted in compliance with regulatory requirements. This revision incorporates conditions of Order No. 8738 that Ecology issued to DOE on September 7, 2011 (EXHIBIT A). Order No. 8738 is a short-term water quality standards modification that increases the project's turbidity limit from 5 NTU (nephelometric turbidity units) to 30 NTU above background 300 feet downstream of the work area and allows use of mixing zone criteria contained in WAC 173-201A-400(7). The mixing zone criteria allows using the average of multiple turbidity measurements as long as the zone does not utilize greater than twenty-five percent of the flow or occupy greater than twenty-five percent of the width of the river. Multiple measurements, when used determine the downstream turbidity, must be spaced equidistant across zone.

Turbidity monitoring will consist of visual observations for turbidity and measurements made with a Hanna Instruments HI 98703 Turbidity Meter (EXHIBIT B), or equivalent, calibrated and maintained per manufacturer's recommendations. Measurements will be taken at 100 feet upstream and 300 feet downstream of the work area. The results the measurements will be recorded on the *Turbidity Monitoring Form* (EXHIBIT C) and consist of:
