100/300 AREA UNIT MANAGER MEETING ATTENDANCE AND DISTRIBUTION

100 & 300 AREA UNIT MANAGER MEETING MINUTES

Groundwater and Source Operable Units; Facility Deactivation, Decontamination, Decommission, and Demolition (D4); Interim Safe Storage (ISS); Field Remediation (FR); Mission Completion; and 100-K Sludge Treatment Project and 100-K Facility Demolition and Soil Remediation Projects

January 9, 2014

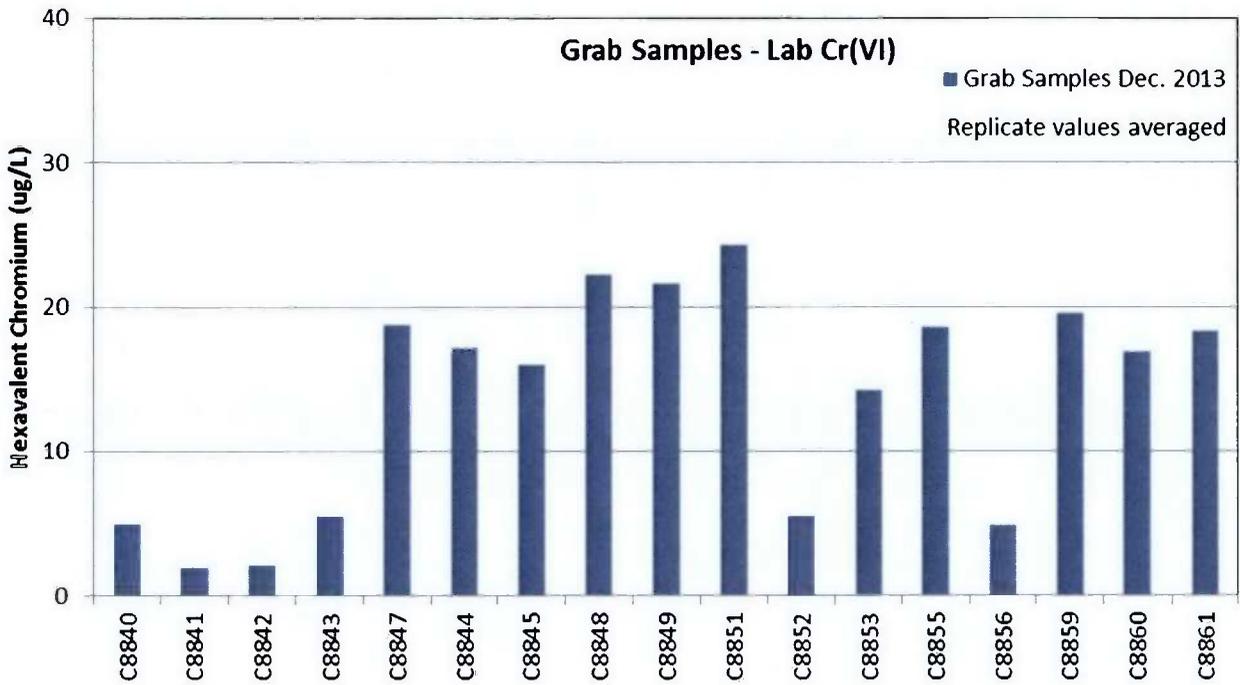
Figure BC-1. Cr(VI) Concentrations in 100-BC Hyporheic Sampling Points

- Monitoring & Reporting
 - Hyporheic sampling points (HSPs): After the first month of high-frequency sampling (November), EPA and DOE agreed that the frequency of future sampling could be reduced. The second round of high-frequency sampling was completed successfully in December, as was the first round of grab samples from 17 HSPs (one HSP out of the 18 HSPs in the network needs repair and was not sampled this month). Figure BC-1 shows Cr(VI) results for grab samples collected in December 2013. Co-contaminant data have not yet been loaded into HEIS.

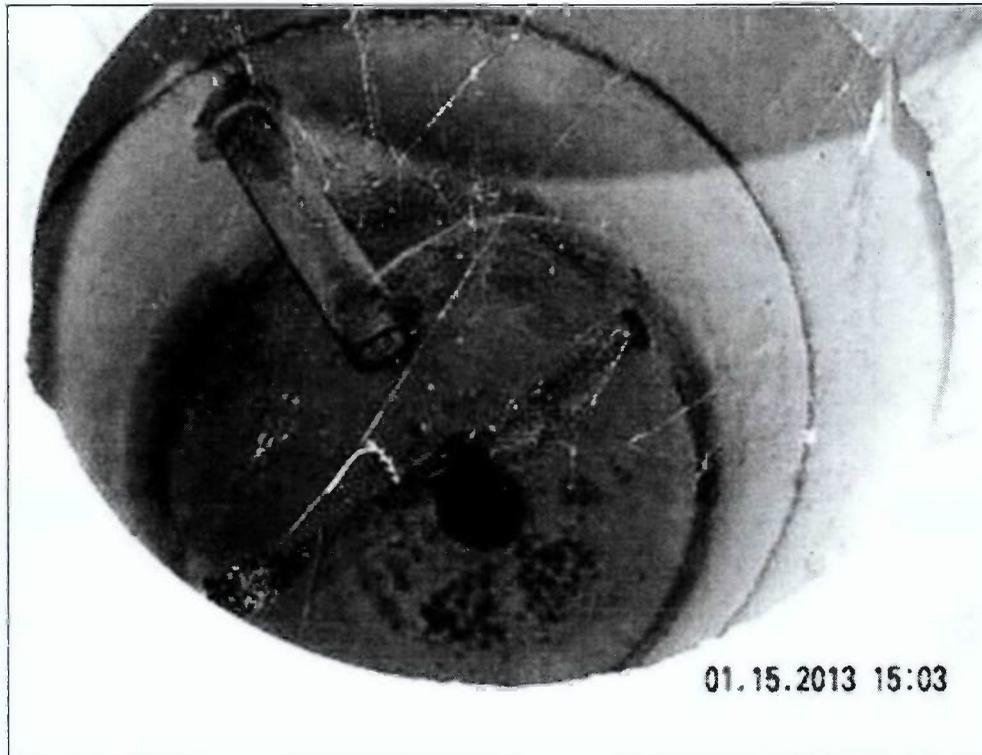
Figure 4. Manhole Along the 100-N-84:5 Pipeline Segment.

The manhole located along the pipeline segment is in good condition with little residual material present (Figure 4).

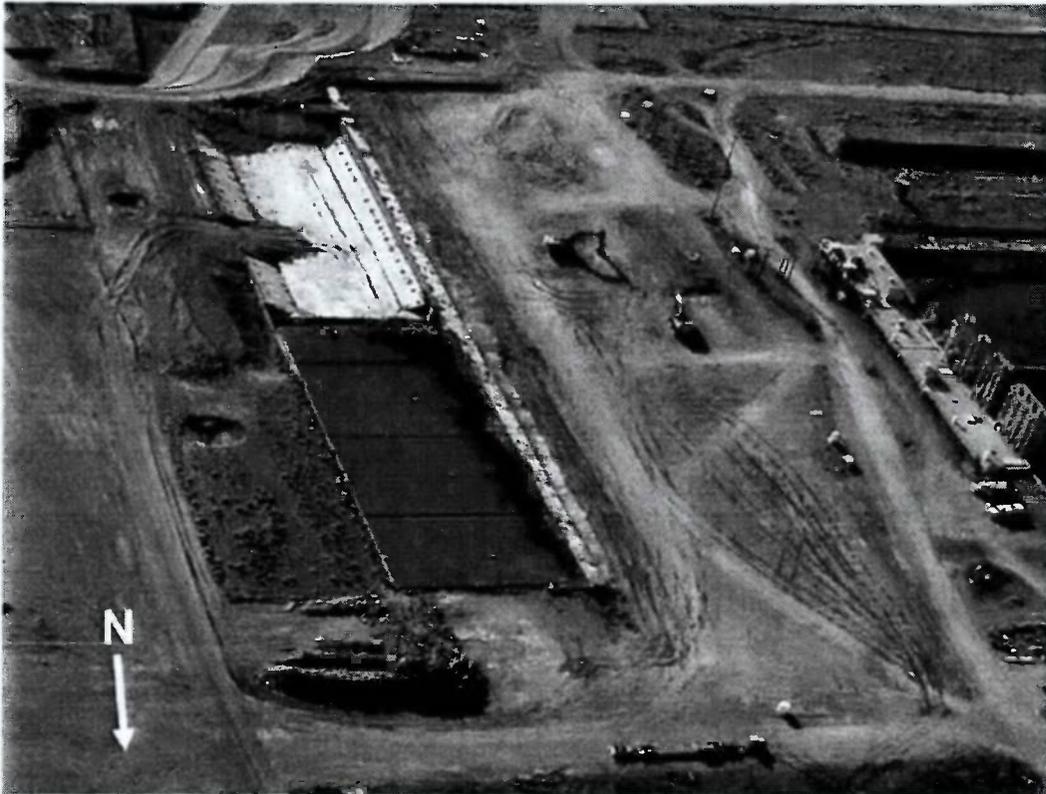
Figure 4. Aerial View of 183D on November 20, 2013 (facing south)

Demolition: Demolition of the facility (above and below grade) began in early 2013 and was completed on November 8, 2013. The debris was removed and disposed of at the ERDF. Presumed Asbestos-Containing Material (PACM) in areas unsafe to access could not be abated and was demolished with the facility.

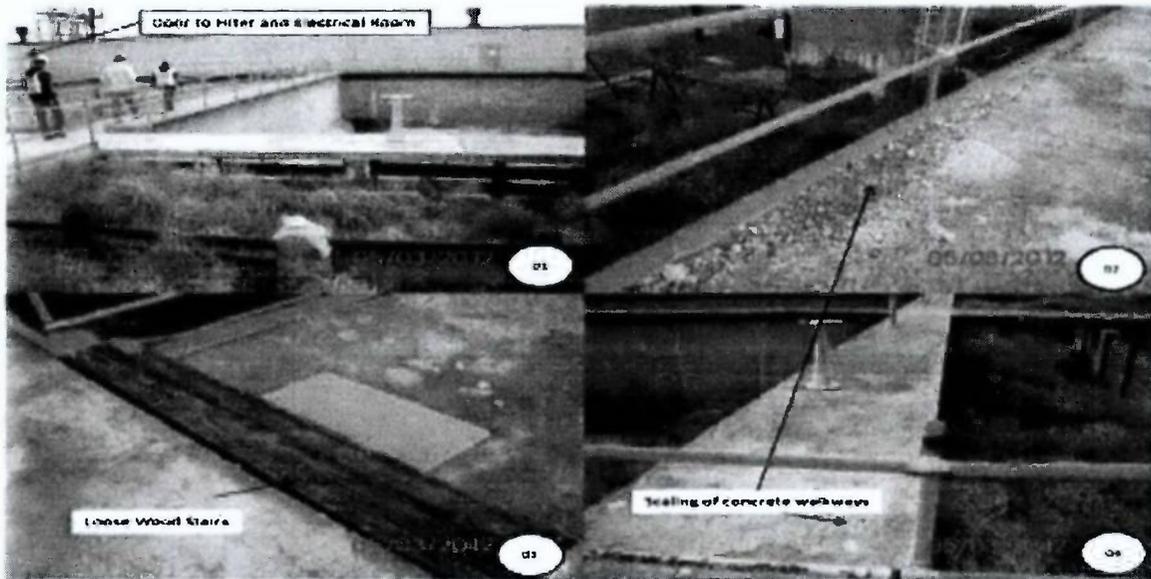
Item 01 – Filter Building Masonry Wall with NO significant Structural Degradation

Item 02 – Sealing of Concrete Walkway

Item 03 – Loose Wooden Stairs

Item 04 – Sealing of Concrete Walkway

- **EXTERIOR STRUCTURE, PATHS AND WALKWAYS** – The walkways exhibit concrete scaling due to the being exposed to a corrosive environment. Some of the walkways exhibit concrete spall with exposed rebar. The rebar common to these areas exhibited moderate corrosion. There are some wooden stairs that were NOT secured properly that are tripping hazards.

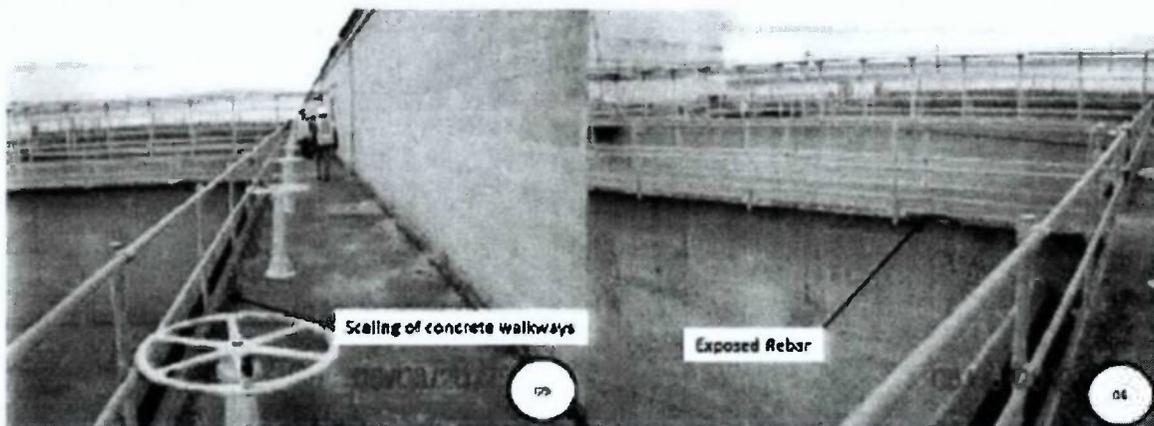
Item 05 – Sealing of concrete Walkways (Note that metal handrails do NOT exhibit structural degradation)

Item 06 – Concrete Spall on Walkway with exposed rebar

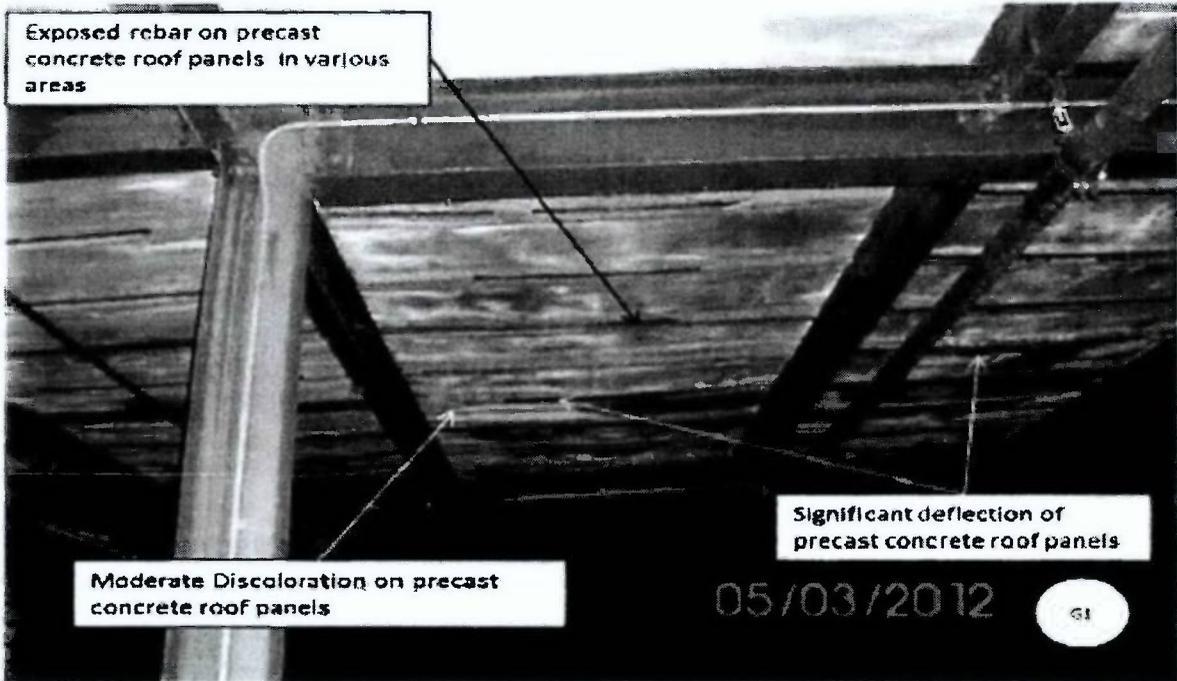
Exposed rebar on precast concrete roof panels in various areas

Significant deflection of precast concrete roof panels

The pre-cast concrete roof panels exhibit severe degradation indicative of a structure that has been exposed to a corrosive environment. There is exposed rebar and significant deflections of the panels. In some cases, large pieces of the concrete panels have become detached and have fallen to the Filter Building floor. The panels also exhibited discoloration that is indicative of a potential chemical attack. These areas had "white stains" on their surfaces.

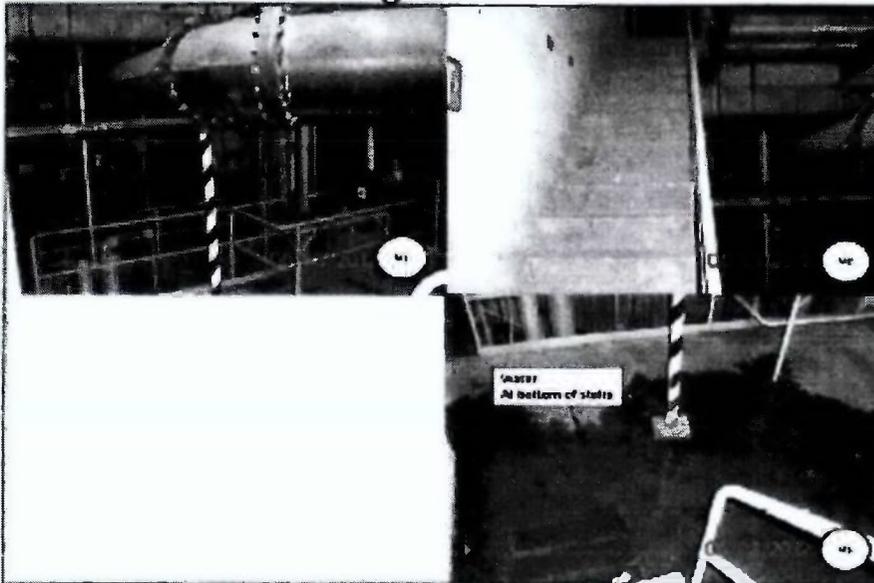
Item M1 – Structures and Components with NO significant Structural Degradation

Item M2 – Concrete Stair with NO significant Structural Degradation

Item M3 – Bottom of stairs with pooled water, NO significant Structural Degradation

- **PUMP ROOM** – The masonry walls appear NOT to have structurally detrimental issues. These walls did NOT exhibit cracking in the grout nor did they exhibit excessive deflection.

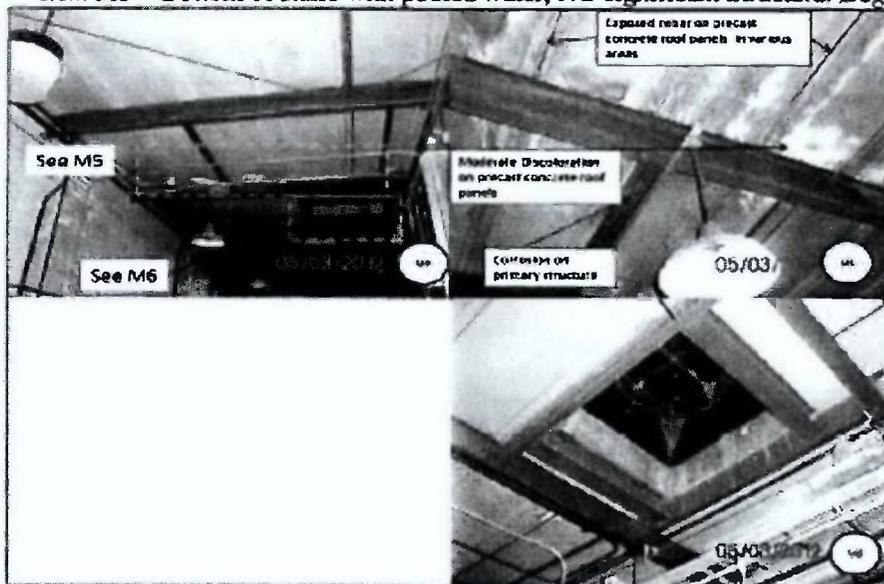
Item M4 – Roof area with minor discoloration, masonry walls have NO significant structural degradation

Item M5 – Metal Beams with moderate corrosion, exposed rebar, and discoloration

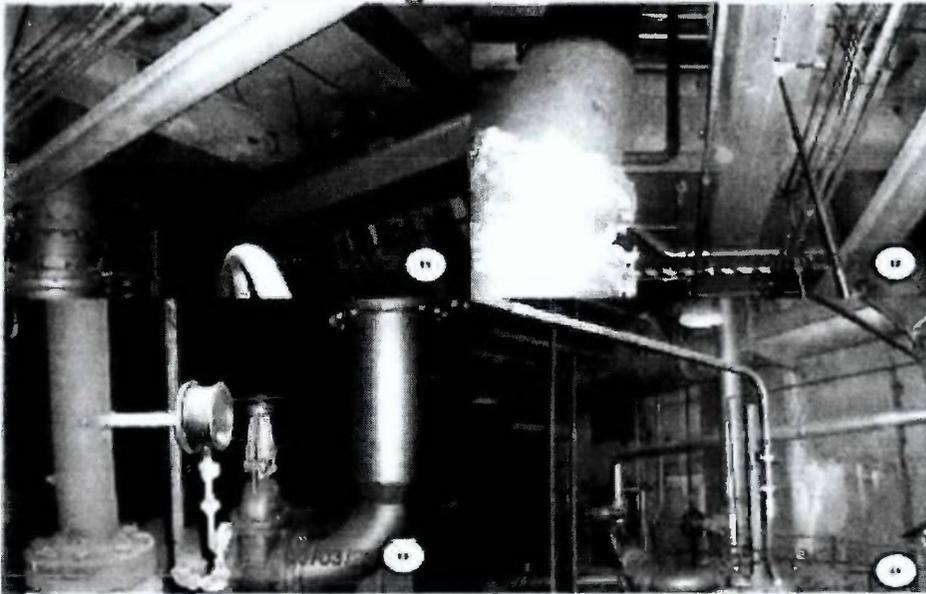
- Item E1* – Concrete Roof with NO significant Structural Degradation
- Item E2* – Concrete Beam with NO significant Structural Degradation
- Item E3* – Structures and Components with NO significant Structural Degradation
- Item E4* – Walls with minor Discoloration

- **PUMP ROOM BASEMENT AND ELECTRICAL SWITCHGEAR ROOM** - The concrete walls and roof exhibited mild discoloration but did NOT exhibit significant structural degradation.

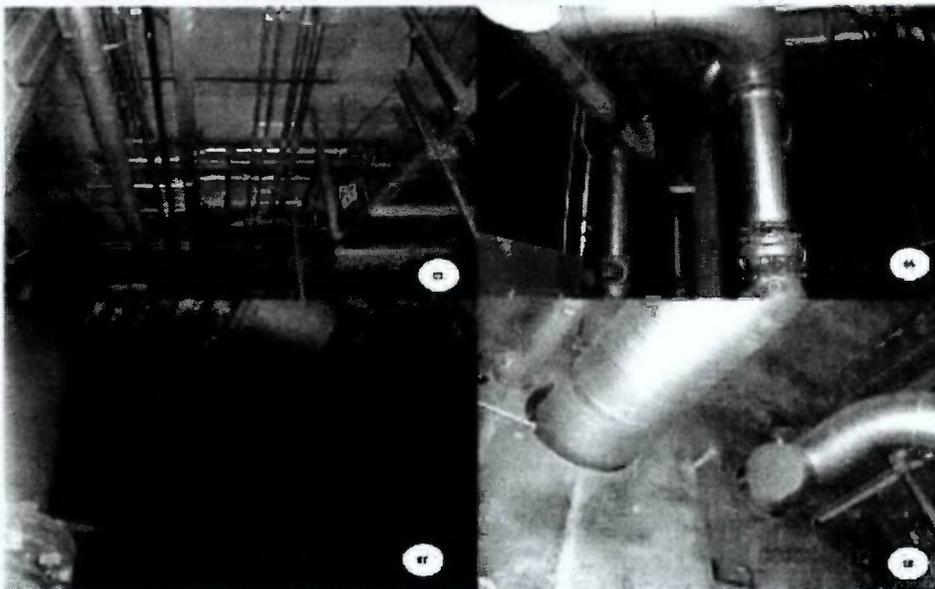
- Item E5* - Concrete Roof with NO significant Structural Degradation
- Item E6* – Structures and Components with NO significant Structural Degradation
- Item E7* – Concrete Roof with NO significant Structural Degradation
- Item E8* – Wall with Pipe Penetrations with NO significant Structural Degradation

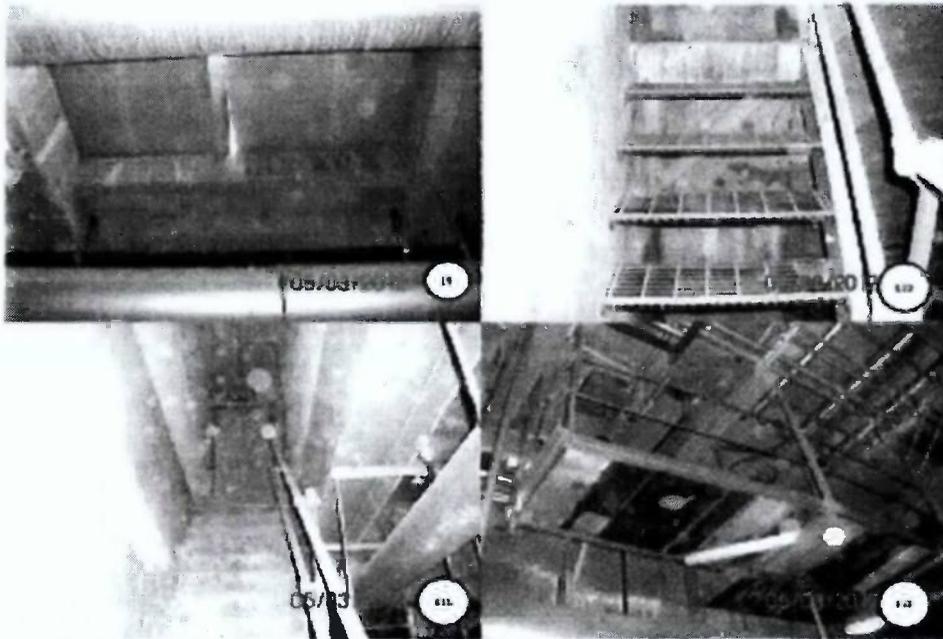
- Item E9 - Concrete Roof Penetration with NO significant Structural Degradation*
- Item E10 - Metal Stairs NO significant Structural Degradation*
- Item E11 - Concrete Stairs and Entry Way with NO significant Structural Degradation (Note: Particulates in room)*
- Item E12 - Balcony with NO significant Structural Degradation*
