## FACILITY STATUS CHANGE FORM

<b>Date Submitted:</b> 6-30-2013 <i>[Signature]</i> <b>Originator:</b> Dan Saueressig <b>Phone:</b> 509-521-5326	<b>Area:</b> 100-N <b>Facility ID:</b> 100-N AOC Area 6 <b>Action Memorandum:</b> 100-N Ancillary Facilities	<b>Control #:</b> D4-100N-0062
---	---	-----------------------------------

## 100-N ANCILLARY FACILITIES REMOVAL ACTION SAMPLING DETERMINATION FORM

Building Name: 100-N AOC Area 6

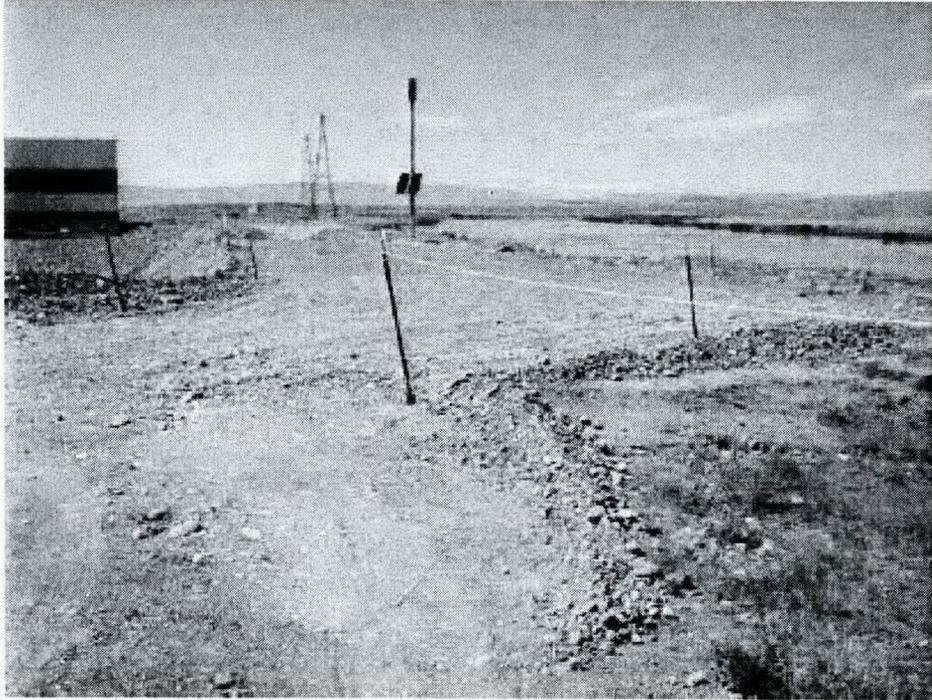
**Photo 1. AOC Area 6 (facing south)**

Mark. I went out to 100-N on Tuesday, inspected AOC Area 6, and took photographs (attached). I didn't see any stains or anomalies. The area looks good. Contact me if you have any questions. Clay

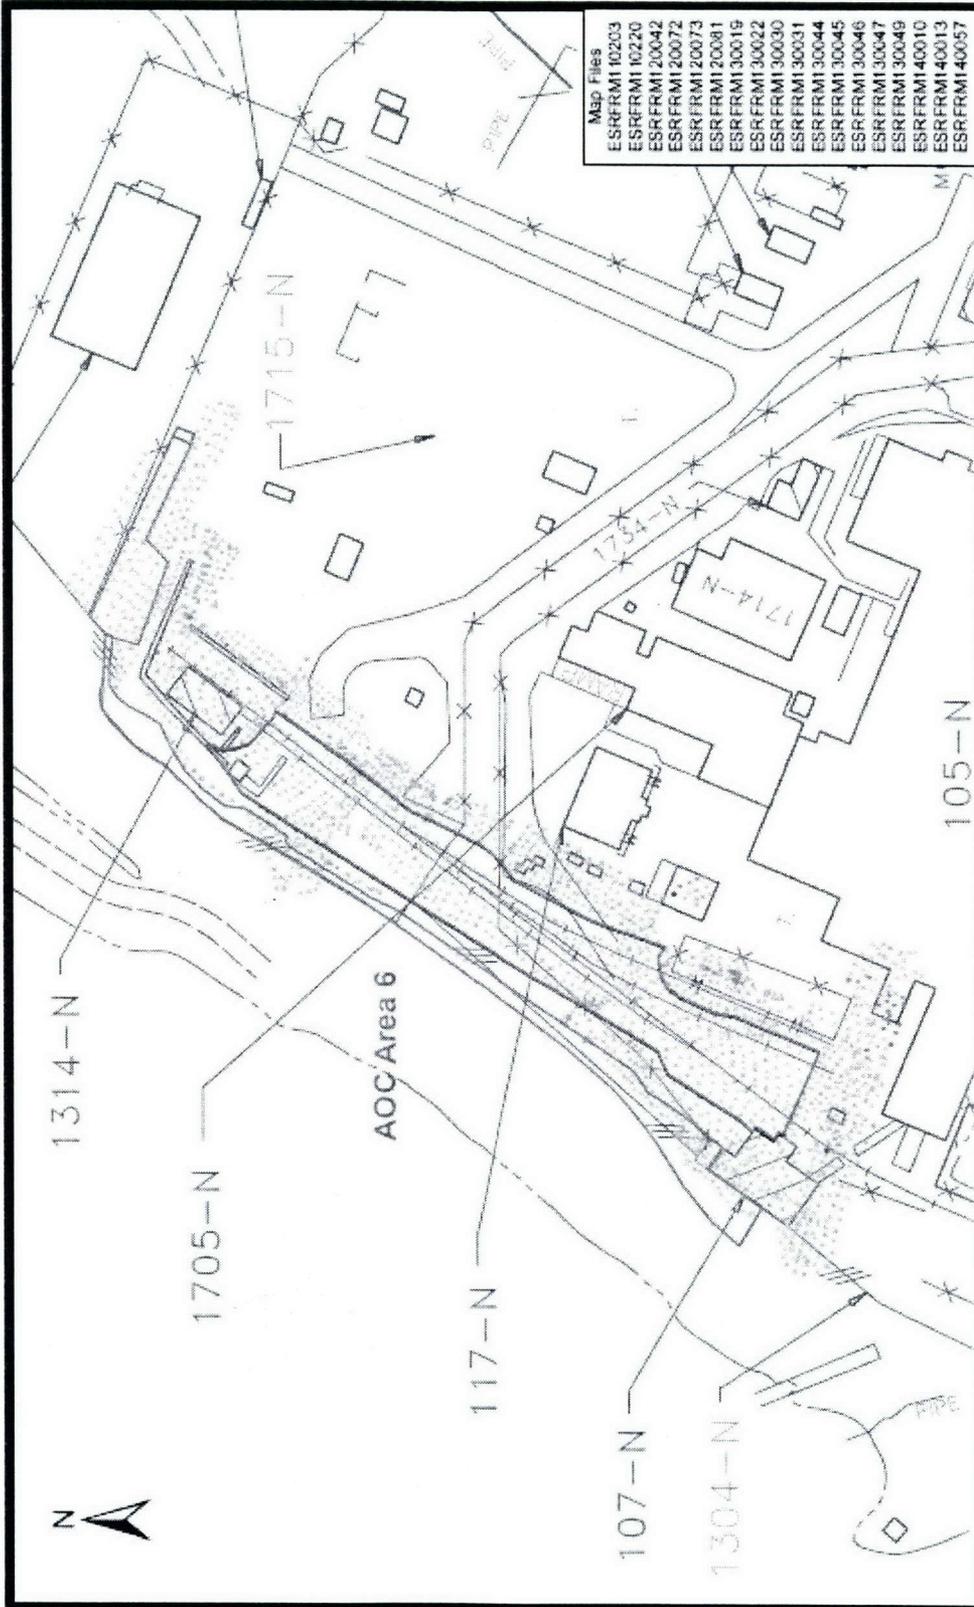
# 100N AOC Area 6 GPERs Radiological Survey Beta Track Map

Radiological surveys of AOC Area 6 for beta and gamma contamination using GPERS identified no contamination greater than 1.5 x background. Composite diagrams of the surveys are presented in Attachment 4. The fence line along the western boundary of 100-N was surveyed by hand. No contamination was identified in the fence excavation, fence materials, or excavator bucket (RSR-100NFR-14-0291). A copy of the RSR is provided in Attachment 5.

Legend		Summary Statistics	
NET CPM		Number of Data Pnts	3,418
X	<1.5	Type of Survey	Beta
x	1.5x bkg	Max GCPM	6,634
●	5000	Avg Bkg CPM	303
●	10000	Survey Dates	12/18/2011 through 06/18/2014
●	25000	Area Surveyed	13,417 m <sup>2</sup>
●		Project File	100N_AOC_6B
		Plot File	100N_AOC_6B.plt

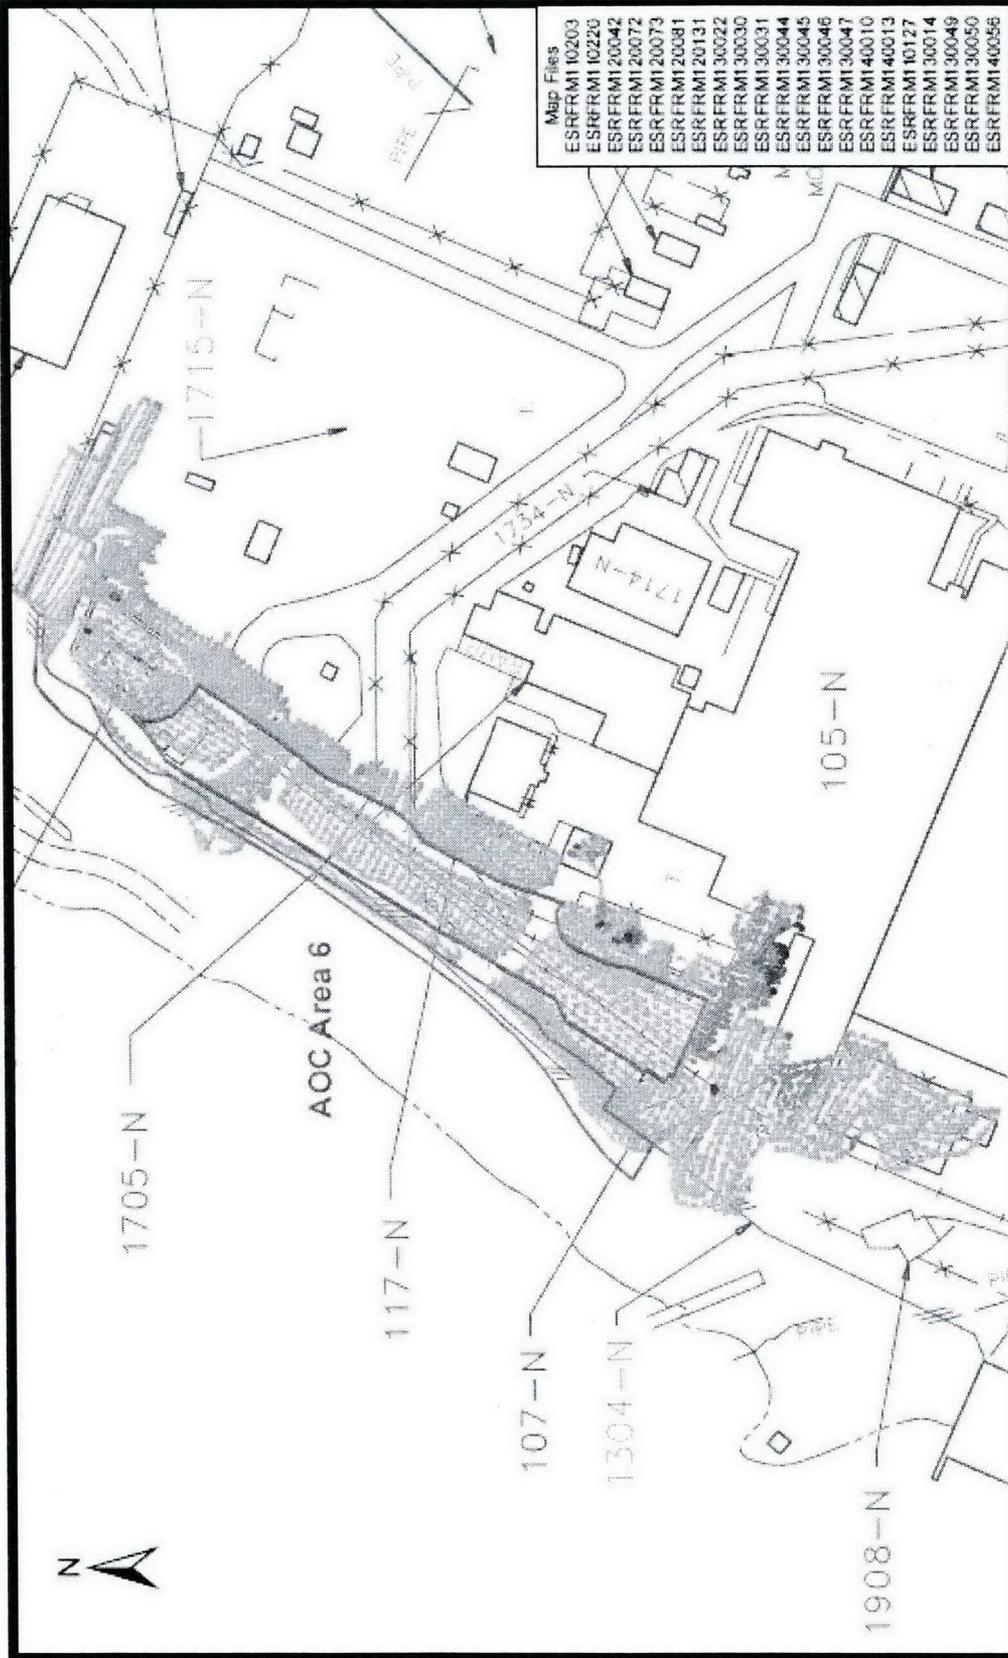
## 100N AOC Area 6 GPERS Radiological Survey Gamma Track Map

Legend		Summary Statistics	
NET CPM		Number of Data Points	51,813
X	<1.5x bkg	Type of Survey	Gamma
●	1.5x bkg - 5000	Max GCPM	99,190
●	5000 - 10000	Avg Bkg CPM	1,258
●	10000 - 25000	Survey Dates	10/18/11 through 08/11/13
●	25000	Area Surveyed	16,128 m <sup>2</sup>
		Project File	100N_AOC_6G
		P of File	100N_AOC_6G_12

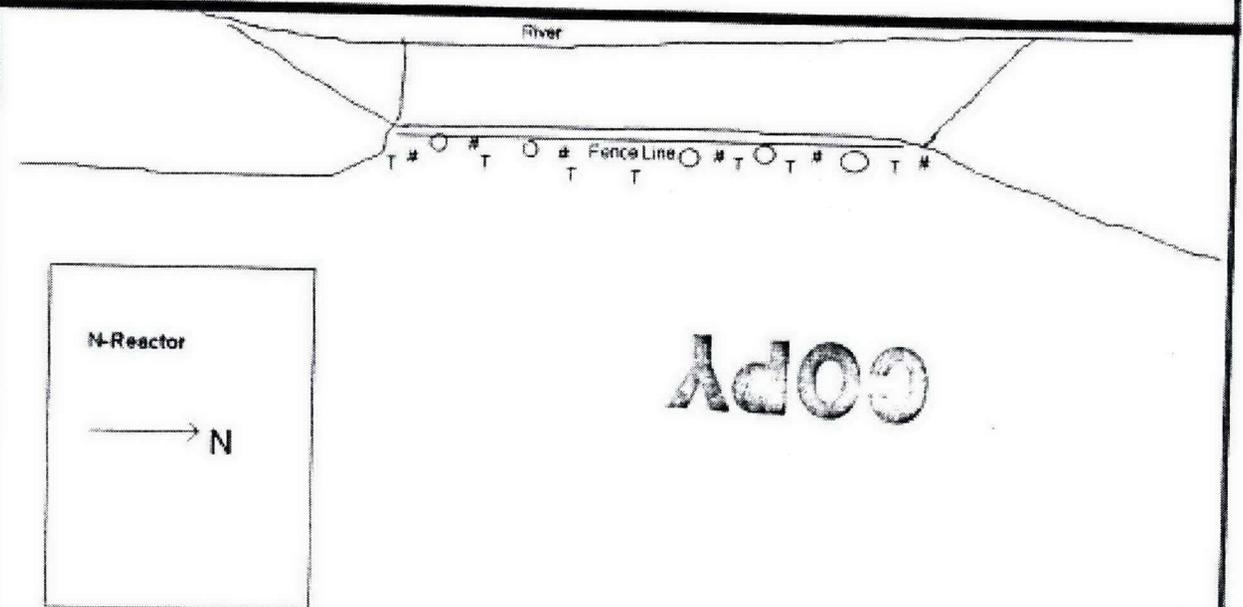
**Description**  
MR, West Fence Site site excavation. Survey of Excavator 3962 (PIN KMTPC192ES4A10300, Bucket Env 13212) and fencing material.

Smears, Transferables, and Directs taken prior to removal of fence. Once fence was removed, survey was performed on fencing material, Smears and Directs. No counts above background detected.

Smears and directs also performed on excavator bucket. No counts above background detected
