**FACILITY STATUS CHANGE FORM**

<b>Date Submitted:</b> 8-6-2014	<b>Area:</b> 100-N	<b>Control #:</b> D4-100N-0065
<b>Originator:</b> Dan Saueressig	<b>Facility ID:</b> 100-N AOC Area 8	
<b>Phone:</b> 509-521-5326	<b>Action Memorandum:</b> 100-N Ancillary Facilities

## 100-N ANCILLARY FACILITIES REMOVAL ACTION SAMPLING DETERMINATION FORM

Determination Number  
SDF-100N-039

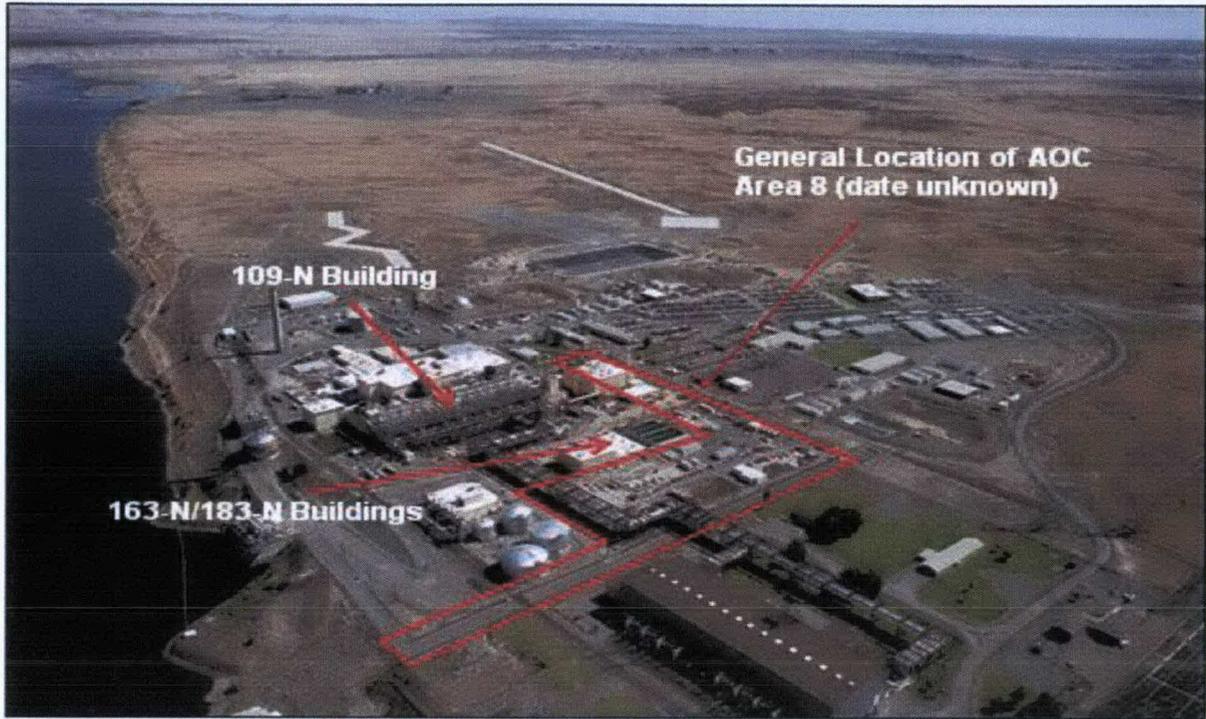
Photo 2. AOC Area 8 at 100-N

The 100-N Area of Contamination (AOC) Area 8 consists of a large area south and east of the 109-N Heat Exchanger Building and provided access/entry to the facilities in the vicinity (105-ND Remote Air Intake, 108-N Chemical Unloading Facility, 151-N Electrical Substation, 153-N Electrical Switchgear Building, 182-N High Lift Pumphouse, 184-N Power House, 163-N Demineralized Water Plant, 183-N Water Treatment Plant and the 185-N HGP Turbine Generator Plant). The area has been backfilled to existing grade.

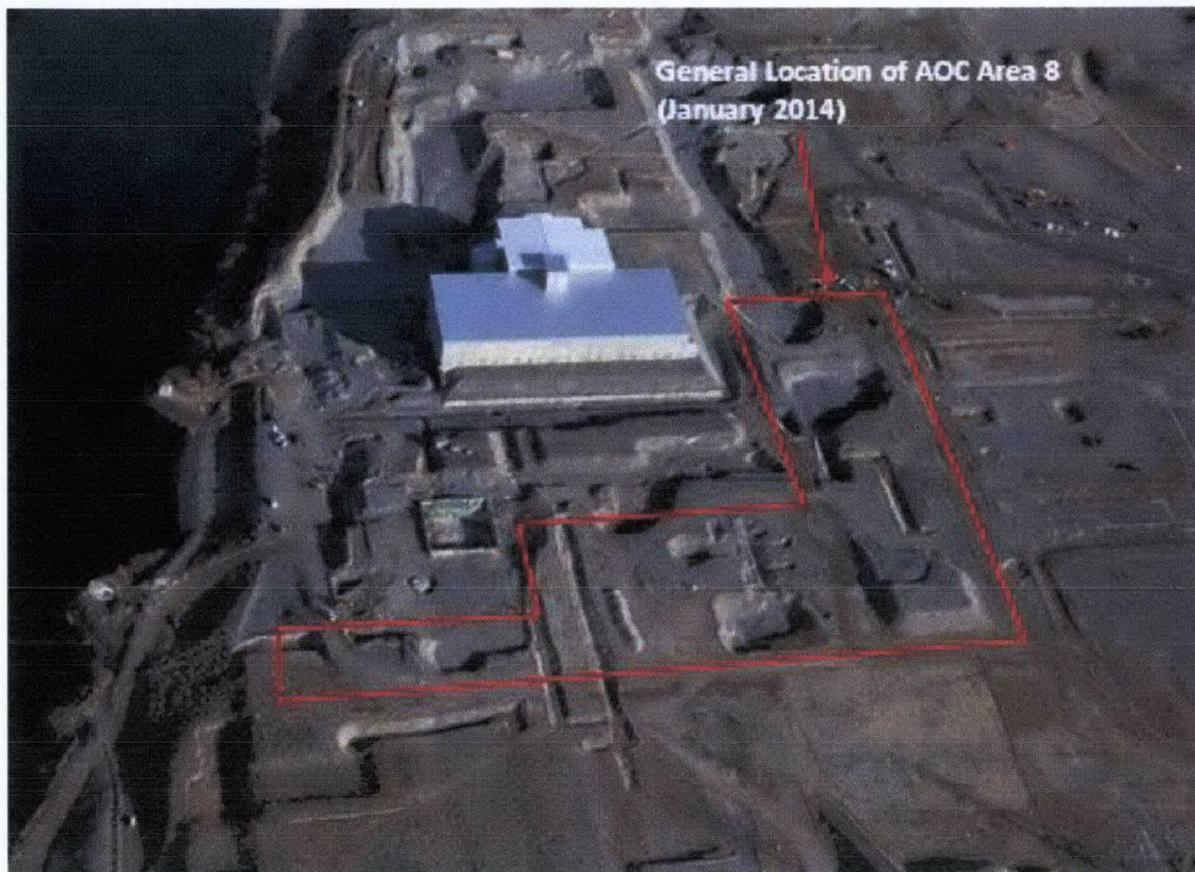
Photo 6. AOC Area 8 in January 2014

The 100-N AOC Area 8 consists of a large area south and east of the 109-N Heat Exchanger Building and provided access/entry to the facilities in the vicinity (105-ND Remote Air Intake, 108-N Chemical Unloading Facility, 151-N Electrical Substation, 153-N Electrical Switchgear Building, 182-N High Lift Pumphouse, 184-N Power House, 163-N Demineralized Water Plant, 183-N Water Treatment Plant and the 185-N HGP Turbine Generator Plant). The area has been backfilled to existing grade.

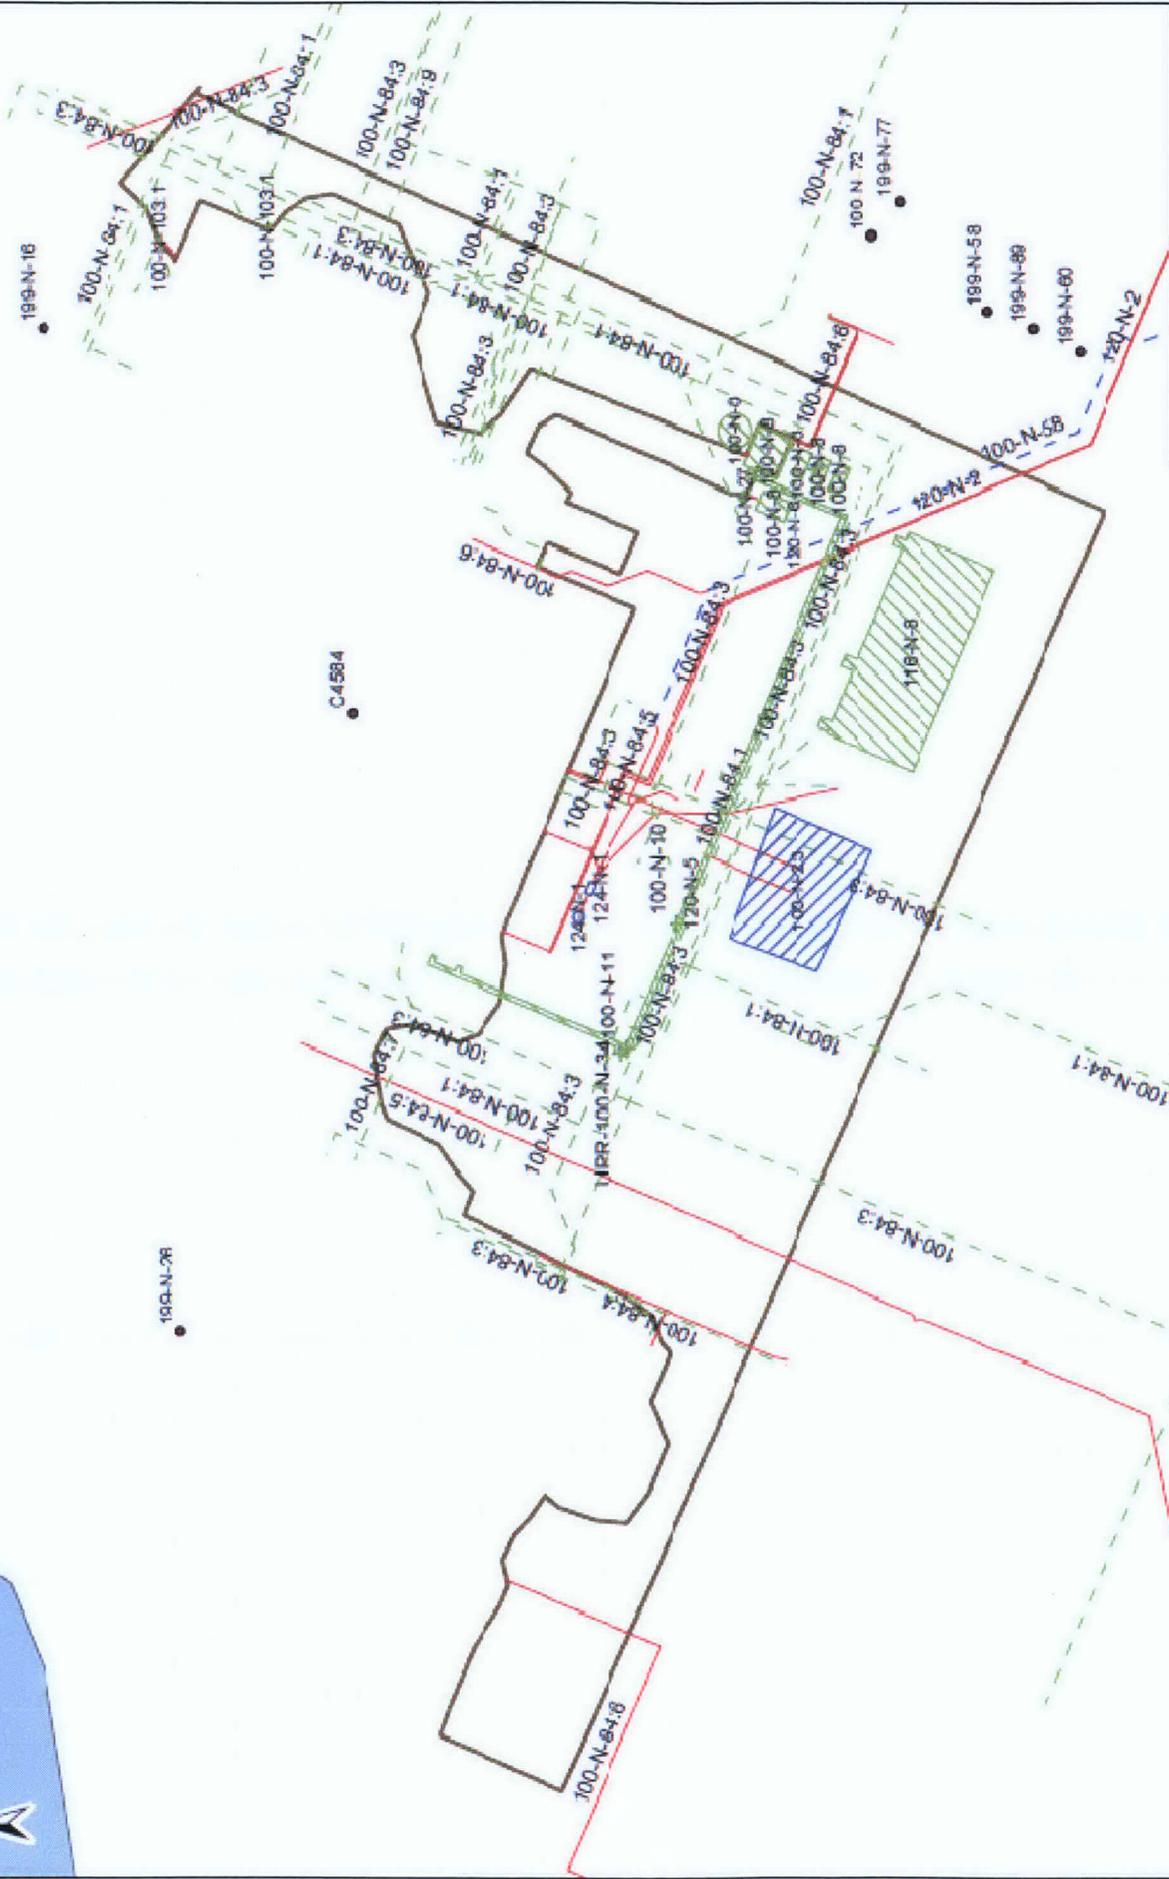
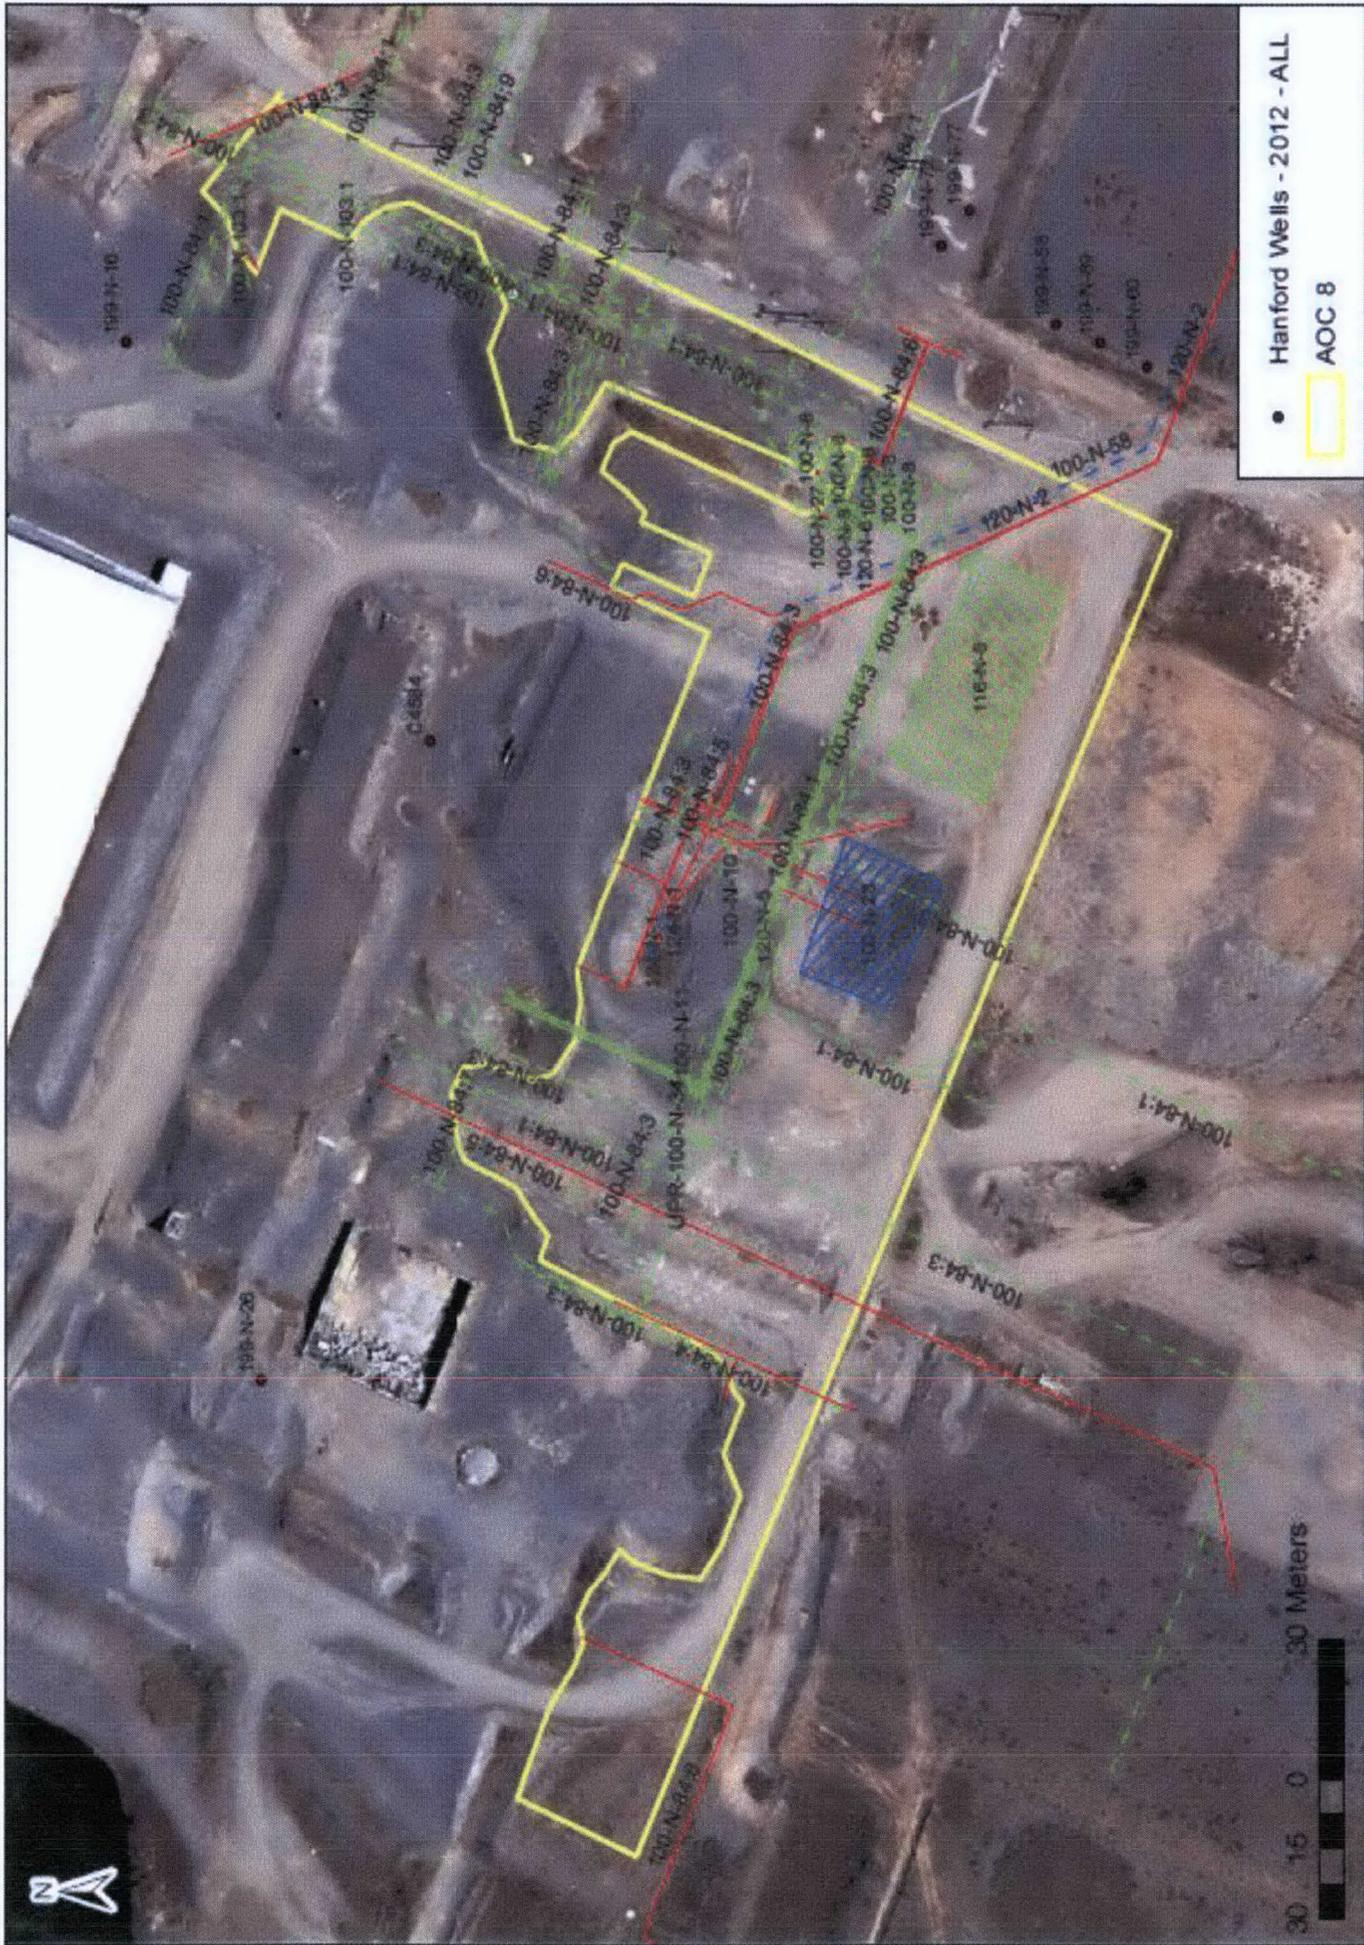
WIDS Sites and Wells Around AOC Area 8

Buildings within or near AOC Area 8 include the 105-ND Remote Air Intake, 108-N Chemical Unloading Facility, 151-N Electrical Substation, 153-N Electrical Switchgear Building, 163-N Demineralized Water Plant, 183-N/NA/NB/NC/ND/NE/NF Water Treatment Plant and support buildings, the 1330-N Waste Storage Facility, 1802-N Pipe Trestle, the 1900-N Water Supply Tanks and the 182-N High Lift Pumphouse. All wells within 10 feet from AOC Area 8 have been decommissioned.

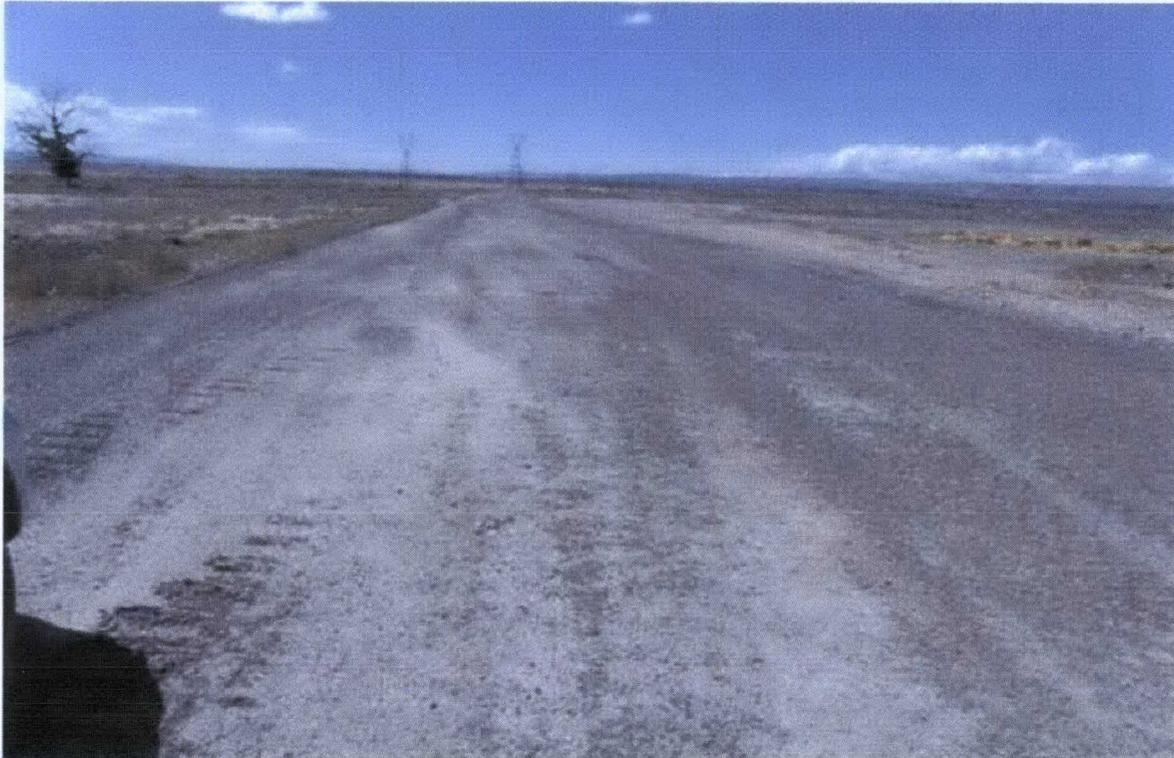
Photo 1. Southeast Corner of AOC Area 8 Road (facing west)

Visual inspection performed (Attachment 3) confirming no staining or other anomalous conditions observed.

Mark, I went out to 100-N on June 24 and inspected AOC Area 8 and took photographs (attached). I didn't see any stains or anomalies, the area looked good. Area 8 is a large area (I also included an aerial photograph with Area 8 overlaid) that's why there are some many photographs. Give me a call if you have any questions.

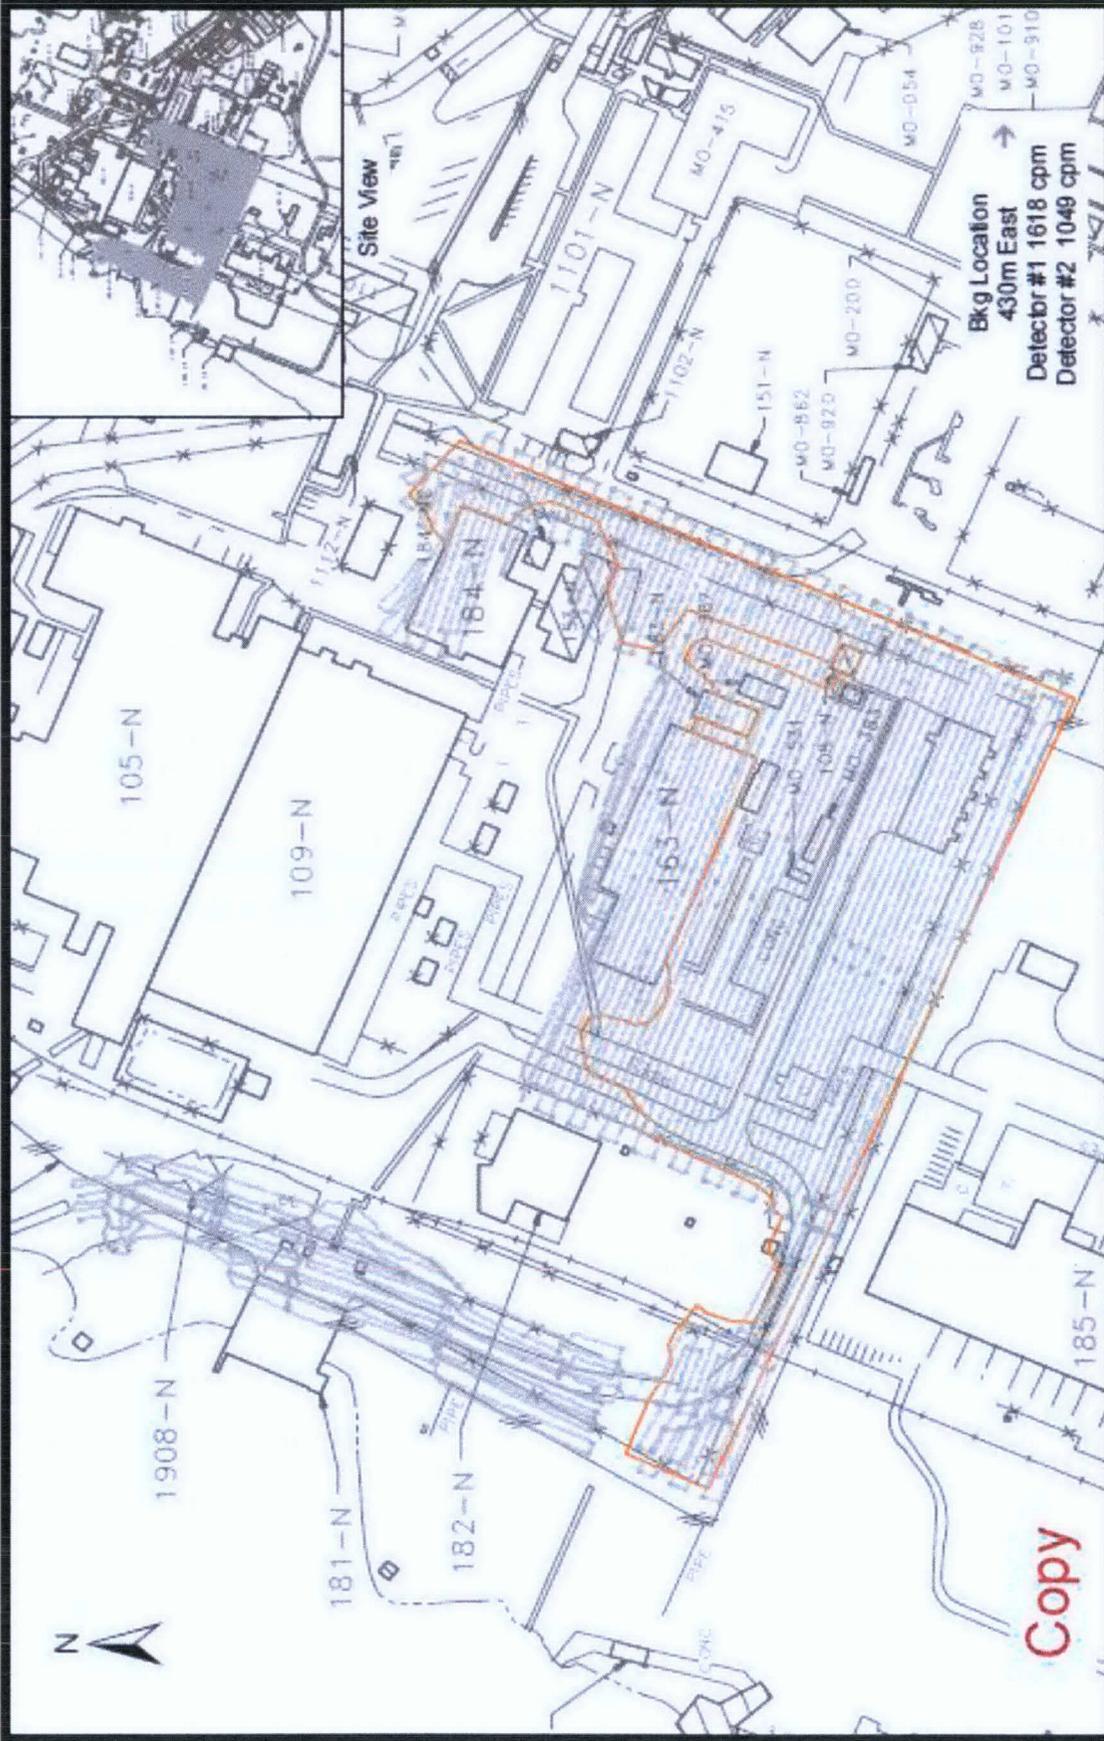
Global Positioning Environmental Radiological Surveyor (GPERS) Survey  
of AOC Area 8

Radiological surveys of AOC Area 8 for gamma contamination using GPERS identified no contamination greater than 1.5 x background. A composite diagram of the survey is presented in Attachment 4. In addition, numerous in-process hand held surveys never indicated that radiological contamination was discovered south of the reactor or within the Field Remediation waste sites in AOC Area 8.

Coverage File: N199\_A.B  
 Number of Data Pnts: 20,931  
 Type of Survey: gamma  
 Max GCPM: 2368  
 Avg Bkg CPM: 1333  
 Survey Date: 7/18/2014  
 Area Surveyed: 43,650 m<sup>2</sup>  
 Project File: ESRFRM140068  
 Pdf File: ESRFRM140068\_2C

**Bkg Location**  
 430m East  
 Detector #1 1618 cpm  
 Detector #2 1049 cpm
