FACILITY STATUS CHANGE FORM

Date Submitted: 7-28-2014	Area: 100-N	Control #: D4-100N-0064
Originator: Dan Saueressig	Facility ID: 100-N AOC Area 7	
Phone: 509-521-5326	Action Memorandum: 100-N Ancillary Facilities

Determination Number
SDF-100N-038

Visual Inspection Photographs of 100-N AOC Area 7
June 10, 2014

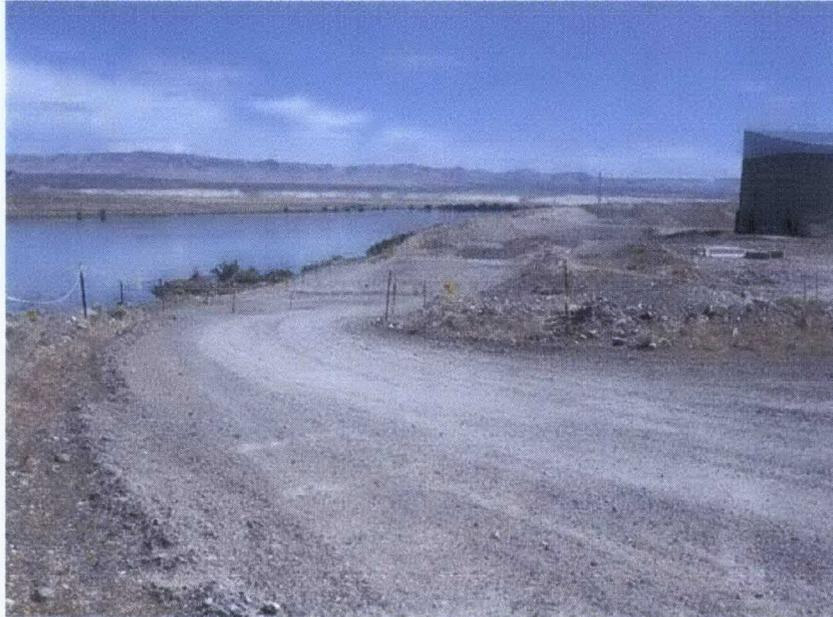
Photo 1. Road Down to AOC Area 7 (facing north)

Mark. I went out to 100-N on Tuesday, inspected AOC Area 7, and took photographs (attached). I didn't see any stains or anomalies. The area looks good. Contact me if you have any questions. Clay
