## FACILITY STATUS CHANGE FORM

<b>Date Submitted:</b> 9-17-2014 <b>Originator:</b> Dan Saueressig <b>Phone:</b> 509-521-5326	<b>Area:</b> 100-N <b>Facility ID:</b> 100-N AOC Area 9 <b>Action Memorandum:</b> 100-N Ancillary Facilities	<b>Control #:</b> D4-100N-0063/6
--	---	-------------------------------------

## 100-N ANCILLARY FACILITIES REMOVAL ACTION SAMPLING DETERMINATION FORM

Visual Inspection of 100-N AOC Area 9

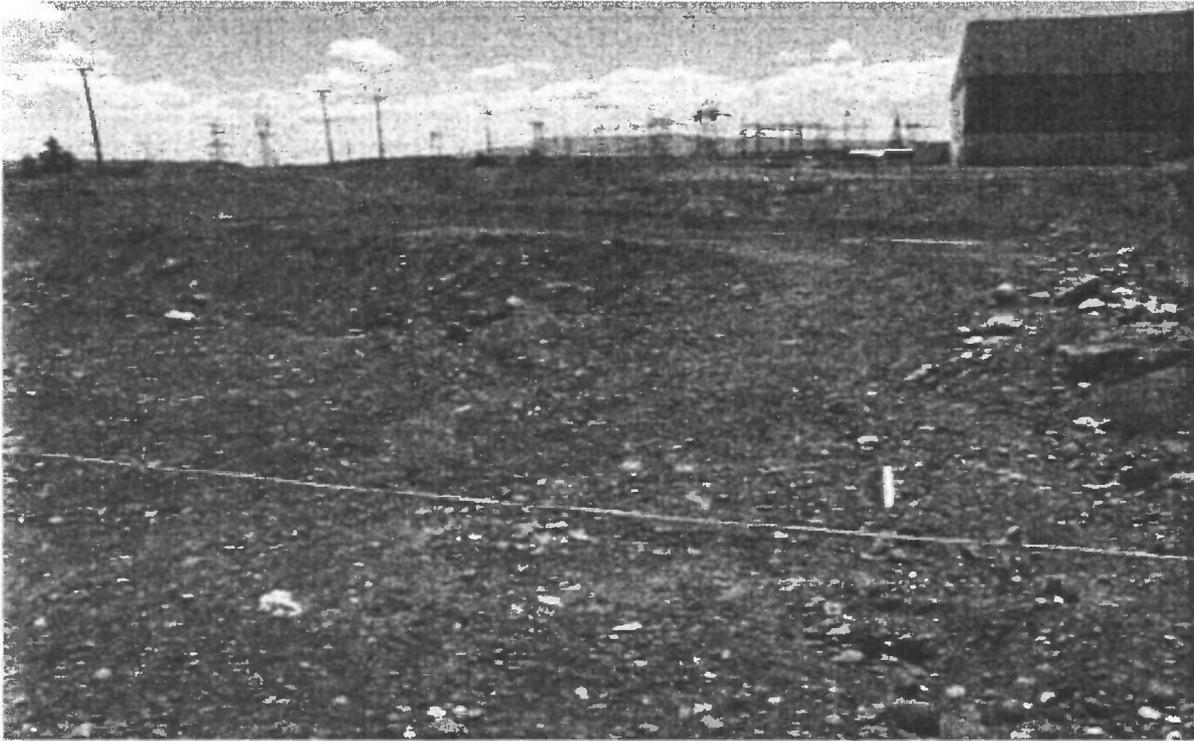
**Photo 1. Northern Portion of AOC Area 9 (facing south)**

Mark, I went out to 100-N on June 24, 2014 and inspected AOC Area 9 and took photographs (attached). I didn't see any stains or anomalies, the area looked good. Area 9 is a large area (I also included an aerial photograph with Area 9 overlaid), that's why there are so many photographs. Give me a call if you have any questions.

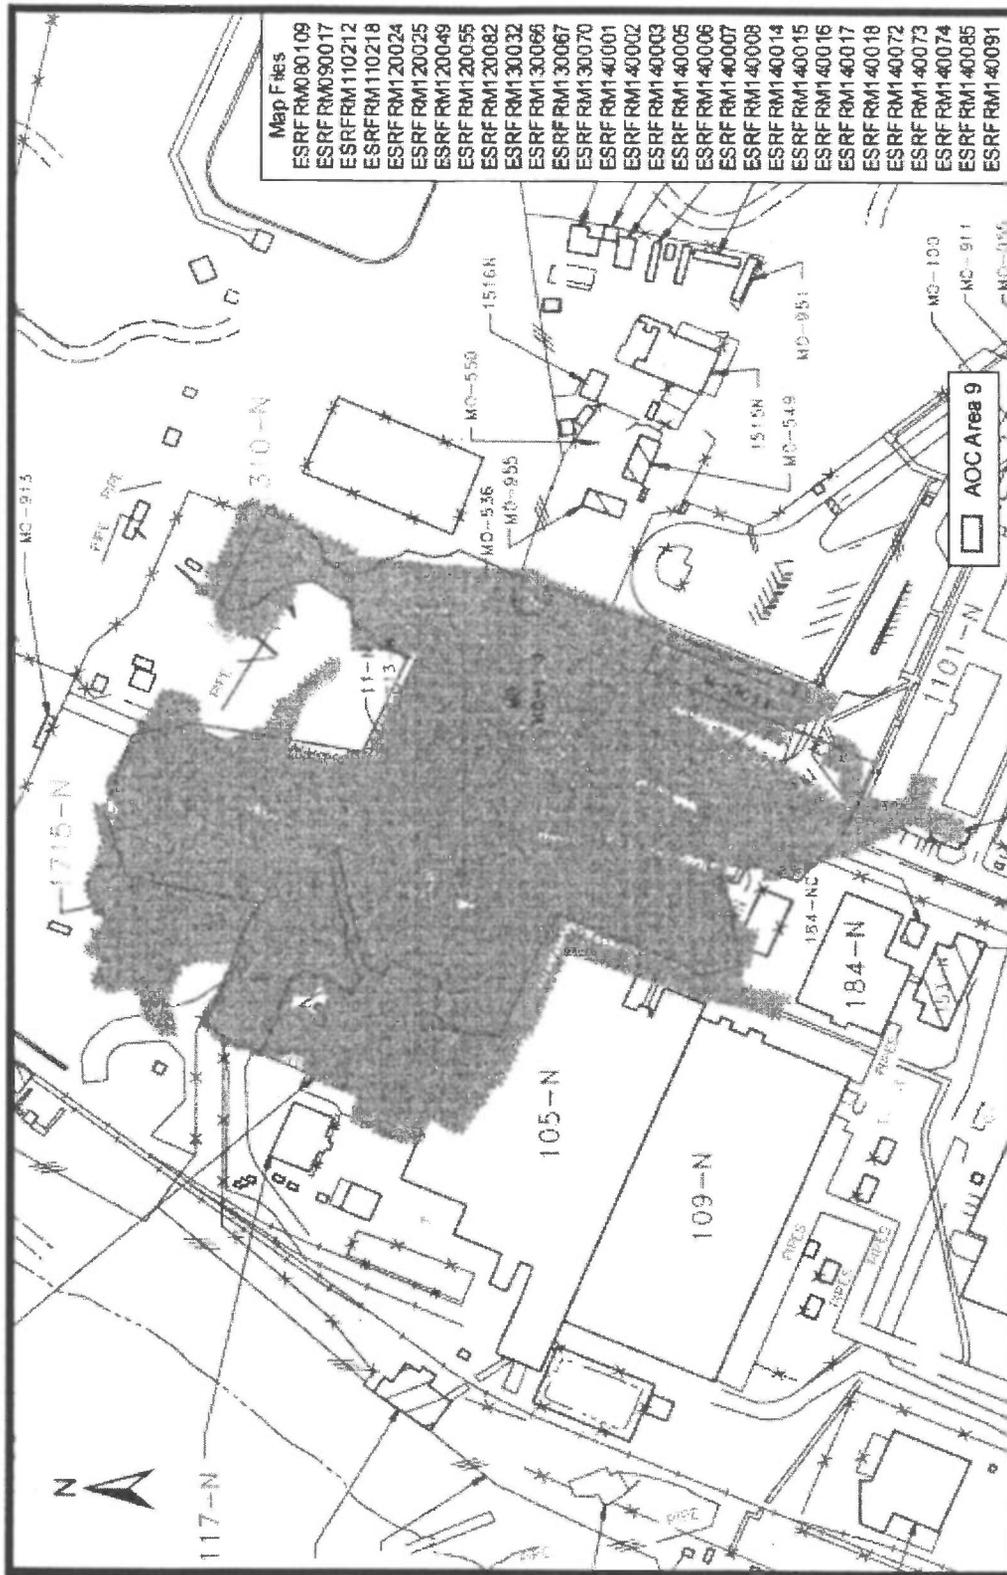
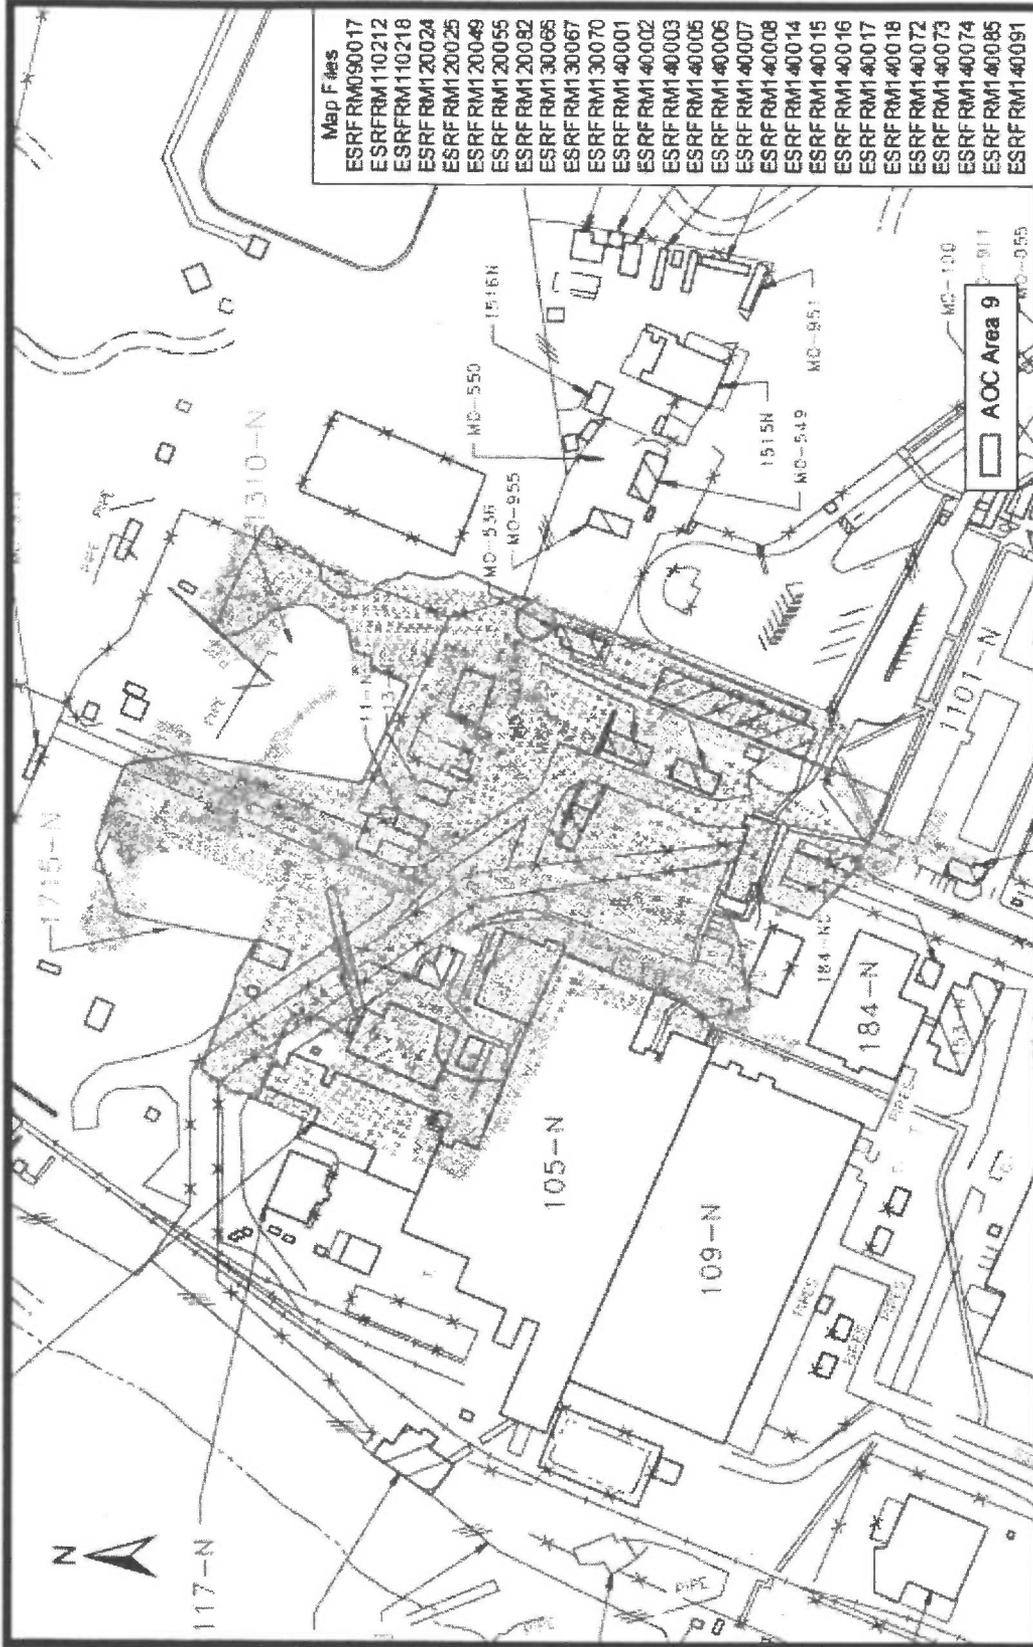
# 100N D4 AOC Area 9 GPERs Radiological Survey Beta Track Map

Radiological surveys of AOC Area 9 for beta and gamma contamination using GPERS identified no contamination greater than 1.5 x background except where residual deep zone contamination was left as documented in the respective RSVP/CVP. A composite diagram of the survey is presented in Attachment 4.

NET CPM	Summary Statistics
X	Number of Data Points: 10,267
●	bkg
●	1.5x bkg - 5000
●	5000 - 10000
●	10000 - 25000
●	25000
	Type of Survey: Beta
	Max GCPM: 2,611
	Avg Bkg CPM: 37.5
	Area Surveyed: 41,718 m <sup>2</sup>
	Project File: 100N_D4_AOC_9
	Pdf File: 100N_D4_AOC_9B_75

Any radiologically contaminated soil discovered was removed with the waste site excavation unless residual deep zone contamination was left as documented in the respective RSVP/CVP.
