STATE OF WASHINGTON  
DEPARTMENT OF ECOLOGY

Re: Dangerous Waste Compliance Inspection on April 29, 2015 of the Waste Receiving and Processing Facility, Resource Conservation and Recovery Act (RCRA) Site ID: WA7890008967, Nuclear Waste Program (NWP) Compliance Index No. 15.520

### Compliance Report

**Site:** Waste Receiving and Processing Facility

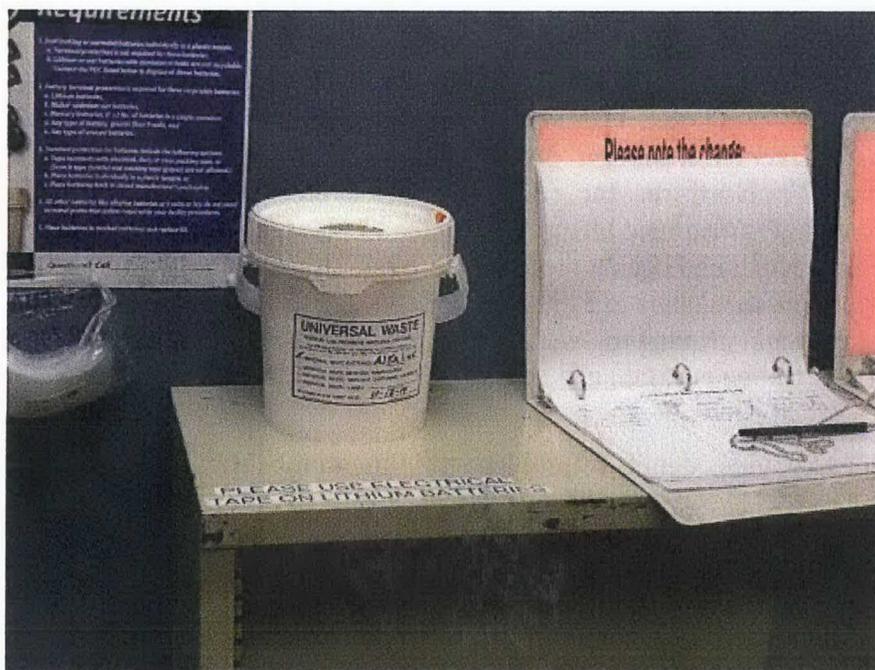
Photo DSC00767, Bldg. 2336W, Room 125, UW Container of Alkaline Batteries

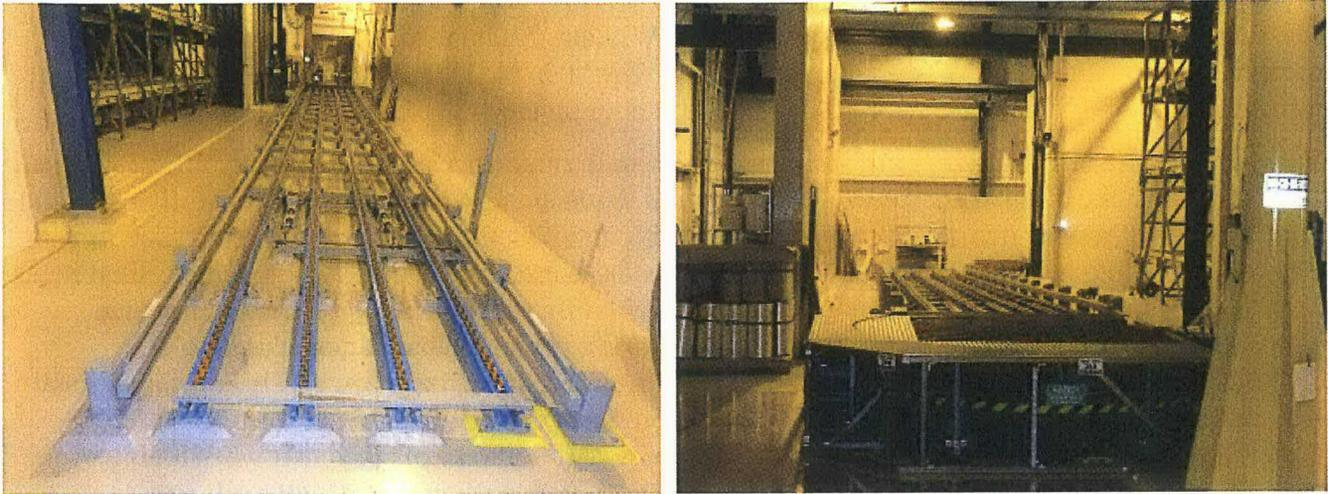
As we made our way to 2404WC to inspect the MW containers in storage, Mr. Mortensen gave us a tour of the WRAP facility. He showed us the 101 Shipping and Receiving Area and the TRU-Pact Bay. We also observed the NDE and the NDA Area. He explained that x-rays are taken in the NDE area, and in the NDA area they performed assays to determine if waste is LLW or TRU waste. I asked what maintenance is performed in waste storage and process areas that are not currently active. Mr. Mortensen explained that NCOs perform full DW inspections of the areas and document problems that require a remedy. He also said that the WRAP facility is fully maintained to accept additional DW or MW at any time.

Photos DSC00769 and DSC00770, Bldg. 2336W, Shipping and Receiving and NDE

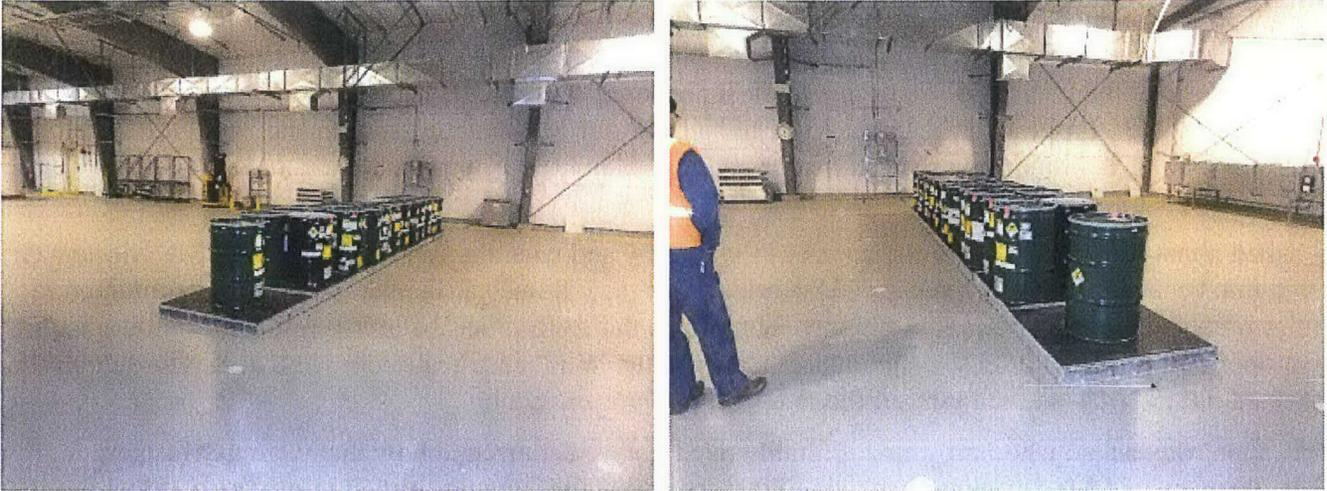
We walked to 2404WC where I observed 24 metal drums labeled as DW, radioactive. I observed no problems with the containers of MW. Mr. Mortensen stated that WRAP had recently received two shipments from Perma-Fix Northwest Inc. (PFNW) – one shipment of 17 drums and another of 7 drums. He said the waste containers originated from the Hanford Engineering and Development Laboratory (HEDL) waste stream, which had been a problematic waste stream while in storage at CWC. He told us that CWC Operations sent the drums to PFWN to be repackaged and grouted. Mr. Mortensen said that once PFWN repackaged and grouted the waste containers, the drums were shipped back to WRAP for storage until the drums can be certified and sent to the Waste Isolation Pilot Plant (WIPP) for long-term storage.

Photos DSC00773 and DSC00774, Bldg. 2404WC, 24 MW containers of "HEDL" waste

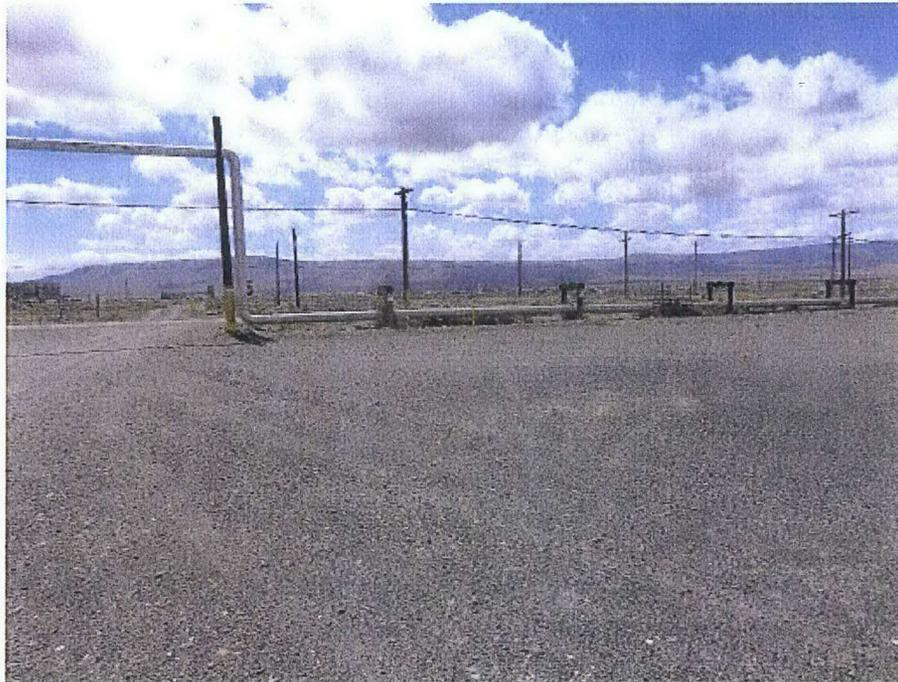
As we walked back to the 2336W conference room, we observed a gravelled area outside of the 2336W Building which was used for MW container storage. I observed that the area held no MW containers during the inspection.

Photo DSC00775, gravel storage area outside of 2336W
