STATE OF WASHINGTON
DEPARTMENT OF ECOLOGY

Re: Dangerous Waste Compliance Inspection on March 12, 2015 at the Hanford Site PUREX Plant and Storage Tunnels, Resource Conservation and Recovery Act (RCRA) Site ID: WA7890008967, Nuclear Waste Program (NWP) Compliance Index No. 15.517

16-NWP-021
PUREX Plant and Storage Tunnels
RCRA Site ID: WA7890008967
NWP Compliance Index No.: 15.517
Inspection Date: March 12, 2015

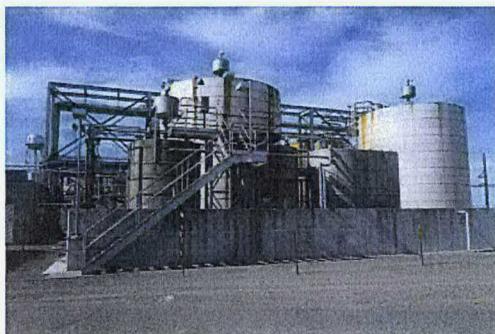
Photo 2: 203-A Acid Pump House/Acid Storage and Handling Facility (North of 202-A)

We walked to the Tank TK-P4, which according to the PUREX Plant Part A, Tank TK-P4 is a part of 203-A. In the PUREX S&M Plan 203-A is described as the Acid Pump House/Acid Storage and Handling Facility.

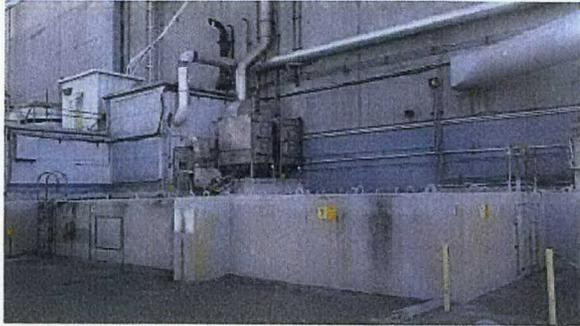
Photo 3: 276-A R-Cell (Northwest side, adjacent to 202-A)

We walked by the Aqueous Makeup Unit (AMU) and then to R-Cell on the Northwest corner of the 202-A canyon building. According to the PUREX Plant Part A, Tanks TK-R1, TK-R2, TK-R7, and Tower T-R2 are located in R-Cell. In the PUREX S&M Plan, R-Cell is also known as 276-A.

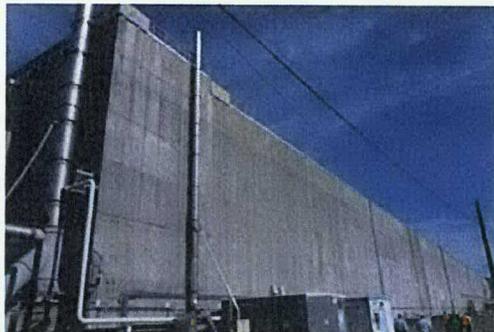
Photo 5: Southwest corner of the 202-A Canyon Building

We walked around the West side of R-Cell and I observed the South side of the 202-A canyon building. According to the PUREX Plant Part A, the containment building and 37 tank and vessel systems are located in the 202-A canyon building cells (D, E, F, G, H, J, K, L, M, and Q), canyon deck, and AMU. In the PUREX S&M Plan, 202-A is described as the PUREX Canyon Building. The 2013 LDR Report describes the containment building as storing one cubic meter of MW.

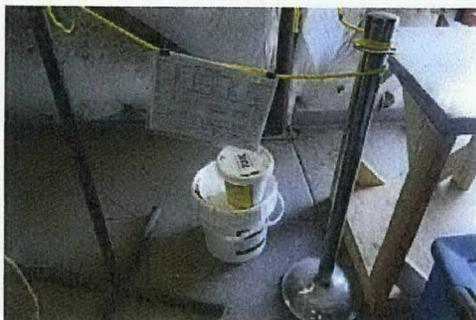
Photo 6: 221-A SAA (South of 202-A)

We walked to the SAA in the 221-A Storage Building, South of 202-A. I observed two plastic containers with one container labelled as "Hazardous Waste" and marked "Corrosive/Toxic," and the other labelled as "Washington State DW" with the waste code "WSC2." I observed that both containers appeared to be closed and in good condition.

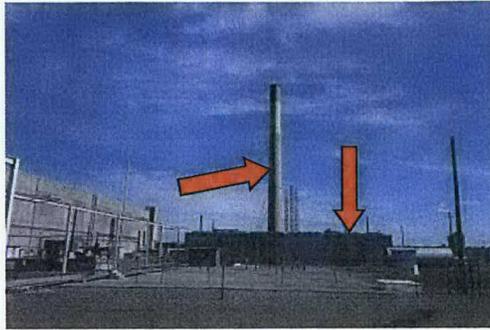
Photo 7: 291-AE in front and 291-A-1 Stack in back (South of 202-A)

We walked to our next location, where I saw the PUREX Plant ventilation system. The PUREX S&M Plan states, "The major portions of the 202-A Building ventilation system that remain active are deep-

bed Filter No.2, portions of the No.4 Filter bank (291-A-1 stack HEPA filters in the 291-AE Building), 291-A Building electric exhaust fans, air tunnels, 292-AB building, and sampling instrumentation.” I observed the HEPA filters in 291-AE, the outside of 291-A, the 291-A-1 stack and the Surveillance, Monitoring, and Control System (SAMCONS) Instrument and Control Unit in Building 217-A.

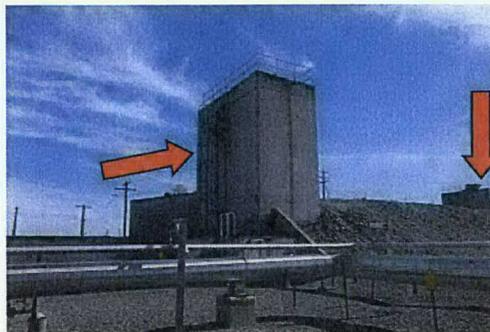
Photo 8: Tunnel 1 front and center, Tunnel 2 on the Right.

We walked to our next location, where I saw the PUREX Storage Tunnels. According to the PUREX Storage Tunnels Part A, Tunnel 1 (218-E-14) has 8 modified railroad cars, which were placed in the tunnel between 1960 and 1965. The PUREX Storage Tunnels Part A also indicates that Tunnel 2 (218-E-15) started receiving railcars in 1967 and as of 2000, Tunnel 2 had 28 modified railroad cars.

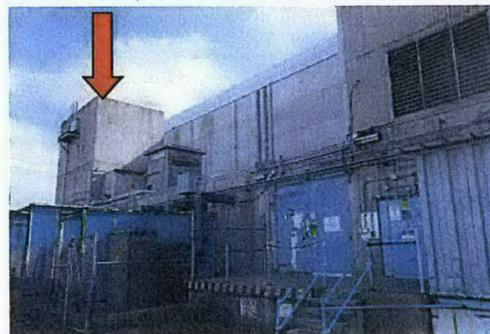
Photo 9: U Cell / Acid Storage Vault (Northwest side, adjacent to 202-A)

We walked to U-Cell, which according to the PUREX Plant Part A, Tanks TK-U3 and TK-U4 are located in U-Cell. In the PUREX S&M Plan U-Cell is also known as 204-A Acid Storage Vault. U-Cell was not visible from our location, but it is situated behind the concrete structure identified below, adjacent to the 202-A Canyon Building.

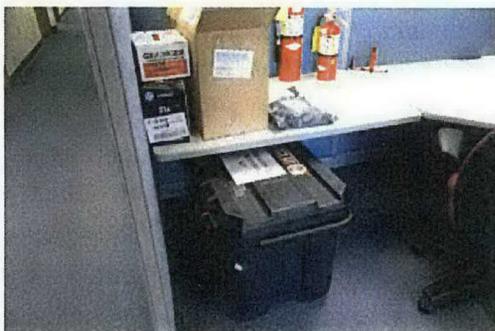
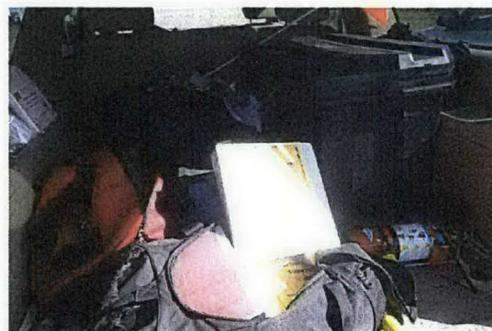
Photo 12 & 13: Emergency Equipment (Southeast corner in MO-294) and the “BED Rig” (South parking lot for MO-294)

The “BED Rig” is a mobile alternate Incident Command Post (ICP) and building MO-294 is the primary ICP for facilities covered by the S&M BEP. He said depending on the work being performed, the BED Rig would accompany S&M personnel when visiting S&M facilities. He said the BED Rig would accompany personnel on annual S&M inspections, since contaminated areas would be accessed.

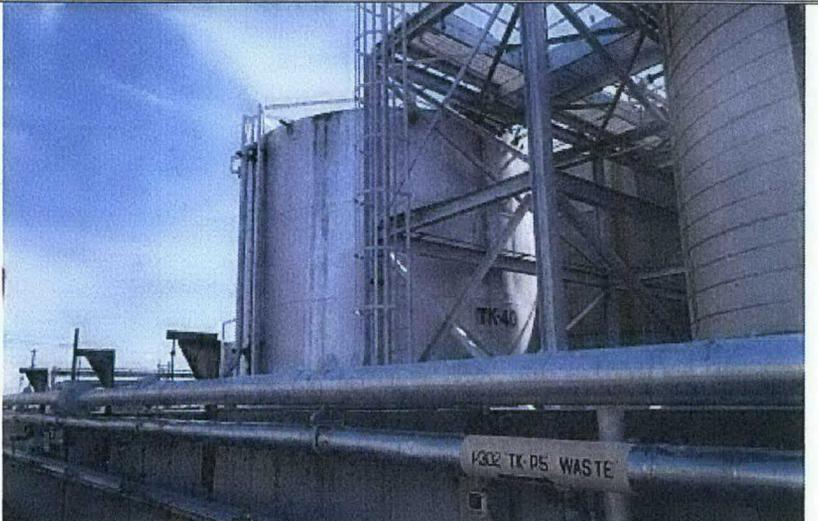
No.	Location	Activity Description or Other Comment	Photo
1.	PUREX – 200 Area East - Hanford Site	Tank TK-40 in Tank Farm 211-A.

A photograph showing a large, cylindrical stainless steel storage tank labeled 'TK-40' in a tank farm. The tank is surrounded by a complex network of metal scaffolding and pipes. In the foreground, a horizontal pipe is labeled 'K302 TK-05 WASTE'. The sky is clear and blue.

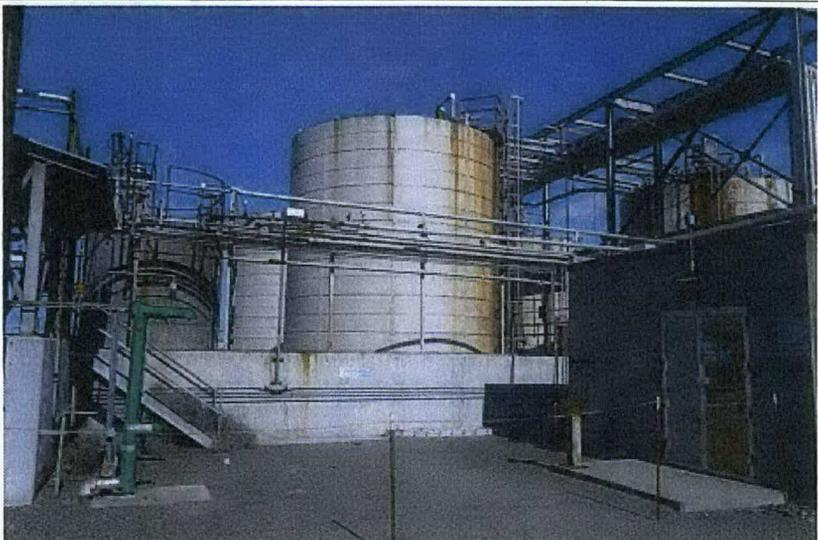
3.	PUREX – 200 Area East - Hanford Site	Tank Farm 203A Acid Pump House/ Acid Storage and Handling Facility – Facing North.

A photograph showing a tank farm with several large, cylindrical stainless steel tanks. The tanks are surrounded by a complex network of pipes and metal structures. In the foreground, there is a concrete walkway and a dark-colored building. The sky is blue.

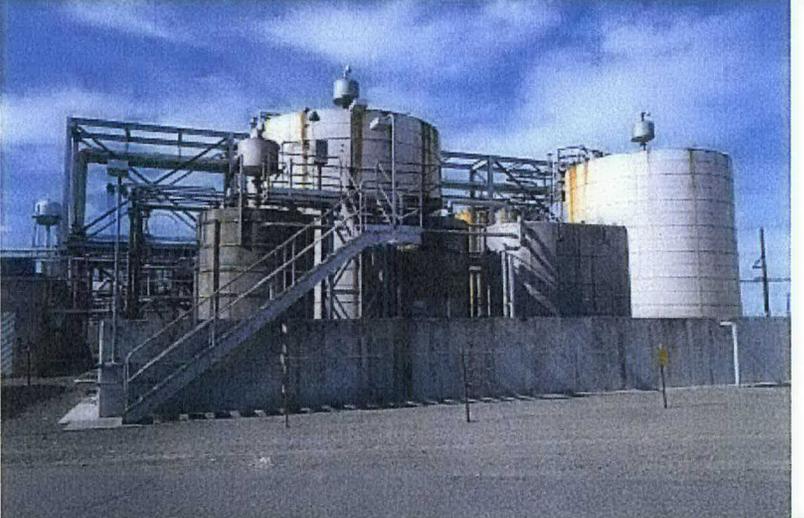
No.	Location	Activity Description or Other Comment	Photo
4.	PUREX – 200 Area East - Hanford Site	Tank Farm 203A Acid Pump House/ Acid Storage and Handling Facility – Facing West.

A photograph showing an industrial facility with several large white cylindrical tanks and a complex network of metal pipes and scaffolding. A concrete wall is in the foreground, and the sky is blue with some clouds.

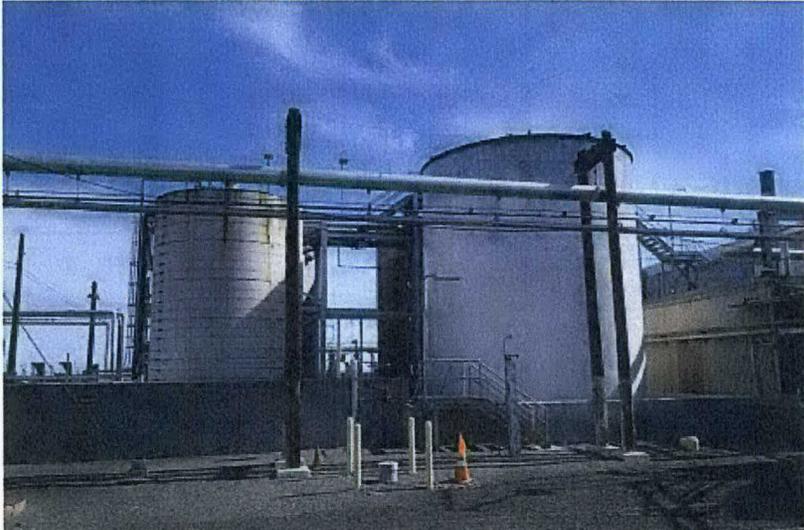
6.	PUREX – 200 Area East - Hanford Site	Tank Farm 211-A Bulk Cold Chemical Tank Farm – Facing East.

A photograph of an industrial facility with large white cylindrical tanks and a complex piping system. A concrete wall is in the foreground, and the sky is blue.

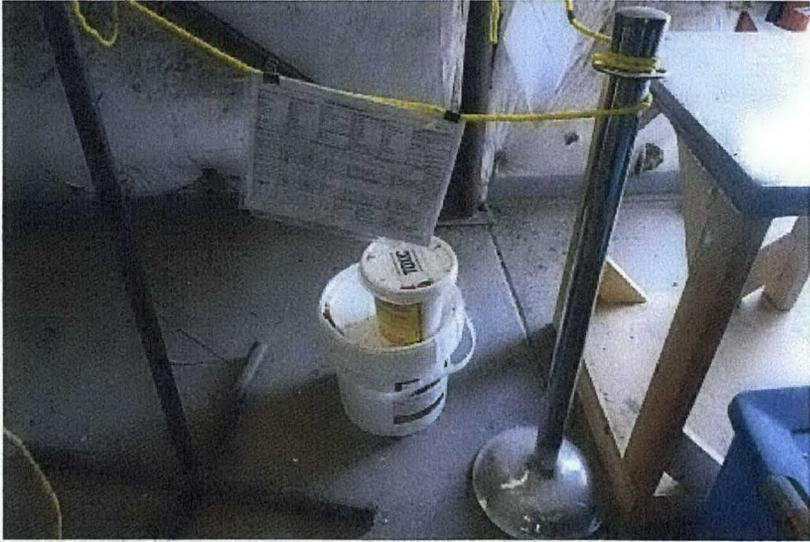
17.	PUREX – 200 Area East - Hanford Site	Satellite Accumulation Area (SAA) in 221-A building.

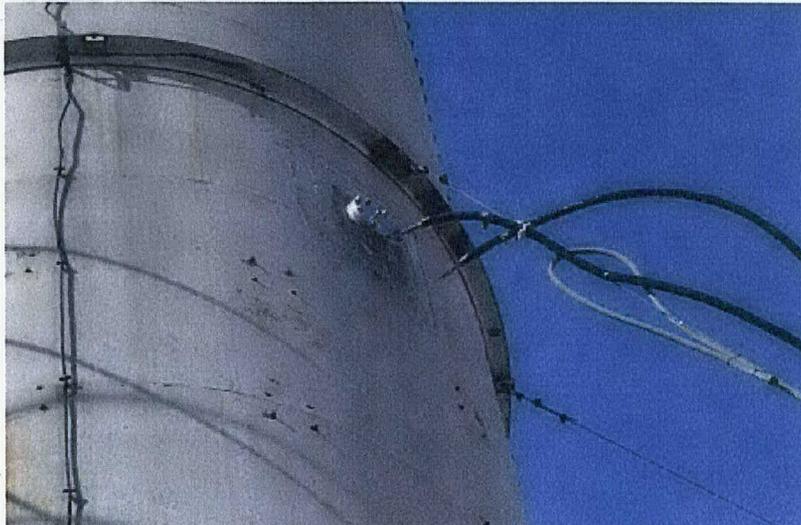
24.	PUREX – 200 Area East - Hanford Site	Detached RAD sampling probe on 291-A-1 Exhaust Stack for 202-A.

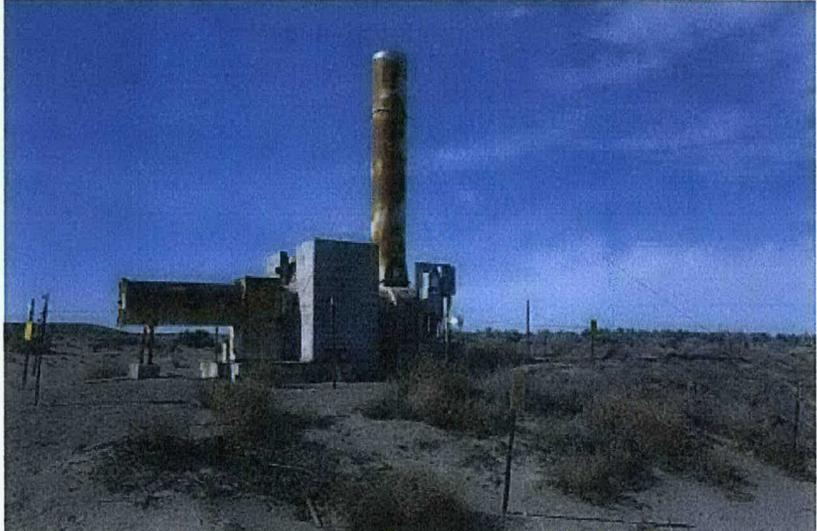
33.	PUREX – 200 Area East - Hanford Site	Shut down exhaust on Purex Storage Tunnel 2 – South end of tunnel.

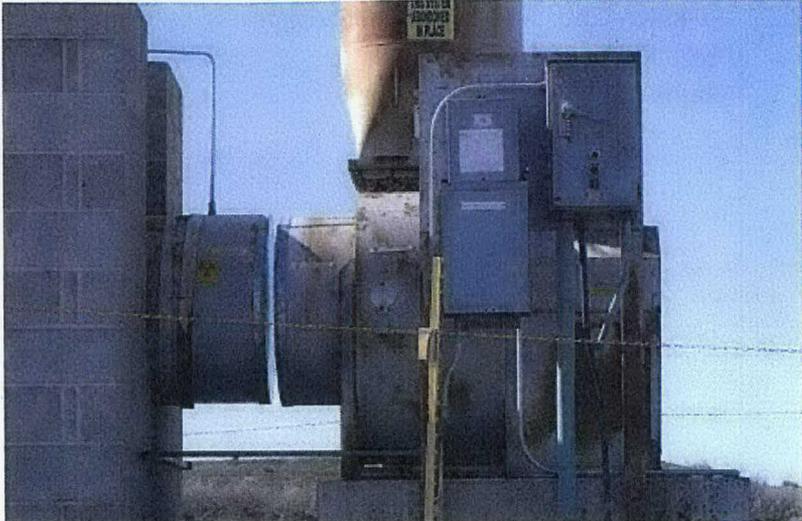
No.	Location	Activity Description or Other Comment	Photo
34.	PUREX – 200 Area East - Hanford Site	Isolated exhaust on Purex Storage Tunnel 2 – South end of tunnel.

A photograph showing an industrial exhaust system. A vertical pipe with a yellow label at the top is connected to a large metal structure. The background shows a clear blue sky and some industrial buildings.

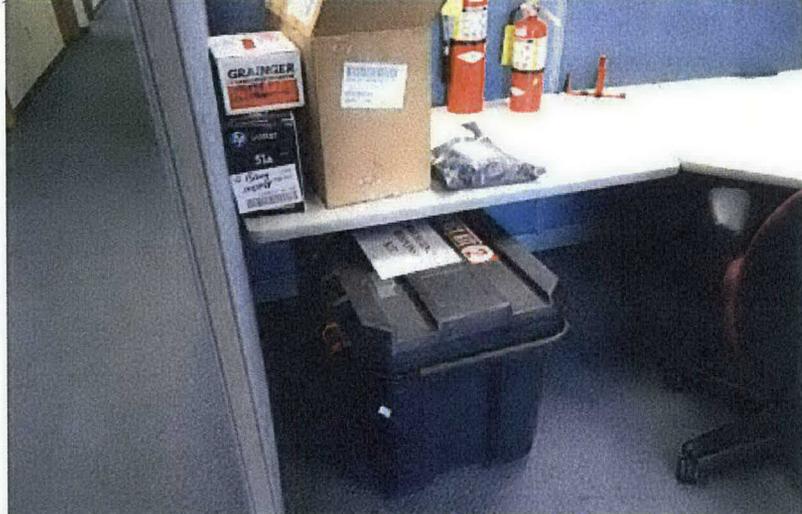
35.	200 Area East - Hanford Site	Backup emergency equipment box.

A photograph of a room containing emergency equipment. On a white desk, there are several boxes, including one labeled 'GRAMIER', and two red fire extinguishers. A black plastic storage bin is on the floor in front of the desk.

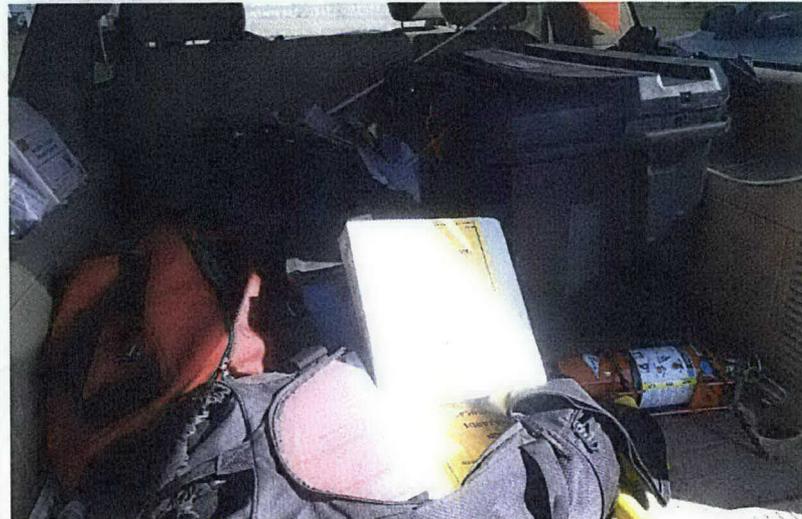
36.	200 Area East - Hanford Site	Emergency equipment and manuals in back of BED Rig for surveillance and maintenance.

A photograph of a storage area. In the foreground, there is a grey bag containing a white box and other items. In the background, there is a large black trash bin and other equipment.
