STATE OF WASHINGTON
DEPARTMENT OF ECOLOGY

Re: Dangerous Waste Compliance Inspection on July 28, 2015 at the Hanford Site Single-Shell Tank System – Generator Activities, Resource Conservation and Recovery Act (RCRA) Site ID: WA7890008967, Nuclear Waste Program (NWP) Compliance Index No. 15.545

16-NWP-040
Single-Shell System – Generator Activities
RCRA Site ID: WA7890008967
NWP Compliance Index No.: 15.545
Inspection Date: July 28, 2015

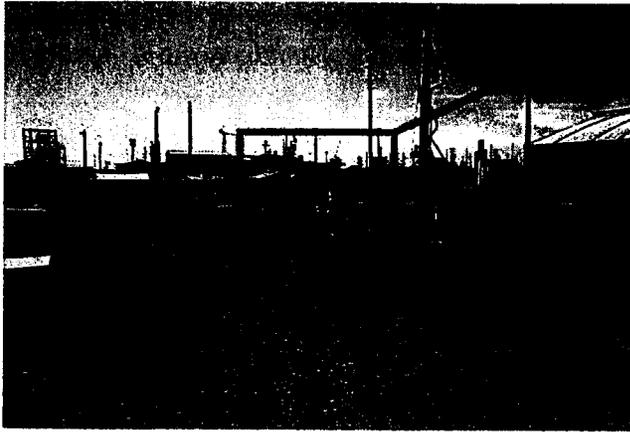
Photo 1: 241-A Tank Farm 90 Day Accumulation Area

At 9:05 a.m. we began the field inspection near the 241-A Tank Farm. The 90-Day Area was within a fence line of what appeared to be the 241-AY Tank Farm fence line, which is associated with the Double Shell Tank (DST) System. The 241-AY Tank Farm is adjacent to the 241-A Tank Farm. From a closed gate, I observed three containers (two drums and one large box). The two drums were surrounded on three sides by metal barriers with one side closed off by a chain. With a pair of binoculars, I observed signs on the chain, which appeared to state "90-Day Accumulation Area." The large box I observed, appeared to be in a separate designated section adjacent to the 90-Day Area. I requested the inventory log since I could not clearly identify the labels on the containers or the contents.

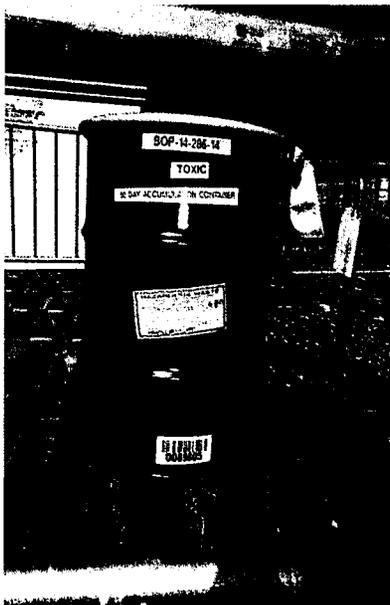
Photo 4: 241-B, 241-BX, and 241-BY Tank Farms 90 Day Area

At 10:02 a.m. we arrived at the 241-B, 241-BX, and 241-BY Tank Farms. The 90-Day Area for the three tank farms are consolidated into one 90-Day Area, located on the east side of the 241-BX Tank Farm. I observed one container (Photo 4) with the following labels.

- 90 Day Accumulation Container
- Accumulation Date: June 17, 2015
- CIN: 0089805
- PIN: BOP-14-286-14
- Hazardous Waste
- Toxic

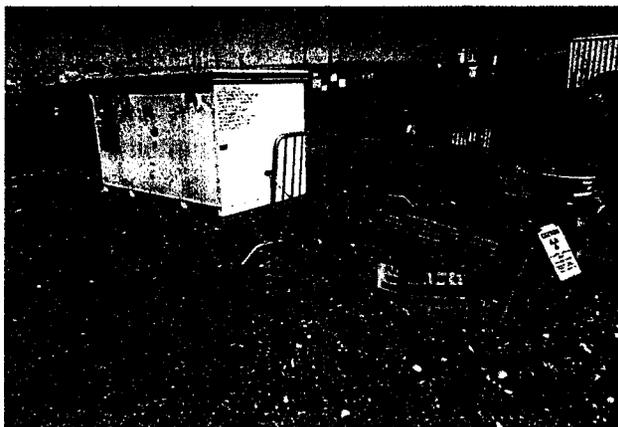
Photo 5: 241-B, 241-BX, and 241-BY Tank Farms 90 Day Area

I also observed two LLW labeled containers adjacent to the area where the MW container (Photo 4 and Photo 5) was located. The MW container (CIN: 0089805) matched the Tank Farm Container Inventory.

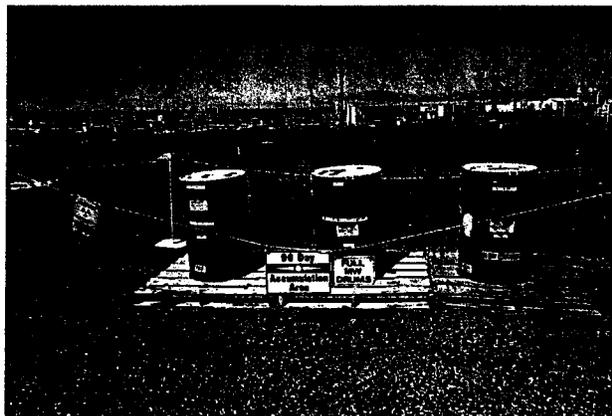
Photo 7: 241-SY Tank Farm 90 Day Area

At 10:58 a.m. we arrived at a 90-Day Area on the east side of 241-SY Tank Farm. The 241-SY Tank Farm is a part of the DST System. I observed the 90-Day Area is located outside of the fence line. I observed three containers labeled as MW staged in the 90-Day Area (Photo 7). I also observed one container inside the fence line approximately 20 feet from the east side gate. The container had the following labels (Photo 8).

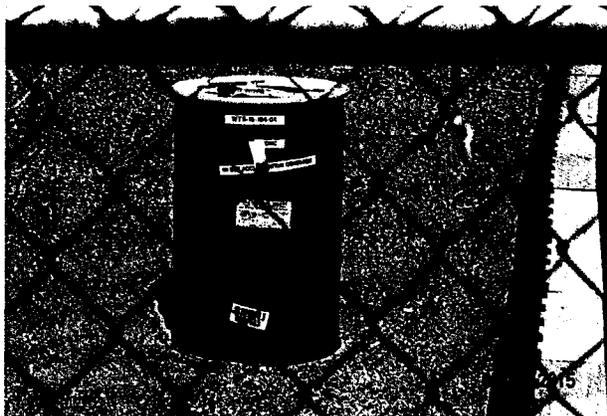
Photo 8: 241-SY Tank Farm Container (CIN: 0089653)

- 90 Day Accumulation Container

- Accumulation Date: July 28, 2015
- CIN: 0089653
- PIN: WTS-15-104-04
- Hazardous Waste
- Toxic

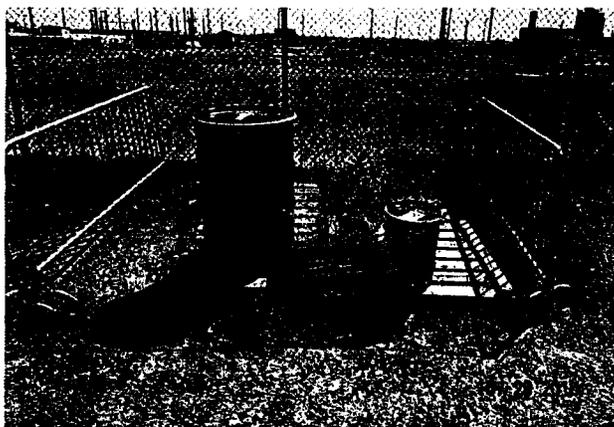
Photo 9: 241-SX Tank Farm 90 Day Area

At 11:10 a.m. we arrived at the 90-Day Area on the west side of the 241-SX Tank Farm. The 241-SX Tank Farm is a part of SST System. I observed the 90-Day Area is outside the fence line of the 241-SX Tank Farm. I also observed one LLW labeled container (CIN: 0091177) and one MW labeled container (PIN: TFP-14-227-10 and CIN: 0086574) staged in the 90 Day Area (Photo 9).

The Tank Farm Container Inventory list states the following regarding the containers observed above (Photo 9) and other MW containers not observed within the 90-Day Accumulation Area.

Inventory (CIN: 0091176). When I looked at the container numbers on the Tank Farm Container Inventory list for 241-SY I observed LLW container (CIN: 0091177). It is not clear why the LLW Container (CIN:0091177) is located within this 241-SX Tank Farm 90-Day Area, considering the Tank Farm Container Inventory list documents the container as being in the 241-SY Tank Farm. It is also not clear where the LLW container (CIN: 0091176) is located.

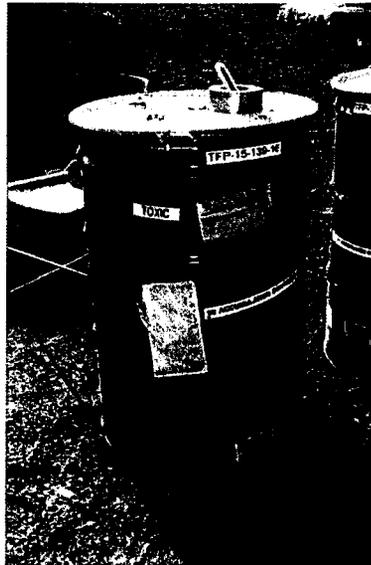
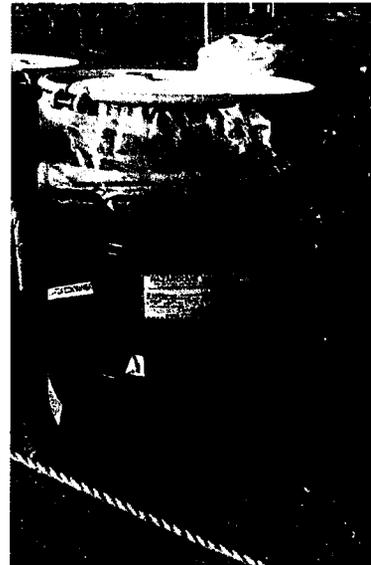
Photo 10 Title: ITEM 2 ECY Insp Doc Req 15.545 Drum Photo-1 AX Farm 07.28.15

I observed three container identification numbers in Photo 10 and 11, which are 0090017, 0091536, and 0091521. According to the *Tank Farm Waste Containers In The Field* inventory list, the 241-A Tank Farm had no dangerous waste or mixed waste containers. I observed in the inventory 241-AX Tank Farm had 25 containers reserved for accumulating mixed waste, of which 9 containers had accumulation start dates. I did not receive photographs of the following containers, which were identified in the Tank Farm Container Inventory.

Whether the containers were staged within the 90-Day Area for the 241-AX/AZ Tank Farms is not clear. I observed the containers listed above stated the “90” for location detail, which could indicate the containers would be located within the 90-Day Area for the 241-AX/AZ Tank Farms.

I only observed three containers in Photo 10 and 11. I observed the inventory 241-AX Tank Farm listed 25 containers reserved for accumulating mixed waste, of which 9 containers had accumulation start dates. I did not receive photographs of the 9 containers observed on the Tank Farm Container Inventory. For future generator inspections with restricted access, accommodations need to be made during the day of the inspection for photographs to be taken inside of tank farms. Ecology typically provides very little advance notice of generator inspections, so a system needs to be developed for when inspectors are conducting inspections, photographs can be taken of containers, labels, signs, etc. the day of the inspection.

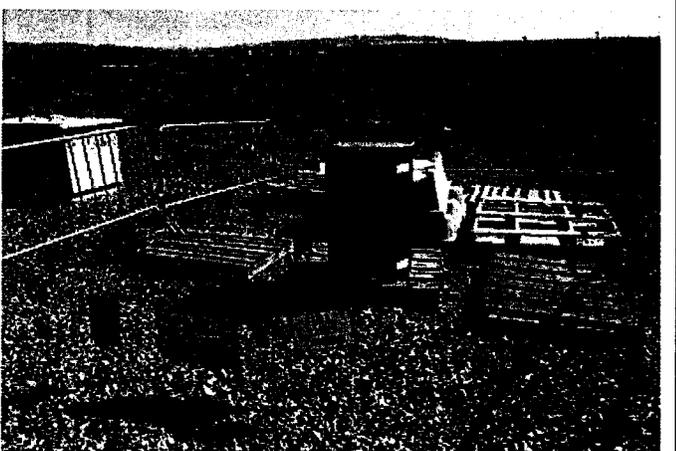
3.	Single Shell Tank Farm – East side of C Farm	9:50 a.m. 90 Day Accumulation Area outside the tank farm's fence line. One (1) Low Level Waste container and no dangerous waste or mixed waste containers present.

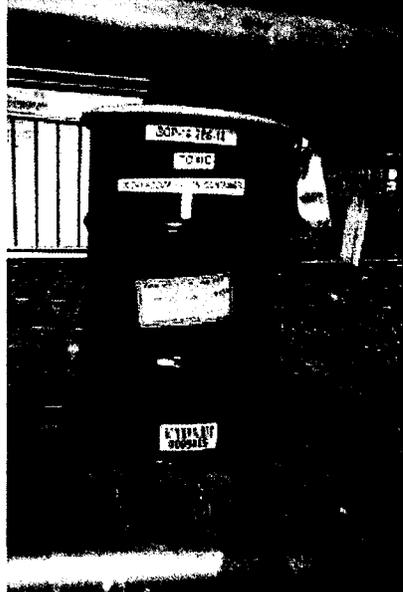
5.	Single Shell Tank Farm – East side of BX Farm	10:08 a.m. 90 Day Accumulation Area outside the tank farm's fence line. Two (2) Low Level Radioactive Waste containers and one mixed waste container present. ID: BOP-14-286-14 / 0089805 Hazardous Waste Acc. Start Date: 6/17/15 Major Risk: Toxic

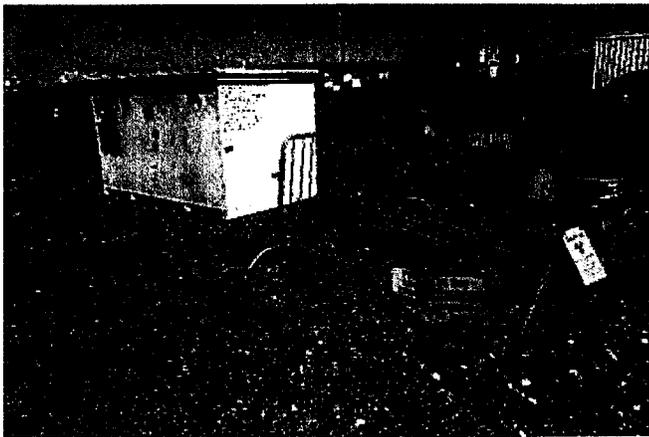
6.	Single Shell Tank Farm – East side of B Farm	10:08 a.m. 90 Day Accumulation Area outside the tank farm's fence line. Two (2) Low Level Radioactive Waste containers and one mixed waste container present.

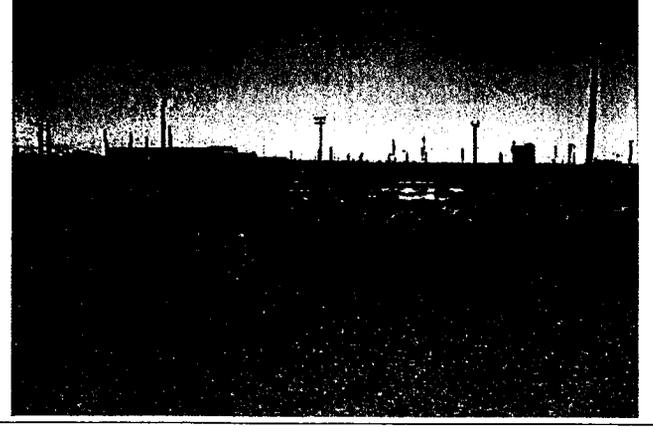
9.	Single Shell Tank Farm – West side of U Farm	10:46 a.m. 90 Day Accumulation Area outside the tank farm's fence line. Approximately Eight (8) Low Level Radioactive Waste containers and no dangerous waste or mixed waste containers present.

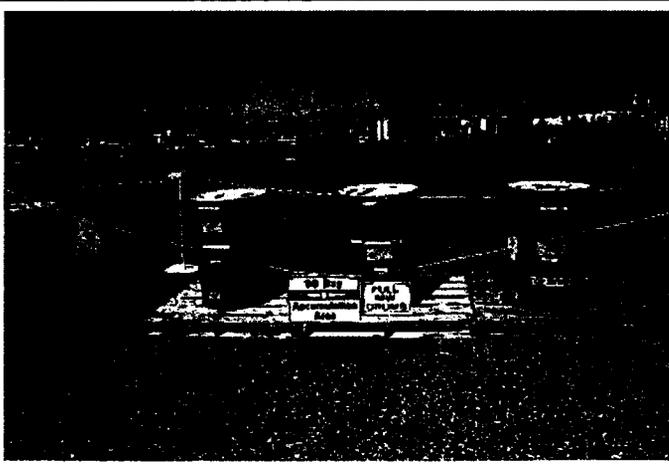
12.	Single Shell Tank Farm – East side of S/SY Farm	10:56 a.m. 90 Day Accumulation Area outside the tank farm's fence line. Three (3) mixed waste containers present.

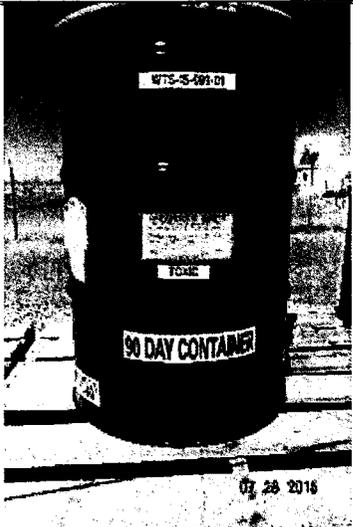
No.	Location	Activity Description or Comment	Photo
13.	Single Shell Tank Farm – East side of S/SY Farm	<p>10:57 a.m.</p> <p>90 Day Accumulation Area outside the tank farm's fence line. Three (3) mixed waste containers present.</p> <p>ID: WTS-15-099-01 / 0089668 Hazardous Waste Acc. Start Date: 7/21/15 Major Risk: Toxic</p>

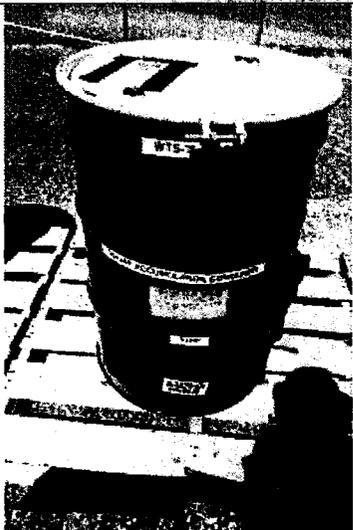
14.	Single Shell Tank Farm – East side of S/SY Farm	<p>10:57 a.m.</p> <p>90 Day Accumulation Area outside the tank farm's fence line. Three (3) mixed waste containers present.</p> <p>ID: WTS-15-104-05 / 0089649 Hazardous Waste Acc. Start Date: 7/8/15 Major Risk: Toxic</p>

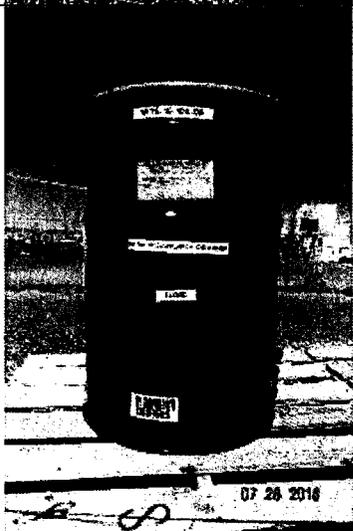
15.	Single Shell Tank Farm – East side of S/SY Farm	<p>10:57 a.m.</p> <p>90 Day Accumulation Area outside the tank farm's fence line. Three (3) mixed waste containers present.</p> <p>ID: WTS-15-104-06 / 0089565 Hazardous Waste Acc. Start Date: 7/14/15 Major Risk: Toxic</p>

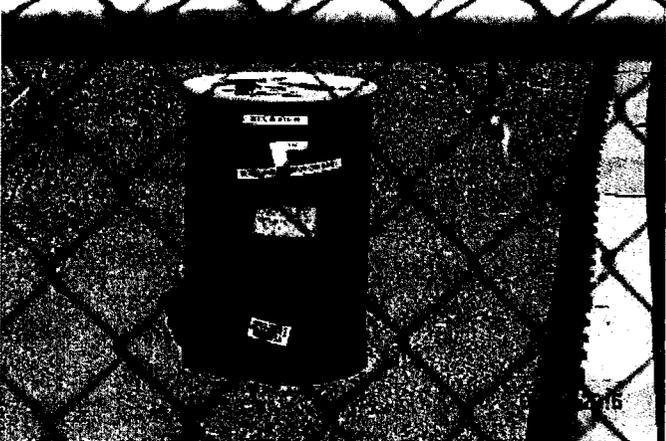
No.	Location	Activity Description or Comment	Photo
16.	Single Shell Tank Farm – East side of S/SY Farm	11:01 a.m. 90 Day Accumulation Area outside the tank farm's fence line. One (1) mixed waste container within the Tank Farm's fence line. ID: WTS-15-104-04 / 0089653 Hazardous Waste Acc. Start Date: 7/28/15 Major Risk: Toxic

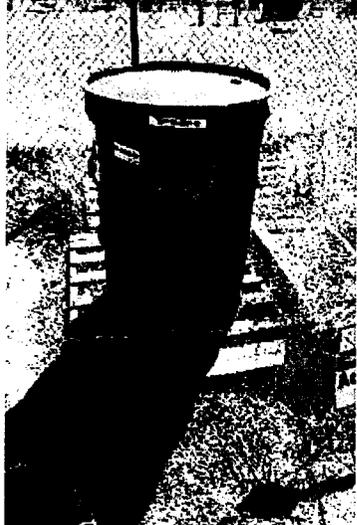
17.	Single Shell Tank Farm – West side of SX Farm	11:12 a.m. 90 Day Accumulation Area outside the tank farm's fence line. One (1) Low Level Radioactive Waste Container and one (1) mixed waste container present. ID: TFP-14-227-10 / 0086574 Hazardous Waste Acc. Start Date: 7/13/15 Major Risk: Toxic

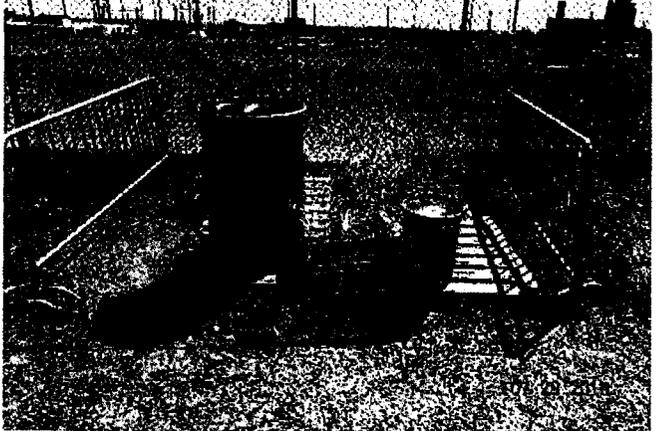
18.	Single Shell Tank Farm – West side of SX Farm	11:12 a.m. 90 Day Accumulation Area outside the tank farm's fence line. One (1) Low Level Radioactive Waste Container and one (1) mixed waste container present.
