DOE/RL-94-76

Constructability Report for the 200-BP-1 Prototype Surface Barrier

Date Published
September 1994

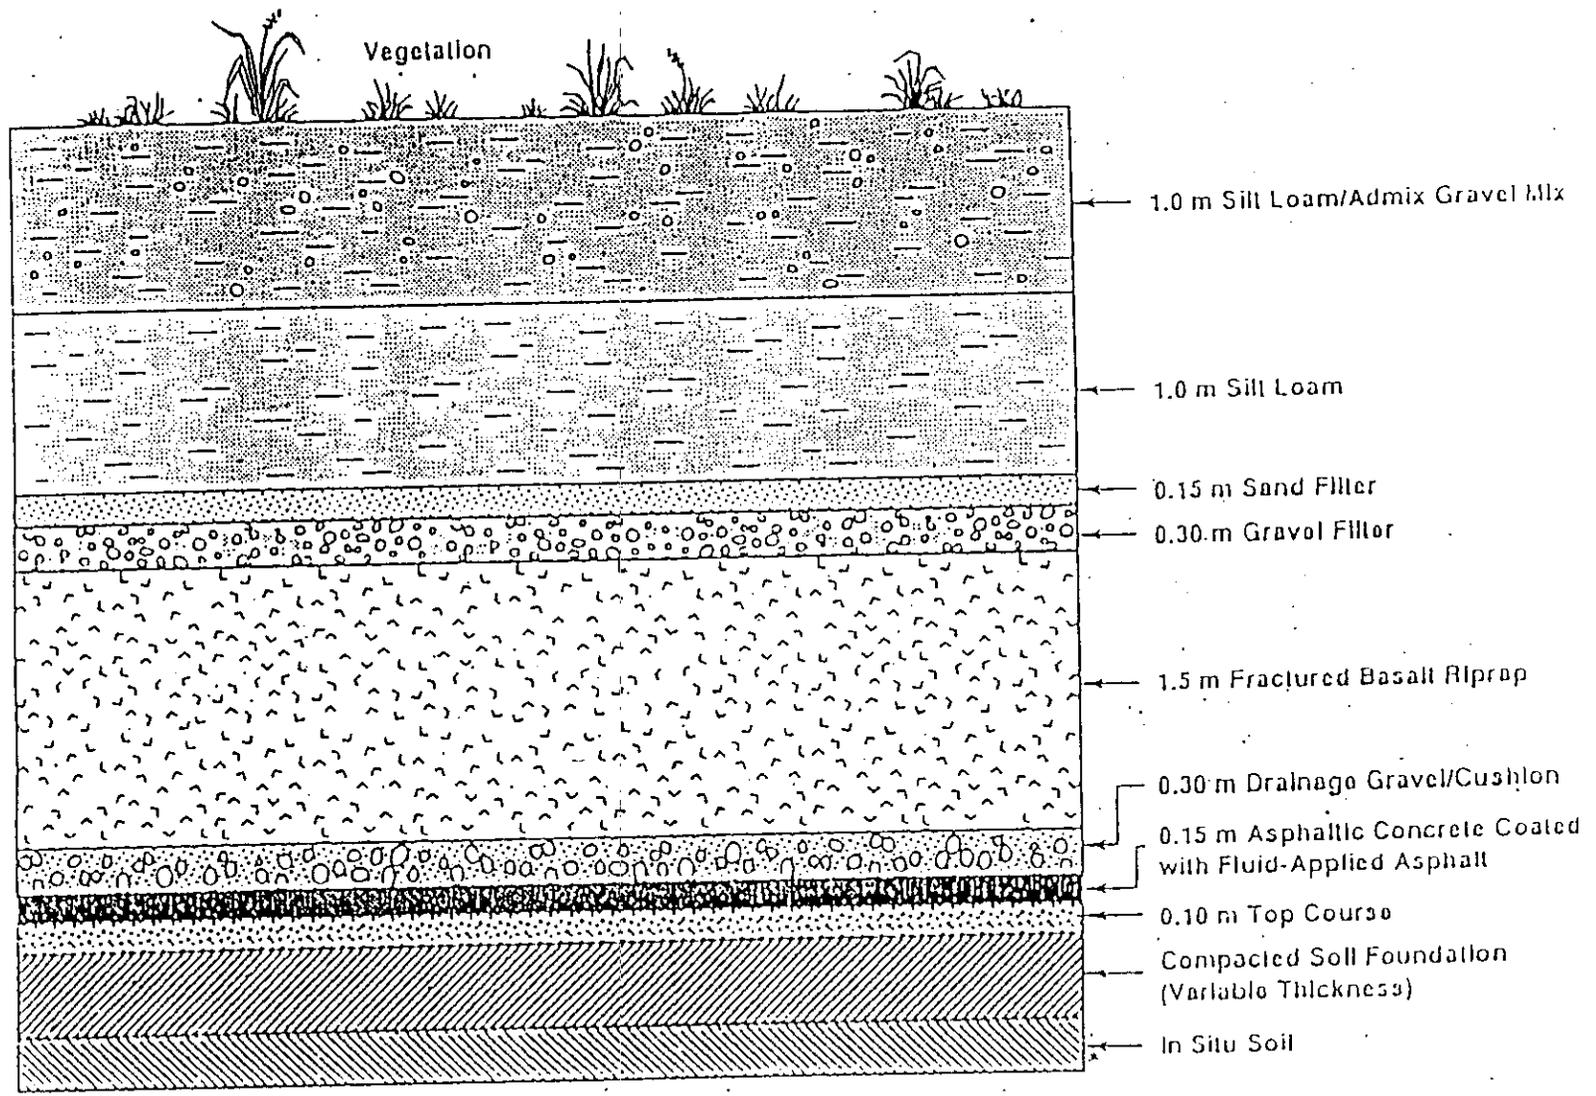
Figure 1. Cross Section of Surface Isolation Barrier.

Figure 1 shows a cross section of surface isolation barrier layers.

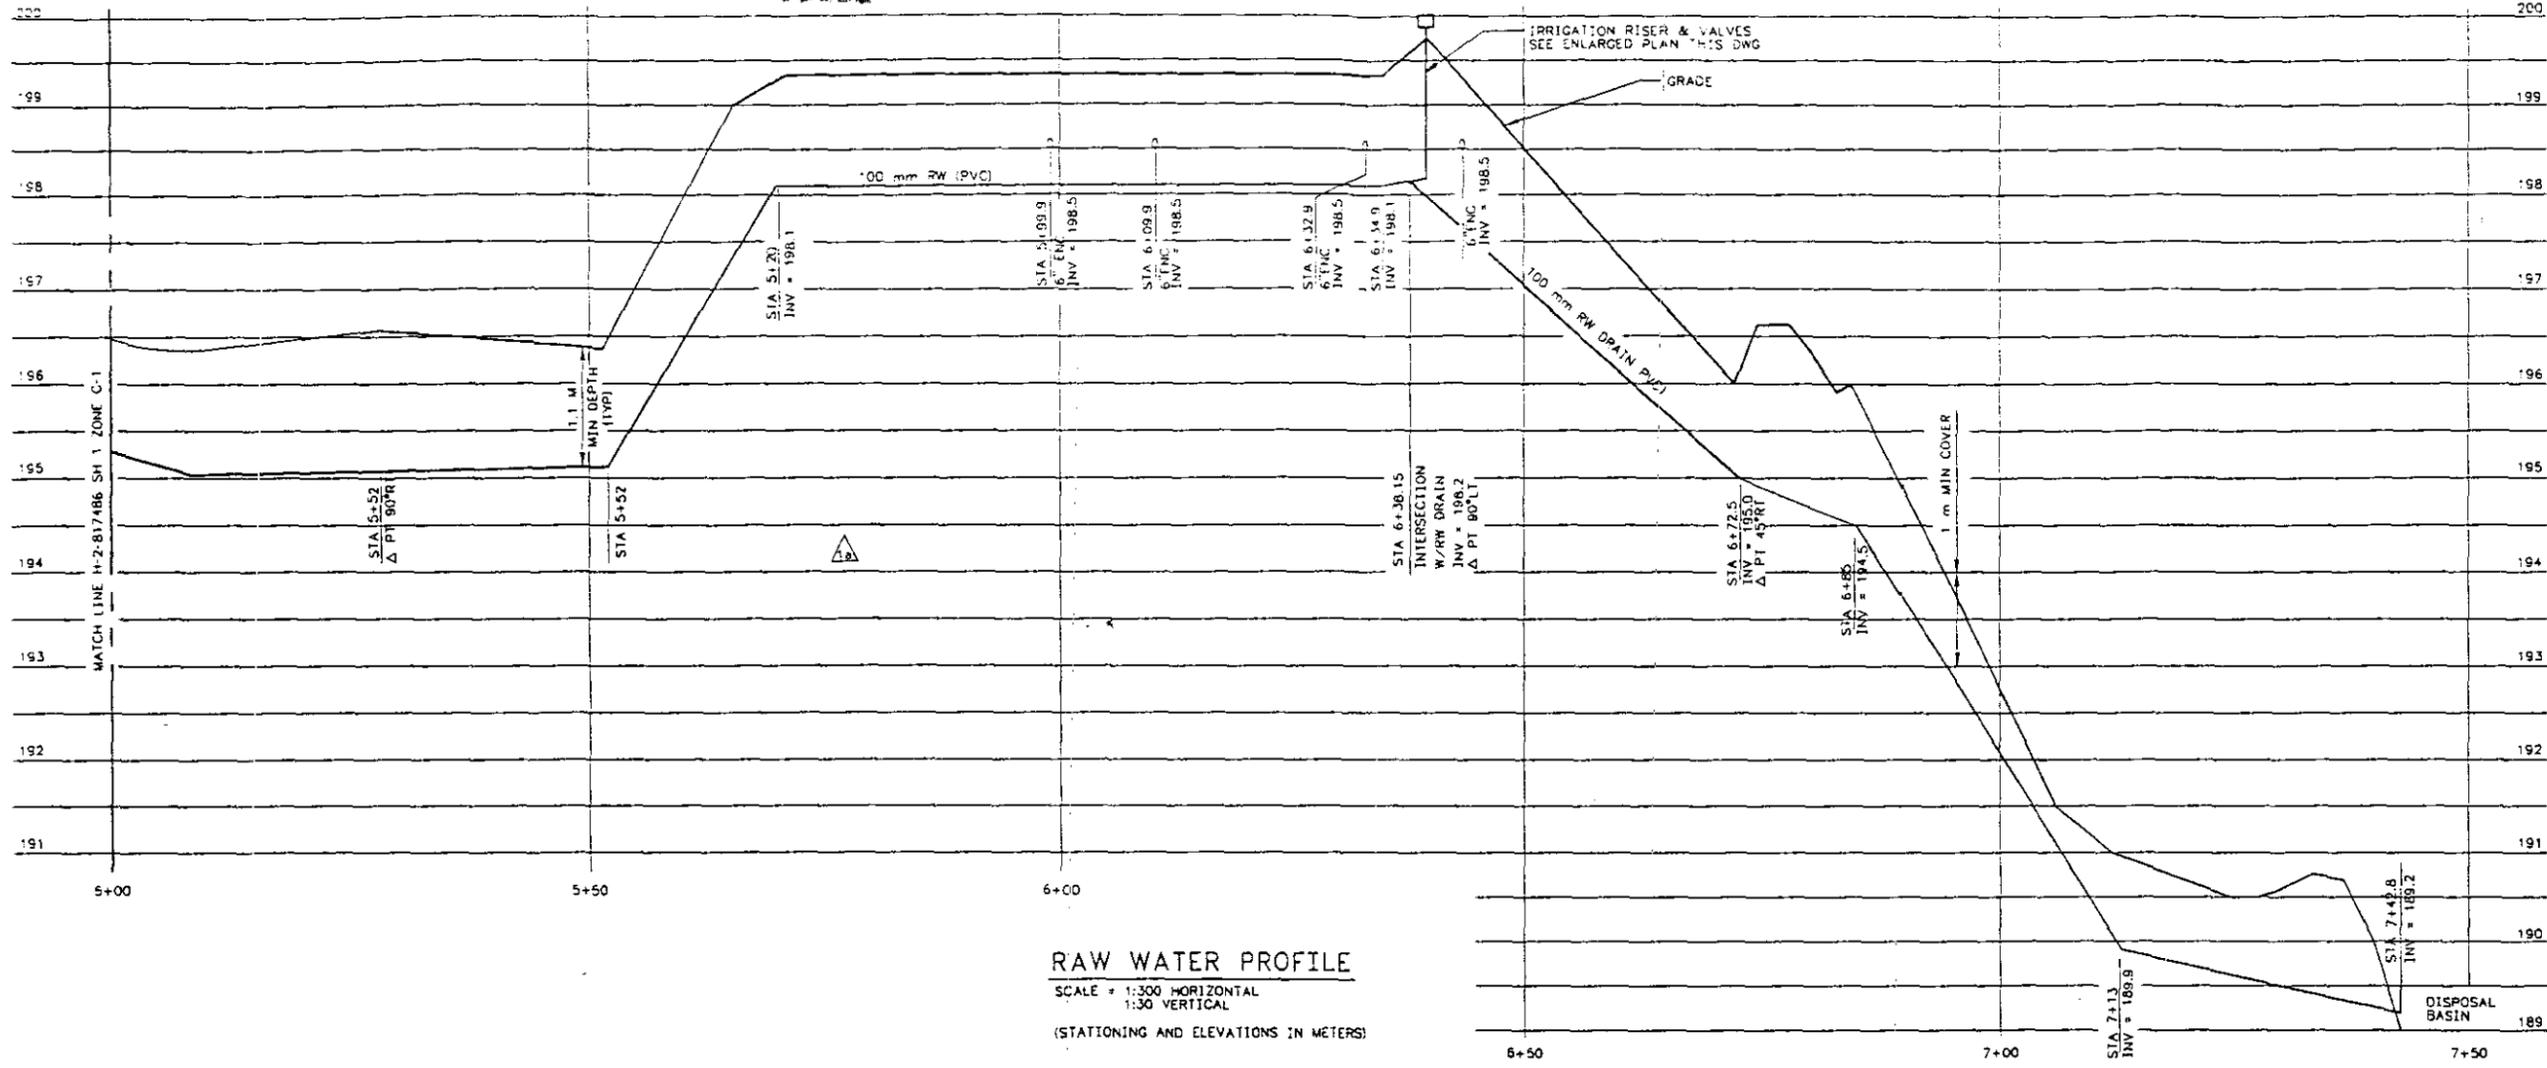
RAW WATER PROFILE

SCALE = 1:300 HORIZONTAL
 1:30 VERTICAL
 (STATIONING AND ELEVATIONS IN METERS)

The raw water pipeline developed several leaks after it was installed. Initially, a water hammer occurred causing the pipe to burst. The system was redesigned to include pop-off valves to eliminate the water hammer.

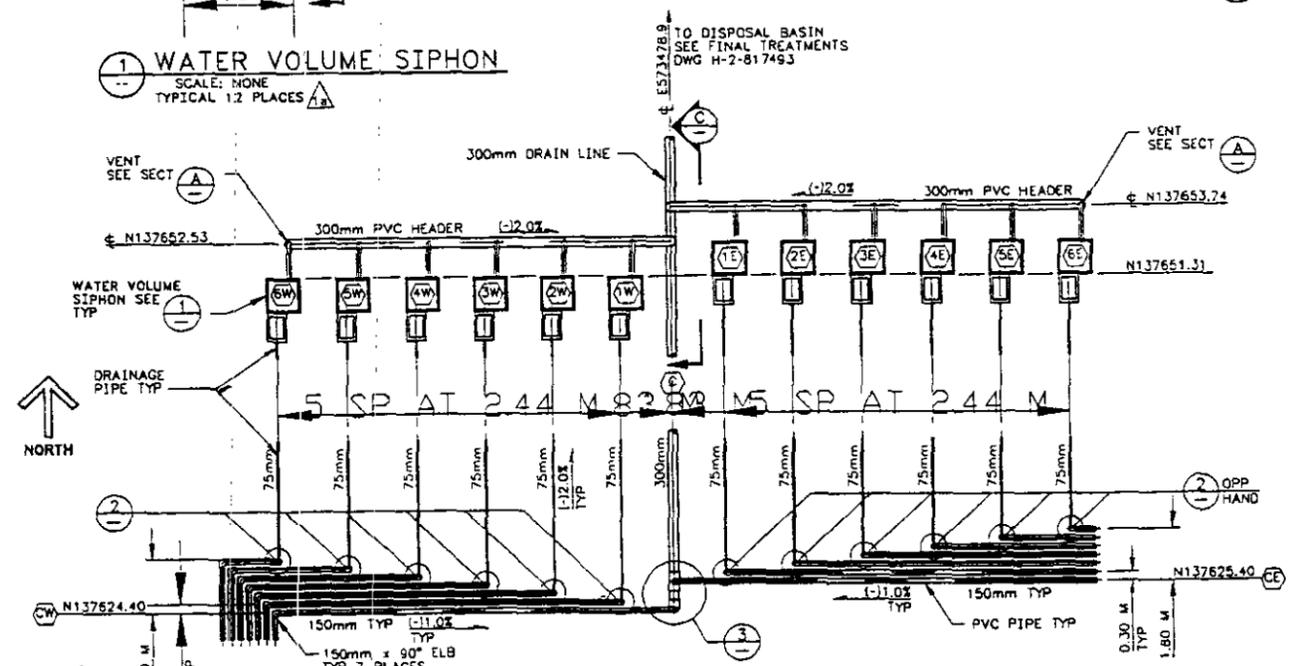
ENLARGED PLAN - SIPHON VAULTS
SCALE: 1:100

2 DETAIL INVERT ELEVATIONS

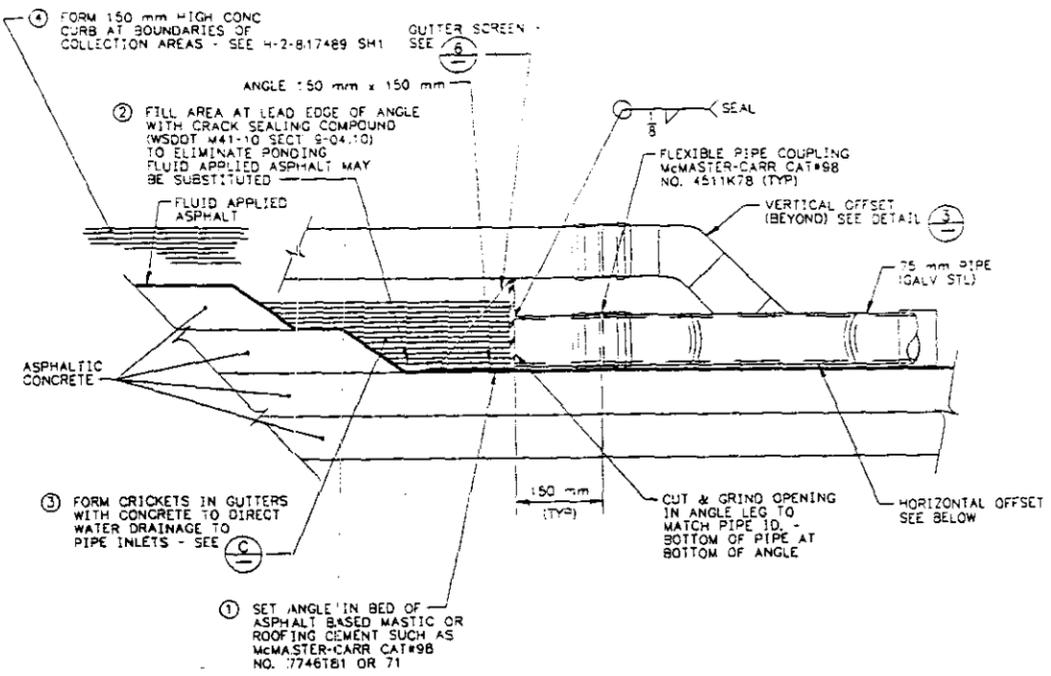
DETAIL - WATER COLLECTION SECTION (1) H-2-817489 SH 1 SCALE = 1:5

NOTE: NUMBERS IN CIRCLES (1) DENOTE SEQUENCE OF CONSTRUCTION BEGINNING AFTER APPLICATION OF FLUID APPLIED ASPHALT AND 24 HOUR CURE

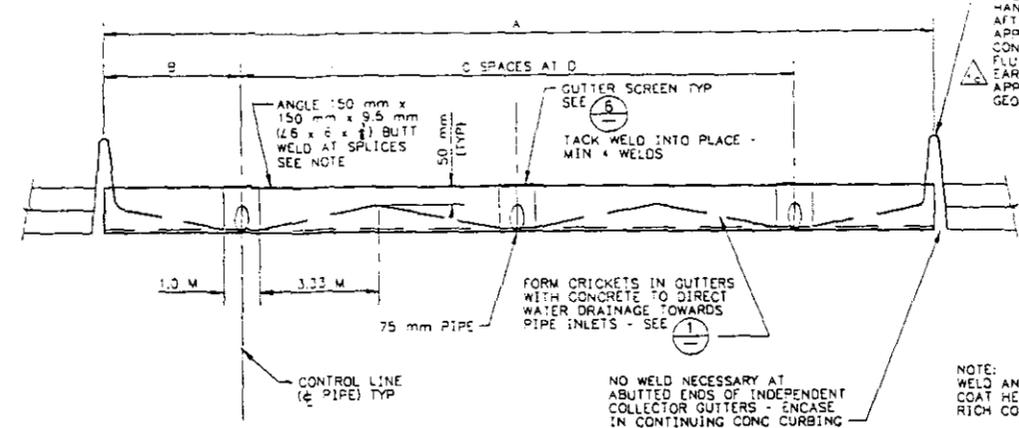
REPAIR TRANSITION AT GUTTERS AND JOINTS. HAND FORM TRANSITION AT GUTTERS AND JOINTS. AFTER MINIMUM OF 5 DAYS OF CURE (AND 24 HOURS MINIMUM AFTER APPLICATION OF REPAIR GROUT) FILL CRACKS IN CURBING THAT CONTINUE TO OPEN DUE TO DAILY TEMPERATURE FLUCTUATIONS WITH FLUID APPLIED ASPHALT. APPLY FLUID APPLIED ASPHALT TO CRACKS EARLY IN THE MORNING. PLACE GEOTEXTILE OVER CURBING. APPLY FLUID APPLIED ASPHALT SATURATING GEOTEXTILE TO THE POINT WHERE THE GEOTEXTILE ADHERES TO THE CONCRETE CURBING.

NOTE: WELD ANGLE AT SPLICES USING 1/2" BUTT WELD. COAT HEAT AFFECTED AREA WITH 2 COATS ZINC RICH COMPOUND.

SECTION - WATER COLLECTOR ELEVATION (C) H-2-817489 SH 1 SCALE: HORIZ = 1:50 VERT = 1:5

Heat from the sun caused the curbs to expand and buckle. Upon cooling and contraction, cracks in the curbs appeared at the joints with dikes. The cracks were repaired by applying fluid-applied asphalt over a geotextile. Once the overlaying materials were placed, the temperature will remain stable and the expansion problem will be eliminated.

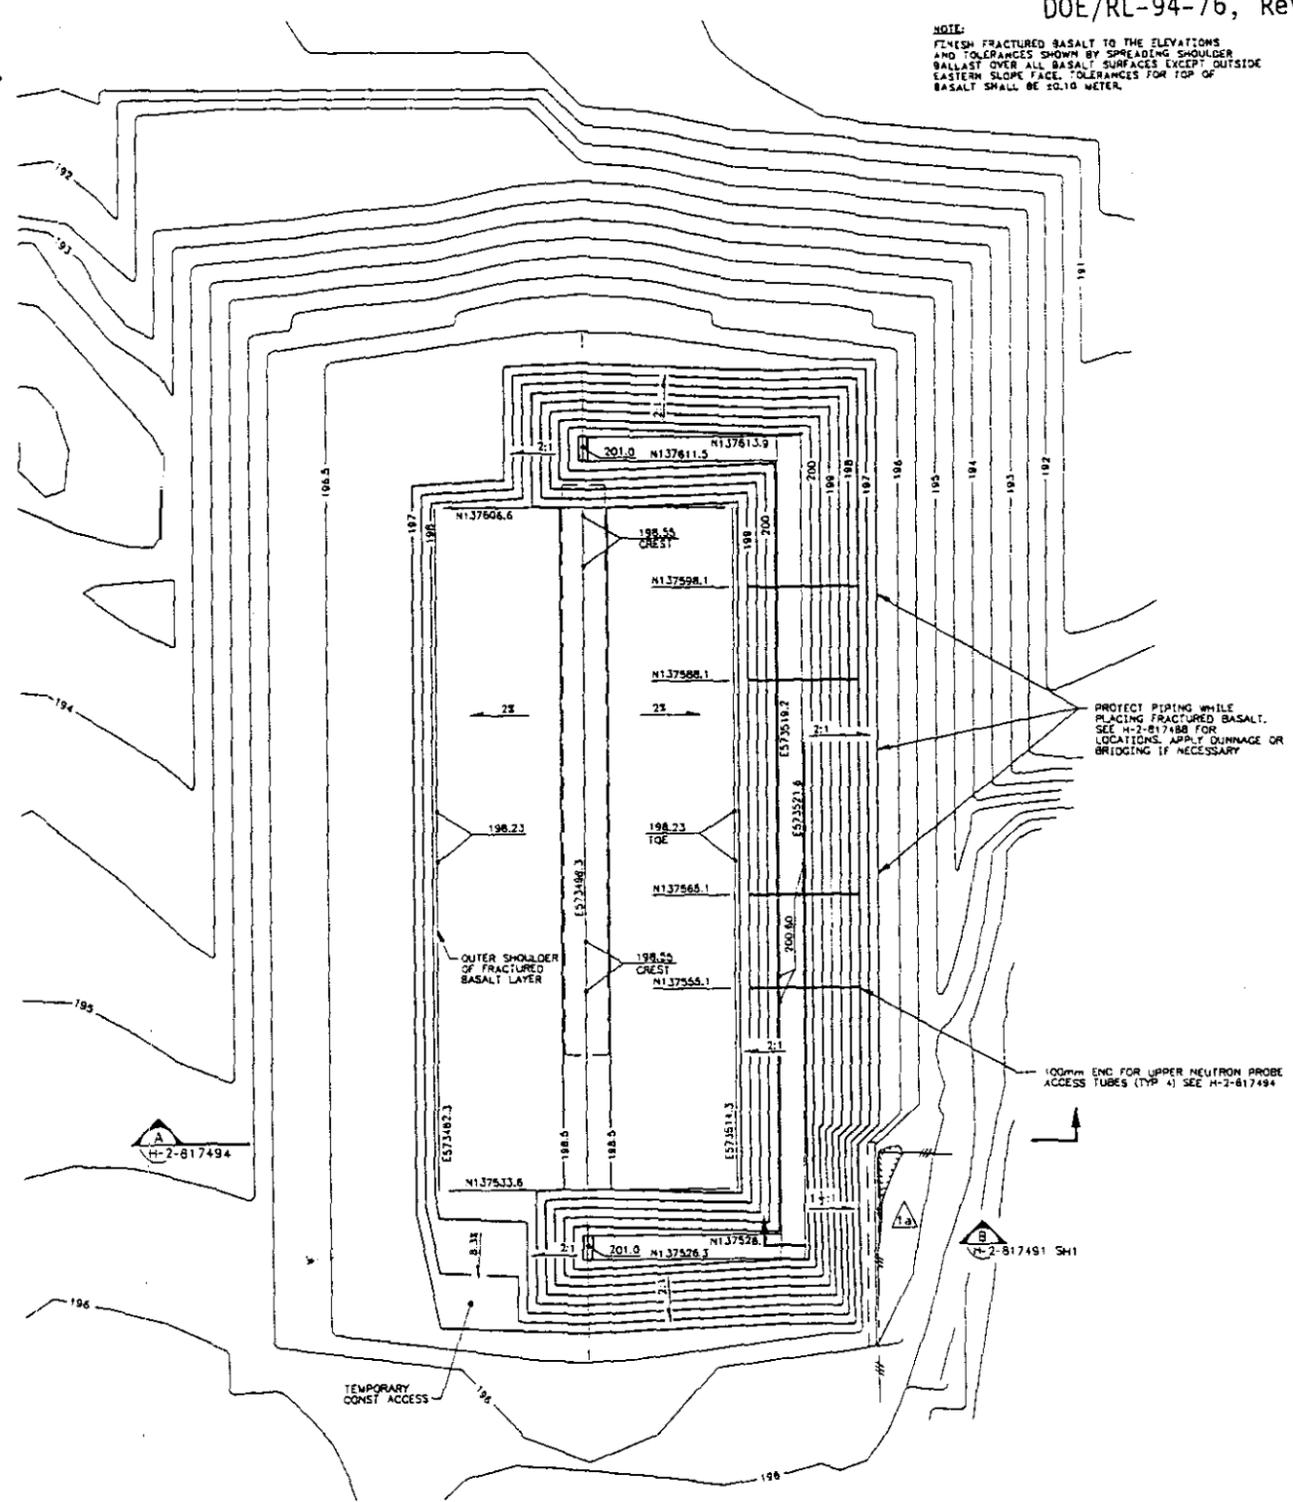
FRACTURED BASALT PLACEMENT
SCALE = 1:300

NOTE:
FINISH FRACTURED BASALT TO THE ELEVATIONS
AND TOLERANCES SHOWN BY SPREADING SHOULDER
BALLAST OVER ALL BASALT SURFACES EXCEPT OUTSIDE
EASTERN SLOPE FACE. TOLERANCES FOR TOP OF
BASALT SHALL BE 50.10 METER.

PROTECT PIPING WHILE
PLACING FRACTURED BASALT.
SEE H-2-817498 FOR
LOCATIONS. APPLY DUNNAGE OR
BRIDGING IF NECESSARY

100mm ENC FOR UPPER NEUTRON PROBE
ACCESS TUBES (TYP 4) SEE H-2-817494

Initially the basalt product contained an excess of fine particles, rendering it slightly out of specification. The cause was determined to be that the basalt contained normal cracks that had occurred during initial placement of the basalt and throughout the ensuing time. The cracks filled from the natural weathering processes with wind and waterborne silt, which, when combined with the small fraction of the blasted basalt, biased the range of particle sizes. The intent of the specification was met by the produced basalt, and the specification was modified to allow the use of the native materials as was originally intended.

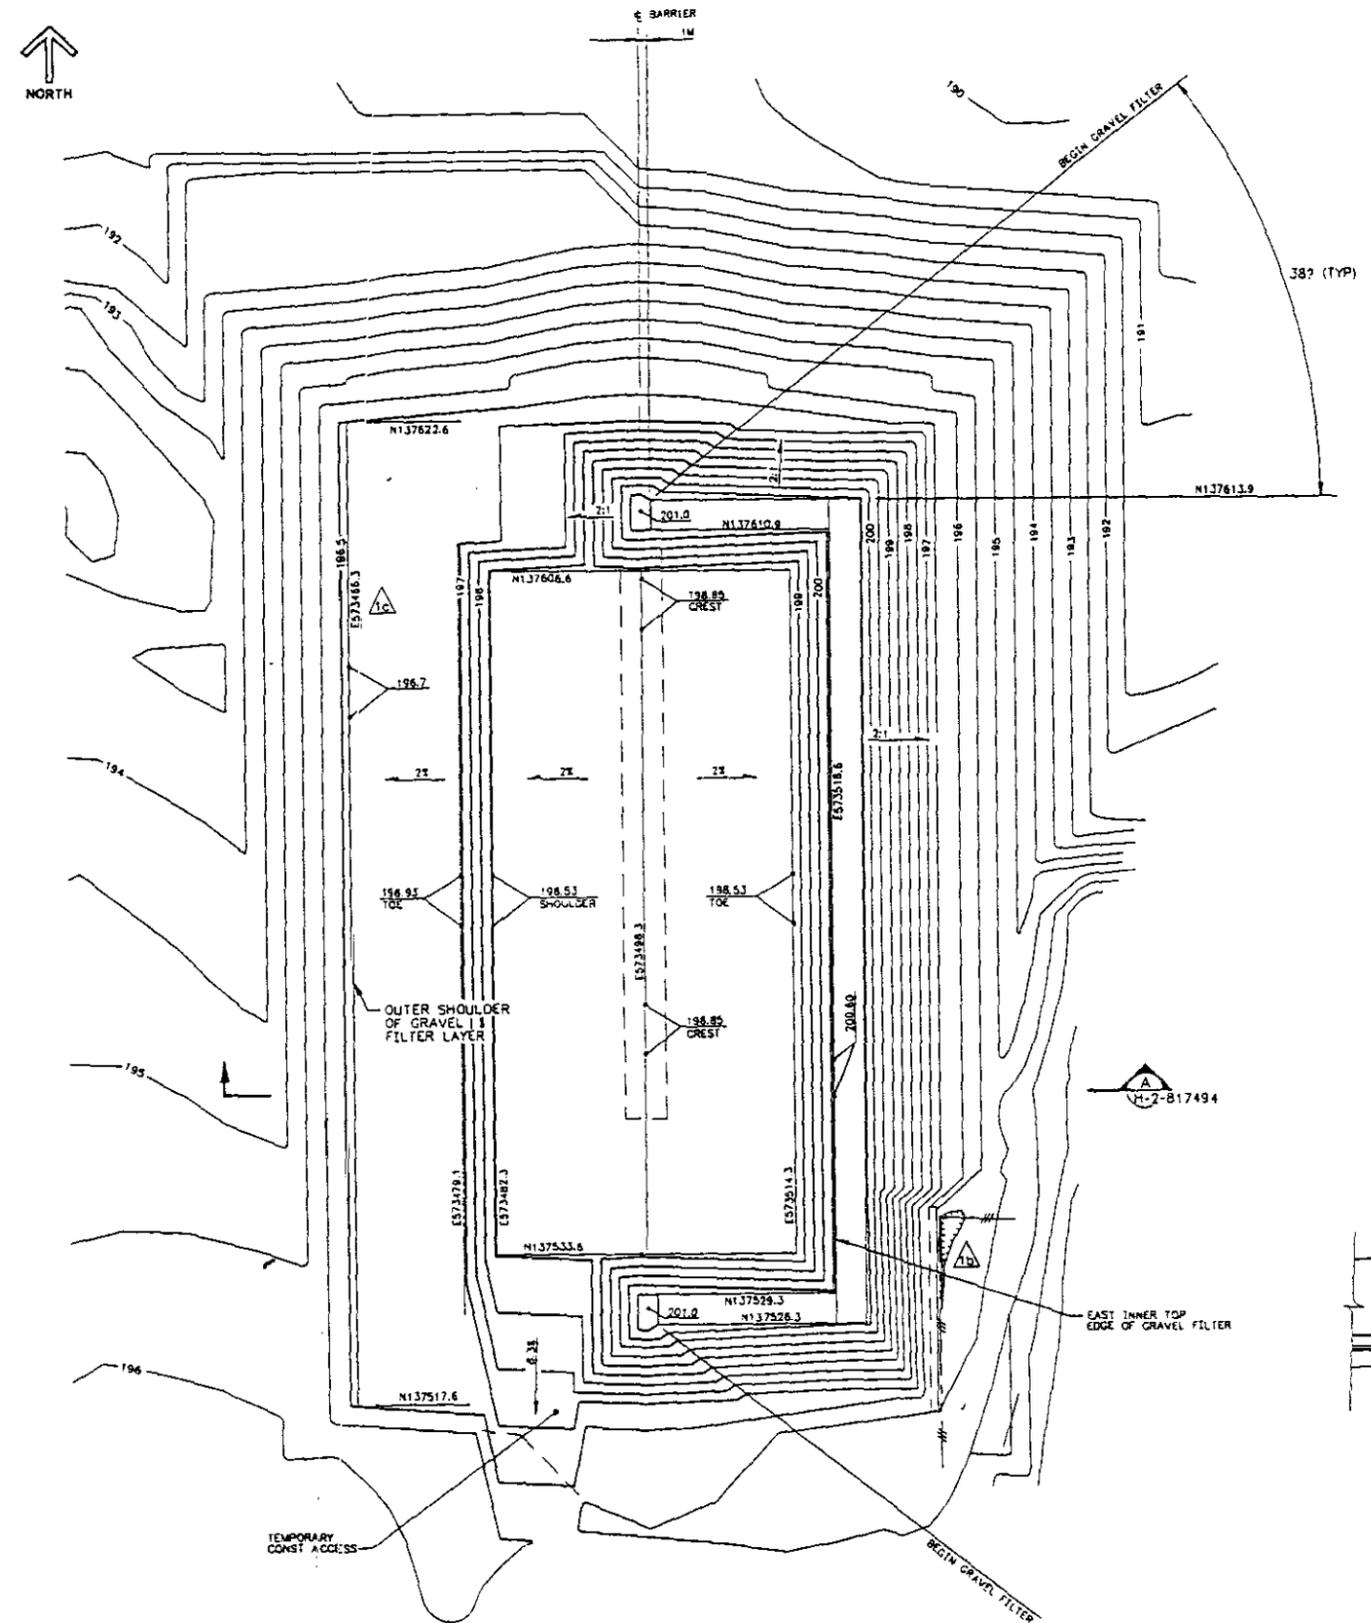
GRAVEL FILTER LAYER
SCALE = 1:300

NOTE: AT CONTRACTOR OPTION PLACEMENT OF CLEAN FILL SIDE SLOPE MAY BE STAGED BY PROVIDING A BENCH AT THE SILT LAYER INTERFACE FROM WHICH TO PLACE THE SILT.
I.E. ELEV 199.85
