0039232
DOE/RL-94-76
Rev. 1

Constructability Report for the 200-BP-1 Prototype Surface Barrier

PROTOTYPE SURFACE BARRIER CONSTRUCTABILITY REPORT

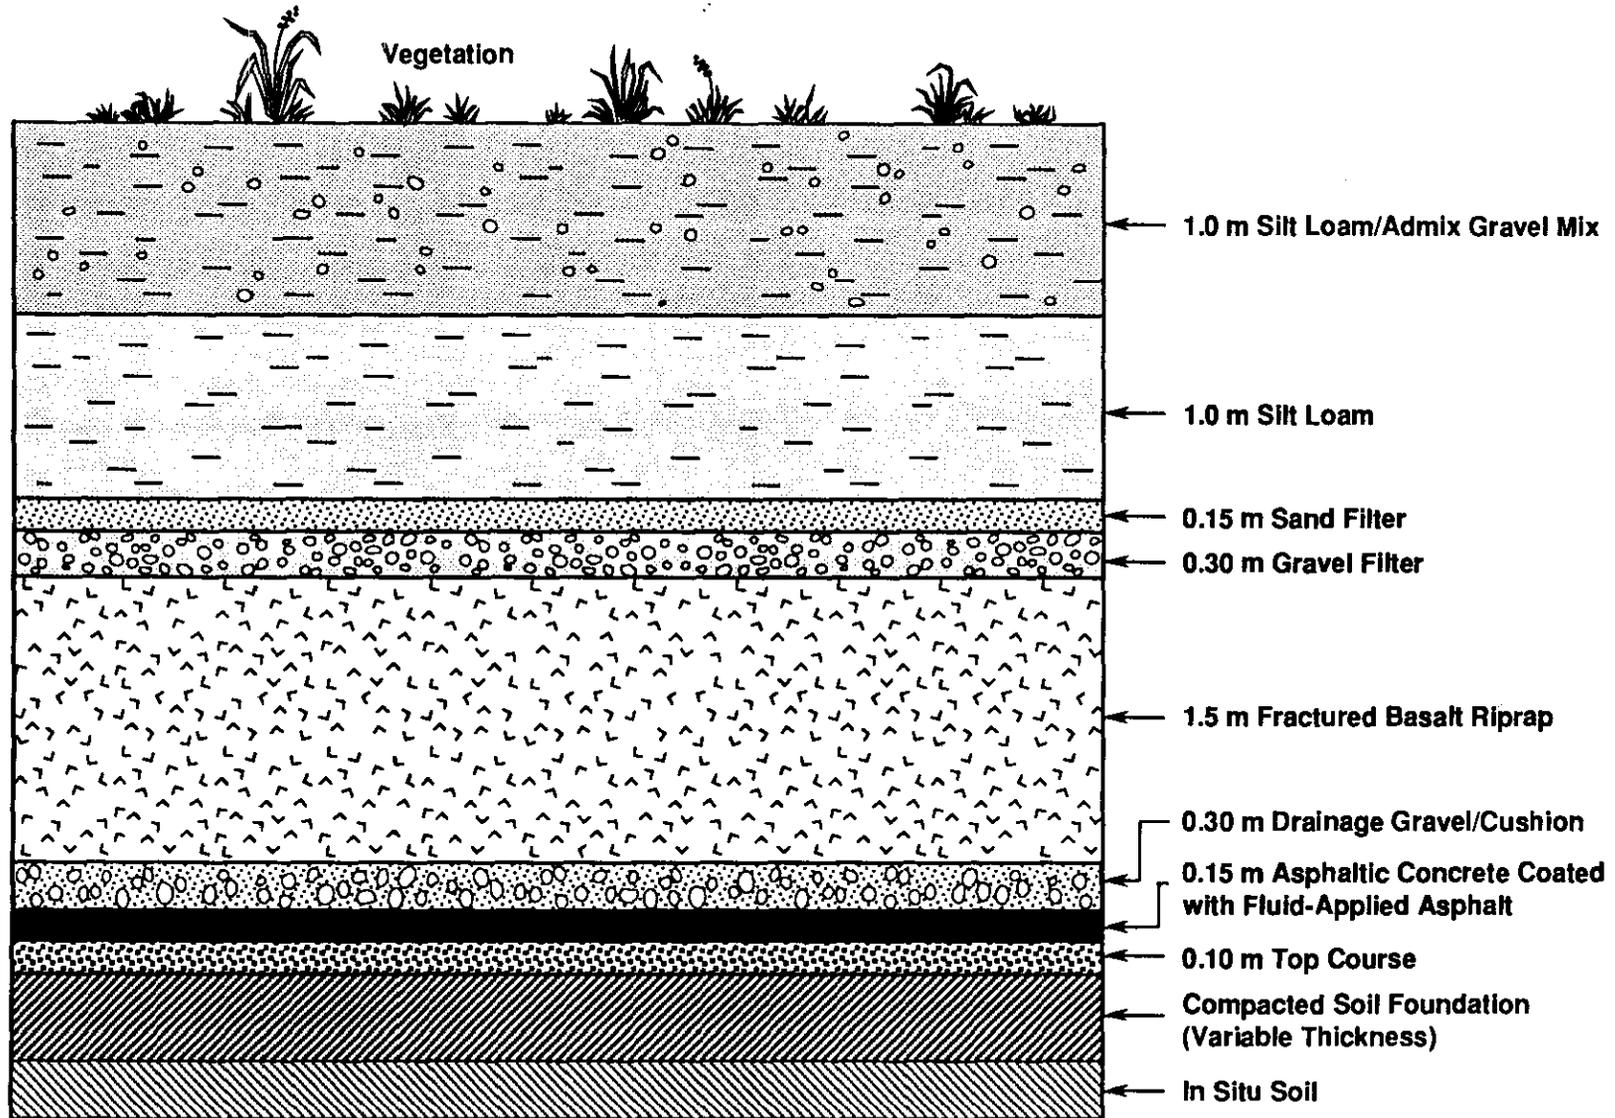
Figure 1. Cross Section of Surface Isolation Barrier.

Typical Barrier Cross Section

Figure 1 shows a cross section of surface isolation barrier layers.

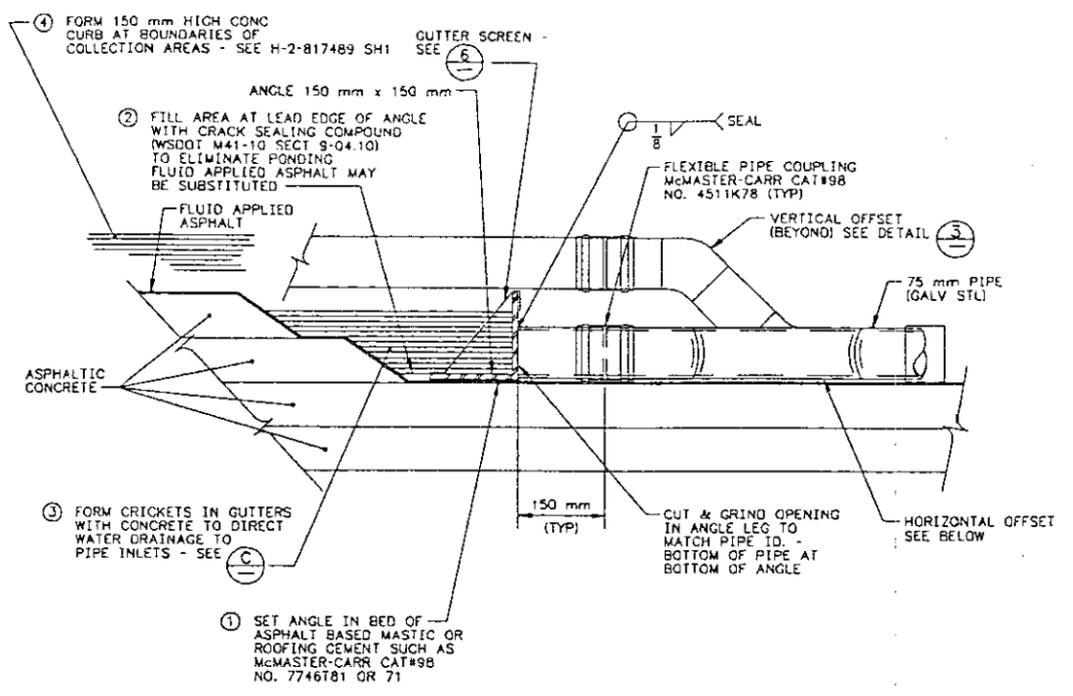
DETAIL - WATER COLLECTION SECTION (1) H-2-817489 SH1 SCALE = 1:5

NOTE: NUMBERS IN CIRCLES ① DENOTE SEQUENCE OF CONSTRUCTION BEGINNING AFTER APPLICATION OF FLUID APPLIED ASPHALT AND 24 HOUR CURE

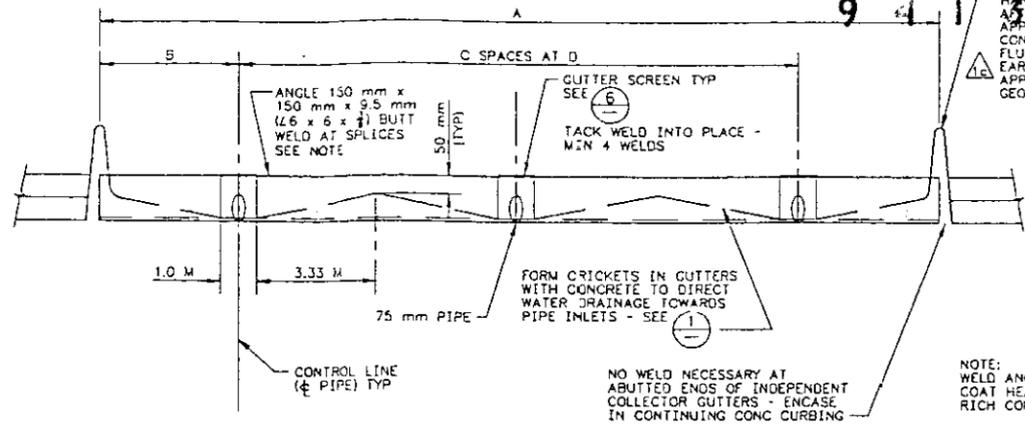
SECTION - WATER COLLECTOR ELEVATION (C) H-2-817489 SH1 SCALE: HORIZ = 1:50 VERT = 1:5

COLLECTOR ZONE (SEE H-2-817489 SH 1)	DIMENSION				QUANTITY
	A	B	C	D	
SOUTH END COLLECTOR	31.00 M	3.875 M	3	7.75 M	2
BUFFER ZONE COLLECTOR	10.00 M	2.50 M	1	5.00 M	2
NORTHWEST END COLLECTOR	18.00 M	3.00 M	2	6.00 M	1*
COLLECTORS 1 THRU 6 (E & W)	23.00 M	3.83 M	2	7.67 M	12

NOTE: WELD ANGLE AT SPLICES USING 1/2" BUTT WELD. COAT HEAT AFFECTED AREA WITH 2 COATS ZINC RICH COMPOUND.

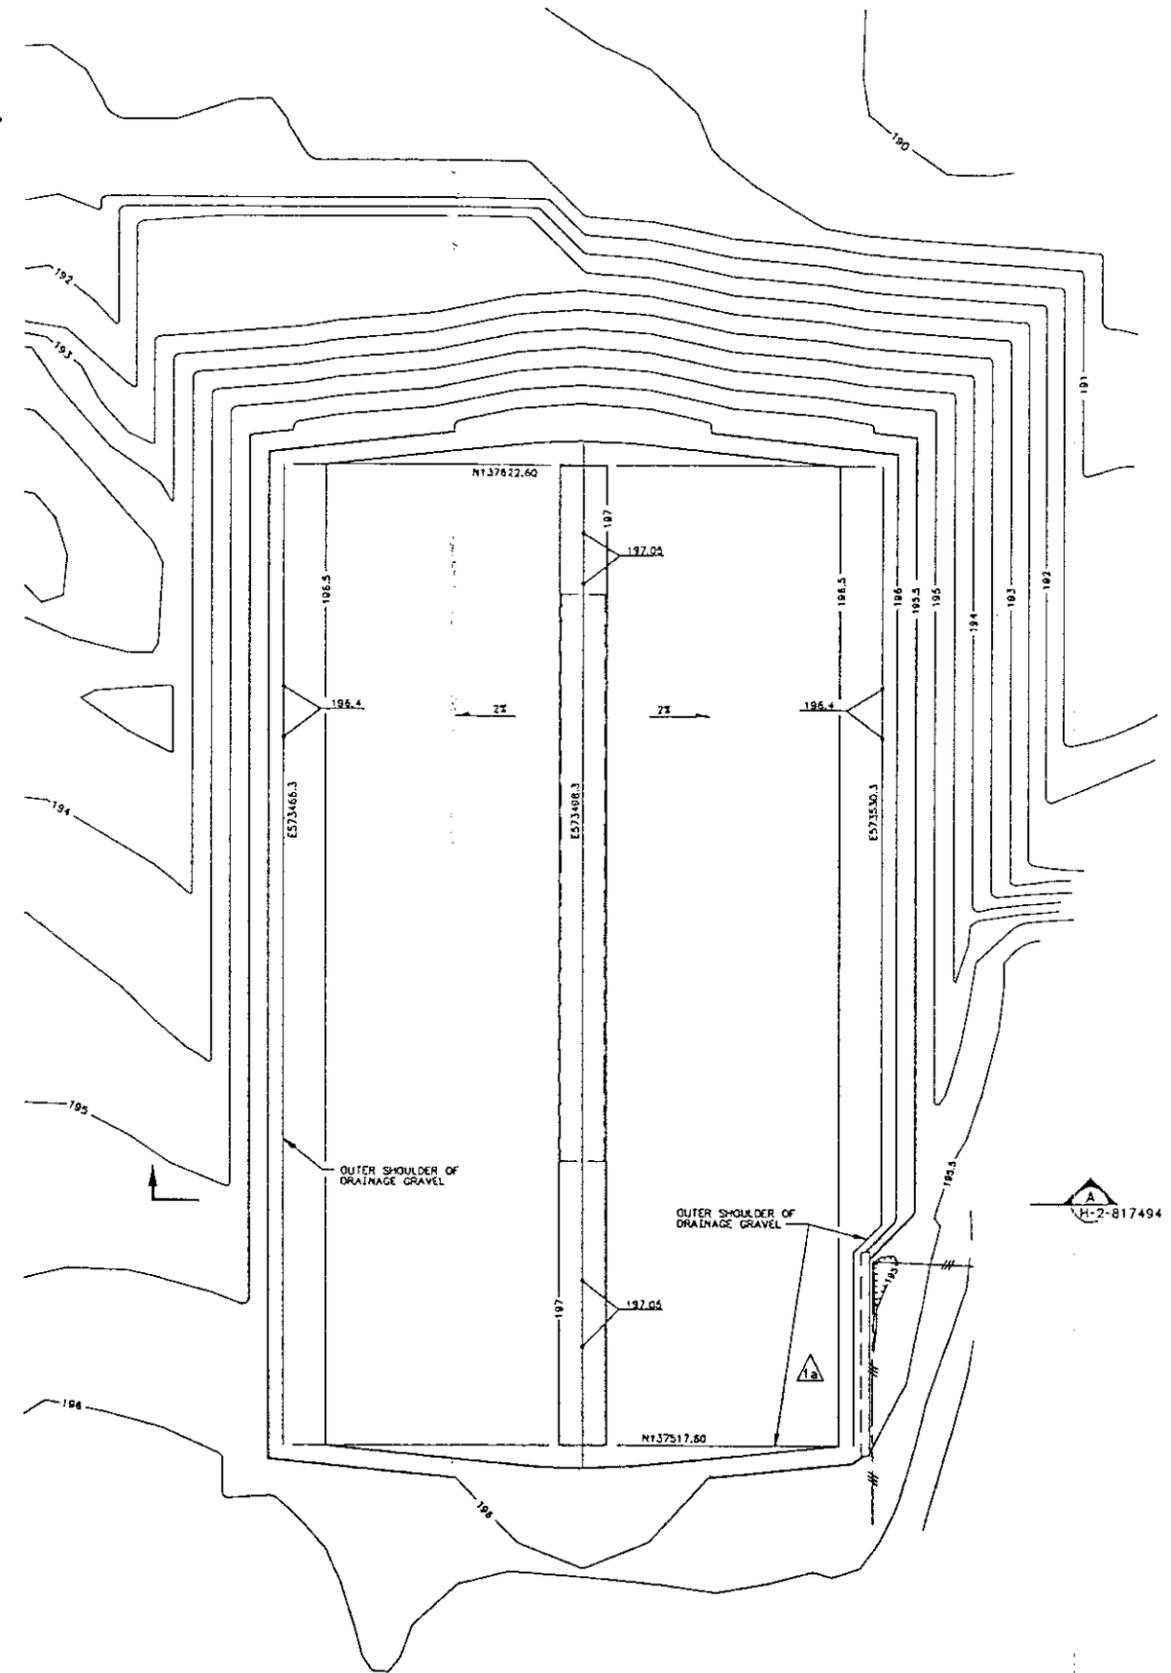
DRAINAGE GRAVEL LAYER
SCALE = 1:300

NOTE:
FINISH FRACTURED BASALT TO THE ELEVATIONS
AND TOLERANCES SHOWN BY SPREADING SHOULDER
BALLAST OVER ALL BASALT SURFACES EXCEPT OUTSIDE
EASTERN SLOPE FACE. TOLERANCES FOR TOP OF
BASALT SHALL BE ±0.10 METER.

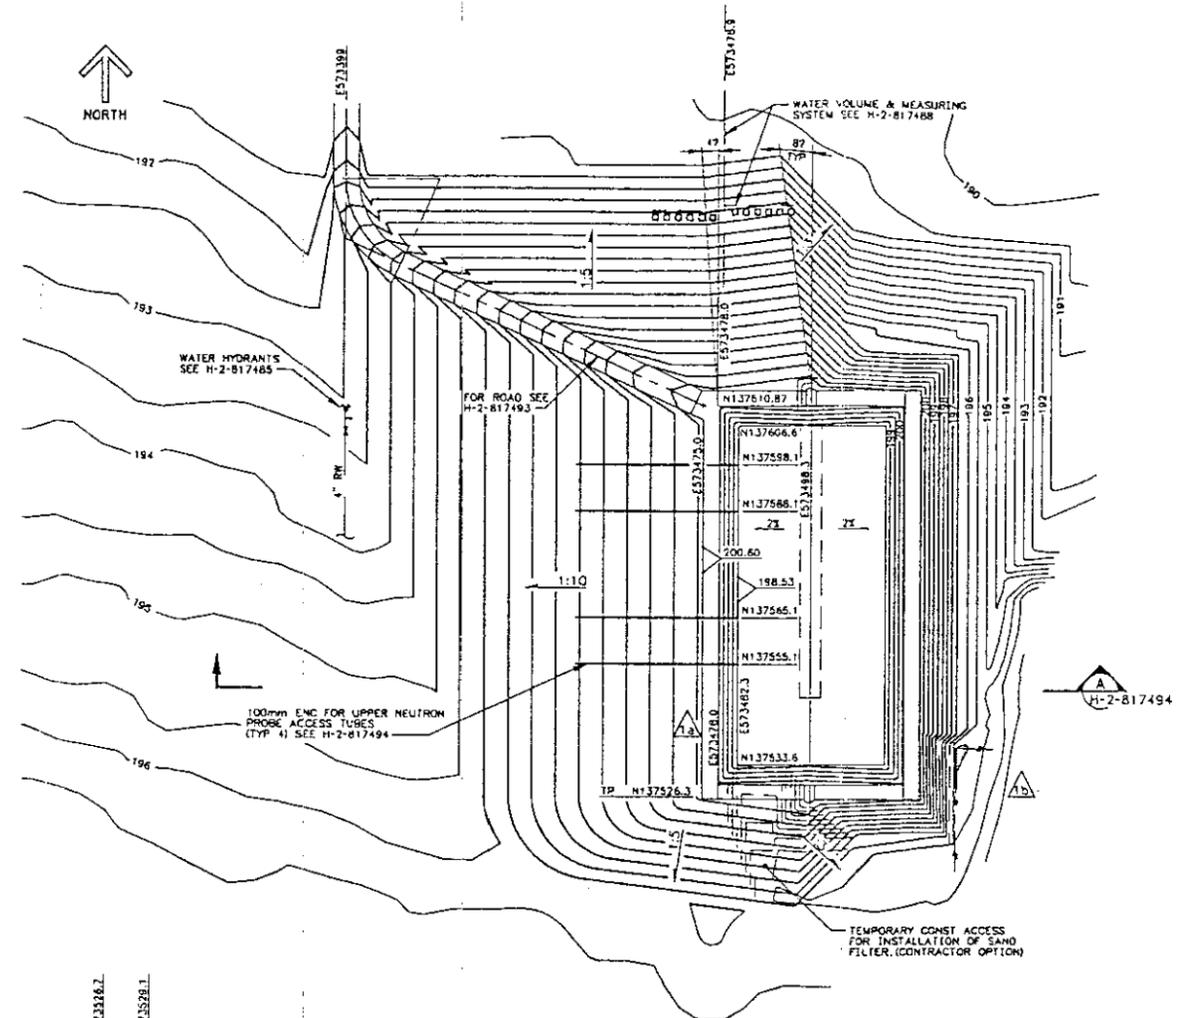
CLEAN FILL SIDE SLOPE
SCALE = 1:600

NOTE: AT CONTRACTOR OPTION PLACEMENT OF CLEAN FILL SIDE SLOPE MAY BE STAGED BY PROVIDING A BENCH AT THE SILT LAYER INTERFACE FROM WHICH TO PLACE THE SILT. (i.e. ELEV 199.85)

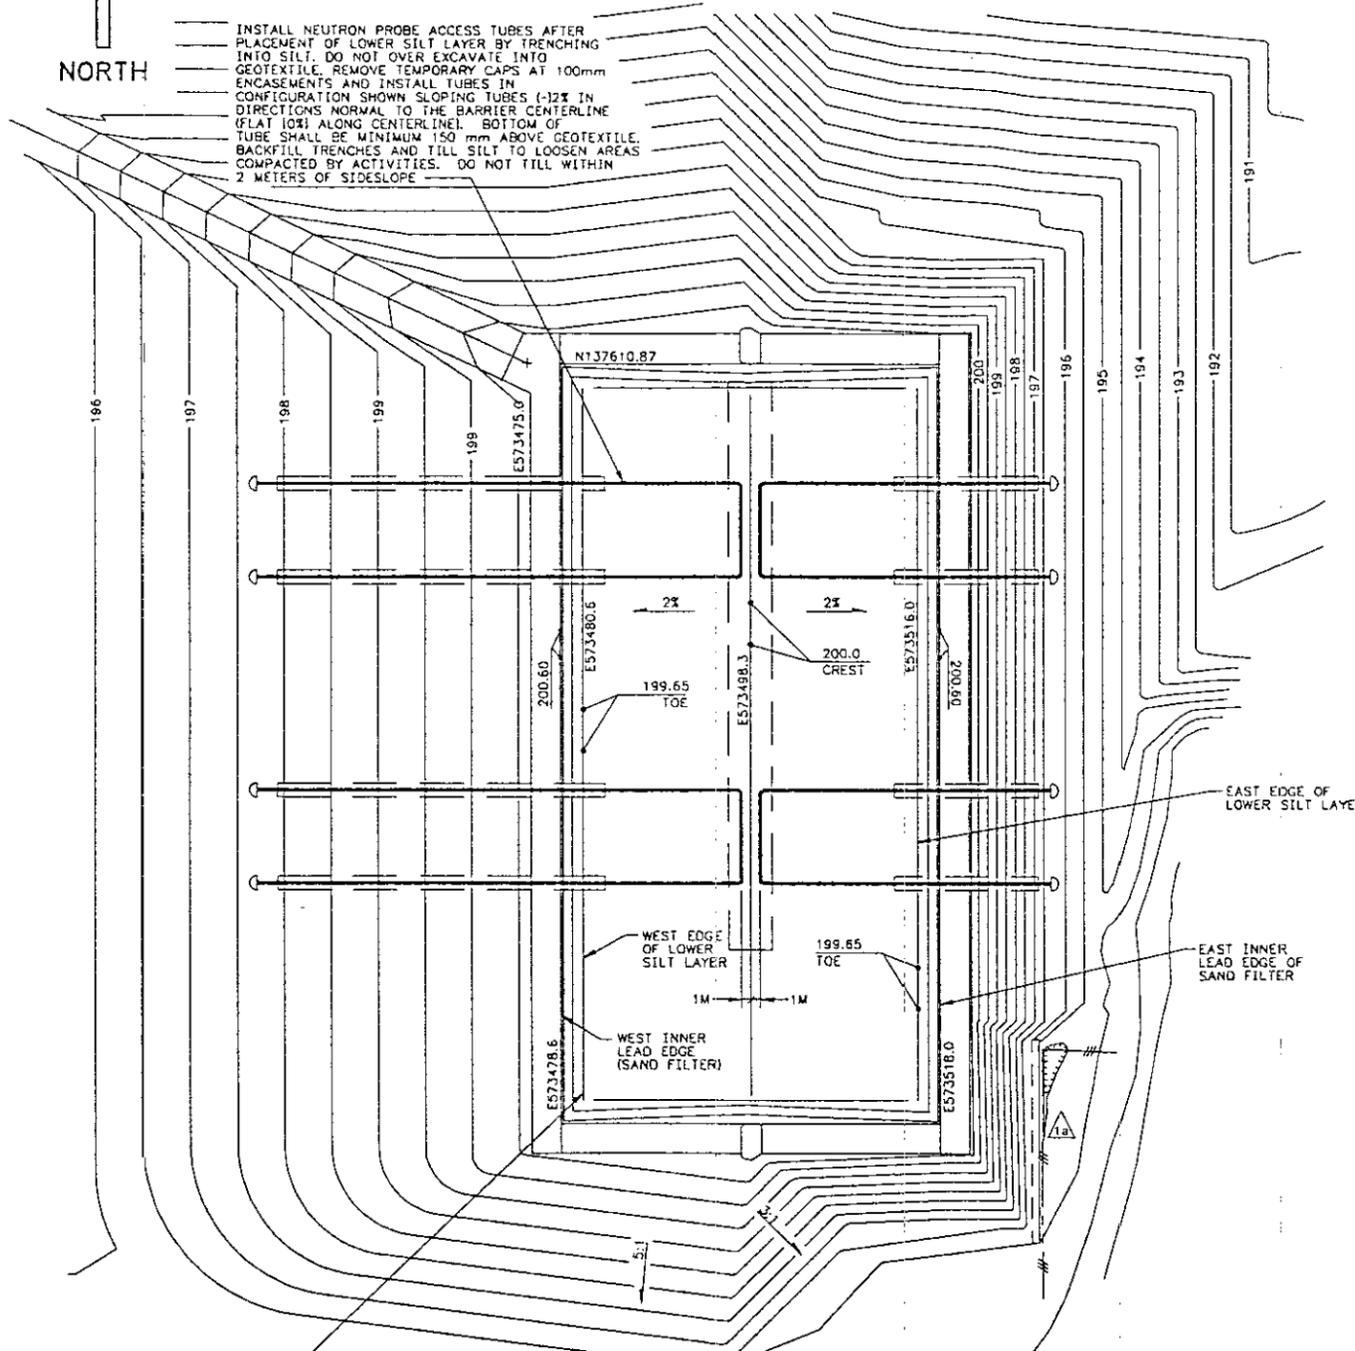
LOWER SILT LAYER
SCALE = 1:300

INSTALL NEUTRON PROBE ACCESS TUBES AFTER
PLACEMENT OF LOWER SILT LAYER BY TRENCHING
INTO SILT. DO NOT OVER EXCAVATE INTO
GEOTEXTILE. REMOVE TEMPORARY CAPS AT 100mm
ENCASEMENTS AND INSTALL TUBES IN
CONFIGURATION SHOWN SLOPING TUBES (1:2% IN
DIRECTIONS NORMAL TO THE BARRIER CENTERLINE
(FLAT 10% ALONG CENTERLINE). BOTTOM OF
TUBE SHALL BE MINIMUM 150 mm ABOVE GEOTEXTILE.
BACKFILL TRENCHES AND TILL SILT TO LOOSEN AREAS
COMPACTED BY ACTIVITIES. DO NOT TILL WITHIN
2 METERS OF SIDESLOPE

PLACE LOWER SILT LAYER
IN A SINGLE LIFT BY
DUMPING OVER WEST LEAD
EDGE AND SHAPING BY
BULLDOZER - DO NOT DRIVE
RUBBER TIRED VEHICLES
OVER SILT LAYERS

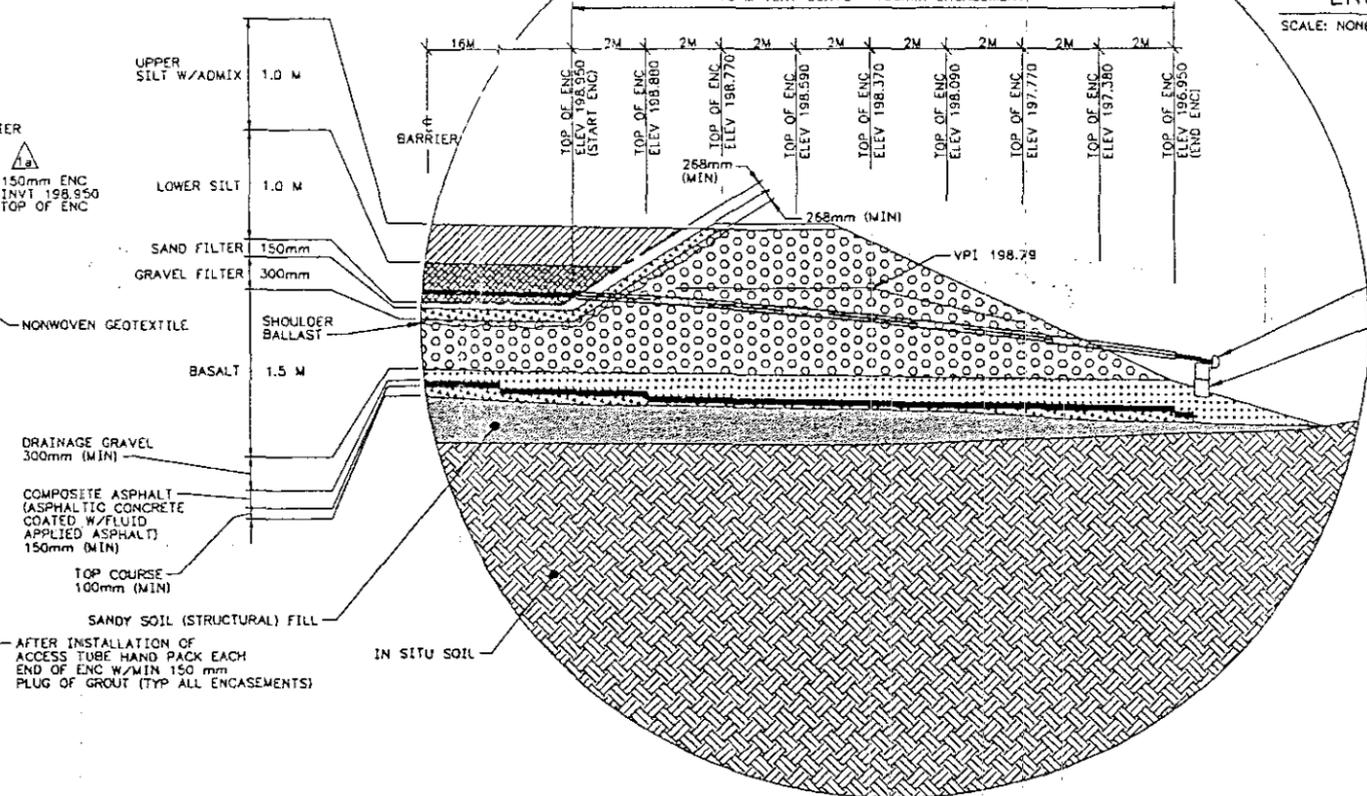
DETAIL
SCALE = 1:75

65mm SOG PVC PIPE CAP (TYP EA END)
STACK CONCRETE BLOCKS (8 x 8 x 16 CMU) TO PROVIDE SUPPORT (TYP)

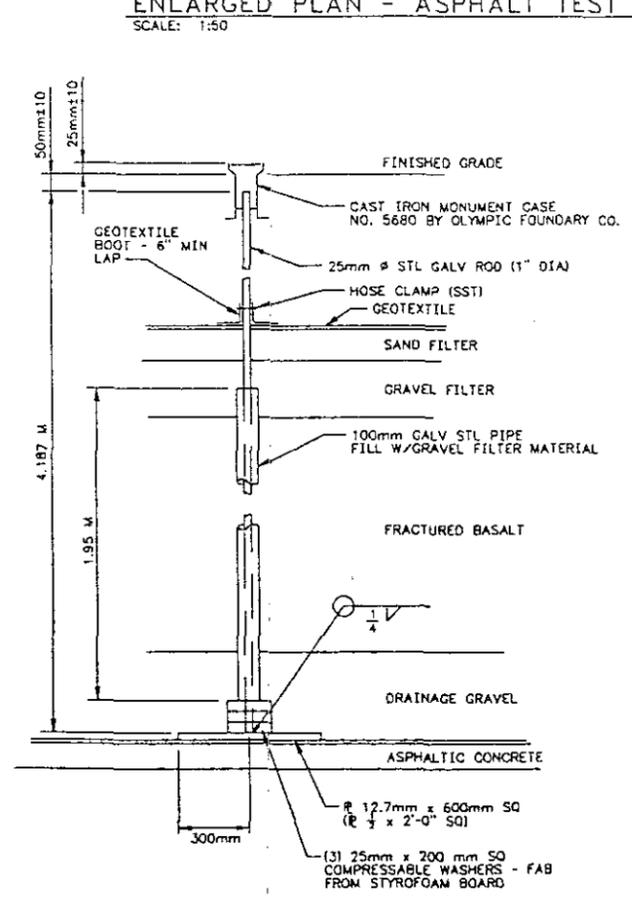
ENLARGED PLAN - SUBSIDENCE POSTS
SCALE: NONE

NOTE: MAINTAIN POST PLUMB WITHIN 1 CM/METER DURING ALL CONSTRUCTION ACTIVITIES

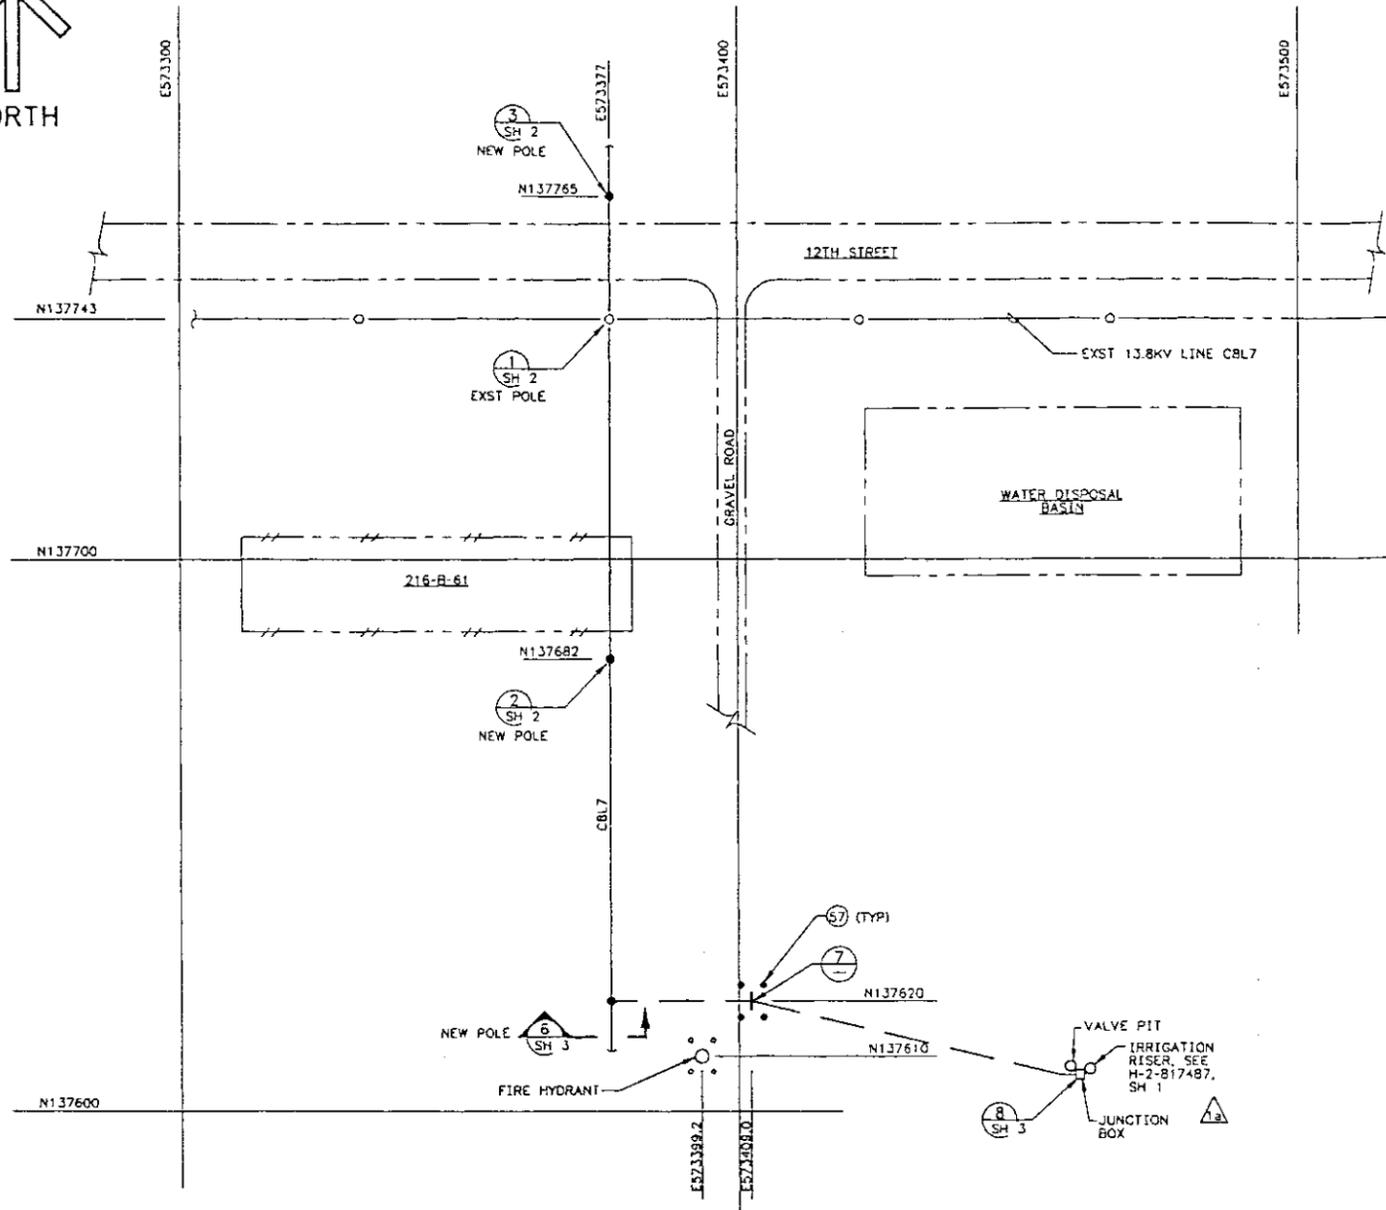
SITE PLAN
SCALE: 1+500 (METRIC)

STRINGING SAG & TENSION CHART
RULING SPAN LENGTH = 203 FEET

AMBIENT TEMPERATURE °F									
	0°	15°	30°	45°	60°	75°	90°	105°	120°	
SAG(Ft)	3.1	3.4	3.6	3.9	4.1	4.3	4.5	4.8	5.0	
TENSION (LB)	133	123	115	108	101	96	92	88	84
