ENGINEERING DATA TRANSMITTAL

15. DATA TRANSMITTED					(F)	(G)	(H)	(I)
(A) Item No.	(B) Document/Drawing No.	(C) Sheet No.	(D) Rev. No.	(E) Title or Description of Data Transmitted	Impact Level	Reason for Transmittal	Originator Disposition	Receiver Disposition
1	WHC-SD-EN-TI-239		0	100-K Area Technical Baseline Report	NA	1/2	1

Title 100-K Area Technical Baseline Report			Unclassified Category UC-	Impact Level 4
New or novel (patentable) subject matter? <input checked="" type="checkbox"/> No <input type="checkbox"/> Yes If "Yes", has disclosure been submitted by WHC or other company?		Information received from others in confidence, such as proprietary data, trade secrets, and/or inventions?		
<input type="checkbox"/> No <input type="checkbox"/> Yes Disclosure No(s).		<input checked="" type="checkbox"/> No <input type="checkbox"/> Yes (Identify)		
Copyrights? <input checked="" type="checkbox"/> No <input type="checkbox"/> Yes If "Yes", has written permission been granted?		Trademarks?		
<input type="checkbox"/> No <input type="checkbox"/> Yes (Attach Permission)		<input checked="" type="checkbox"/> No <input type="checkbox"/> Yes (Identify)		
Complete for Speech or Presentation

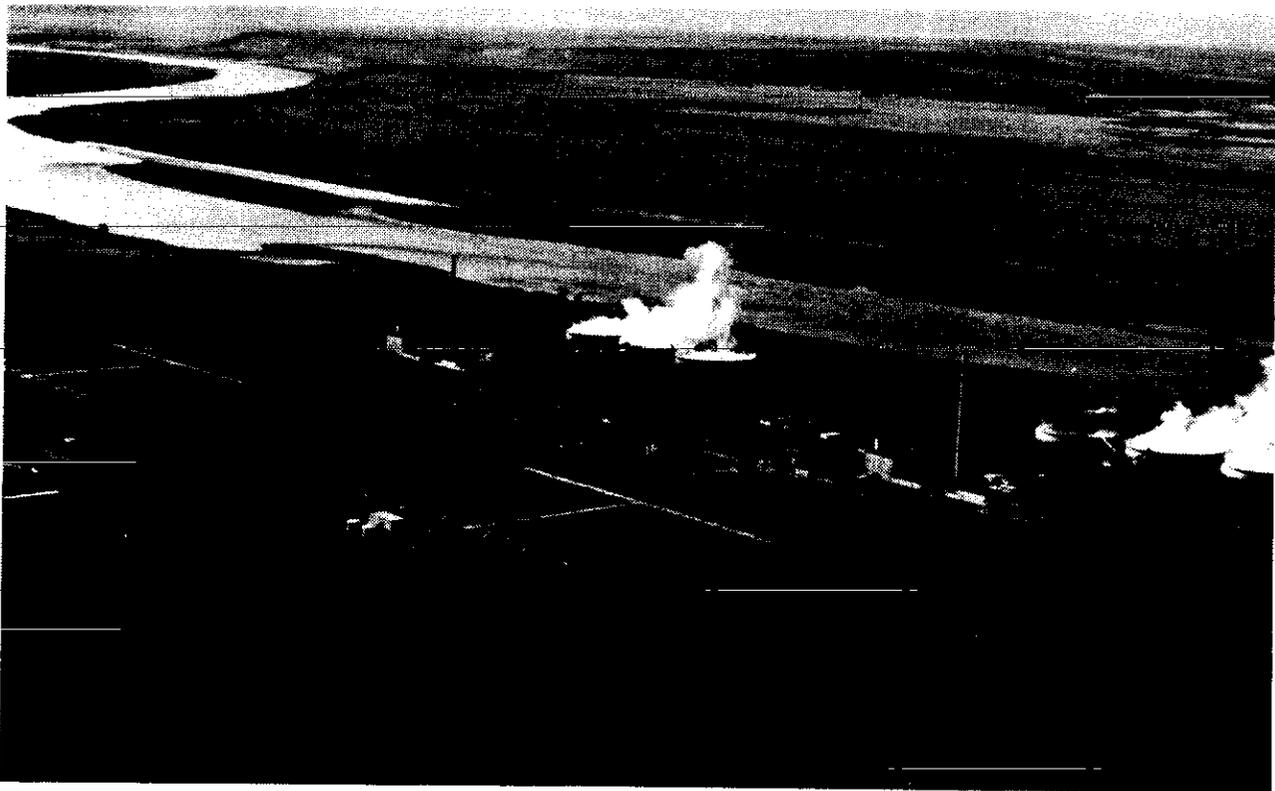
Figure 2-1. 100-K Area, March 1, 1962.

Nine water-cooled, graphite moderated, plutonium production reactors were constructed by the U.S. Government along the Columbia River at the Hanford Site between 1943 and 1963. All nine are owned by the U.S. Government and are managed by the DOE. The reactors are retired from service and have been declared surplus by DOE; all except N Reactor are available for decommissioning at this time (DOE 1989). The 105-KE and 105-KW Reactors are two of these nine (Figure 2-1).

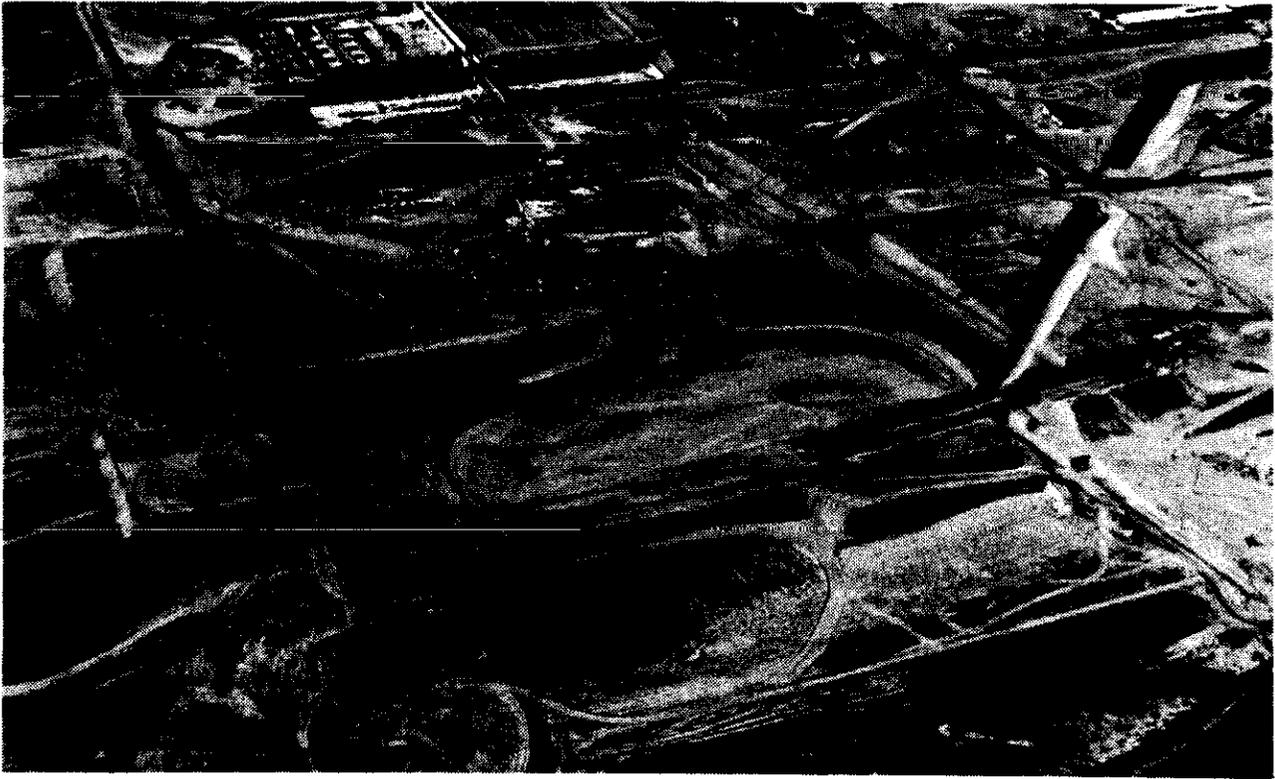
Figure 2-3. 100-K Area During Construction, June 3, 1953.

The 100-KE and 100-KW Reactors were the largest of the reactors built as of that date. The design and construction of all 100-K Area facilities "embodied maximum provision for minimum damage and quick recovery from enemy attack", consistent with a minimum increase in cost (Figures 2-3 and 2-4). Features of this design included:

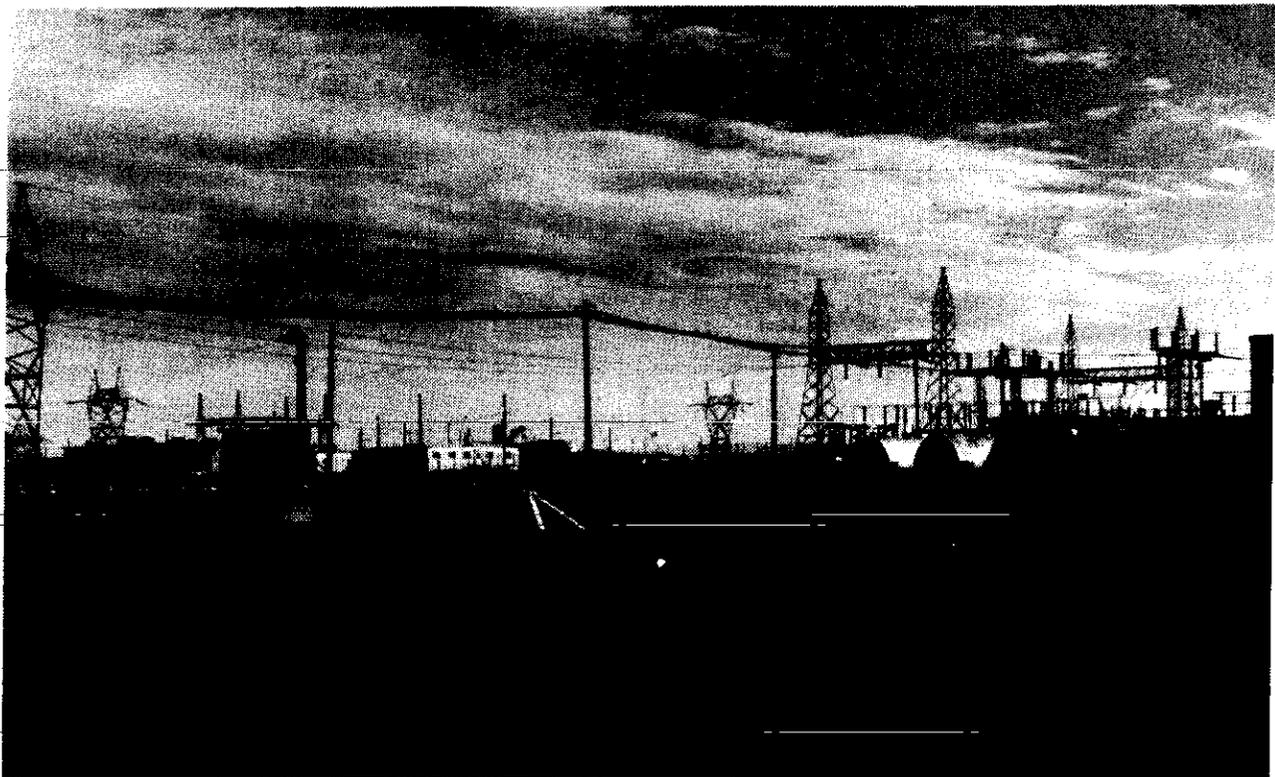
Figure 2-10. Gas Transfer Station and 110-KW Building, December 1993.

The 115-KE and 115-KW Gas Recirculating Facilities provided service to each respective reactor. Their purpose was to provide a closed-loop nonreactive gas environment in the graphite cores that would remove moisture and gases from the cores and serve as a heat transfer medium between the cores and the process tubes.

The system also served to detect water leaks within the reactor cores. A mixture of helium and carbon dioxide and later nitrogen, driven at low pressure by a blower system, was circulated through the graphite piles. Filters, gas coolers, blowers, condensers, and silica gel drying towers were located in each building. The systems maintained gas pressure in the reactors at a slightly positive value with respect to the ventilation air so that outside air could not make contact with the graphite cores. When a leak was detected, the gas was routed to the ventilation exhaust systems. The 115-KW Building (Figure 2-10) included a wing (110-KW Building) that was used for the storage and transfer of gases for both reactors.

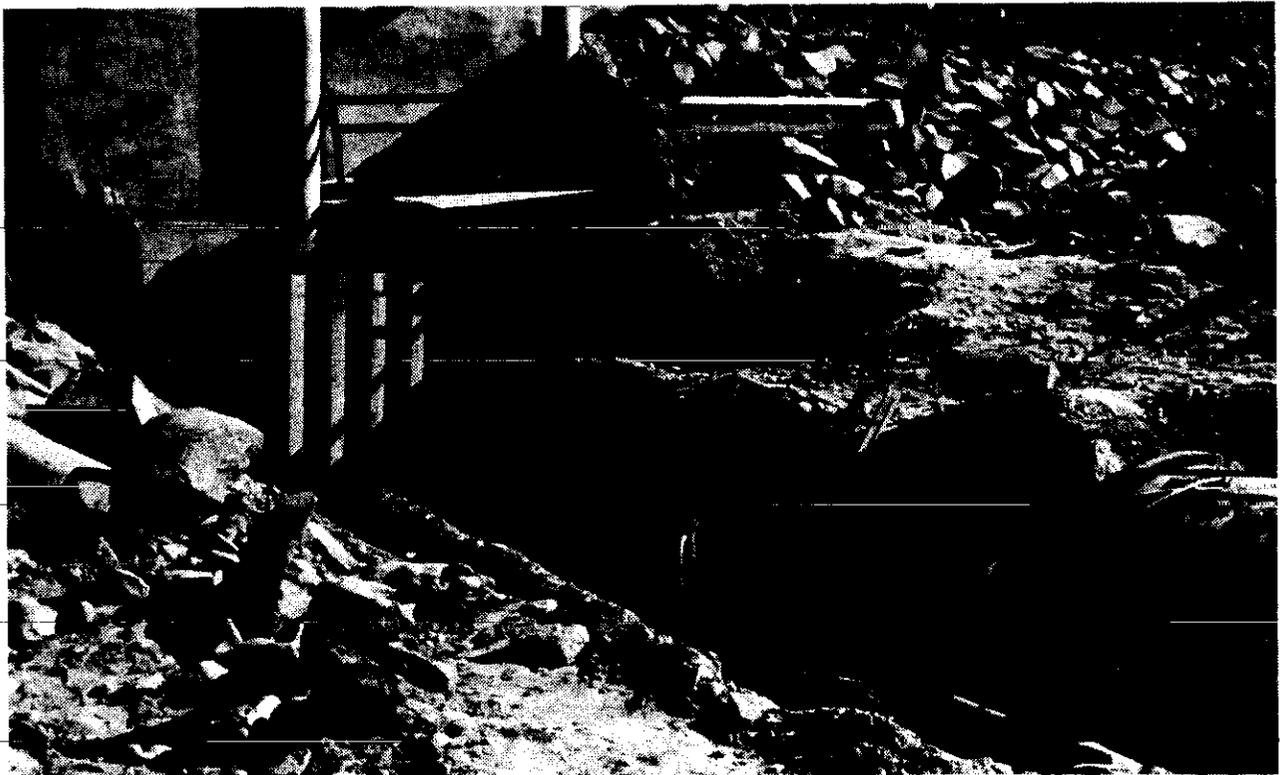
Figure 4-5. Outfall Repair Efforts, 1955.

From the retention basins, the water was transferred through large pipes to the 116-K-3 outfall structure and then into 84-in. pipes that discharged at the bottom center of the Columbia River. Shortly after initial operations, in April 1955 these effluent lines began to float and the top surface of the pipe was observed to rise out of the river to about 1.5 ft above the water surface. The lines failed and the reactors were shutdown until repairs could be made in May of that same year.

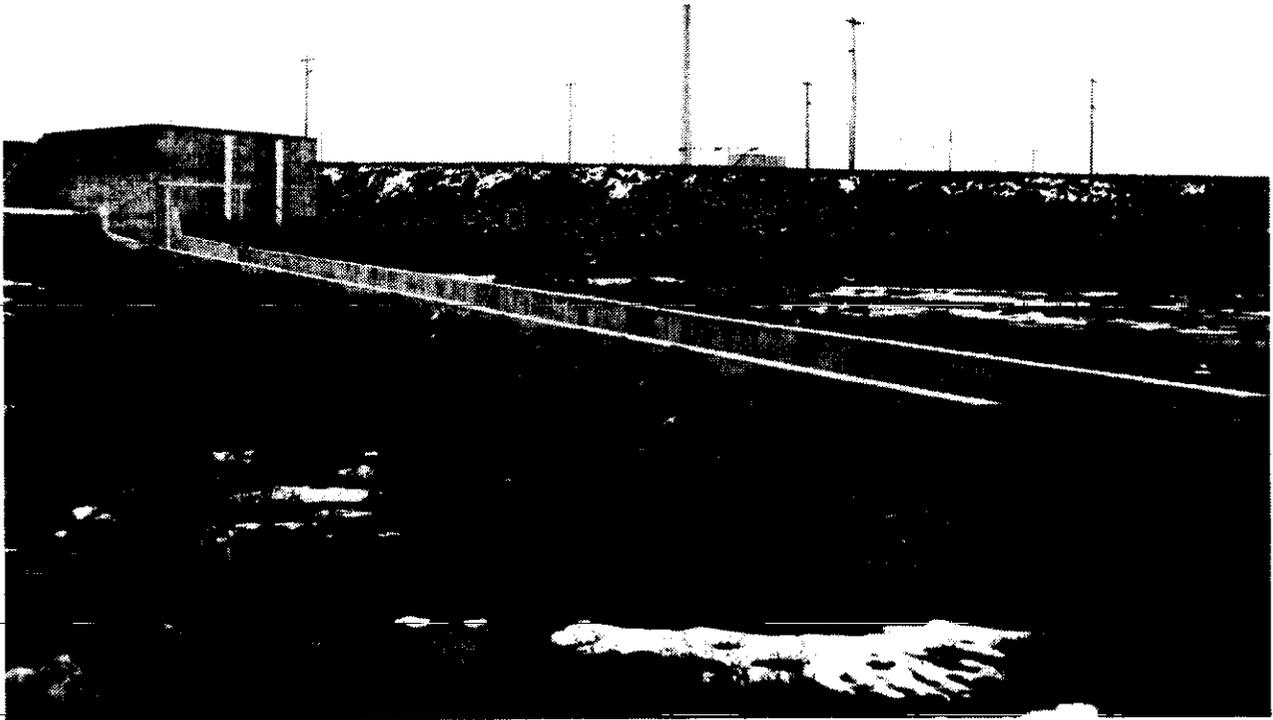
Figure 4-7. 1904-K Outfall, January 25, 1955.

The outfall appears today much the same as it did during reactor operations. It is still used for the discharge process sewer wastes. The spillway remains in place but has been back filled beyond the 8 ft security fence around the outfall structure. Although DOE-RL (1992b) reports that the concrete portions of the spillway were removed, the concrete outfall flume walls have not been removed. They have been covered to grade to their termination point. The soil ditch beyond remains open. In the outfall line, just before the river shoreline, are four vent pipes, approximately 8-in. diameter. The riprap continues on out to the river. The openings to the outfall flume overflows have been covered with wooden box frame and wire mesh aviary covers. The outfall is posted with "Surface Contamination" warning signs.

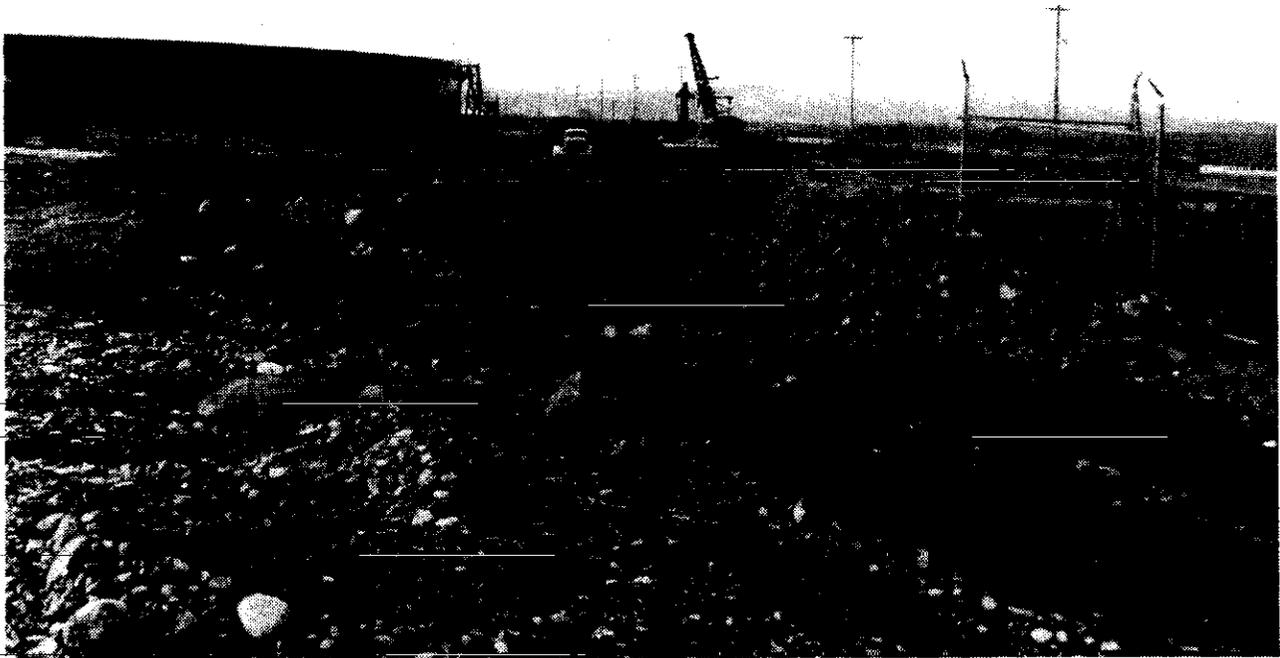
Figure 4-9. 100-K Retention Basin Leach Trench, March 1, 1955.

During reactor operations, the basins frequently developed leaks. The first indications of large leaks occurred before 1965 when extensive ponding reportedly developed between the basins and the road directly to the north. To circumvent this, 2 to 3 ft of fill was placed in this area. Leakage rates were estimated at 10,000 to 20,000 gal/min. The leak rate from the butterfly valves (that went to an adjacent trench) could have been as high as 5,000 to 10,000 gal/min. Cooling water that leaked from the basins flowed over land and under the road by way of a culvert. Refer to Figure 4-9 for a photograph depicting a leach trench for the 107-K retention basins. Because the basins were less than 1,000 ft from the shoreline, effluent leaked to the Columbia River (DOE-RL 1992b and WHC 1991).

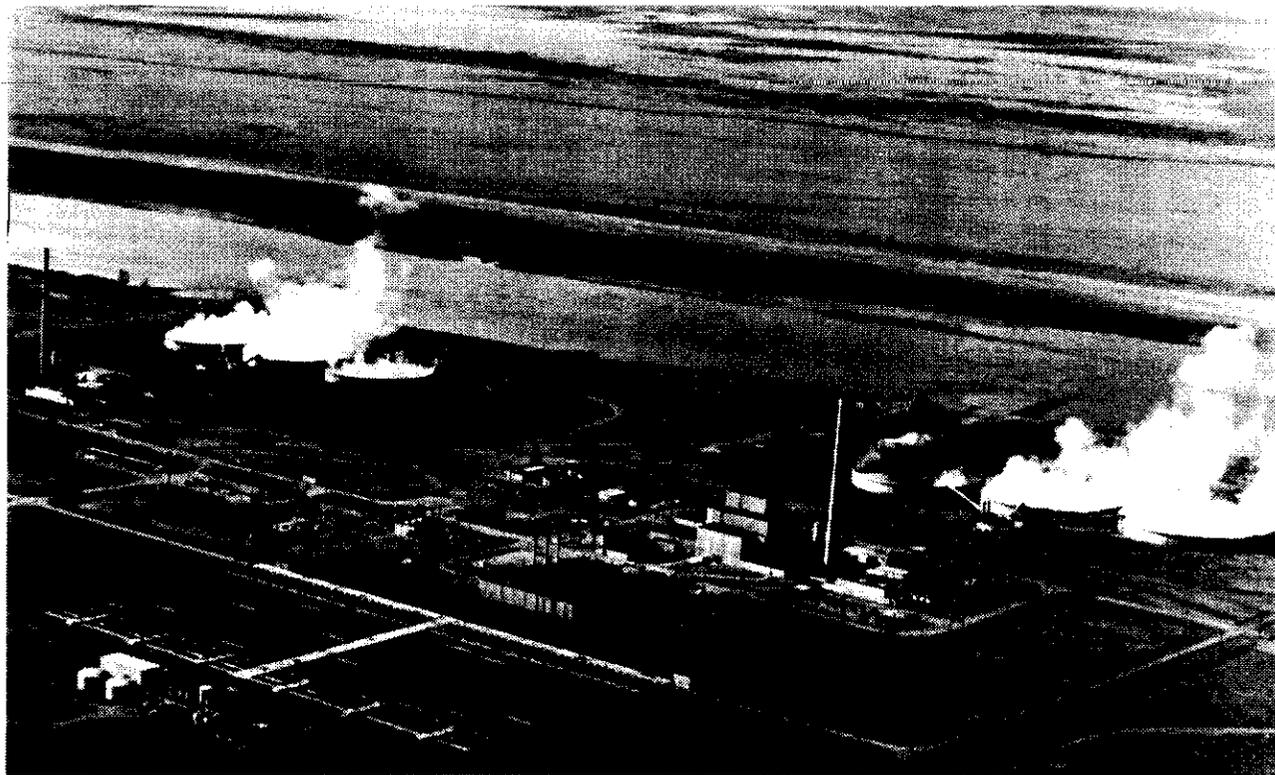
Figure 4-11. 107-KE/KW Retention Basins During Operations, March 1, 1962.

Today, the tanks and piping remain in place and the site appears much as it did during operations with the exception of large diameter openings that were cut in late 1993 for decommissioning activities. The south side of the berms around the basins have been excavated out for entry of heavy equipment through the basin walls. Reportedly, efforts are under way to clean and dismantle the retention basins. The material is to be excessed as clean steel or removed to the 200 Areas for burial. The interior of the basins are covered with about 2 ft of fill material and have sagebrush and other natural vegetation growing on the surface. This site is included in a fenced area that also includes the 107-KE retention basins and is posted with "Surface Contamination" warning signs.

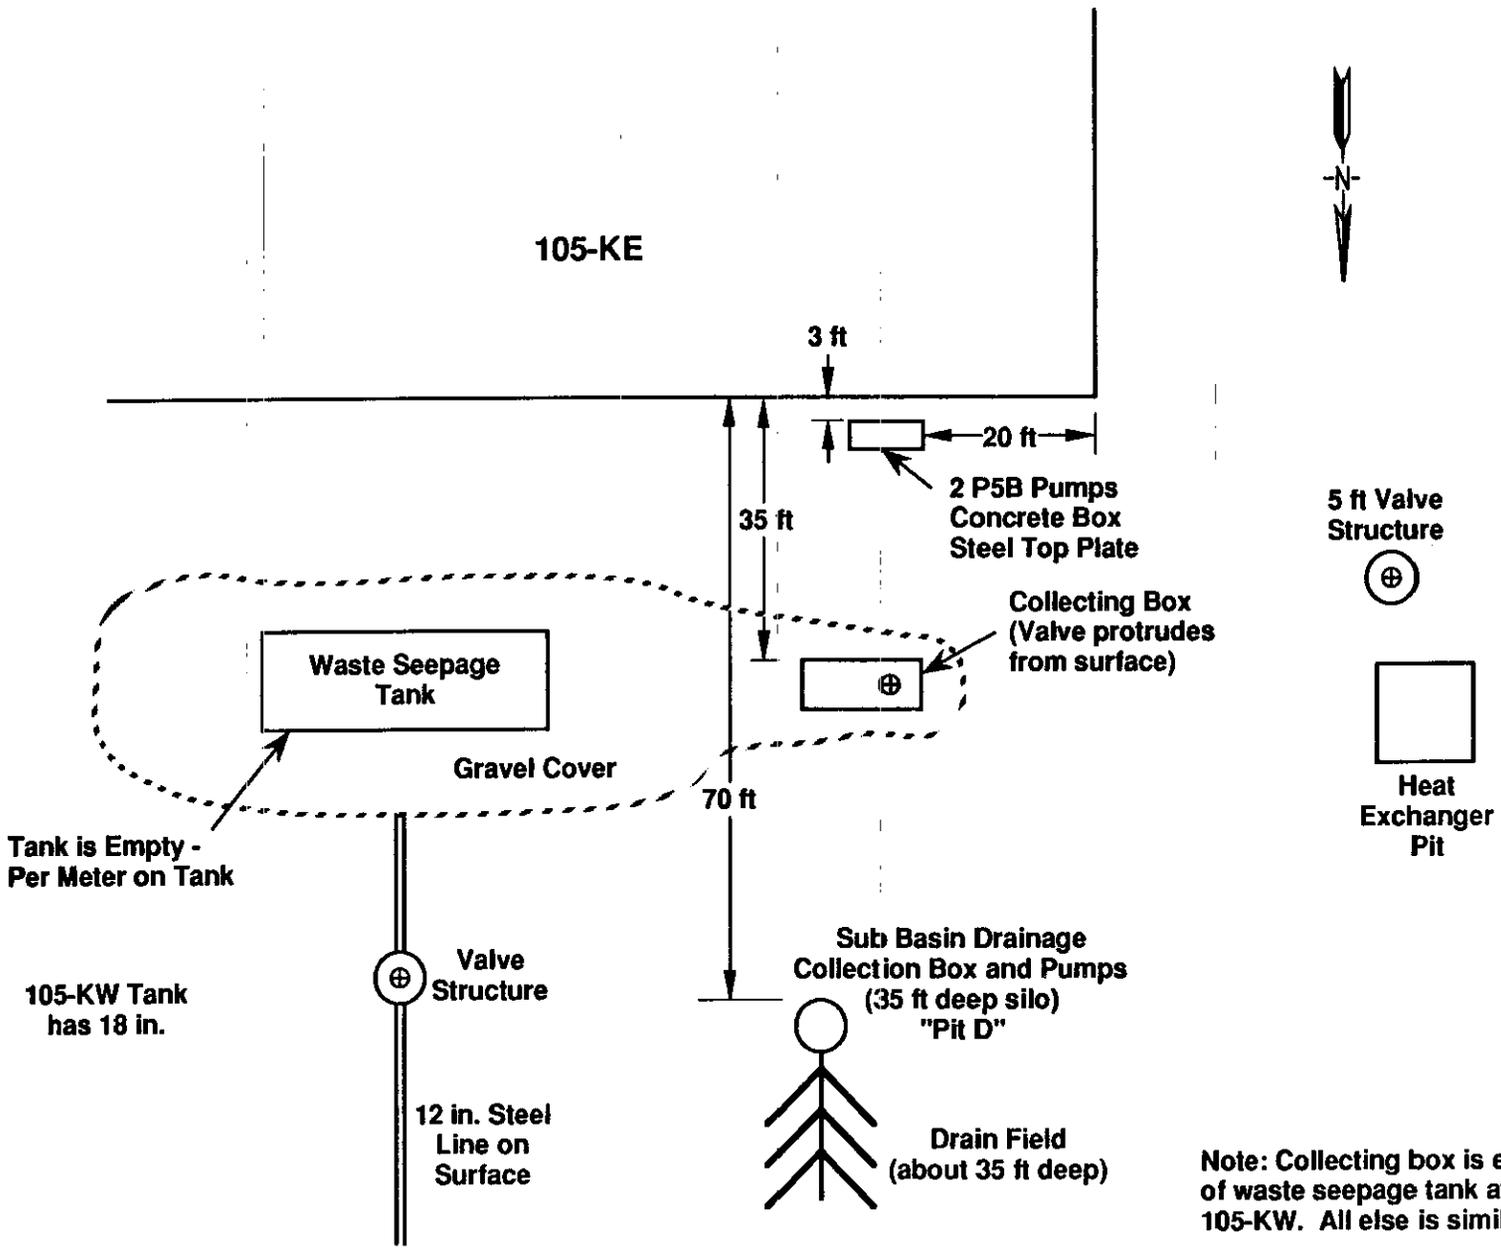
Note: Collecting box is east of waste seepage tank at 105-KW. All else is similar.

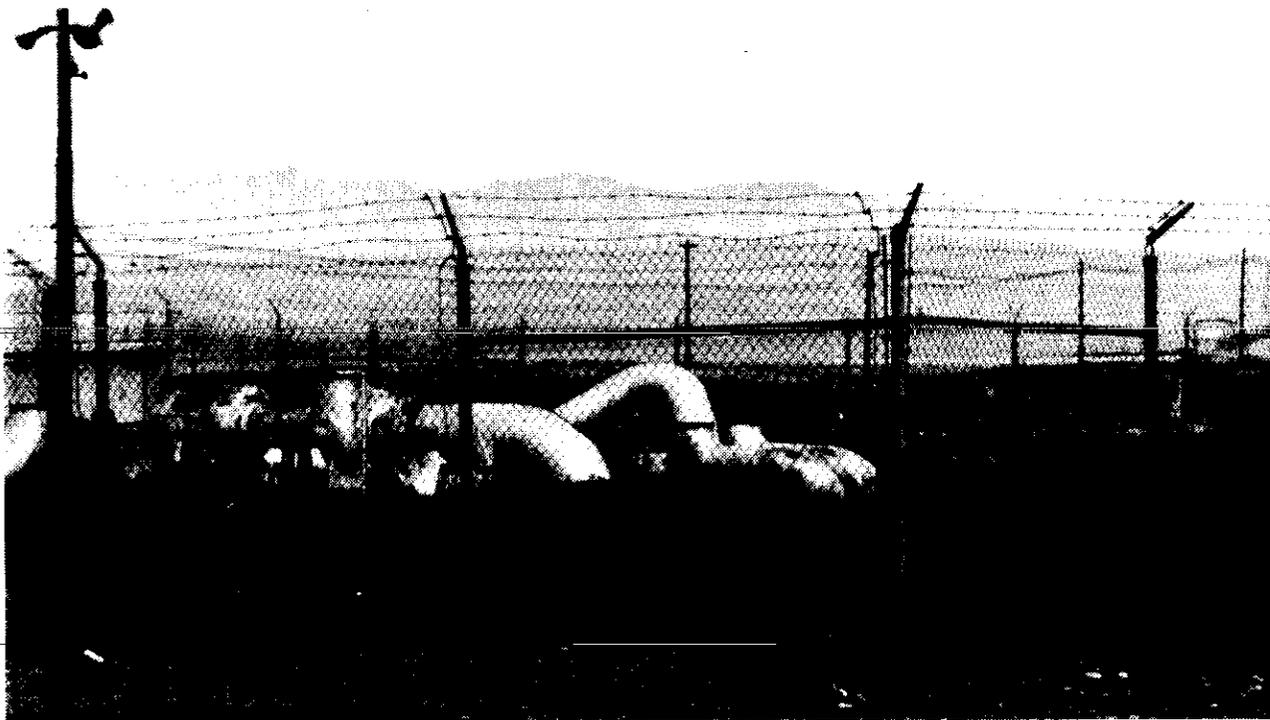
Figure 5-5. 100-K Area Heat Recovery Station.

The facility was constructed on a concrete pad (Figure 5-5), had approximately 945 ft² of space, and consisted of heat exchangers and associated piping (Cramer 1987 and Kiser 1984). Heat was transferred from the reactor cooling water effluent by an ethylene glycol system (see Section 5.11) and piped to 100-K Area buildings to be used for space heating and to heat storage tank solutions at the 183-K facilities (DOE-RL 1992b).

Today, the 116-KE-5 waste site appears much as it did during operations, except the heat exchangers have been removed and are in use in the 150-KE fuel storage facility (WHC 1991). Disconnected piping remains at the site; the ends have been covered with plywood. The entire station is surrounded by an 8-ft chain-link fence posted with "Surface Contamination" warning signs. Natural vegetation grows in all soil areas within the fenced area.

"For the first time in the history of the Hanford Project, waste heat from an atomic reactor was used" to heat reactor facilities. The heat exchanger systems (Figure 5-5) were inter-tied to provide for the needs of either or both of the reactor facilities. The heating medium consisted of a 34% ethylene glycol-water solution. The glycol solution was maintained at a "substantially higher pressure" than the cooling water effluent stream to preclude the possibility of reactor cooling water entering the glycol system (Figure 5-10) (Hale 1957b).

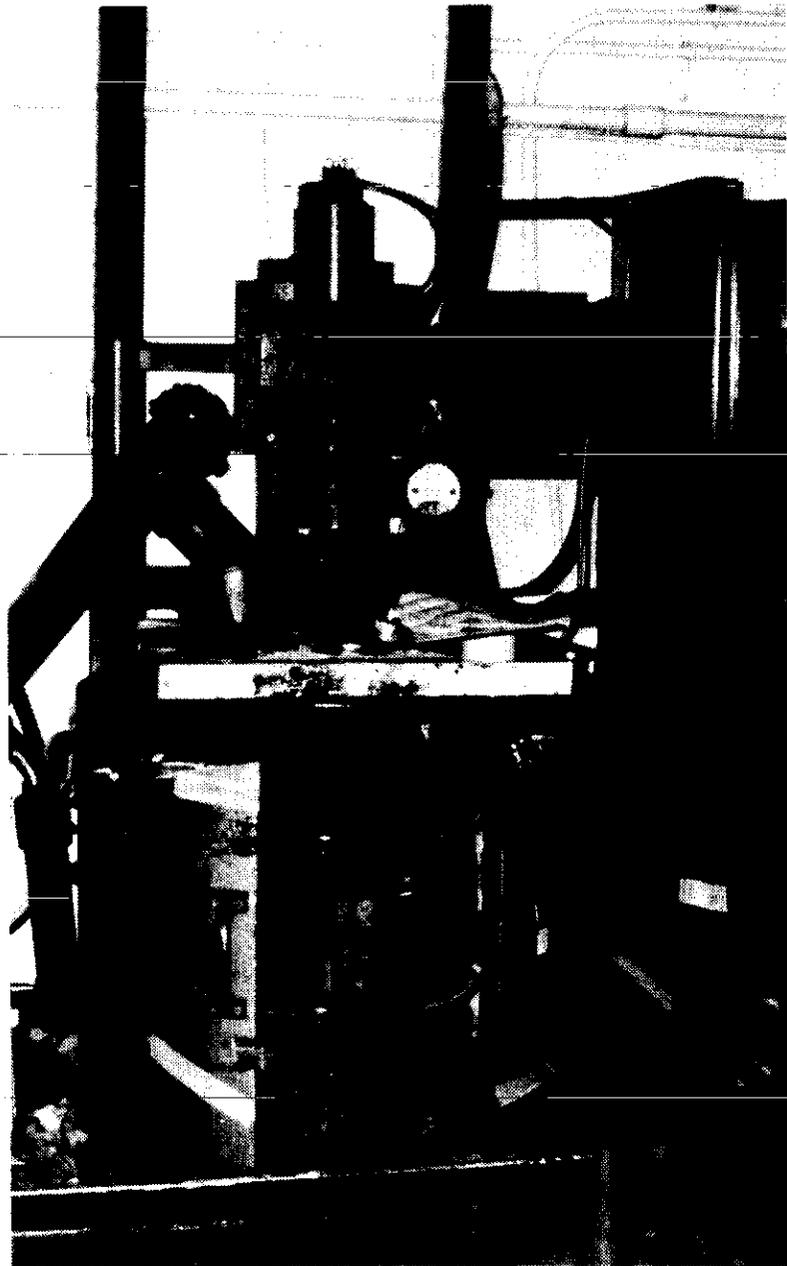
Figure 5-7. 1706-KE Evaporation Tank, January 1994.

In mid 1984, a new system of radioactive waste treatment was initiated that consisted of an evaporation and epoxy encapsulation unit. The new IVRS was attached to the existing radioactive waste treatment system. The system involved transferring wastes that had accumulated in the waste accumulation tank to an ion exchange column and continuously recirculating the waste to remove the ionic constituents from the waste stream. The wastes were then transferred to this 30- to 55-gal (steel drum) evaporation tank, which was heated, allowing the liquid wastes to boil to steam (Figure 5-7). The intent was to solidify the radioactive waste. The steam was condensed and collected in a condensate collection tank described in Section 5.5. Exhaust from the evaporation process was passed through a HEPA filter system prior to discharge (Emory 1994, memo and WHC 1991).

The IVRS was abandoned in late 1984 after experiencing numerous failures (Emory 1994, memo). In mid 1986, an attempt to revive the unit to serve as a mixed waste treatment system for N Reactor effluents was initiated. This, however, resulted in a fire on August 18, 1986 and the subsequent forcible ejection of approximately 30-gal waste material from the treatment unit. The system was permanently shutdown. The ejected waste material was cleaned up and packaged for low-level burial by operations personnel. The area was cleaned to background radiation levels of the immediate vicinity (WHC 1991).

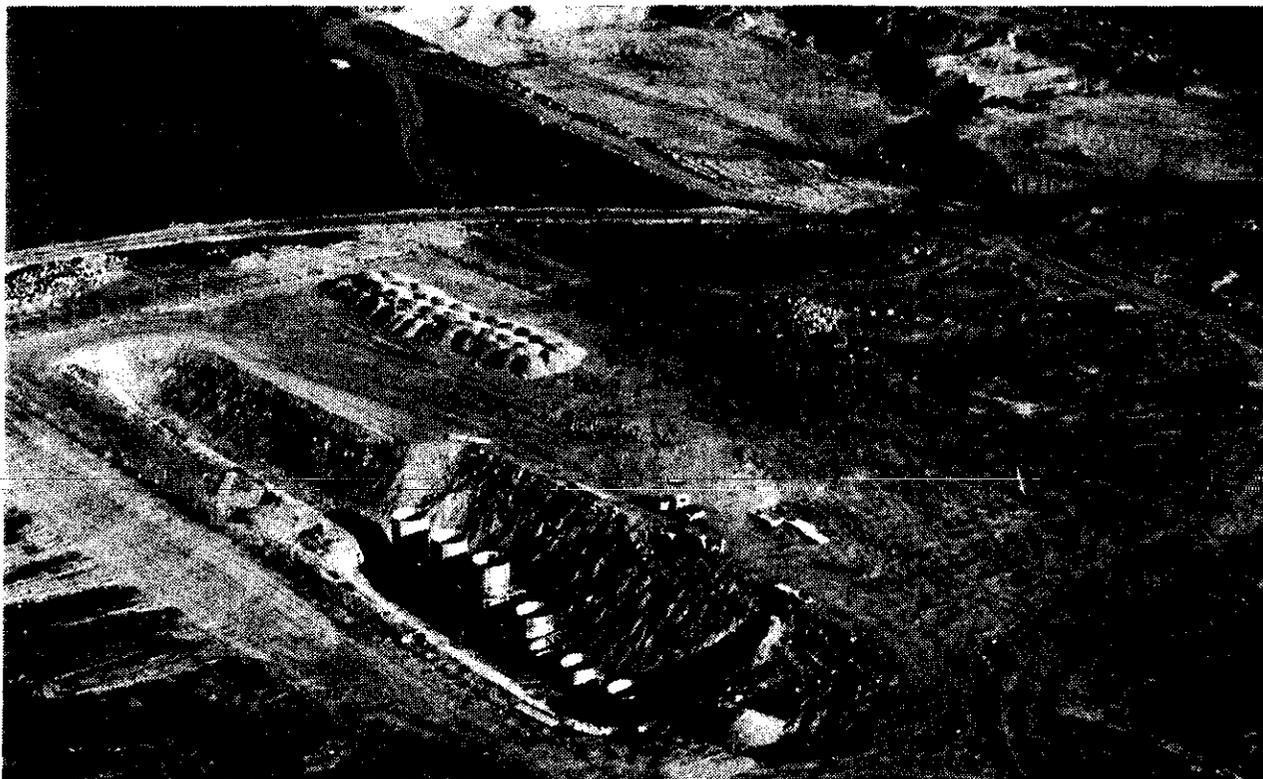
Figure 5-11. 100-K Burial Ground, October 1, 1954.

The 118-K-1 is an inactive solid waste site that operated from 1953 to 1975 (WHC 1991). The burial ground is located at Hanford coordinates N77375 W66991 (corner), which is just outside the east perimeter fence to the 100-K Area, about 800 ft northeast of the 105-KE Reactor Building. The 1,200 by 600 by 20-ft-deep site was used for the disposal of solid wastes generated in the 100-K Area. It is estimated that this burial ground (Figure 5-11) contains an estimated 10,000 m³ of solid wastes.

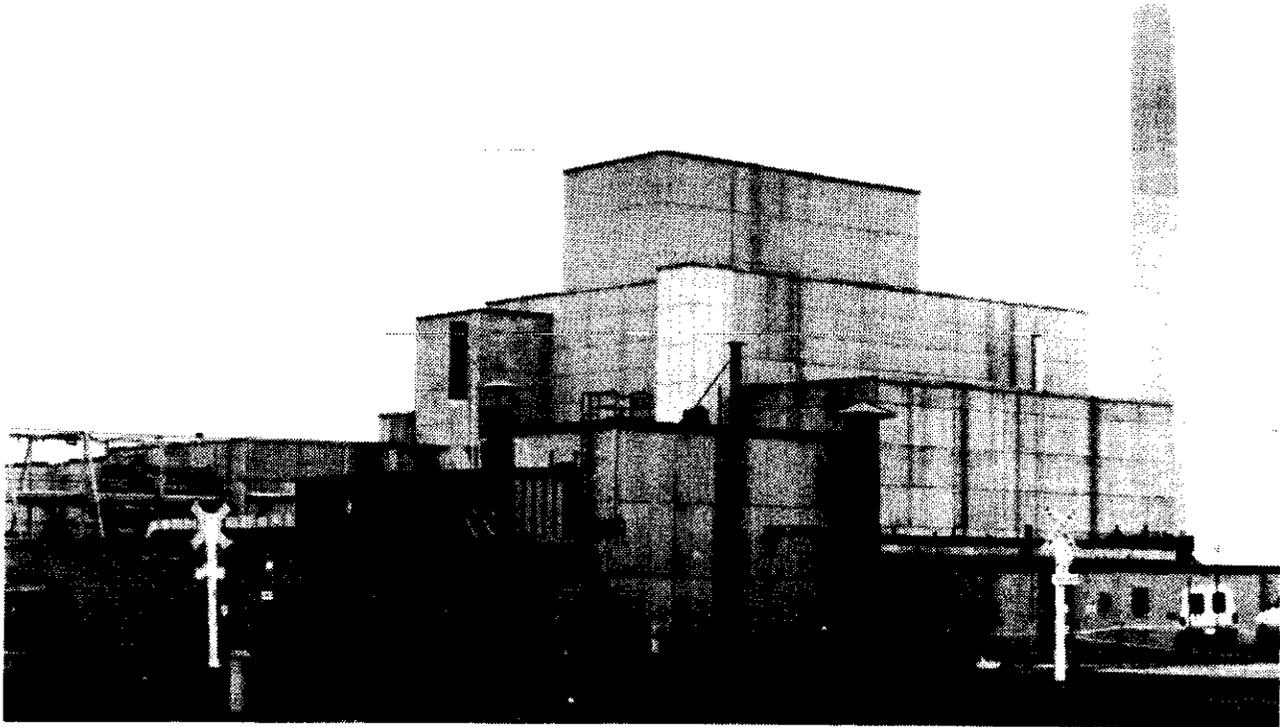
Figure 5-12. 105-KE Reactor, February 1, 1994.

The reactor block consists of a graphite moderator stack encased in cast-iron thermal shielding and a heavy aggregate concrete biological shield, process tubes, and a safety and control system. The block weighs approximately 11,000 tons and measures 44 ft from front to rear, 53 ft from side to side, and 50 ft from top to bottom. The reactor was sealed within a helium-nitrogen gas atmosphere circulated from the respective 115-K facility. The cover, gas, fuel elements, and control systems were removed at the time of deactivation (DOE-RL 1992b).

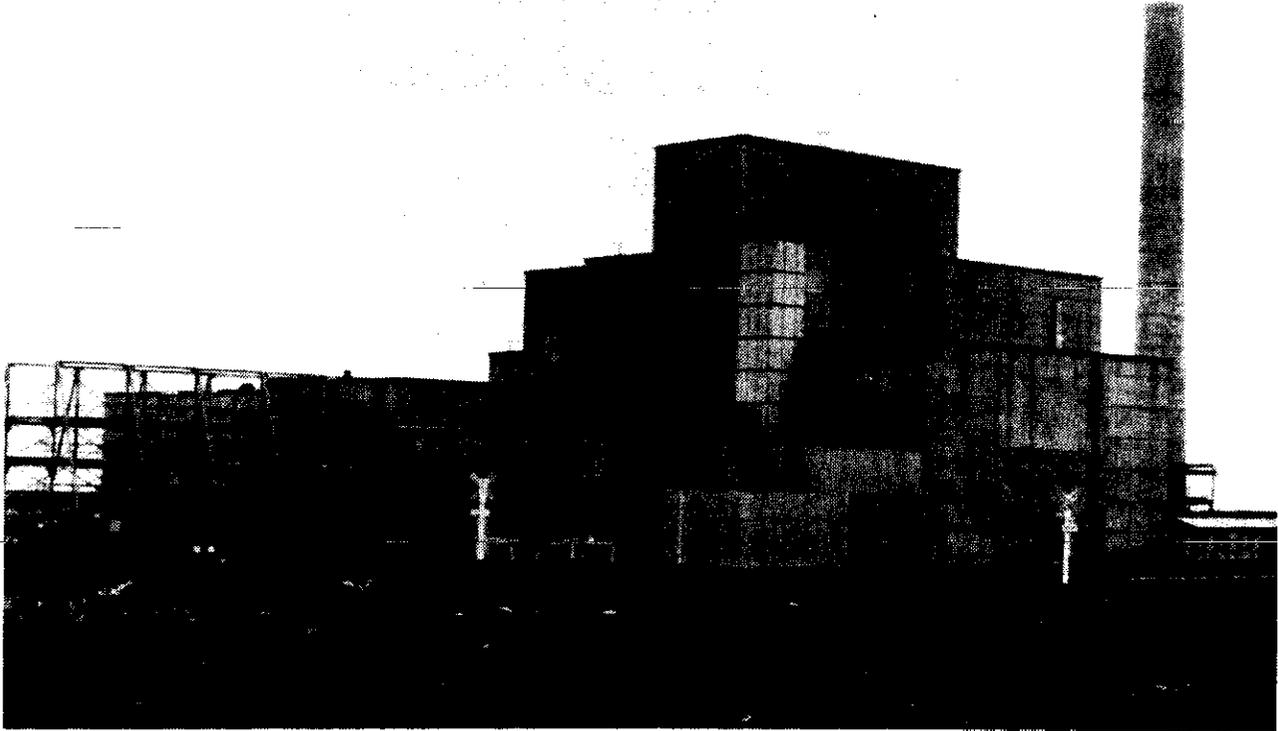
Figure 5-13. 105-KW Reactor, February 1, 1994.

The reactor block consists of a graphite moderator stack encased in cast-iron thermal shielding and a heavy aggregate concrete biological shield, process tubes, and a safety and control system. The block weighs approximately 11,000 tons and measures 44 ft from front to rear, 53 ft from side to side, and 50 ft from top to bottom. The reactor was sealed within a helium-nitrogen gas atmosphere circulated from the respective 115-K facility. The cover, gas, fuel elements and control systems were removed at the time of deactivation (DOE-RL 1992b).

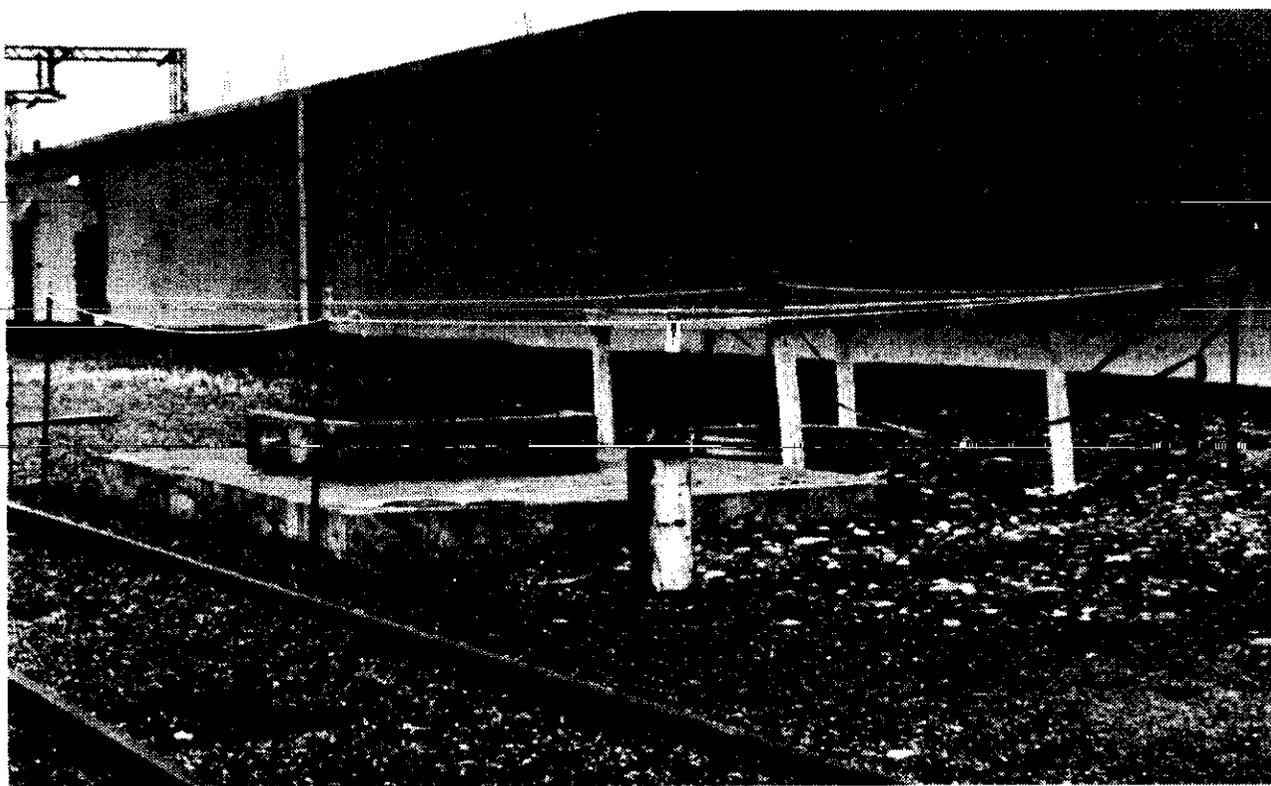
Figure 5-15. 165-KW Brine Pit, February 1, 1994.

This site appears today much as it did during operations. The wooden cover is in poor condition. The pit is surrounded by a light-duty post and yellow rope barricade.

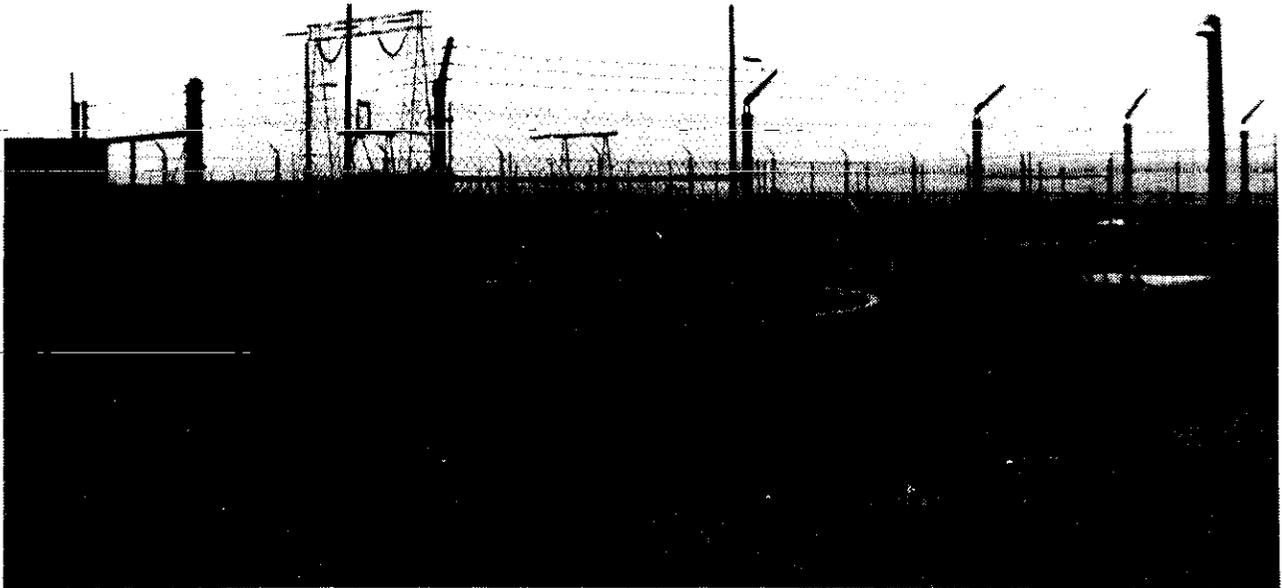
Figure 5-19. Fish Studies Facility - Outside Tanks.

The laboratory consisted of eight 5-ft-long troughs, which a mixture of raw water and heated effluent water was passed through. The water was diverted from the heat exchanger pit, which is described more fully in Section 5.33, on the 105-KE Reactor discharge pipeline. The laboratory was planned in the event of shutdown of the F Reactor and its laboratory. The outdoor tank facilities (Figure 5-19) also included a temporary metal building that was to be used for storage and as a warehouse that remains at the site to this day (Becker 1990).

The facilities located within the 1706-KE Building have been completely dismantled and removed. Today, the outside basins remain in place. They are surrounded by an 8-ft cyclone fence that is posted with "Radiologically Controlled Area" warning signs. The surrounding cobble-covered area has scant sagebrush and vegetation growing on the surface in and around the tanks.

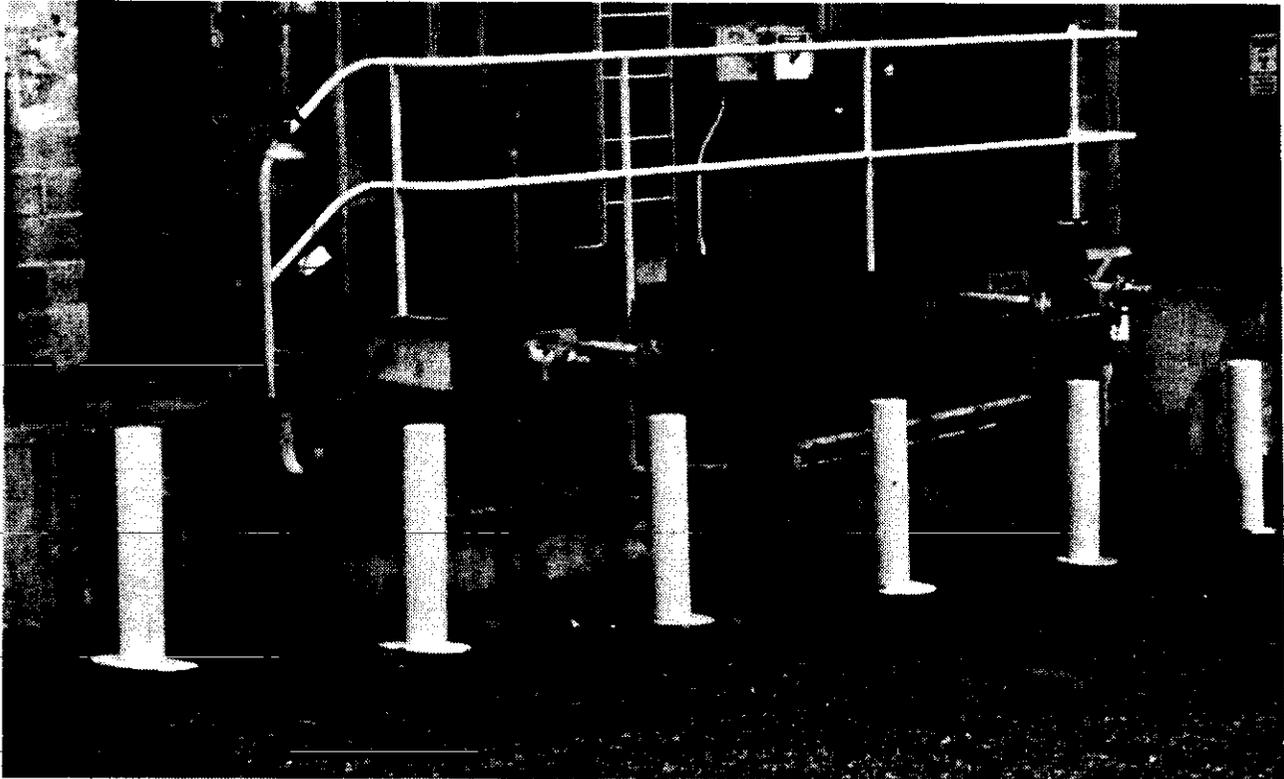
Figure 5-20. Undocumented French Drain - East Side of 1706-KE.

The drain is constructed of an 18-in. vitrified clay pipe that is 4 ft long and buried vertically in the ground. It extends about 3 in. abovegrade and is filled to grade with crushed limestone (Hanford Drawing H-1-33419). Overflow and drain pipes terminate just above the surface of the limestone fill. It is not known if chemical additions were neutralized before disposal to this drain, although it is assumed that they were not.

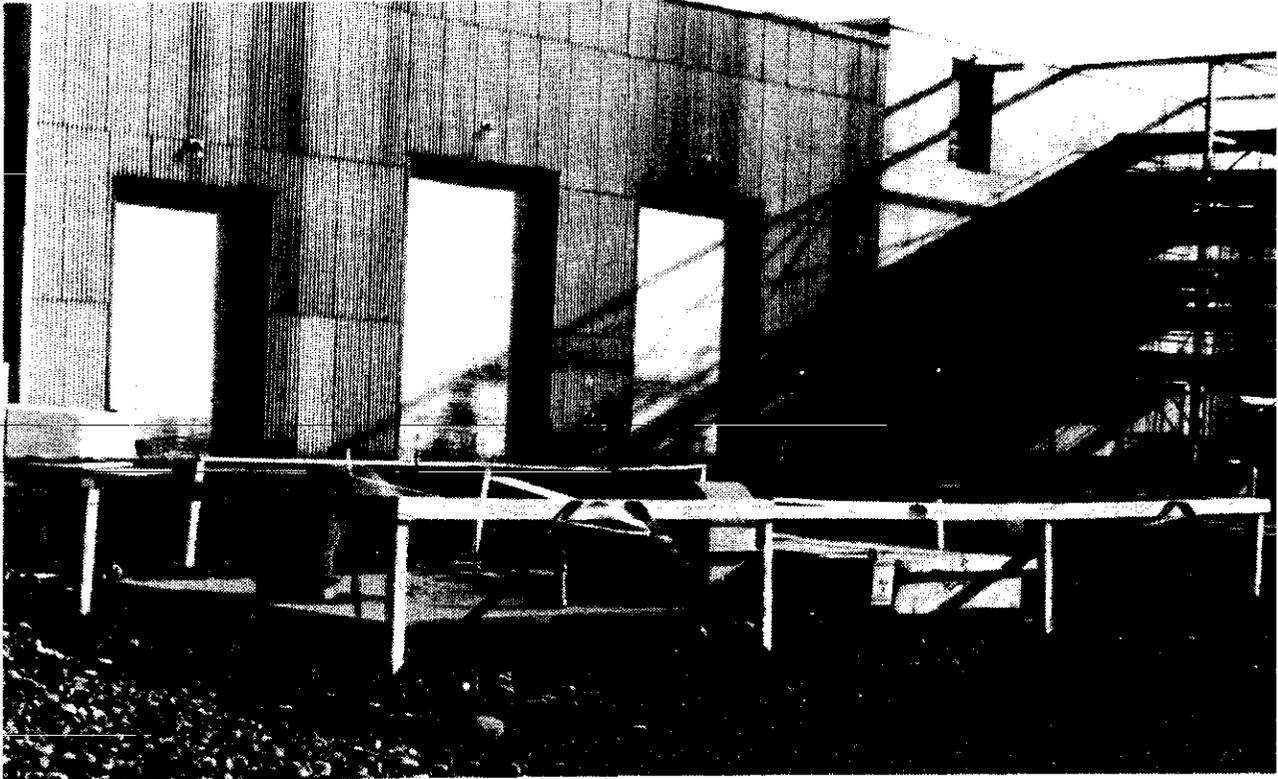
Figure 5-22. 100-KE Heat Exchanger Pit, January 1994.

The heat exchangers were part of the reactor recirculation process tube systems controlled from within the 1706-KE facility. Effluent water in the recirculation tubes was cooled by the heat exchangers. Provisions were made for the drainage of these tubes to the reactor effluent system or to supply the needs of the fish studies laboratory.

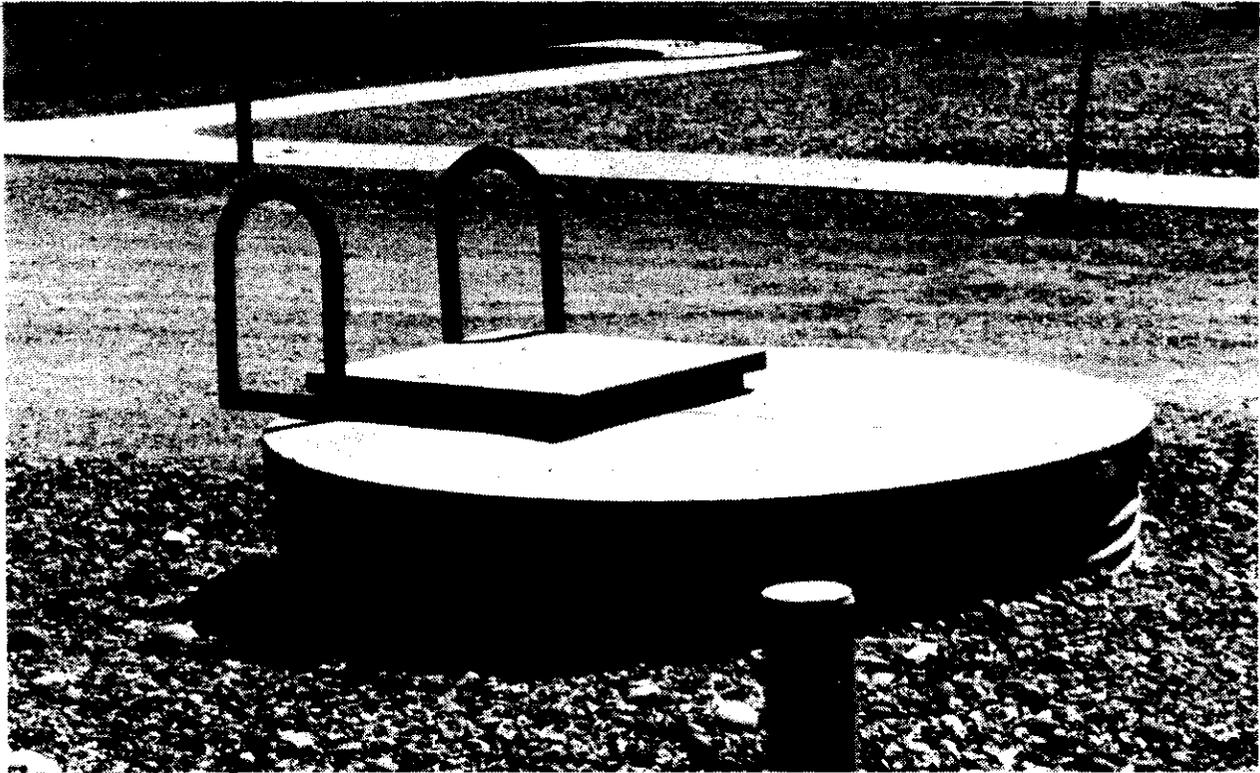
Figure 5-23. Vacuum Pit.

It was found that the pit has a concrete bottom and contains a cyclone separator (Figure 5-24), a vacuum device used to separate solids from the vacuum air stream. Vacuum hoses exit the pit via a small concrete trench with a steel lid located at grade and running due west under the concrete sidewalk and into the Turco pit. The Turco pit is a concrete access pit to the reactor basement and contains a large stainless steel tank. This tank was used to mix Turco decontamination solutions within the reactor facility. Just inside the Turco pit, the vacuum hoses have been cut and sealed with duct tape and radioactive material warning tape.
