ENGINEERING DATA TRANSMITTAL

15. DATA TRANSMITTED					(F)	(G)	(H)	(I)
(A) Item No.	(B) Document/Drawing No.	(C) Sheet No.	(D) Rev. No.	(E) Title or Description of Data Transmitted	Impact Level	Reason for Transmittal	Originator Disposition	Receiver Disposition
1	WHC-SD-EN-TI-239		0	100-K Area Technical Baseline Report	NA	1/2	1

Title 100-K Area Technical Baseline Report			Unclassified Category UC-	Impact Level 4
New or novel (patentable) subject matter? <input checked="" type="checkbox"/> No <input type="checkbox"/> Yes If "Yes", has disclosure been submitted by WHC or other company?		Information received from others in confidence, such as proprietary data, trade secrets, and/or inventions?		
<input type="checkbox"/> No <input type="checkbox"/> Yes Disclosure No(s).		<input checked="" type="checkbox"/> No <input type="checkbox"/> Yes (Identify)		
Copyrights? <input checked="" type="checkbox"/> No <input type="checkbox"/> Yes If "Yes", has written permission been granted?		Trademarks?		
<input type="checkbox"/> No <input type="checkbox"/> Yes (Attach Permission)		<input checked="" type="checkbox"/> No <input type="checkbox"/> Yes (Identify)		
Complete for Speech or Presentation

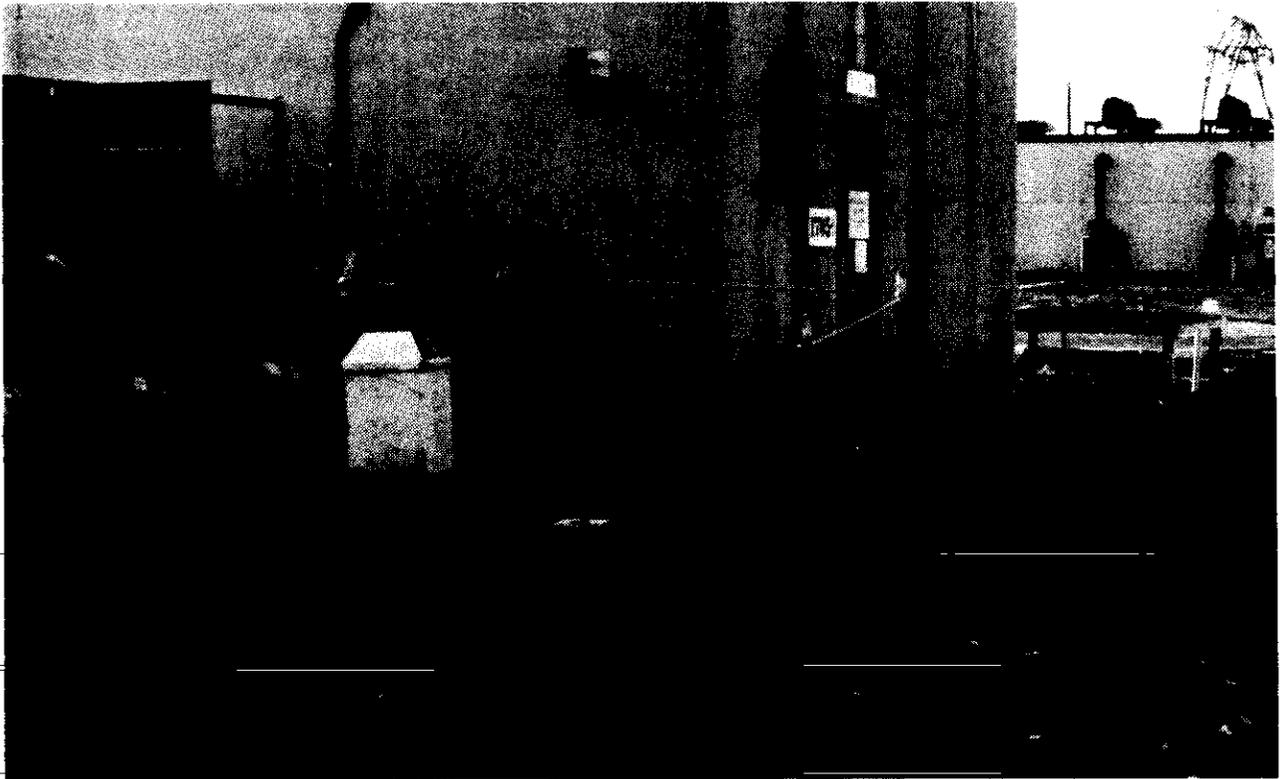
Figure 5-25. Undocumented French Drain - East side of 1705-KE.

There is a 3-ft diameter vitrified clay pipe french drain (Figure 5-25) located just east of the 1705-KE Water Treatment Facility. It is approximately 1 ft above the surrounding grade with a heavy wooden cover.

A thorough search of Hanford drawings and interviews with site employees could not provide a purpose for or use of this french drain. It is surrounded by four light-duty posts and rope barricade and is posted with a "Confined Space" warning sign.

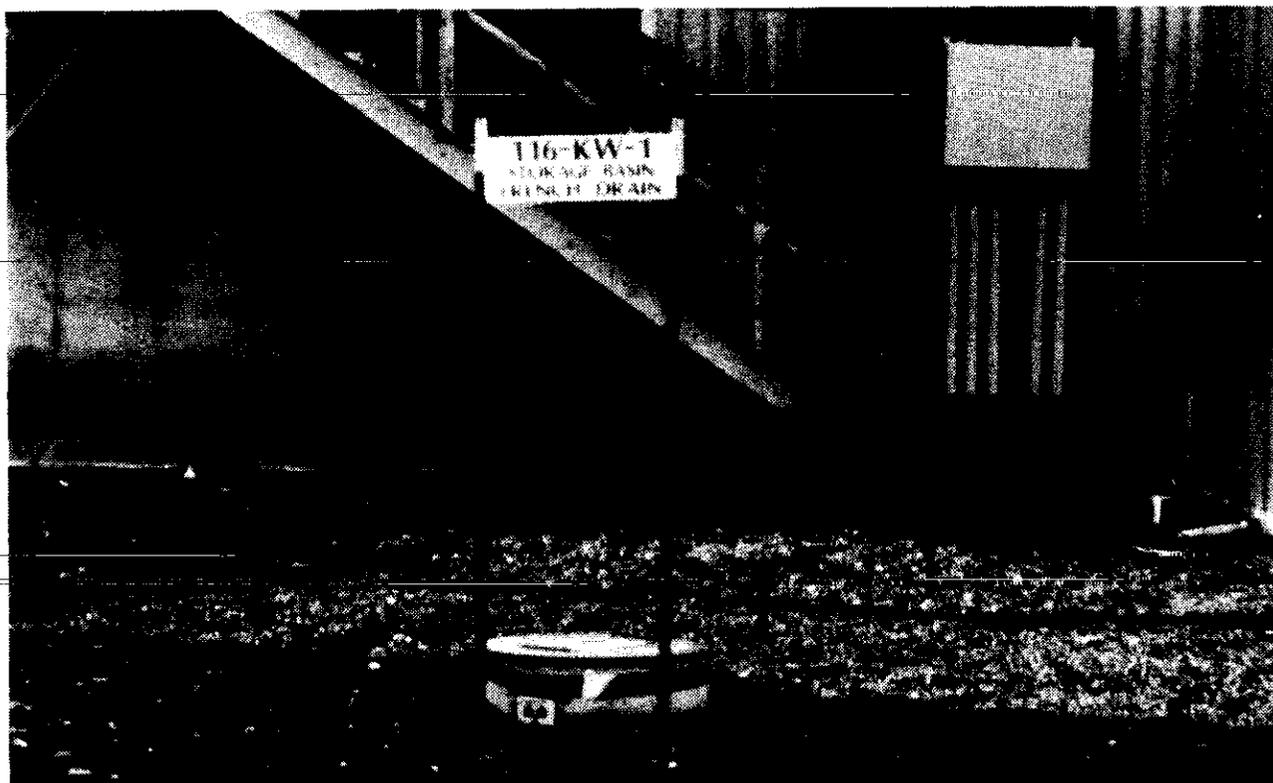
Figure 5-26. Undocumented French Drain - South Side of 119-KW.

East of the 105-KW Reactor Building, between the stack and the 119-KW Exhaust Air Sample Building, there is a french drain that is erroneously labeled as the 116-KW-1 storage basin french drain.

Today, this site appears as a 1-ft-diameter concrete french drain that has been painted blue and extends approximately 6 in. above the surrounding grade. It has a metal cover that is posted with "Confined Space" and "Surface Contamination" warning signs.

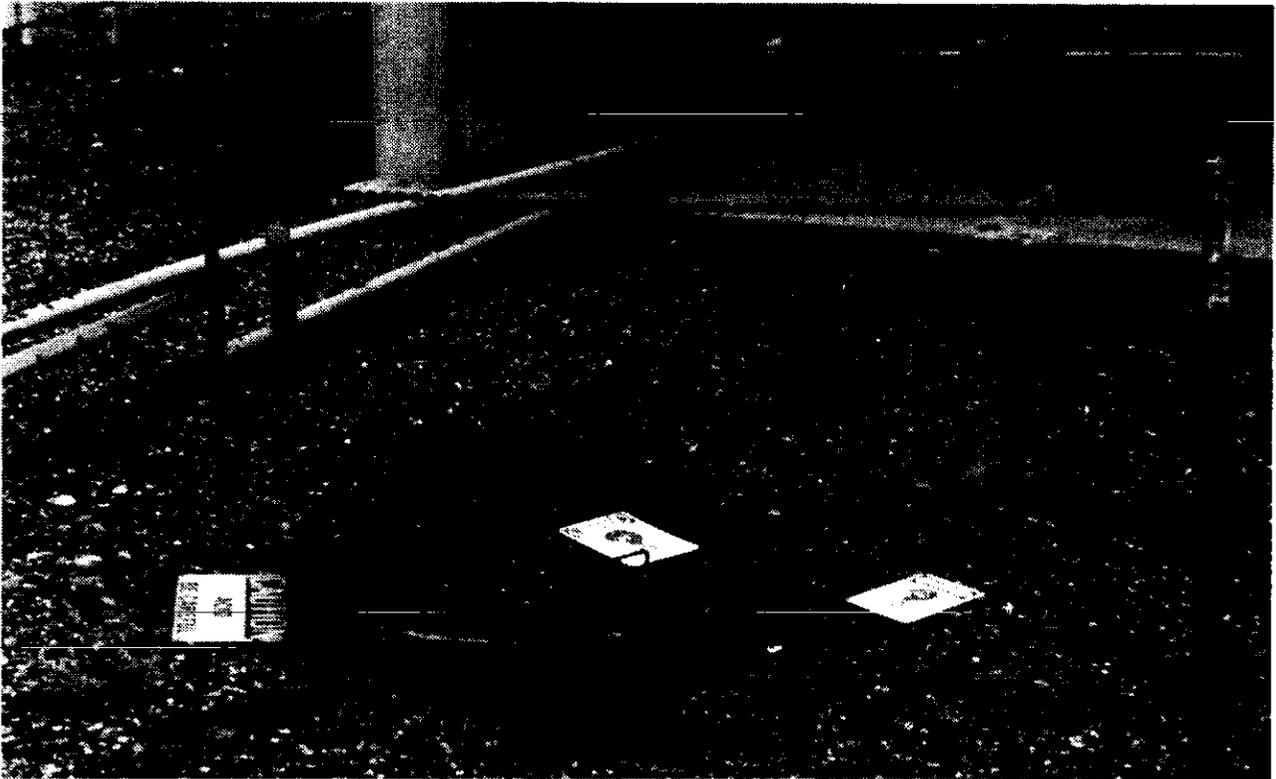
Figure 6-2. 183-KW Water Facility French Drain.

Hanford Drawing H-1-25264 describes this drain as being a 3-ft diameter, 6-ft-long vitrified clay pipe placed vertically in an excavation that was about 13 ft across and 11 ft deep. The bottom 1 ft of the pipe was filled with course rock as was the bottom 5 to 6 ft of the excavation (Figure 6-2).

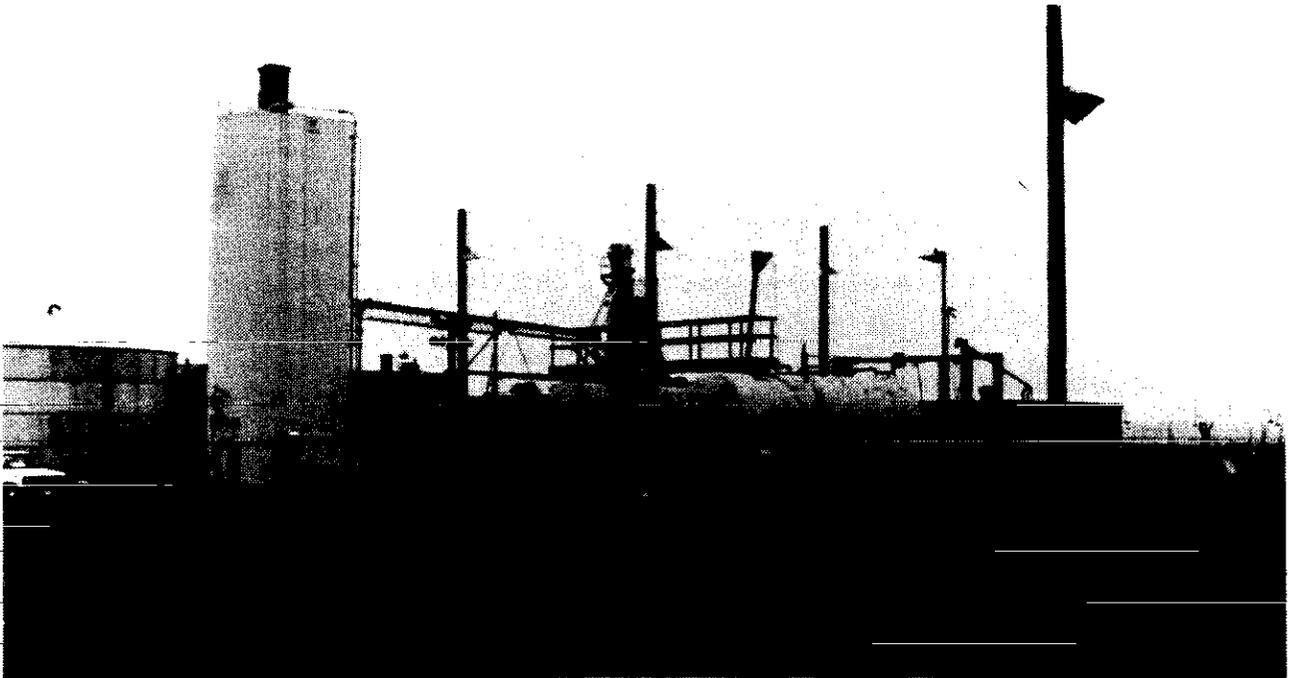
Figure 6-3. 183-KW Water Treatment Facility.

There were two 10,109-gal tanks (Figure 6-3), each measuring 9 ft diameter and 20 ft long and two 20,380-gal tanks, each measuring 10-ft diameter and 33 ft long to supply the needs of the water treatment system. The 20,380-gal tanks are further discussed in Section 6.29.

There were two 10,109-gal tanks (Figure 6-3), each measuring 9 ft diameter and 20 ft long and two 20,380-gal tanks, each measuring 10 ft diameter and 33 ft long to supply the needs of the water treatment system. The 20,380-gal tanks are further discussed in Section 6.29.

The vertical, steel storage tank is cylindrical in shape mounted on a concrete base. It is 40 ft diameter and 20 ft high with a storage capacity of 188,000 gal (UNI-2780). Refer to Figure 6-3.

The vertical, steel storage tank is cylindrical in shape mounted on a concrete base. It is 40 ft diameter and 20 ft high with a storage capacity of 188,000 gal (UNI-2780). See Figure 6-3.

These tanks were 10 ft diameter and 33 ft long. The storage capacity of each tank was 20,380 gal. Refer to Figure 6-3.

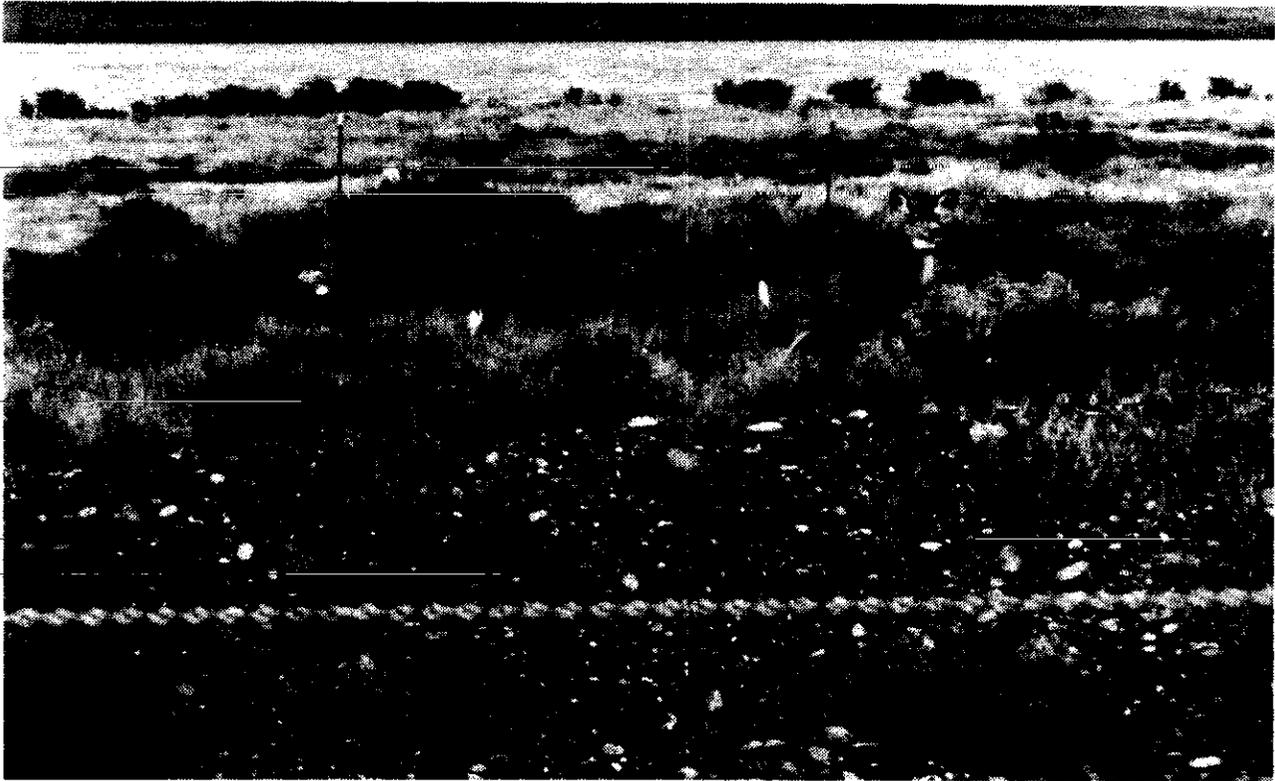
Figure 6-6. 100-K Construction Dump, January 1994.

Today, the site appears as a large depression covered by natural grasses and vegetation surrounded by a light-duty post and single chain fence. The area is posted with asbestos warning signs.

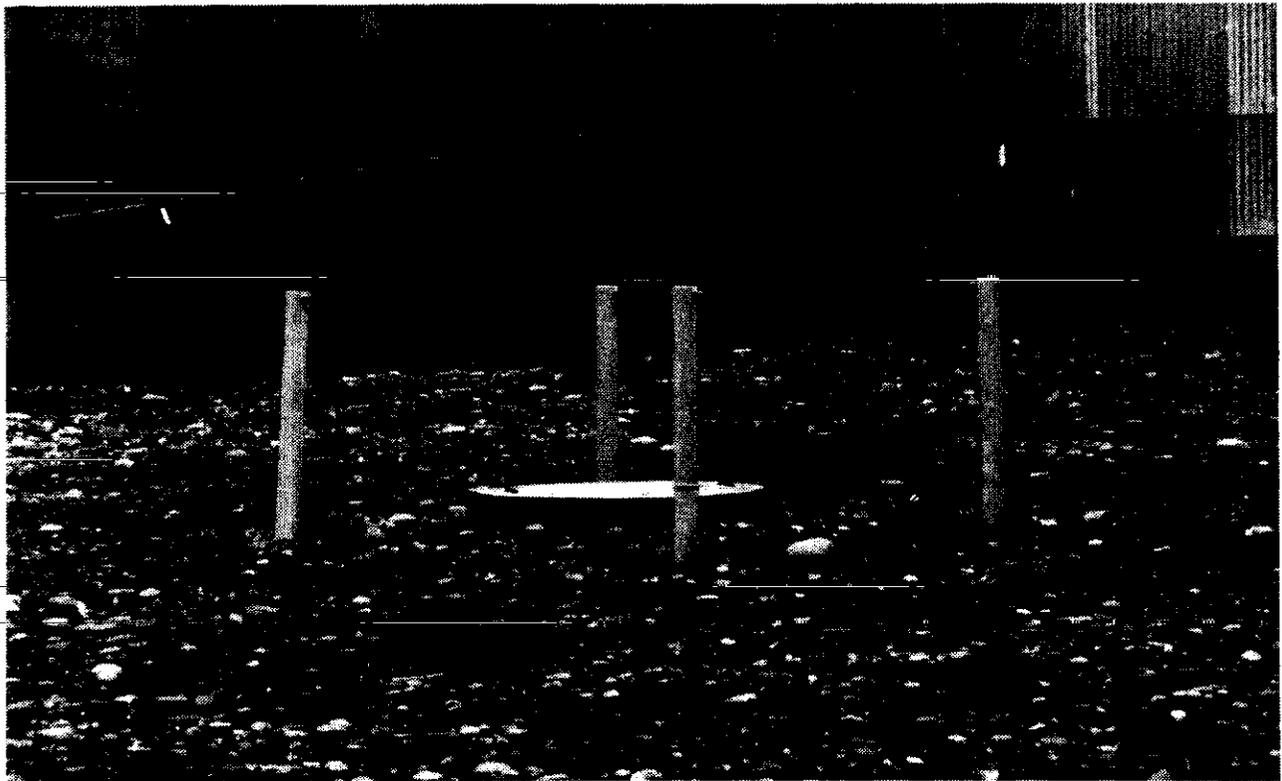
Figure 6-17. Acid Neutralization Pit Overflow French Drain.

The french drain is apparent at the 183-KE site, but there is no evidence of the drain at the 183-KW site.

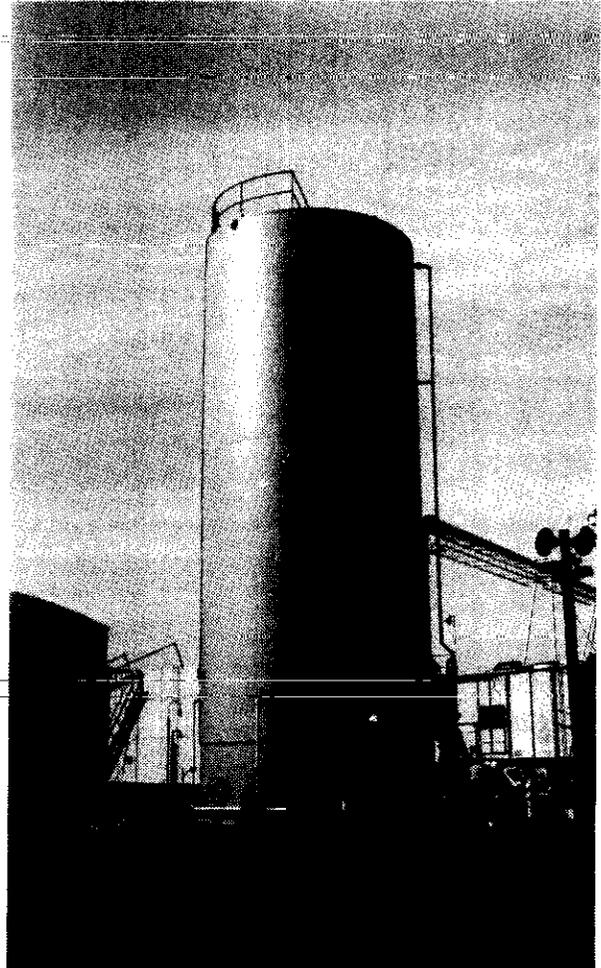
Figure 6-19. Bauxite Tank, October 25, 1966.

A Bauxite storage (Figures 6-18 and 6-19) tank was constructed on the site of each of the former number 1 sodium silicate tanks at 100-K Area coordinates NK3131 WK4680 in 100-KE and NK3131 WK6620 in 100-KW (H-1-25117).

The tanks appear today as they did during operations. They appear to have been emptied, although dry bauxite powder can be seen through a plexiglass cover indicating that no additional clean-up was performed.

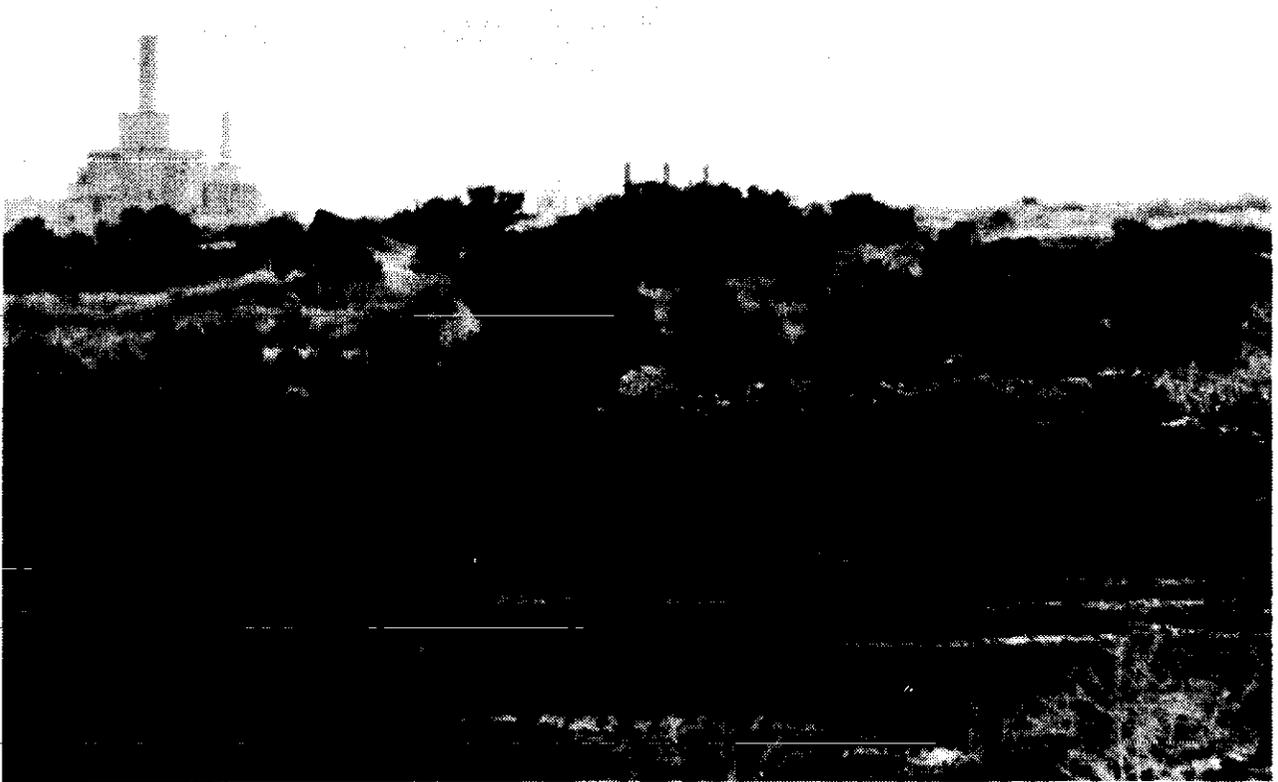
Figure 6-20. Undocumented Paved Area and Collapsed Structure, December 1993.

Adjacent to and to the east of this paved area is a collapsed wooden structure (Figure 6-20). The purpose of the paved area and the wooden structure is unknown at this time. A little further to the east, about 50 yd, is a farm waste dump (Figure 6-21).
