DOE/RL-93-47
Revision 0

North Slope (Wahluke Slope) Expedited Response Action Cleanup Plan

Date Published
February 1994

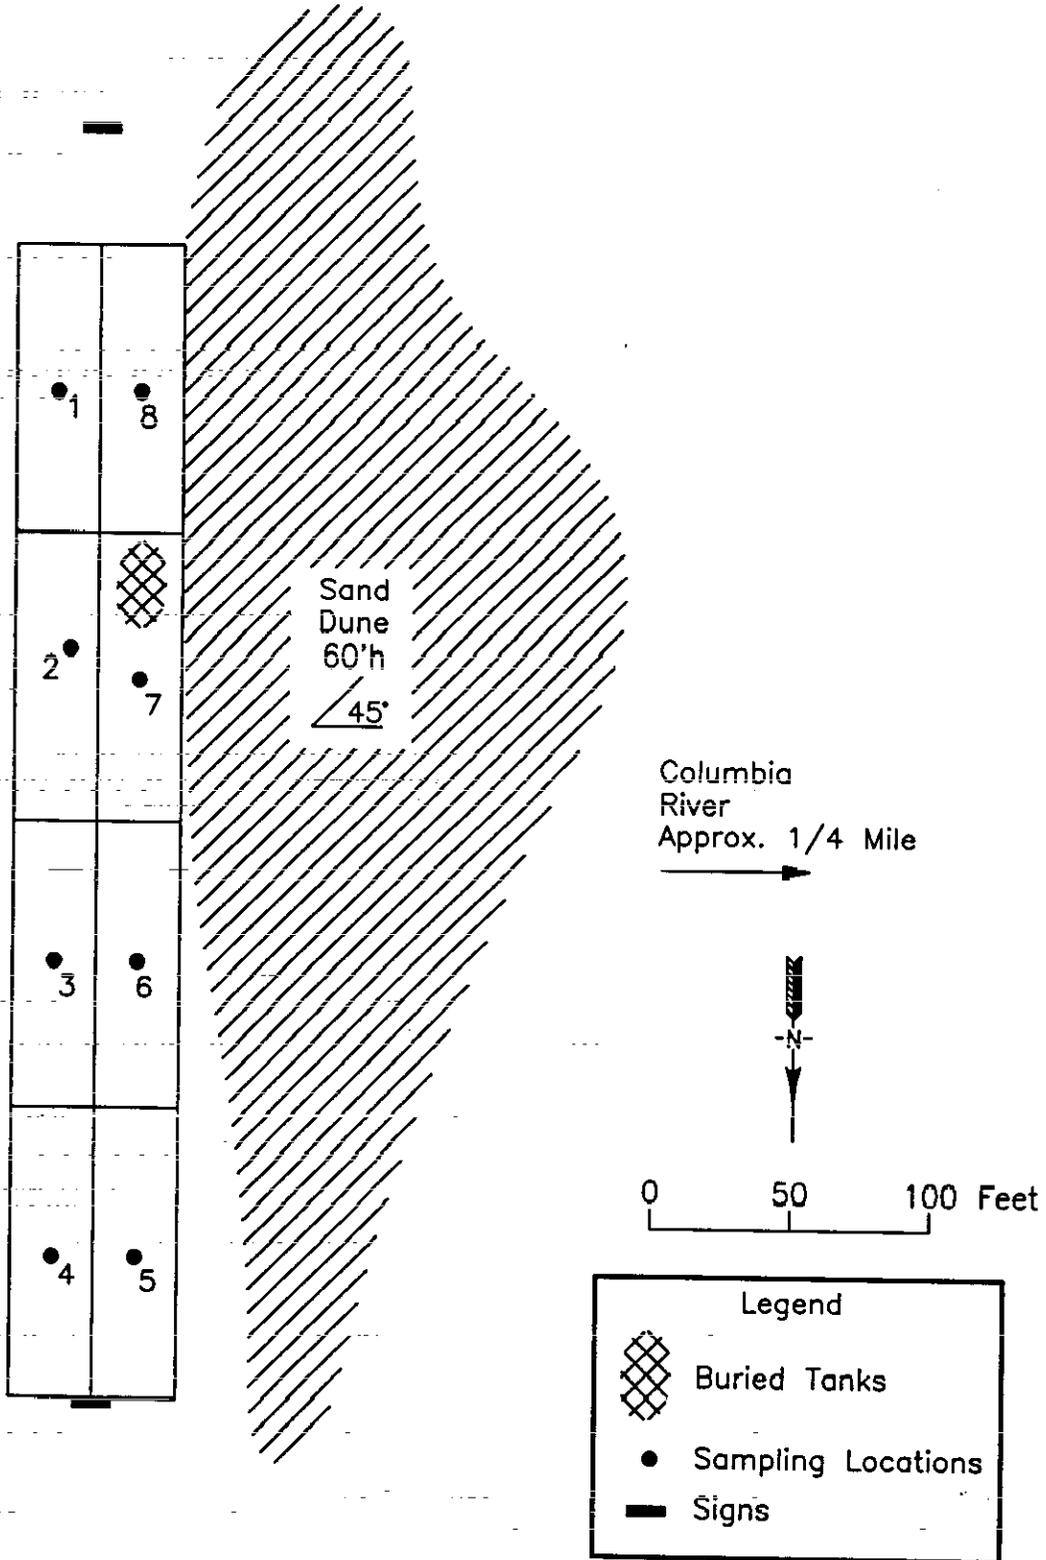
Figure 4. 2-4,D Burial Ground Sampling Location.

An auger rig was used to obtain soil samples from eight locations within the boundaries of the disposal site (Figure 4). Auger cuttings were predominantly a fine sand typical of the surrounding geology. Drilling indicated that the disturbed material-native material interface is at approximately 13 to 15 ft below the surface. A readily evident soil moisture horizon was located 3 to 5 ft below grade.

Samples were obtained from the 13- to 15-ft depths at each of these locations using a split-tube sampler. Each sample set consisted of a 60-mL amber glass bottle for total activity analysis, a 250-mL amber glass bottle for offsite laboratory analysis (if required), and a field screening sample. The 250-mL sample was sent offsite for analysis only if field screening indicated the presence of 2,4-D.

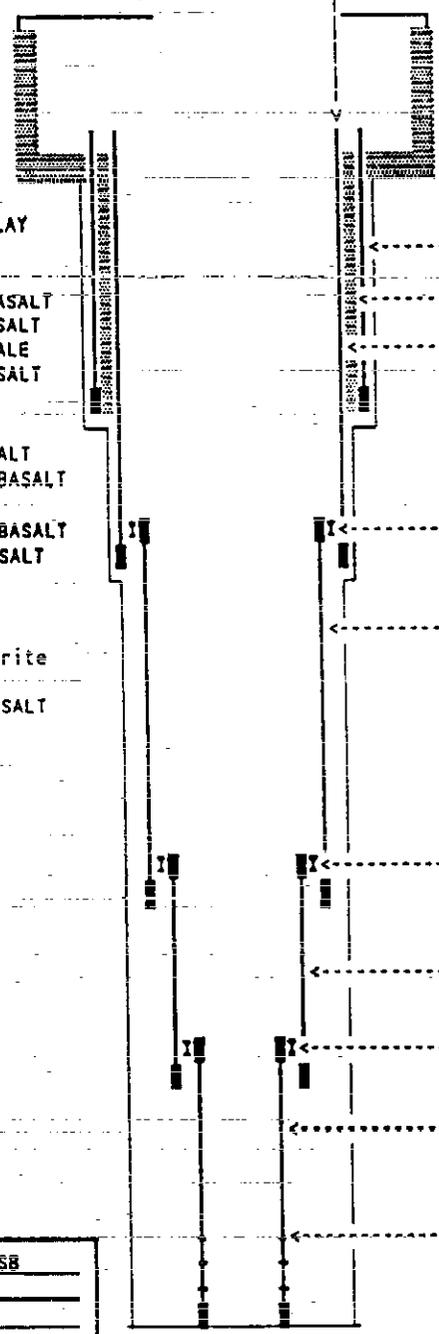
GENERALIZED Driller's STRATIGRAPHY Log

- 0-3: CLAY, SILT, TOP SOIL
- 3-9: CALICHE
- 9-206: Light brown CLAY
- 206-573: Blue, brown green CLAY
- 573-580: Pea GRAVEL with CLAY
- 580-589: SANDSTONE
- 589-601: Hard gray BASALT
- 601-631: Soft red porous BASALT
- 631-697: Black and gray BASALT
- 697-730: Green and blue SHALE
- 730-874: Black and gray BASALT
- 874-883: Porous red ROCK and CLAY
- 883-1027: Porous black BASALT
- 1027-1165: Black and gray BASALT
- 1165-1191: Blue CLAY
- 1191-1246: Gray and black BASALT
- 1246-1261: Porous black BASALT
- 1261-1276: CONGLOMERATE
- 1276-1283: Blue CLAY
- 1283-1291: CONGLOMERATE, rotten wood, pyrite
- 1291-1371: Black BASALT
- 1371-1393: Porous black BASALT
- 1393-1396: BASALT

Type of surface protection:
Concrete pump housing
Grout between 16-20 in casing

20 in casing surface-297 ft
Carbon steel w/steel drive shoe
Concrete grout

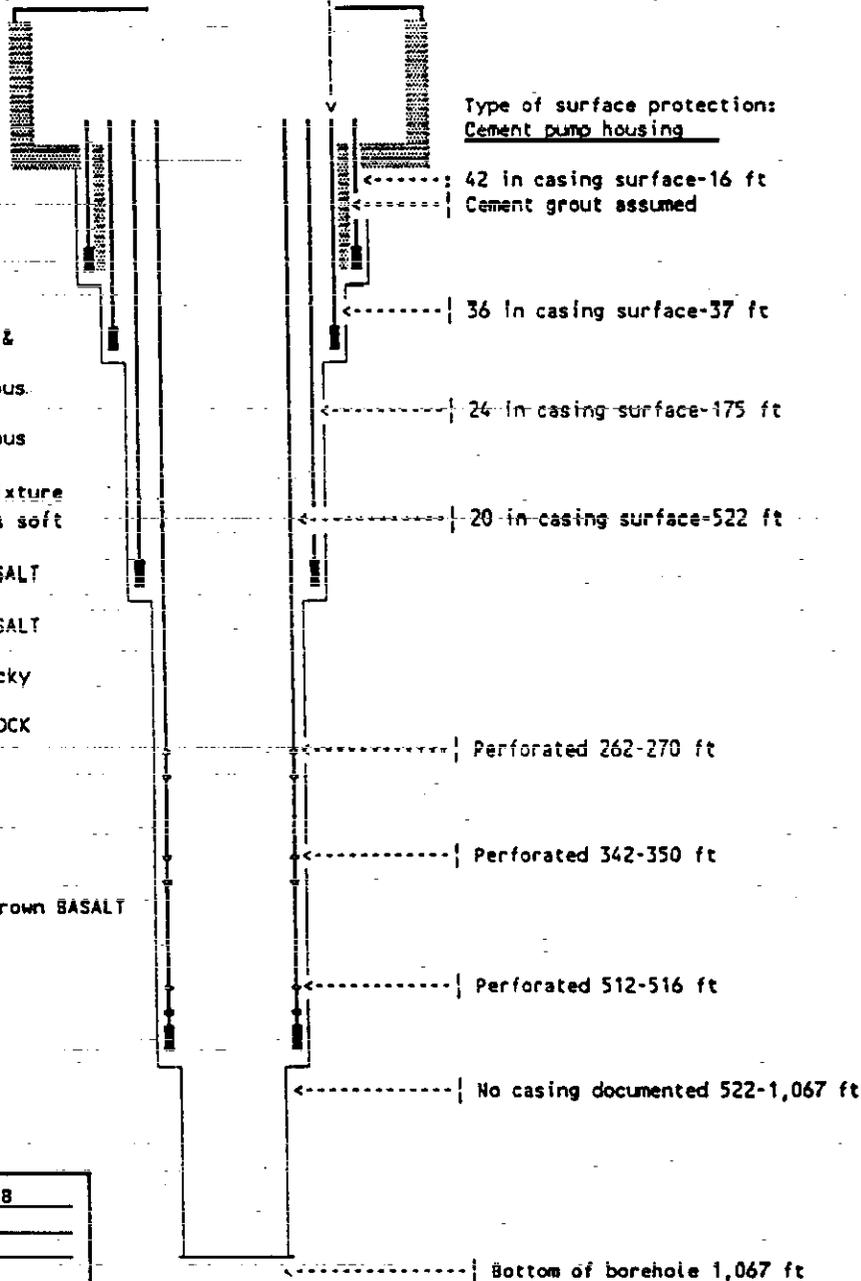
GENERALIZED Driller's STRATIGRAPHY Log

- 0-6: TOPSOIL
- 6-23: CALICHE
- 23-25: White CLAY and GRAVEL
- 25-56: White CLAY
- 56-78: Gray CLAY
- 78-107: Brown CLAY with few GRAVELS
- 107-145: CALICHE?
- 145-158: Sandy CLAY, brown
- 158-277: Sandy CLAY, brown & GRAVELS & SAND
- 277-300: Black BASALT, porous.
- 300-324: Gray BASALT
- 324-358: Black BASALT, porous
- 358-377: Gray BASALT
- 377-404: BASALT and CLAY mixture
- 404-510: Gray BASALT, veins soft to hard
- 510-565: Gray and black BASALT
- 565-580: Gray CLAY
- 580-765: Gray and black BASALT
- 765-797: Blue CLAY
- 797-846: Gray CLAY and sticky yellow CLAY
- 846-872: Black CLAY with ROCK
- 872-879: Black BASALT
- 879-921: Black SANDSTONE
- 921-955: Gray BASALT
- 955-982: Black BASALT
- 982-998: Brown BASALT
- 998-1032: Black BASALT
- 1032-1038: Gray, red and brown BASALT
- 1038-1064: Black BASALT
- 1064-1067: Brown BASALT

Type of surface protections: Cement pump housing

42 in casing surface-16 ft
Cement grout assumed

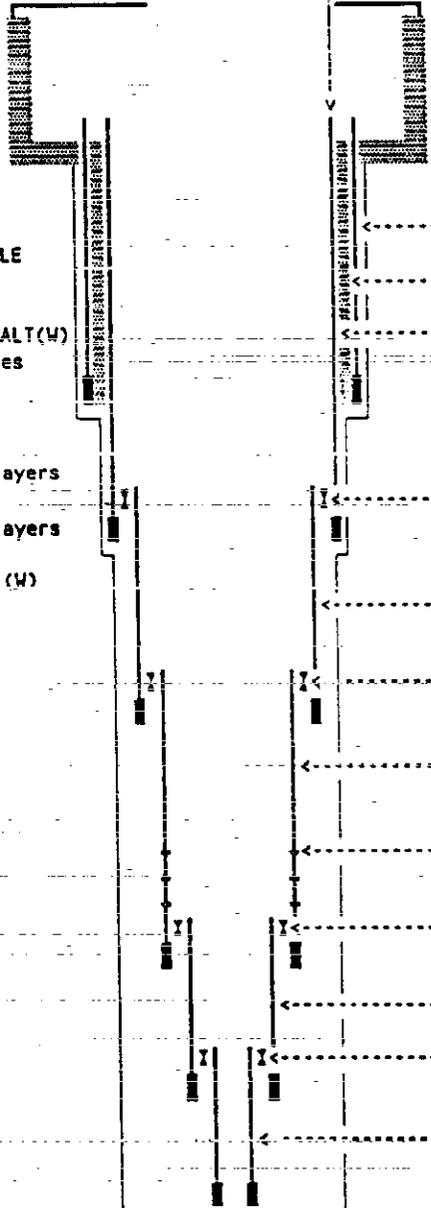
GENERALIZED Driller's STRATIGRAPHY Log

- 0-12: TOPSOIL, sandy SILT
- 12-21: CALICHE
- 21-63: GRAVEL
- 63-183: CLAY and sandy SHALE
- 183-249: Sandy CLAY (W)
- 249-252: CALICHE
- 252-355: SAND, CLAY and SHALE
- 355-625: BASALT, hard, gray
- 625-630: BASALT, broken (W)
- 630-663: Brown CLAY and BASALT(W)
- 663-680: BASALT with crevices
- 680-685: BASALT with CLAY layers
- 685-753: Porous BASALT
- 753-895: BASALT with CLAY layers
- 895-900: SAND (W)
- 900-906: SAND with BASALT layers
- 906-924: BASALT
- 924-938: White porous ROCK (W)

Type of surface protection: Concrete pump housing
Grout between 16-20 in casing

20 in casing surface-198 ft
Carbon steel w/steel drive shoe
Concrete grout

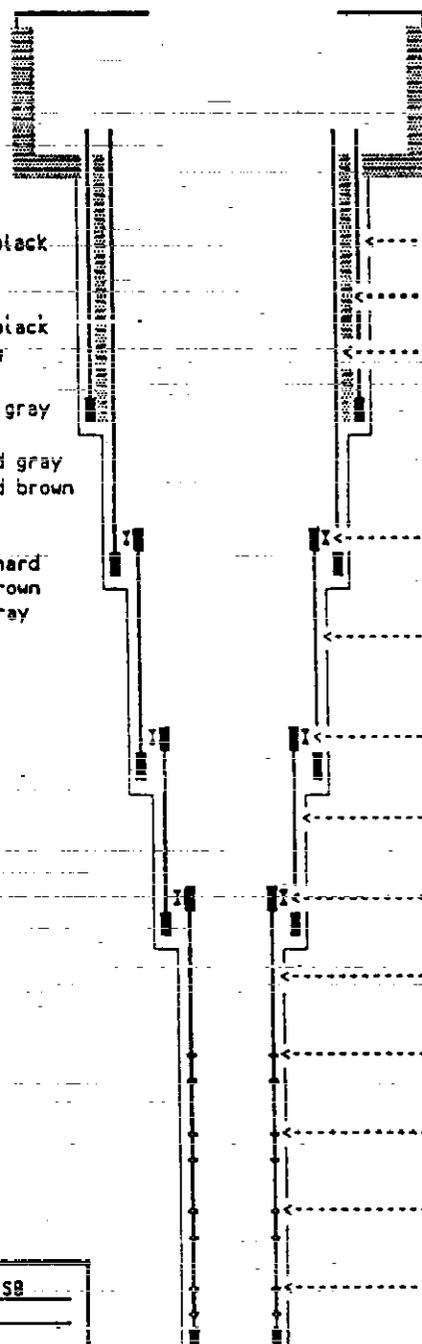
GENERALIZED Driller's STRATIGRAPHY Log

- 0-3: TOP SOIL
- 3-277: CALICHE and CLAY, some SAND
- 277-372: BASALT, porous black and gray
- 372-404: CLAY, SAND, TALUS
- 404-565: BASALT, gray and black
- 565-575: CLAY, gray
- 575-580: Coarse SAND, CLAY
- 580-765: BASALT, gray and black
- 765-862: CLAY, blue, yellow w/broken BASALT
- 862-982: BASALT, black and gray
- 982-998: BASALT, brown (W)
- 998-1034: BASALT, black and gray
- 1034-1038: CINDERS, red and brown
- 1038-1067: BASALT, black
- 1067-1077: BASALT, brown
- 1077-1107: BASALT, black, hard
- 1107-1115: BASALT, light brown
- 1115-1123: BASALT, hard, gray

- Type of surface protection: Cement pump housing
- Grout between 16-20 in casing
- 20 in casing surface-188 ft Carbon steel w/steel drive shoe Cement grout assumed
- 16 in casing surface-405 ft carbon steel w/steel drive shoe
- Lead packer at top of 12 in liner
- 12 in liner 395-720 ft drive shoes at top and bottom of liner
- Lead packer at top of 10 in liner
- 10 in liner 711-873 ft drive shoes at top and bottom of liner
- Lead packer at top of 8 in liner
- 8 in liner 863-1,123 ft drive shoes at top and bottom
- Perforated 982-995 ft 9 per/ft, 3/8" x 4"
- Perforated 1,034-1,038 ft 9 per/ft, 3/8" x 4"
- Perforated 1,067-1,077 ft 9 per/ft, 3/8" x 4"
- Perforated 1,107-1,115 ft 9 per/ft, 3/8" x 4"
- Bottom of borehole 1,123 ft

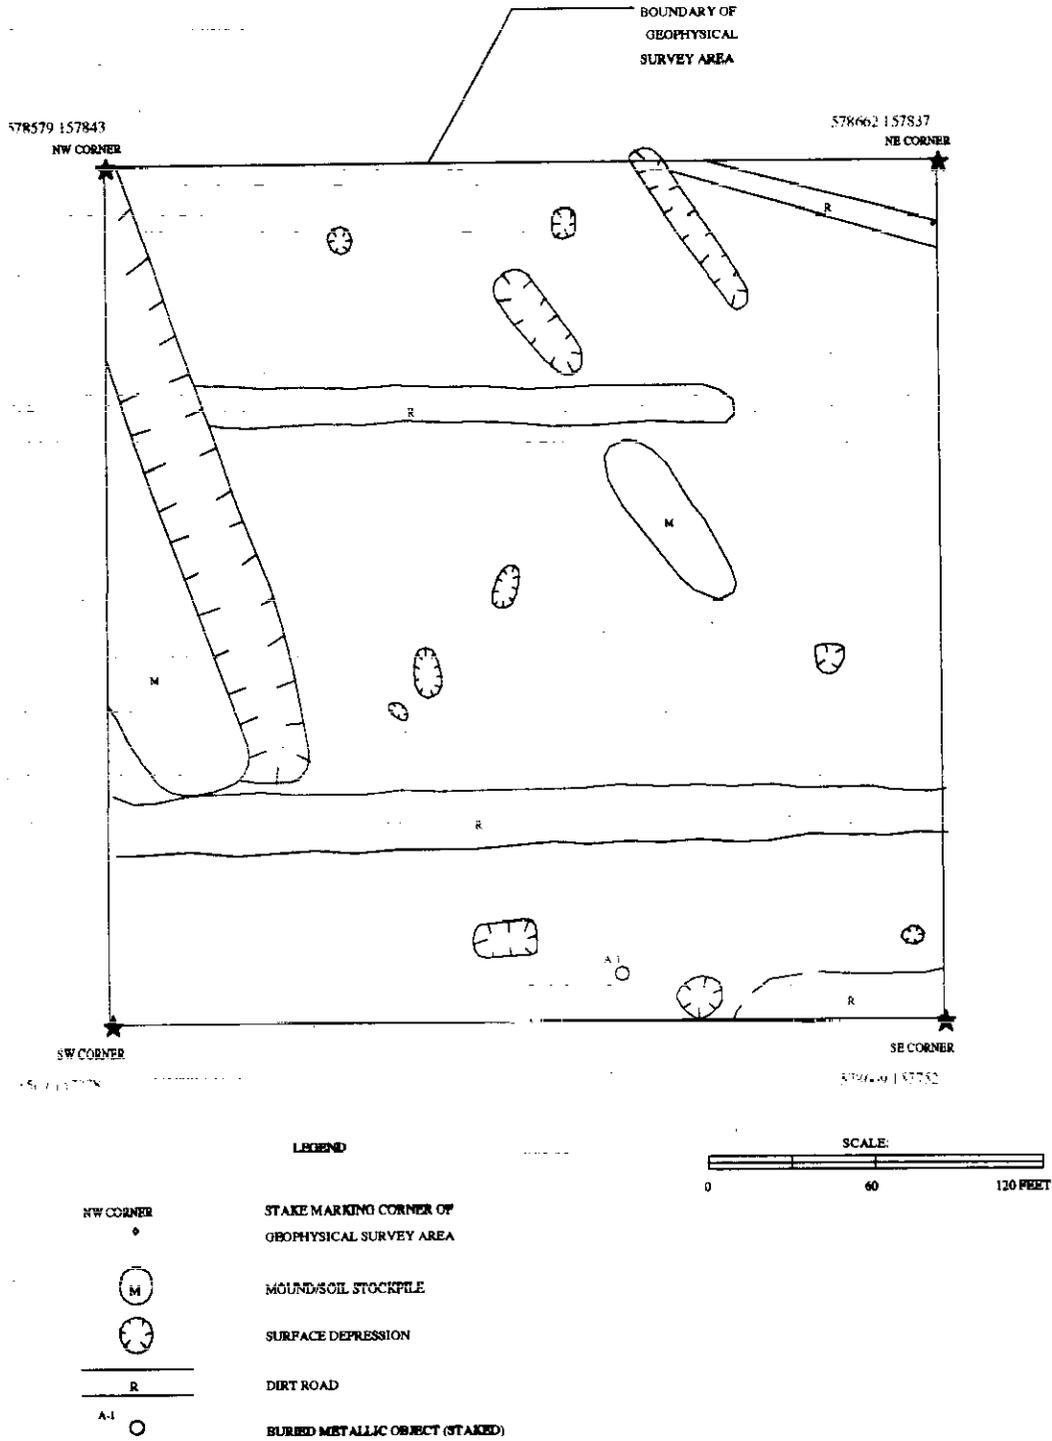
Figure E-1. Site Map with Geophysical Interpretation
Site PSN-04 (North) Wahluke Slope.

The * represents the approximate sample locations. In addition, the site numerical designator from Table 2 is included in the sample location description in the laboratory analytical results appendix (Appendix G).

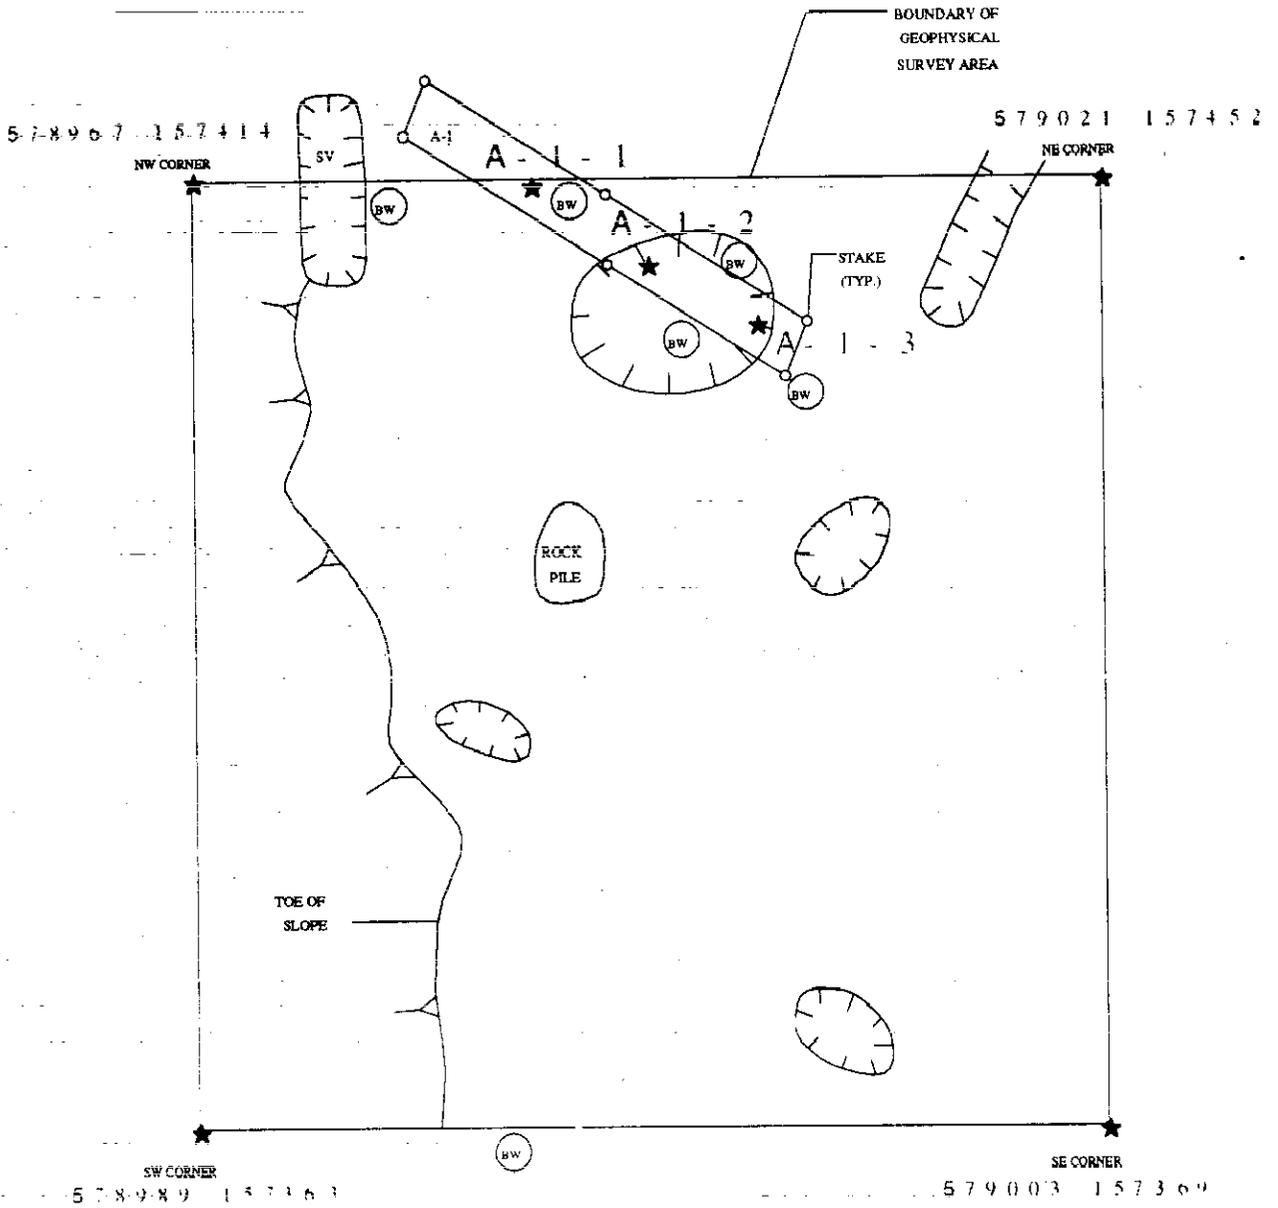
Figure E-3. Site Map with Geophysical Interpretation
Site PSN-04 (East) Wahluke Slope.

The * represents the approximate sample locations. In addition, the site numerical designator from Table 2 is included in the sample location description in the laboratory analytical results appendix (Appendix G).

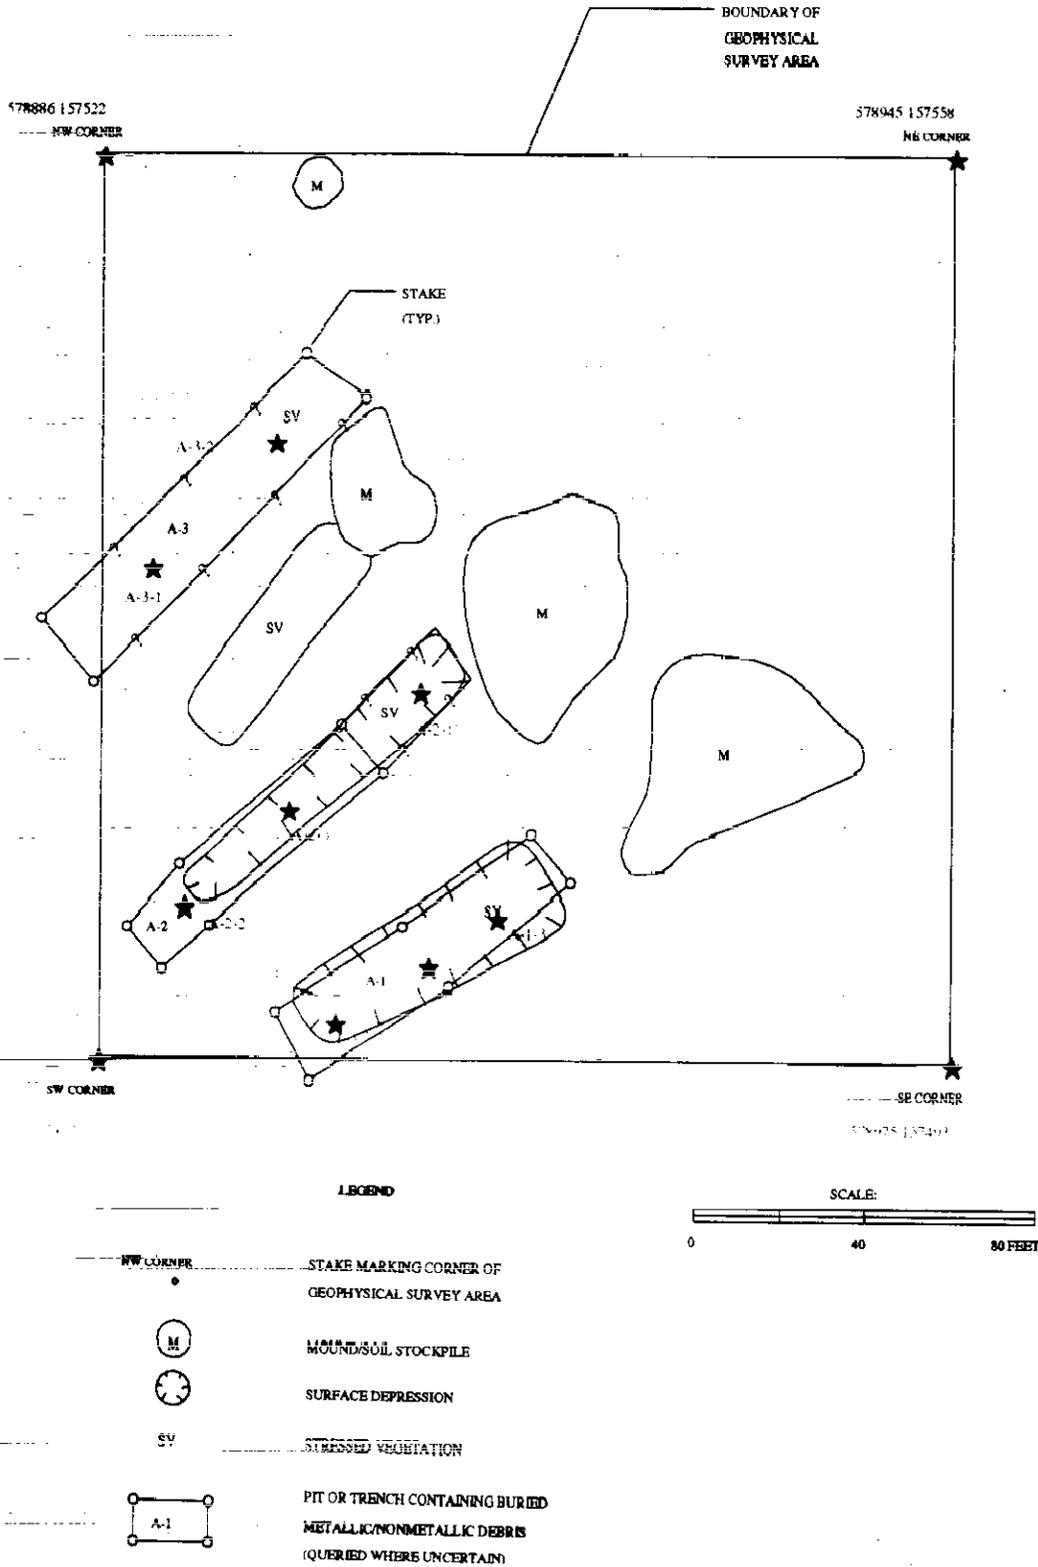
Figure E-4. Site Map with Geophysical Interpretation
Site PSN-04 (West) Wahluke Slope.

The * represents the approximate sample locations. In addition, the site numerical designator from Table 2 is included in the sample location description in the laboratory analytical results appendix (Appendix G).

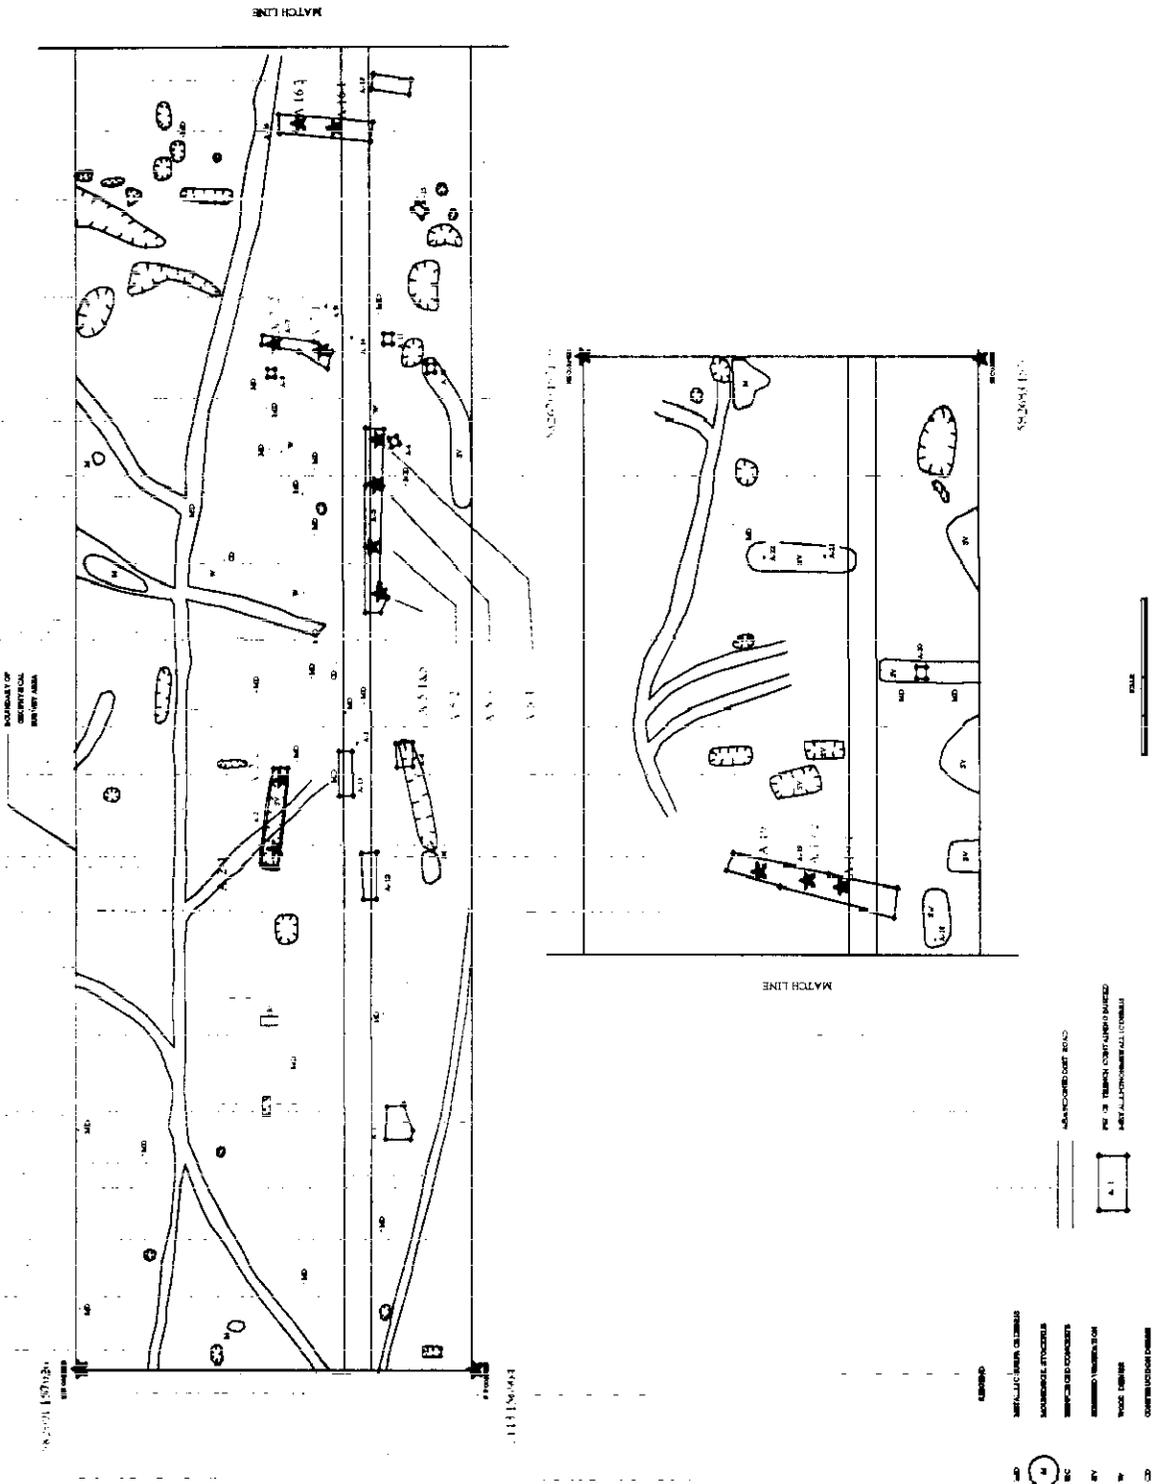
Figure E-6. Site Map with Geophysical Interpretation
 Site H-06-H (West) Wahluke Slope.

The * represents the approximate sample locations. In addition, the site numerical designator from Table 2 is included in the sample location description in the laboratory analytical results appendix (Appendix G).

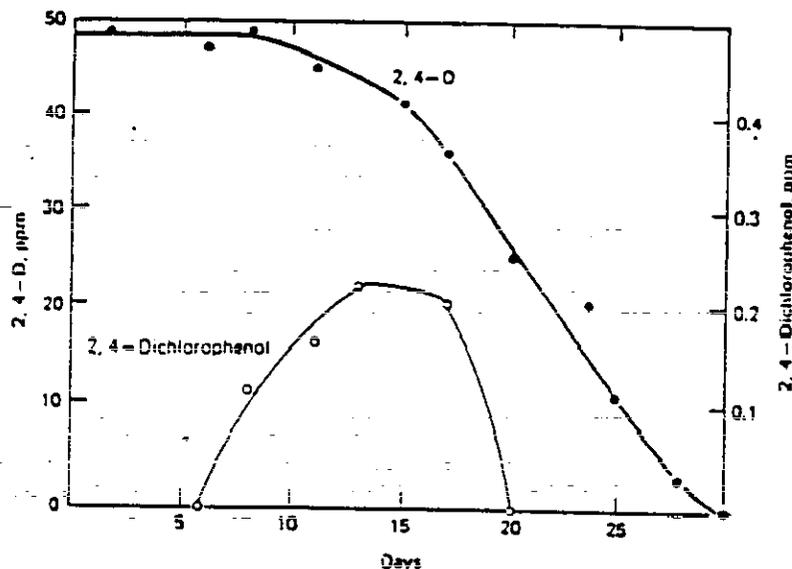
Fortunately, 2, 4-D is one of the only herbicides which is able to be metabolized by bacteria. As shown in the diagram below, the breakdown rate approximately thirty days. Therefore, with some site specific soil and water samples an analysis for 2, 4-D should show no traces of the herbicide.

Figure 26.4. Metabolism of 2,4-D (2,4-dichlorophenoxyacetic acid) and formation of 2,4-dichlorophenol in soil (28). Note that the concentration of the product is low.
