Re: Entry of Site Visit Report to Administrative Record
224-T TRUSAF (S-2-2, M-20-23)

224-T Transuranic Waste Storage and Assay Facility (TRUSAF)
(Group # S-2-2, Milestone M-20-23)
September 14, 1993, Site Visit Report by Alisa D. Huckaby

224-T TRUSAF SITE VISIT REPORT

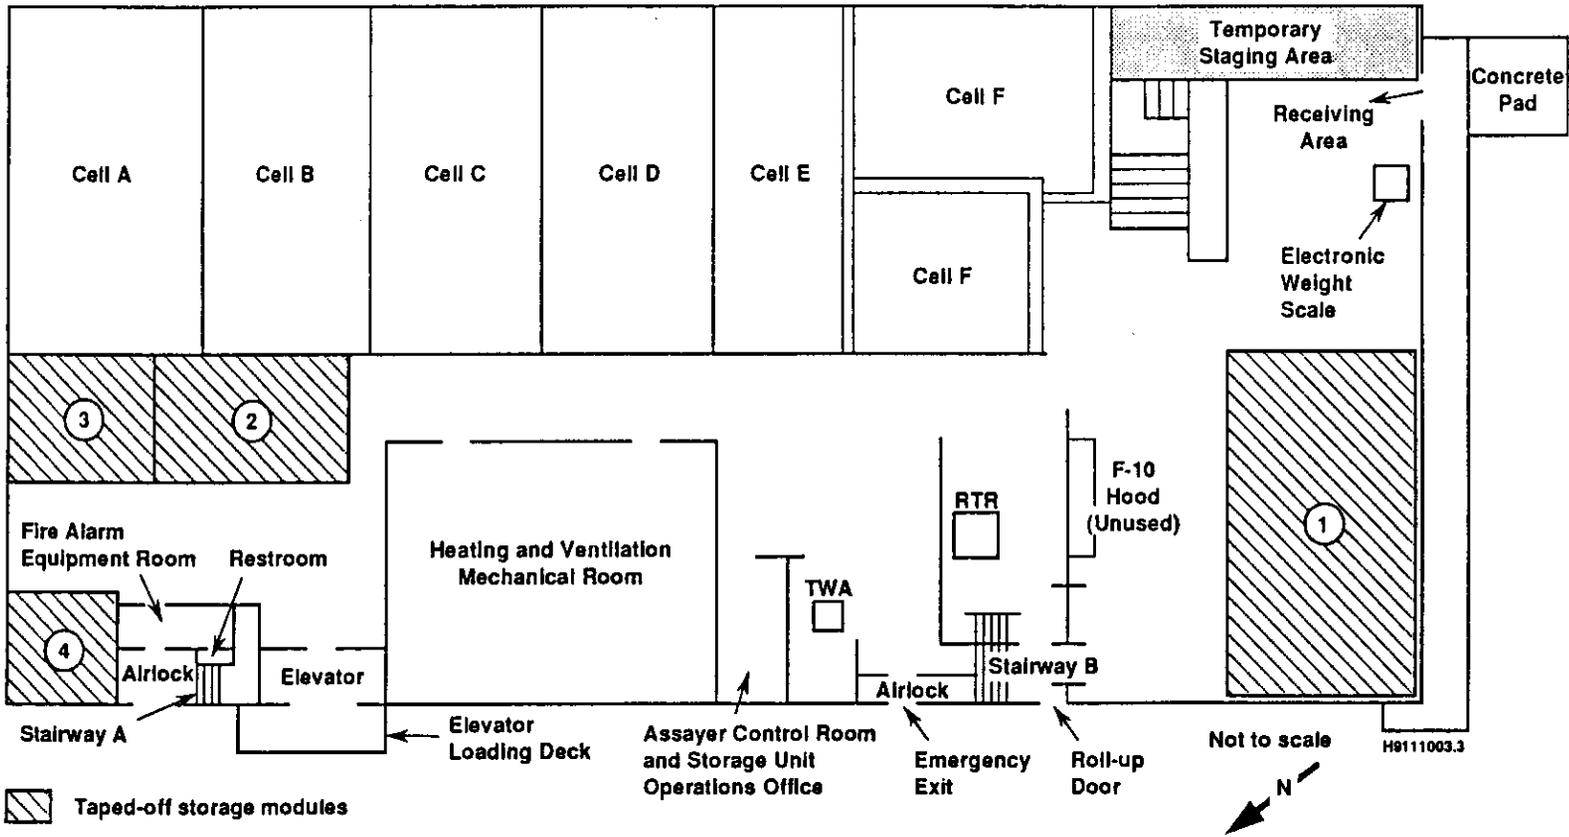
Figure 2-3. 224-T Transuranic Waste Storage and Assay Facility First Floor Plan.

The group proceeded north to the area housing the real-time radiography x-ray system, (shown on attached Figure 2-3). While in this area, photographs numbered 5 and 6 were taken. While in this area, Shoemaker explained that in the future, there will not be drums located in this area due to the x-ray equipment. Shoemaker further explained that the drums were located in this area temporarily while floor sealants were being tested in one of the storage arrays. While in the x-ray radiography room, two continuous airborne monitors (CAMs) were noted. Shoemaker explained that one of the CAMs was an alpha CAM and the other was a beta CAM. Shoemaker further explained that the alpha CAM was for the transuranic wastes and the beta CAM was for the backlog wastes.

From the x-ray radiography room, the group proceeded north to the transuranic waste assayer (TWA) room shown on attached figure 2-3. While in this room, photographs numbered 7, 8, and 9 were taken. While in this room a circular pattern (approximately two feet in diameter) was noted in the concrete (see photograph number 8). A second circular pattern (approximately six inches in diameter) was also noted in this room located near the corner of a rectangular pattern which appeared to be slightly lower than the surrounding concrete (see photo number 9).

The group then proceeded to the northern-most end of the building where several storage modules were noted (shown as modules numbered 2, 3 and 4 on attached Figure 2-3). Within this area, 1989 waste accumulation dates were noted on some of the hazardous waste labels. Shoemaker explained that the facility contained drums which were shipped to 224-T TRUSAF of which could not be accepted or certified because of limitations related to the x-ray radiographic techniques utilized and the certification criteria imposed by the Waste Isolation Pilot Plant (WIPP) in Carlsbad, New Mexico, where the waste is proposed to be disposed. LaBarge further explained that since the drums were over 90 days old, they could not be shipped back to the generator.

Prior to being radiologically "surveyed out," McDonald explained that plans were progressing to enter the radiologically contaminated process cells B and F (shown on attached Figure 2-3) on September 28 or 29, 1993. Ecology representatives left the facility at approximately 2:00 p.m.

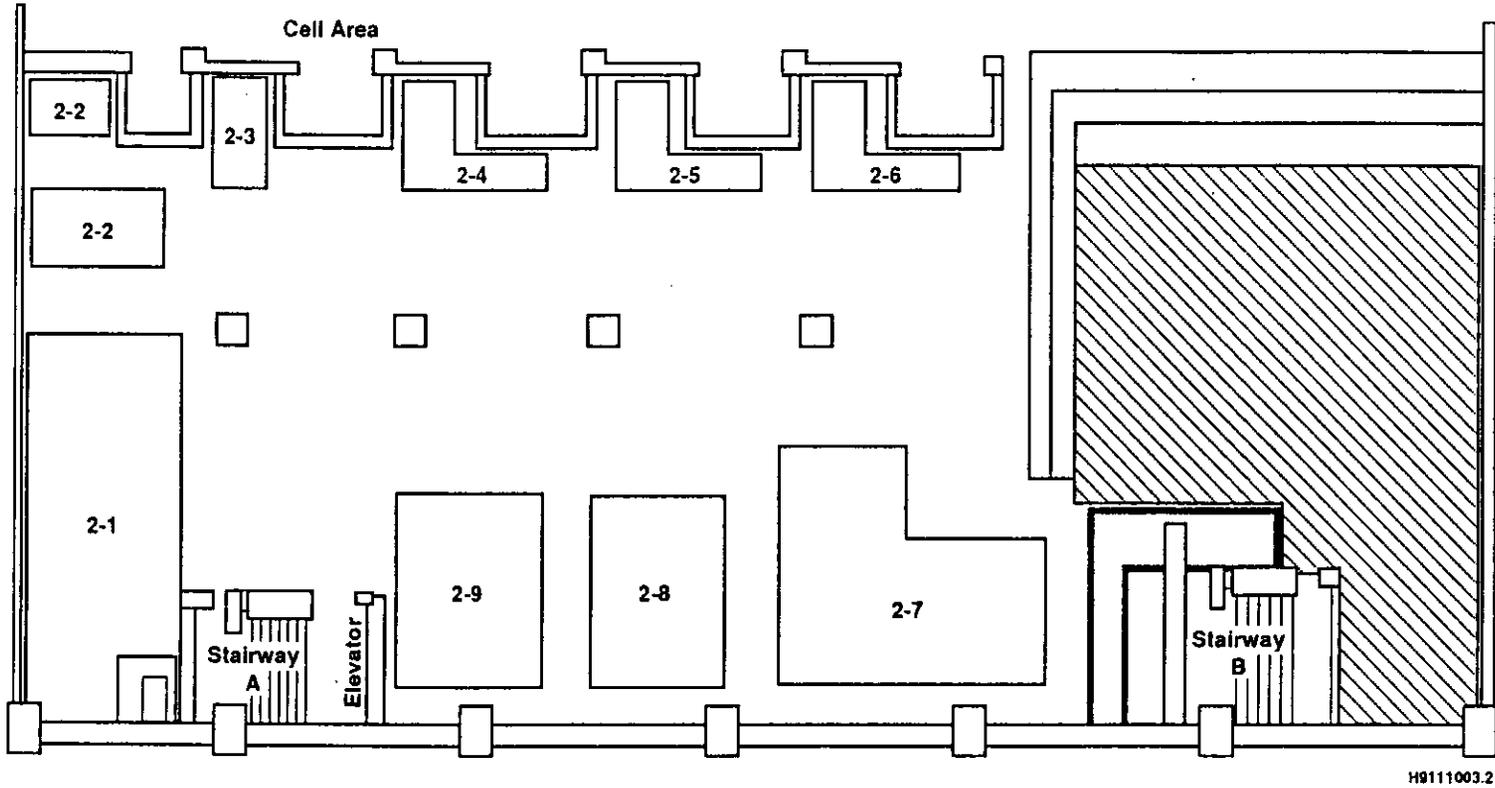
Figure 2-4. 224-T Transuranic Waste Storage and Assay Facility Second Floor Plan.

The group then proceeded to the second floor at the south end of the building. The area is shown on Figure 2-4 as the shaded area designated for "transuranic mixed waste as designated by supervisor." Within this area, one area, approximately 20' X 20' and marked with a line of tape, was labelled "oxidizers" (see attached photograph number 11). Directly adjacent, was an area labelled "satellite accumulation" (see attached photograph number 12). In this same room, there were areas with signs stating "acids, return to generator," etc. Photograph number 13 was taken of drums stored in one such open array module. While in this area, it was noted by Ruud, that one drum located in a "return to generator acids" module was not labelled with a hazardous waste label, although it had a "corrosive" label facing the wall. Photograph number 15 was taken of this drum and Ruud requested a copy of the documentation for this drum which was in a plastic envelope on top of the drum. Shoemaker provided a copy (copy attached). Also while in this area, a rectangular shaped patch was noted beneath the satellite accumulation drum (see photograph number 12). Shoemaker and McDonald explained that a sealant was being "tested." Shoemaker further explained that the sealant selected for upgrading the secondary containment would be grey in color rather than the brown color sealant tested in the satellite accumulation area. Also while in this room, Hensley and Wallace noted ceiling cracks which appeared to be discolored as though indicating leakage (see attached photograph number 14).

The group then proceeded north to the next room (shown on Figure 2-4 as unshaded portion with open array modules numbered 2-1 through 2-9). While in this room, additional discolored ceiling cracks were noted. Photographs numbered 16, 17, 18, 19, and 20 were taken in this room. The storage arrays (2-1 and 2-2) at the northern-most end of the building contained drums with higher radiation readings.

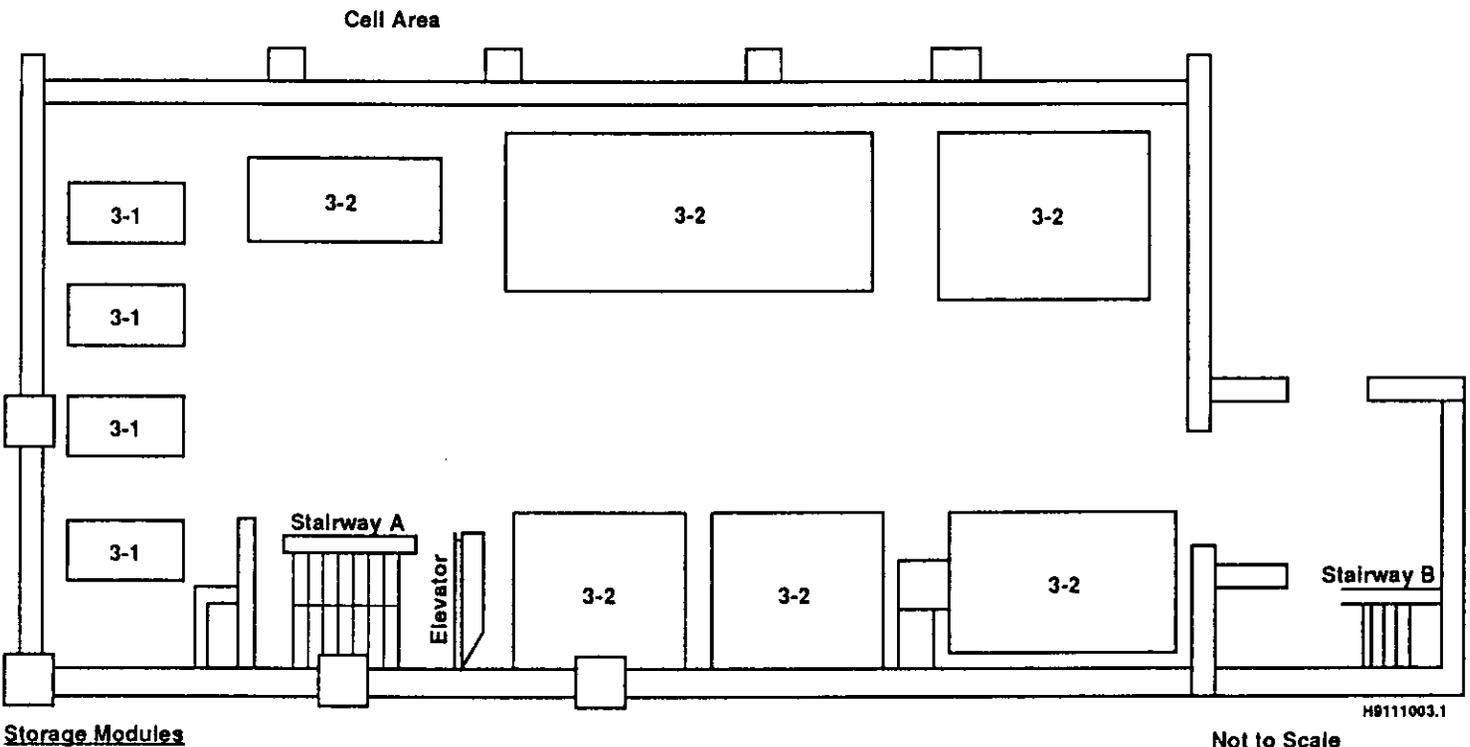
1
2
Figure 2-5. 224-T Transuranic Waste Storage and Assay Facility
Third Floor Plan.

22	"Other mixed waste" shown at northern end of third floor. Of attached Figure 2-5, a portion of storage modules numbered 3-1 are shown.
23	Photo of scaling and chipping paint on western wall of third floor of building.
24	Close-up photo of the scaling and chipping paint of photo number 23.
25	Photo of stained floor of elevator.

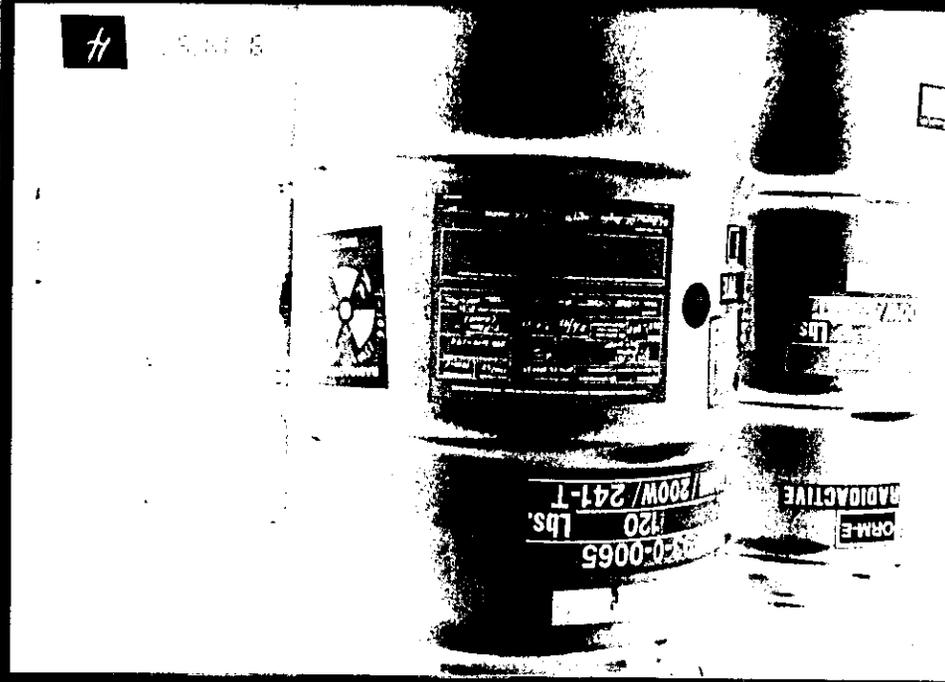
1 88.11.8

NUMBER	COMMENTS:
1	Hazardous waste drums (Backlog Waste) in first floor storage module number 1 (transuranic mixed waste initial storage) of attached Figure 2-3. Photo taken facing west.
2	Hazardous waste drums (Backlog Waste) in receiving area of first floor (see area identified on attached Figure 2-3) on portable secondary containment system. Photo taken facing southeast.
3	Close-up photo of label on one hazardous waste drum (Backlog Waste) in first floor storage module number 1 (transuranic mixed waste initial storage) of attached Figure 2-3.
4	Photo of hazardous waste drum showing label of photo number 3 in first floor initial storage module number 1 of attached Figure 2-3.
5	Drums in real-time radiography (RTR) x-ray room (see "RTR" room of attached Figure 2-3). Photo taken facing west.
6	Real-time radiography (RTR) x-ray system (shown as "RTR" on attached Figure 2-3). Photo taken facing north.
